Profile/Photo Observation Report

Street:	W 40th ave	Flow Control:	Not Controlled
City:	Hobart, IN	Year Renewed:	
Location:	Other	Tape/Media #:	
Purpose:	Not Known	Dia/Height:	8"
Use:	Sanitary	Material:	VCP
Drain Area:	NA	Lining:	
Category:	NA		
Comment:

Location Details:		Direction of Survey:	Downstream
US MH:	M-603-010	DS MH:	M-603-011
		Total Length Surveyed (ft):	29.7

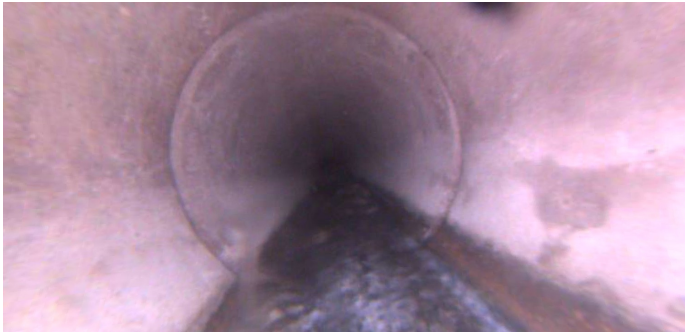
Code:	MWL
Description:	Water Level

Distance (ft):	.0
Structural Grade:	0
O&M Grade:	0
Clock Start/From:	
Clock To:	
1st Value:	
2nd Value:	
Value Percent:	5.000
Continuous Index:	
Within 8" of Joint:	NO
Remarks:

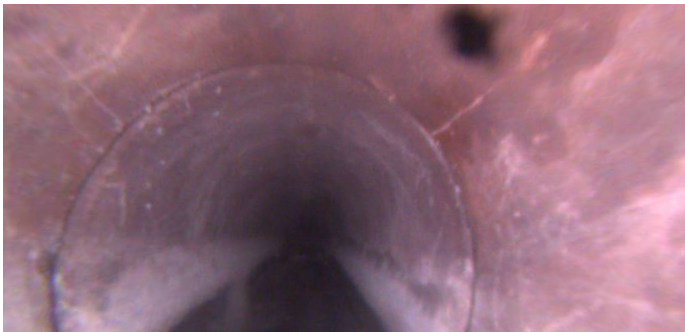
Code:	CM
Description:	Crack Multiple

Distance (ft):	10.6
Structural Grade:	3
O&M Grade:	0
Clock Start/From:	10
Clock To:	2
1st Value:	
2nd Value:	
Value Percent:	
Continuous Index:	
Within 8" of Joint:	YES
Remarks:

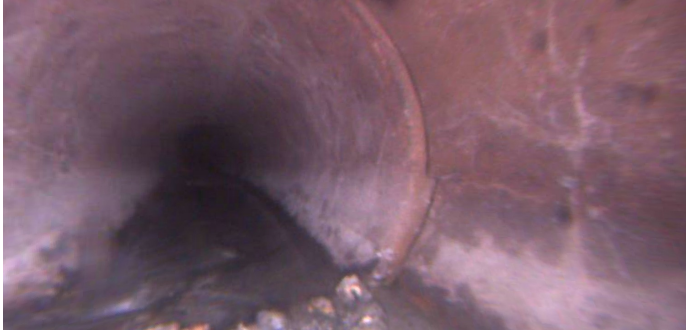
Code: **CL**
Description: **Crack Longitudinal**

Distance (ft): **13.7**
Structural Grade: **2**
O&M Grade: **0**
Clock Start/From: **3**
Clock To:
1st Value:
2nd Value:
Value Percent:
Continuous Index:
Within 8" of Joint: **YES**
Remarks:

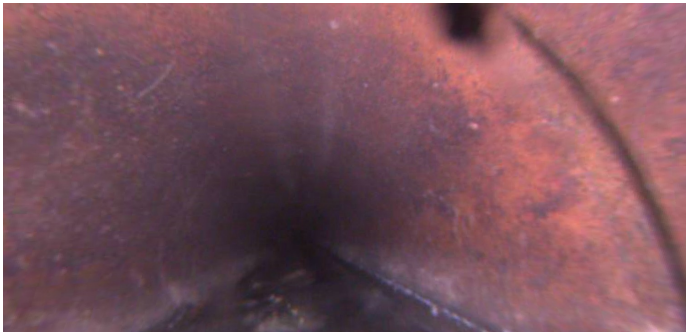
Code: **MSA**
Description: **Abandoned Survey**

Distance (ft): **29.7**
Structural Grade: **0**
O&M Grade: **0**
Clock Start/From:
Clock To:
1st Value:
2nd Value:
Value Percent:
Continuous Index:
Within 8" of Joint: **NO**
Remarks: **DEBRIS UNDER WATER**
