Profile/Photo Observation Report

Date:	08/05/2023	Weather:		Coding:	PACP 7.0
Pipe Length (ft):	190.2	Owner:	City of Hobart	Pre Clean:	Heavy Cleaning
P.O.#:	YES502259	Surveyor:	S. Bucklin	PSR:	P-603-011-010
Customer:	City of Hobart	Clean Date:	03/26/2023	Shape:	C

Street:	West 39th Place	Flow Control:	Not Controlled
City:	Hobart, IN	Year Renewed:	
Location:	Easement/Right of Way	Tape/Media #:	
Purpose:	Routine Assessment	Dia/Height:	10"
Use:	Sanitary Sewage Pipe	Material:	VCP
Drain Area:		Lining:	None
Category:	NA		
Comment:			
Location Details:		Direction of Survey:	Downstream
US MH:	M-603-010	DS MH:	M-603-011
		Total Length Surveyed (ft):	190.2

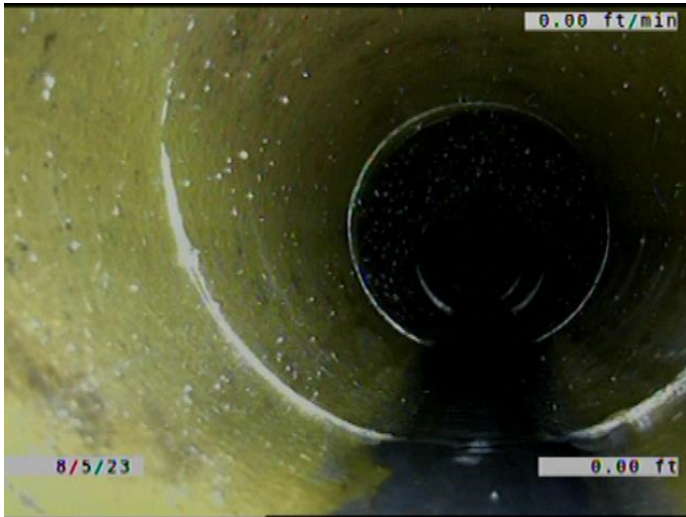
Code: **DSF**
Description: **Deposits Settled Fine**

Distance (ft): **.0**
Structural Grade: **0**
O&M Grade: **2**
Clock Start/From: **5**
Clock To: **7**
1st Value:
2nd Value:
Value Percent: **5.000**
Continuous Index: **S01**
Within 8" of Joint: **YES**
Remarks:

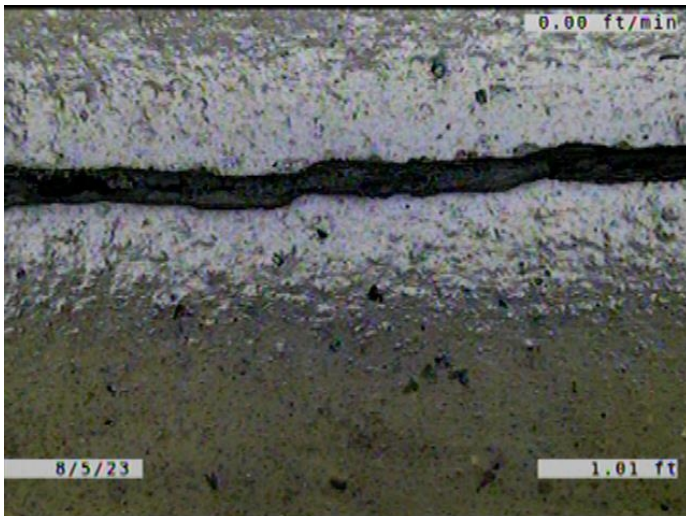
Code: **BVV**
Description: **Broken Void Visible**

Distance (ft): **1.0**
Structural Grade: **5**
O&M Grade: **0**
Clock Start/From: **12**
Clock To: **12**
1st Value:
2nd Value:
Value Percent:
Continuous Index:
Within 8" of Joint: **NO**
Remarks:

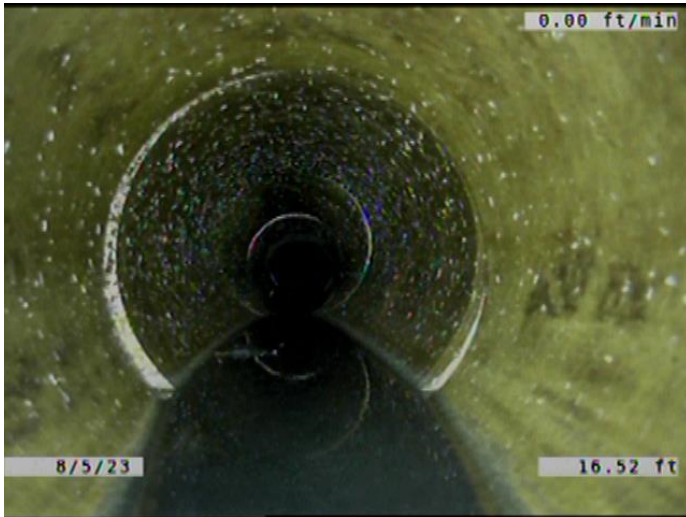
Code: **MWLS**
Description: **Miscellaneous Water Level Sag**

Distance (ft): **16.5**
Structural Grade: **2**
O&M Grade: **0**
Clock Start/From:
Clock To:
1st Value:
2nd Value:
Value Percent: **10.000**
Continuous Index: **S02**
Within 8" of Joint: **NO**
Remarks:

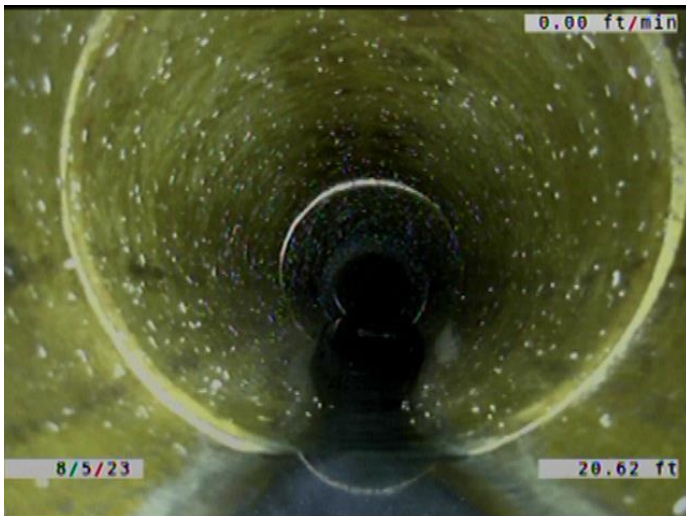
Code: **MWLS**
Description: **Miscellaneous Water Level Sag**

Distance (ft): **20.6**
Structural Grade: **2**
O&M Grade: **0**
Clock Start/From:
Clock To:
1st Value:
2nd Value:
Value Percent: **10.000**
Continuous Index: **F02**
Within 8" of Joint: **NO**
Remarks:

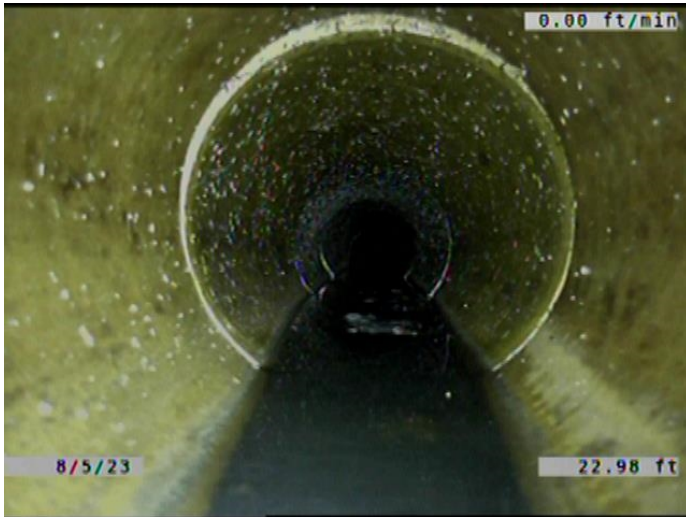
Code: **MWLS**
Description: **Miscellaneous Water Level Sag**

Distance (ft): **23.0**
Structural Grade: **2**
O&M Grade: **0**
Clock Start/From:
Clock To:
1st Value:
2nd Value:
Value Percent: **30.000**
Continuous Index: **S03**
Within 8" of Joint: **NO**
Remarks:

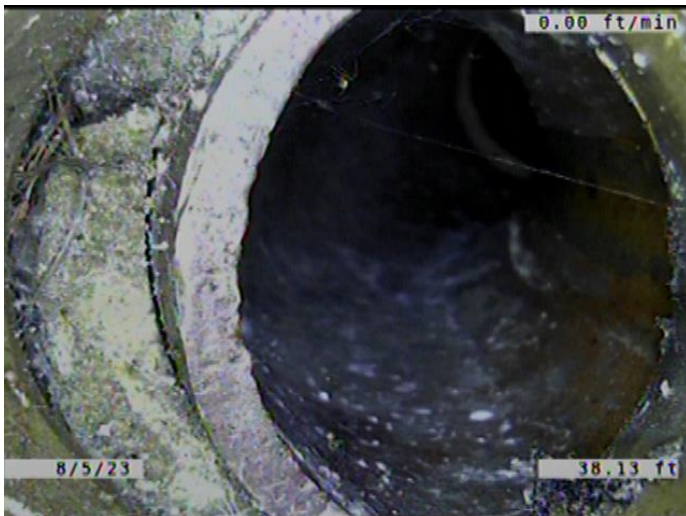
Code: **TFD**
Description: **Tap Factory Defective**

Distance (ft): **38.1**
Structural Grade: **0**
O&M Grade: **3**
Clock Start/From: **2**
Clock To:
1st Value: **6.000**
2nd Value:
Value Percent:
Continuous Index:
Within 8" of Joint: **YES**
Remarks: **SERVICE LARGE OFFSET. SOIL VISIBLE. +**

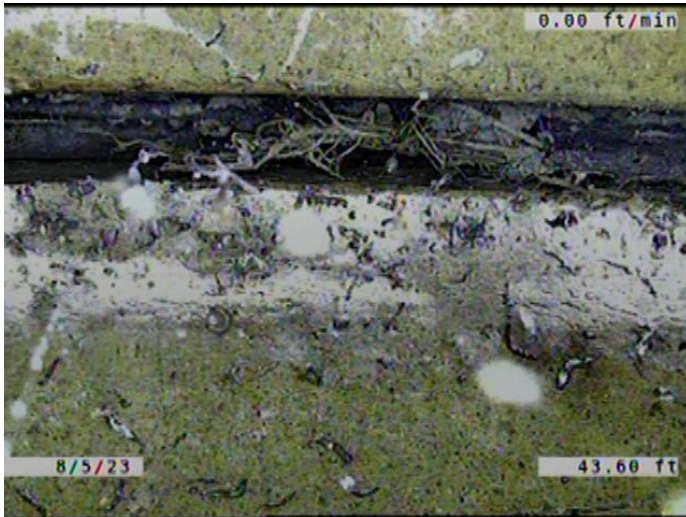
Code: **RFJ**
Description: **Roots Fine Joint**

Distance (ft): **43.6**
Structural Grade: **0**
O&M Grade: **1**
Clock Start/From: **8**
Clock To: **4**
1st Value:
2nd Value:
Value Percent:
Continuous Index: **S04**
Within 8" of Joint: **YES**
Remarks:

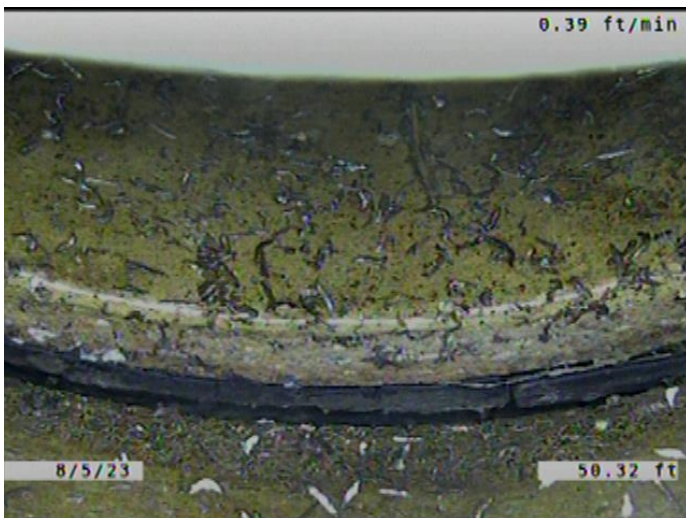
Code: **JOMD**
Description: **Joint Offset Medium Defective**

Distance (ft): **50.3**
Structural Grade: **3**
O&M Grade: **0**
Clock Start/From:
Clock To:
1st Value:
2nd Value:
Value Percent:
Continuous Index:
Within 8" of Joint: **NO**
Remarks:

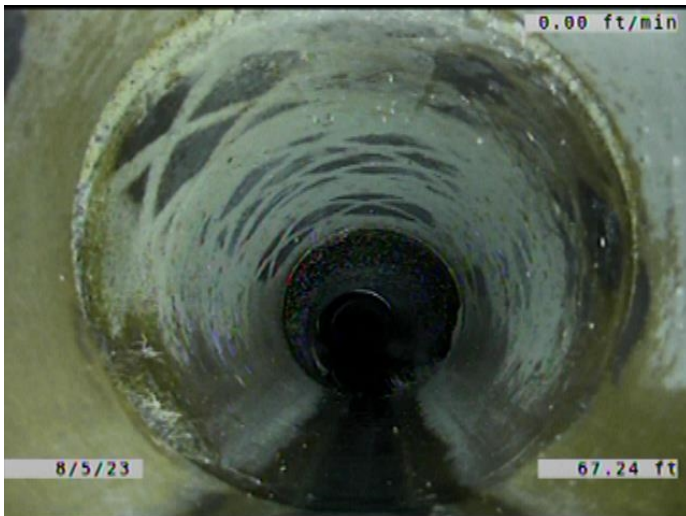
Code: **MWLS**
Description: **Miscellaneous Water Level Sag**

Distance (ft): **67.2**
Structural Grade: **2**
O&M Grade: **0**
Clock Start/From:
Clock To:
1st Value:
2nd Value:
Value Percent: **30.000**
Continuous Index: **F03**
Within 8" of Joint: **NO**
Remarks:

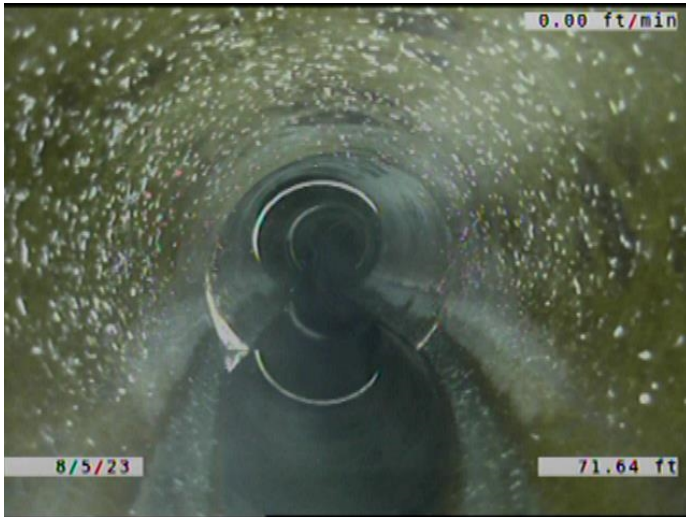
Code: **MWLS**
Description: **Miscellaneous Water Level Sag**

Distance (ft): **71.6**
Structural Grade: **2**
O&M Grade: **0**
Clock Start/From:
Clock To:
1st Value:
2nd Value:
Value Percent: **15.000**
Continuous Index: **S05**
Within 8" of Joint: **NO**
Remarks:

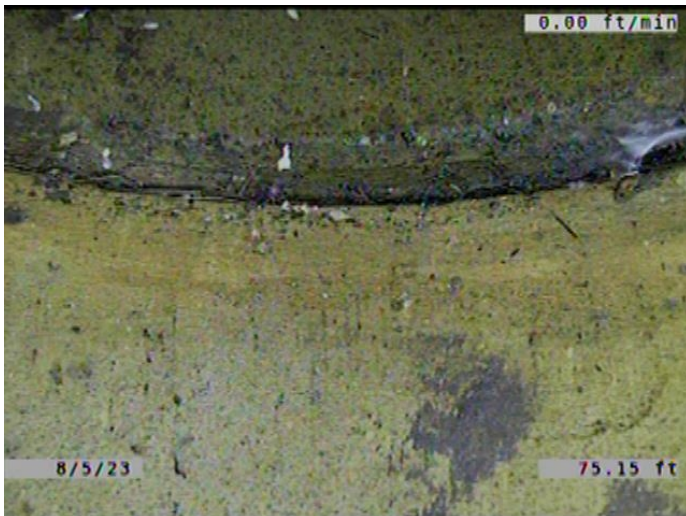
Code: **JOMD**
Description: **Joint Offset Medium Defective**

Distance (ft): **75.1**
Structural Grade: **3**
O&M Grade: **0**
Clock Start/From:
Clock To:
1st Value:
2nd Value:
Value Percent:
Continuous Index:
Within 8" of Joint: **NO**
Remarks:

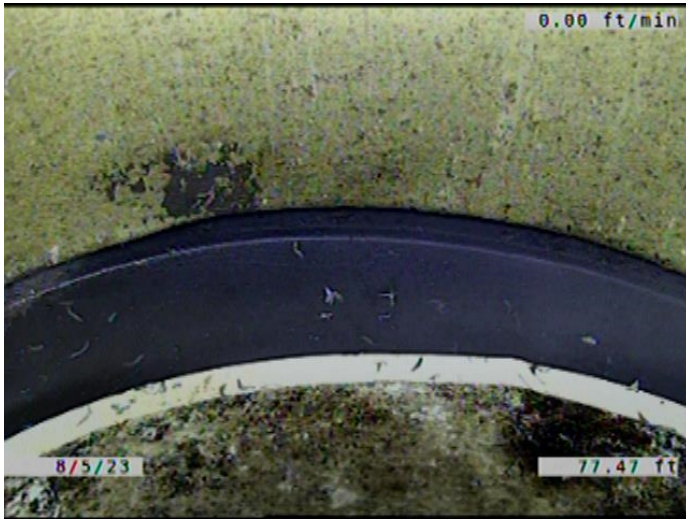
Code: **JOLD**
Description: **Joint Offset Large Defective**

Distance (ft): **77.5**
Structural Grade: **4**
O&M Grade: **0**
Clock Start/From:
Clock To:
1st Value:
2nd Value:
Value Percent:
Continuous Index:
Within 8" of Joint: **NO**
Remarks:

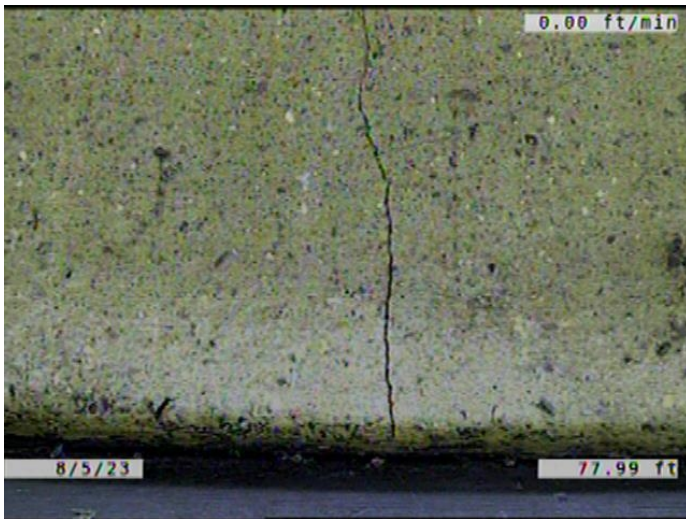
Code: **CL**
Description: **Crack Longitudinal**

Distance (ft): **78.0**
Structural Grade: **2**
O&M Grade: **0**
Clock Start/From: **12**
Clock To:
1st Value:
2nd Value:
Value Percent:
Continuous Index:
Within 8" of Joint: **YES**
Remarks:

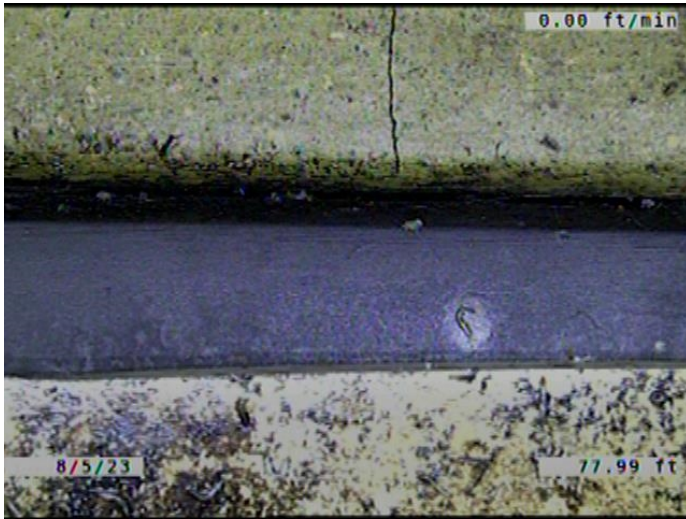
Code: **RPR**
Description: **Point Repair Replacement**

Distance (ft): **78.0**
Structural Grade: **0**
O&M Grade: **0**
Clock Start/From:
Clock To:
1st Value:
2nd Value:
Value Percent:
Continuous Index: **S06**
Within 8" of Joint: **YES**
Remarks: **REPLACED WITH PVC.**

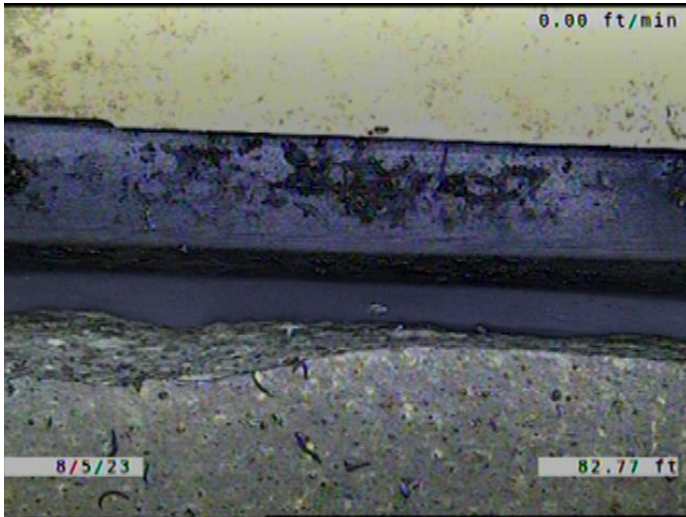
Code: **RPR**
Description: **Point Repair Replacement**

Distance (ft): **82.8**
Structural Grade: **0**
O&M Grade: **0**
Clock Start/From:
Clock To:
1st Value:
2nd Value:
Value Percent:
Continuous Index: **F06**
Within 8" of Joint: **YES**
Remarks: **REPLACED WITH PVC.**

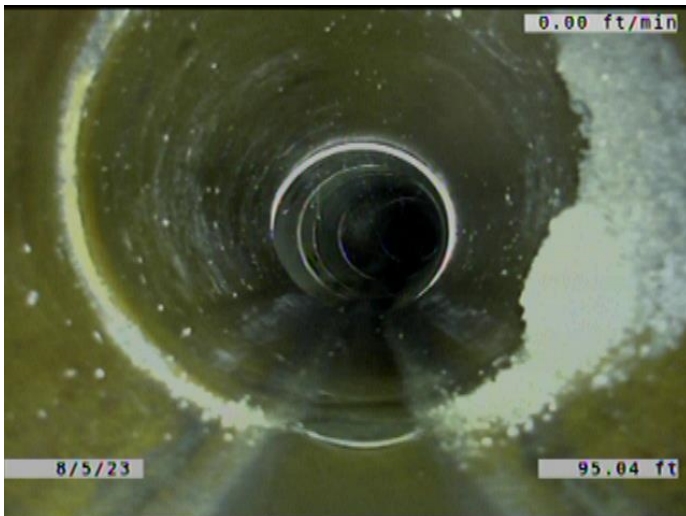
Code: **MWLS**
Description: **Miscellaneous Water Level Sag**

Distance (ft): **95.0**
Structural Grade: **2**
O&M Grade: **0**
Clock Start/From:
Clock To:
1st Value:
2nd Value:
Value Percent: **15.000**
Continuous Index: **F05**
Within 8" of Joint: **NO**
Remarks:

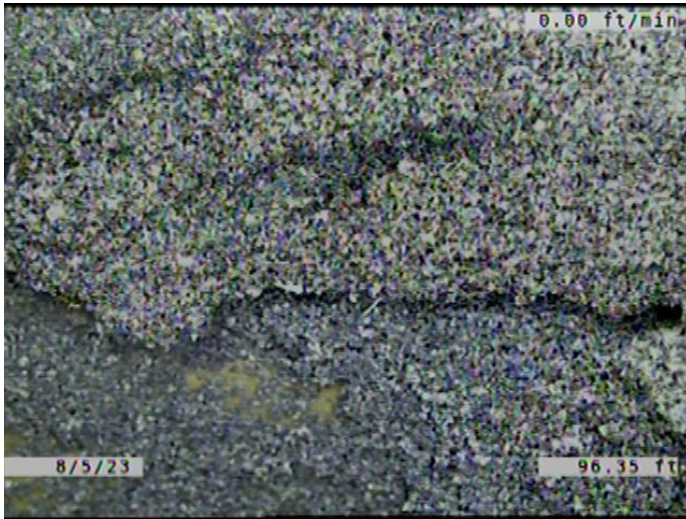
Code: **DAZ**
Description: **Deposits Attached Other**

Distance (ft): **96.4**
Structural Grade: **0**
O&M Grade: **2**
Clock Start/From: **7**
Clock To: **5**
1st Value:
2nd Value:
Value Percent: **5.000**
Continuous Index:
Within 8" of Joint: **YES**
Remarks: **DIRT/MUD**

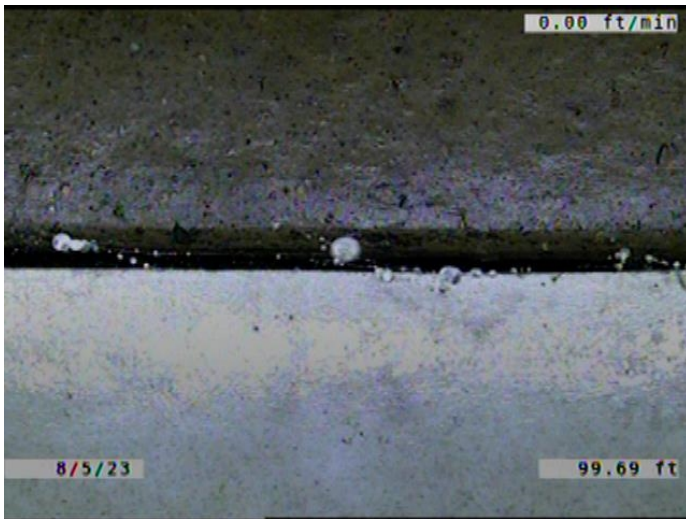
Code: **RPR**
Description: **Point Repair Replacement**

Distance (ft): **99.7**
Structural Grade: **0**
O&M Grade: **0**
Clock Start/From:
Clock To:
1st Value:
2nd Value:
Value Percent:
Continuous Index: **S07**
Within 8" of Joint: **YES**
Remarks: **REPLACED WITH PVC**

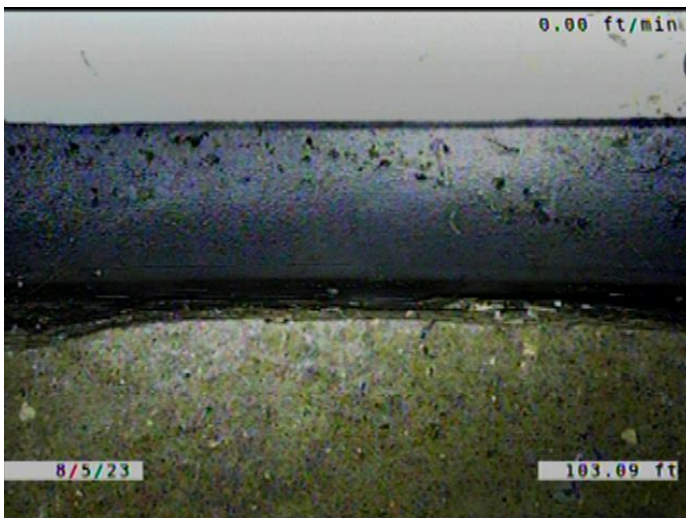
Code:	RPR
Description:	Point Repair Replacement
Distance (ft):	103.1
Structural Grade:	0
O&M Grade:	0
Clock Start/From:	
Clock To:	
1st Value:	
2nd Value:	
Value Percent:	
Continuous Index:	F07
Within 8" of Joint:	YES
Remarks:	REPLACED WITH PVC

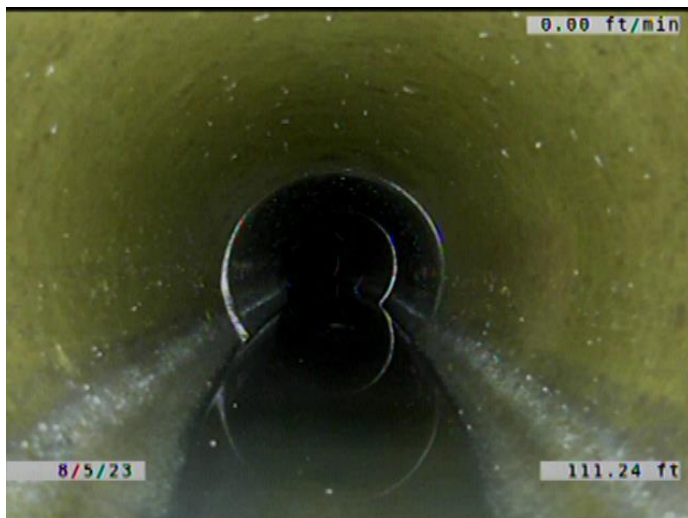
Code: **MWLS**
Description: **Miscellaneous Water Level Sag**

Distance (ft): **111.2**
Structural Grade: **2**
O&M Grade: **0**
Clock Start/From:
Clock To:
1st Value:
2nd Value:
Value Percent: **20.000**
Continuous Index: **S08**
Within 8" of Joint: **NO**
Remarks:

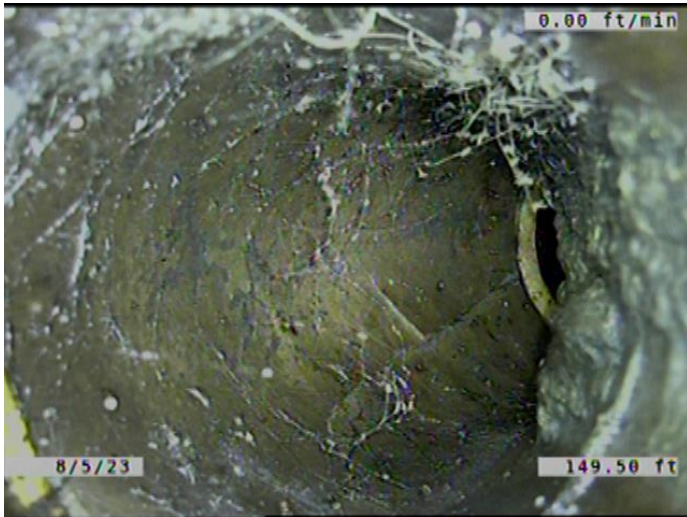
Code: **TFD**
Description: **Tap Factory Defective**

Distance (ft): **149.5**
Structural Grade: **0**
O&M Grade: **3**
Clock Start/From: **2**
Clock To:
1st Value: **6.000**
2nd Value:
Value Percent:
Continuous Index:
Within 8" of Joint: **YES**
Remarks: **SERVICE BROKEN. ROOTS GROWING IN THE JOINTS AND THROUGH THE B**

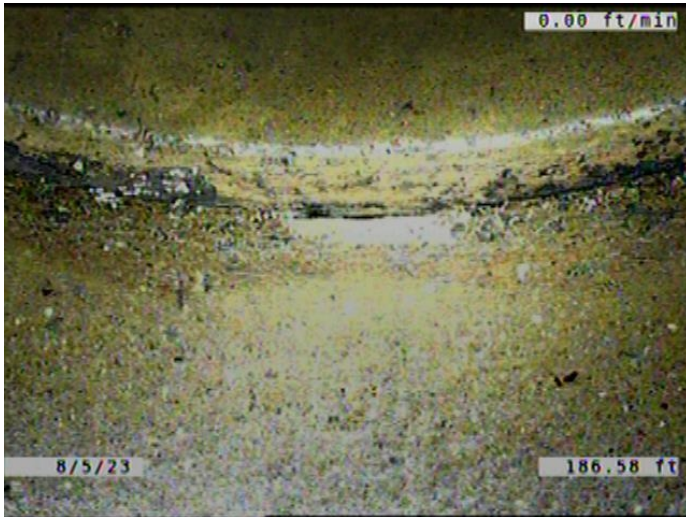
Code: **JOMD**
Description: **Joint Offset Medium Defective**

Distance (ft): **186.6**
Structural Grade: **3**
O&M Grade: **0**
Clock Start/From:
Clock To:
1st Value:
2nd Value:
Value Percent:
Continuous Index:
Within 8" of Joint: **NO**
Remarks:

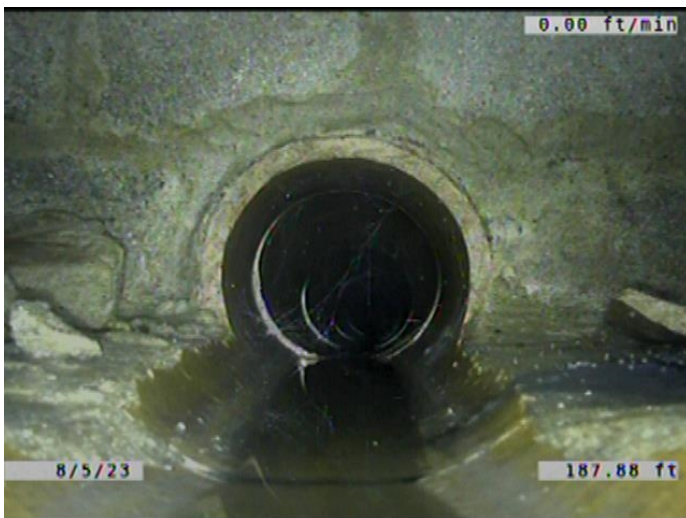
Code: **MWLS**
Description: **Miscellaneous Water Level Sag**

Distance (ft): **187.9**
Structural Grade: **2**
O&M Grade: **0**
Clock Start/From:
Clock To:
1st Value:
2nd Value:
Value Percent: **20.000**
Continuous Index: **F08**
Within 8" of Joint: **NO**
Remarks:

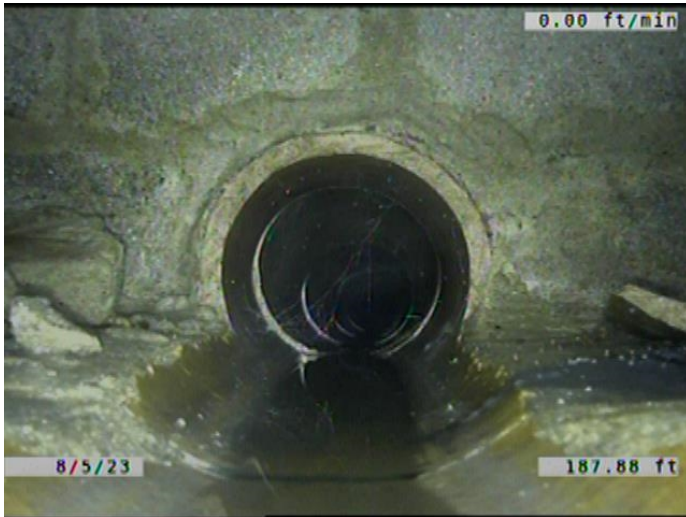
Code: **RFJ**
Description: **Roots Fine Joint**

Distance (ft): **187.9**
Structural Grade: **0**
O&M Grade: **1**
Clock Start/From: **8**
Clock To: **4**
1st Value:
2nd Value:
Value Percent:
Continuous Index: **F04**
Within 8" of Joint: **YES**
Remarks:

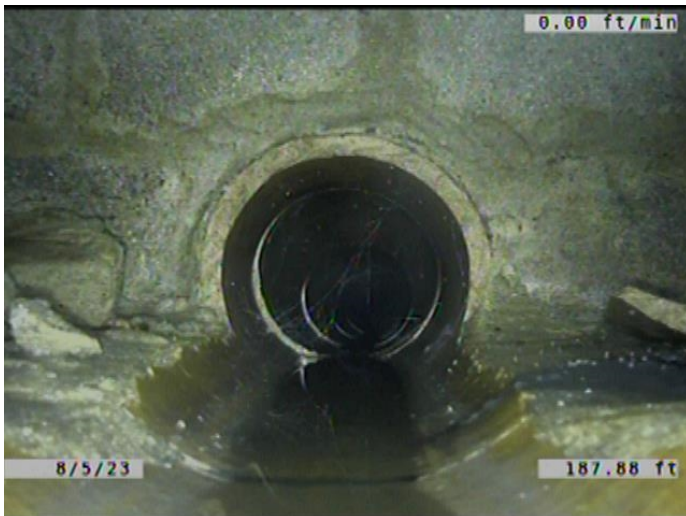
Code: **DSF**
Description: **Deposits Settled Fine**

Distance (ft): **187.9**
Structural Grade: **0**
O&M Grade: **2**
Clock Start/From: **5**
Clock To: **7**
1st Value:
2nd Value:
Value Percent: **5.000**
Continuous Index: **F01**
Within 8" of Joint: **YES**
Remarks:
