Profile/Photo Observation Report

Street:	W 39TH PL	Flow Control:	Not Controlled
City:	Hobart, IN	Year Renewed:	
Location:	Other	Tape/Media #:	
Purpose:	Not Known	Dia/Height:	8"
Use:	Sanitary	Material:	VCP
Drain Area:	NA	Lining:	
Category:	NA		
Comment:

Location Details:		Direction of Survey:	Downstream
US MH:	M-603-011	DS MH:	M-603-012
		Total Length Surveyed (ft):	38.7

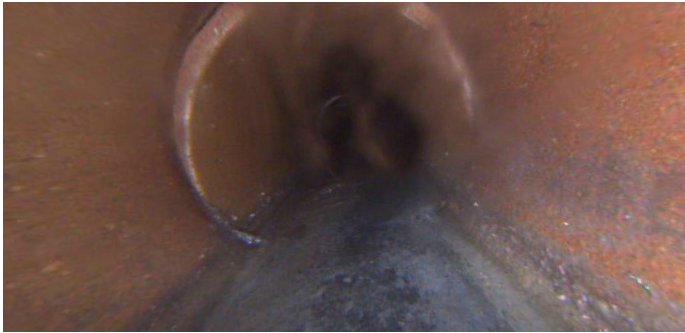
Code:	MWL
Description:	Water Level

Distance (ft):	.0
Structural Grade:	0
O&M Grade:	0
Clock Start/From:	
Clock To:	
1st Value:	
2nd Value:	
Value Percent:	10.000
Continuous Index:	
Within 8" of Joint:	NO
Remarks:

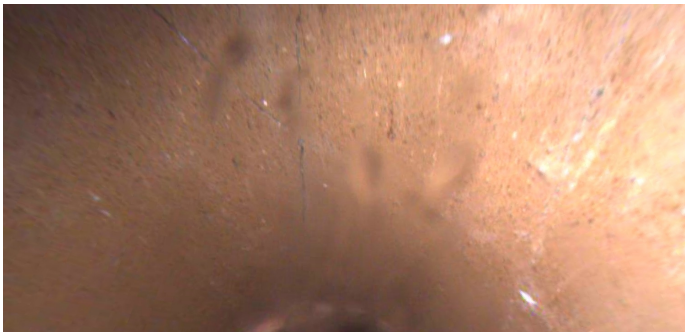
Code:	FM
Description:	Fracture Multiple

Distance (ft):	4.2
Structural Grade:	4
O&M Grade:	0
Clock Start/From:	11
Clock To:	12
1st Value:	
2nd Value:	
Value Percent:	
Continuous Index:	
Within 8" of Joint:	YES
Remarks:

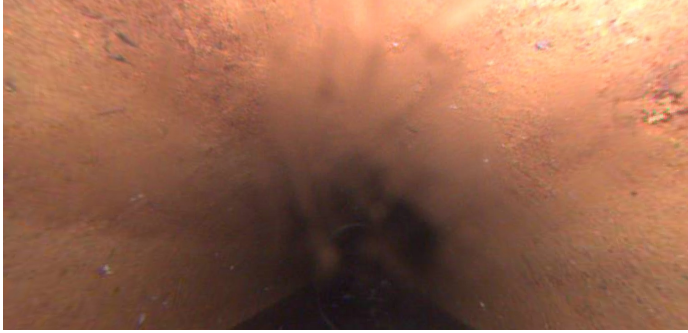
Code:	MSA
Description:	Abandoned Survey
Distance (ft):	38.7
Structural Grade:	0
O&M Grade:	0
Clock Start/From:	
Clock To:	
1st Value:	
2nd Value:	
Value Percent:	
Continuous Index:	
Within 8" of Joint:	NO
Remarks:	debris under water
