## Profile/Photo Observation Report

Street:	<b>W 40th ave</b>	Flow Control:	<b>Not Controlled</b>
City:	<b>Hobart, IN</b>	Year Renewed:	
Location:	<b>Other</b>	Tape/Media #:	
Purpose:	<b>Not Known</b>	Dia/Height:	<b>8"</b>
Use:	<b>Sanitary</b>	Material:	<b>VCP</b>
Drain Area:	<b>NA</b>	Lining:	
Category:	<b>NA</b>		
Comment:

Location Details:		Direction of Survey:	<b>Downstream</b>
US MH:	<b>M-603-011</b>	DS MH:	<b>M-603-012</b>
		Total Length Surveyed (ft):	<b>38.7</b>

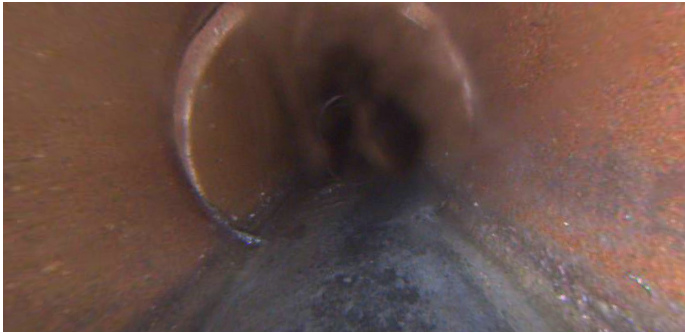
Code:	<b>MWL</b>
Description:	<b>Water Level</b>

Distance (ft):	<b>.0</b>
Structural Grade:	<b>0</b>
O&M Grade:	<b>0</b>
Clock Start/From:	
Clock To:	
1st Value:	
2nd Value:	
Value Percent:	<b>10.000</b>
Continuous Index:	
Within 8" of Joint:	<b>NO</b>
Remarks:

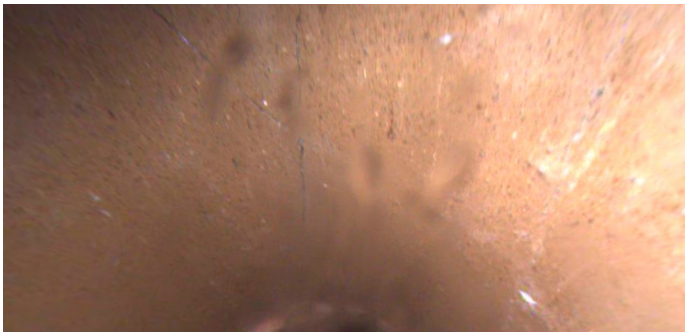
Code:	<b>FM</b>
Description:	<b>Fracture Multiple</b>

Distance (ft):	<b>4.2</b>
Structural Grade:	<b>4</b>
O&M Grade:	<b>0</b>
Clock Start/From:	<b>11</b>
Clock To:	<b>12</b>
1st Value:	
2nd Value:	
Value Percent:	
Continuous Index:	
Within 8" of Joint:	<b>YES</b>
Remarks:

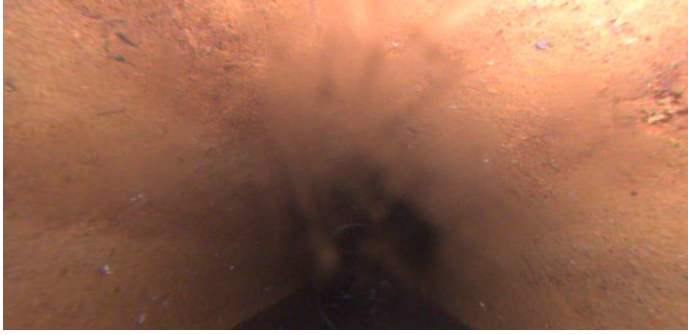
Code:	<b>MSA</b>
Description:	<b>Abandoned Survey</b>
Distance (ft):	<b>38.7</b>
Structural Grade:	<b>0</b>
O&M Grade:	<b>0</b>
Clock Start/From:	
Clock To:	
1st Value:	
2nd Value:	
Value Percent:	
Continuous Index:	
Within 8" of Joint:	<b>NO</b>
Remarks:	<b>debris under water</b>
