Date:	10/24/2021	Weather:	Lisbort IN	Coding:	PACP 6.0
Pipe Length (ft) P.O.#:	995_2	Owner: Surveyor:	Hobart, IN M. Pielacha	Pre Clean: PSR:	Not Known P-603-019-018
Customer:	Hobart, IN	Clean Date:		Shape:	C
Street:	37th Avenue		Flow Control:		
City:	Hobart, IN		Year Renewed:		
Location:	Light Highway		Tape/Media #:	995	
Purpose:	Routine Assessment		Dia/Height:	8"	
Use:	Sanitary		Material:	VCP	
Drain Area:			Lining:		
Category:	NA				
Comment:					
Location Detail	s:		Direction of Surv	ey: Upstream	
US MH:	M-603-18	DS MH:	M-603-19	Total Length Surveyed (ft)	: 58.0
0&M Index:	2.00	O&M Quick:	2100	0 O&M Rating:	2.00
Structural Index:	0.00	– Structural Qu	uick: 0000	Structural Rating:	0.00
verall Index: 2.00		Overall Quick		Overall Rating:	2.00

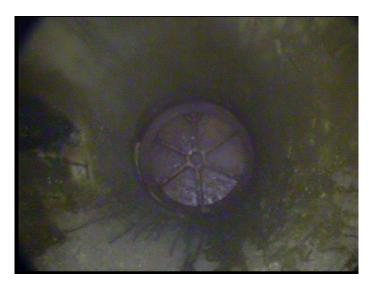
Code: Description:	AMH Manhole
Distance (ft):	.0
Structural Grade:	0
O&M Grade:	0
Clock Start/From:	
Clock To:	
1st Value:	
2nd Value:	
Value Percent:	
Continuous Index:	
Within 8" of Joint:	NO
Remarks:	M-603-19

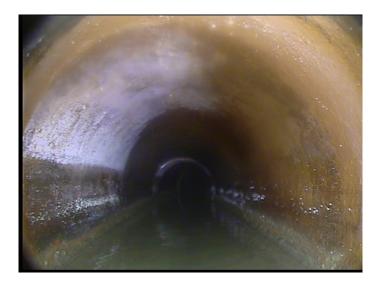
Code:	MWL
Description:	Water Level
Distance (ft):	.0
()	
Structural Grade:	0
O&M Grade:	0
Clock Start/From:	
Clock To:	
1st Value:	
2nd Value:	
Value Percent:	10.000
Continuous Index:	
Within 8" of Joint:	NO
Remarks:
