Profile/Photo Observation Report

Date:	10/18/2021	Weather:		Coding:	PACP 6.0
Pipe Length (ft):		Owner:	Hobart, IN	Pre Clean:	Not Known
P.O.#:	883_1	Surveyor:	M. Pielacha	PSR:	P-603-0SL-022
Customer:	Hobart, IN	Clean Date:		Shape:	C

Street:	YMCA Parking Lot	Flow Control:	
City:	Hobart, IN	Year Renewed:	
Location:	Parking Lot	Tape/Media #:	883
Purpose:	Routine Assessment	Dia/Height:	8"
Use:	Sanitary	Material:	VCP
Drain Area:		Lining:	
Category:	NA		
Comment:

Location Details:		Direction of Survey:	Upstream
US MH:	M-603-22	DS MH:	M-603-22
		Total Length Surveyed (ft):	105.6

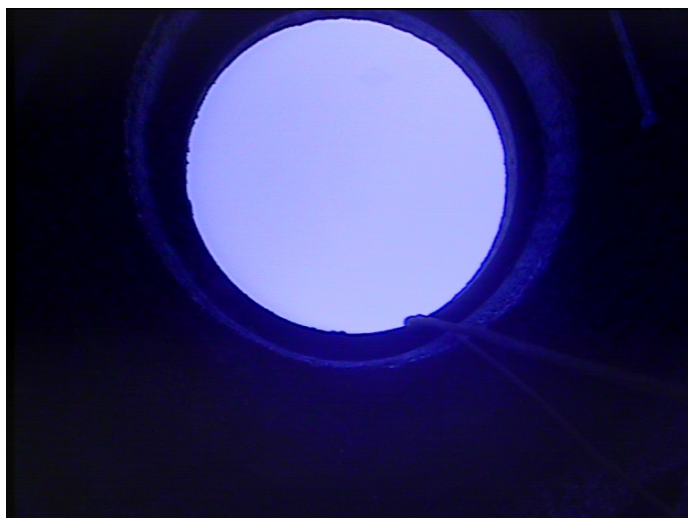
Code: **AMH**
Description: **Manhole**

Distance (ft): **.0**
Structural Grade: **0**
O&M Grade: **0**
Clock Start/From:
Clock To:
1st Value:
2nd Value:
Value Percent:
Continuous Index:
Within 8" of Joint: **NO**
Remarks: **M-603-22**

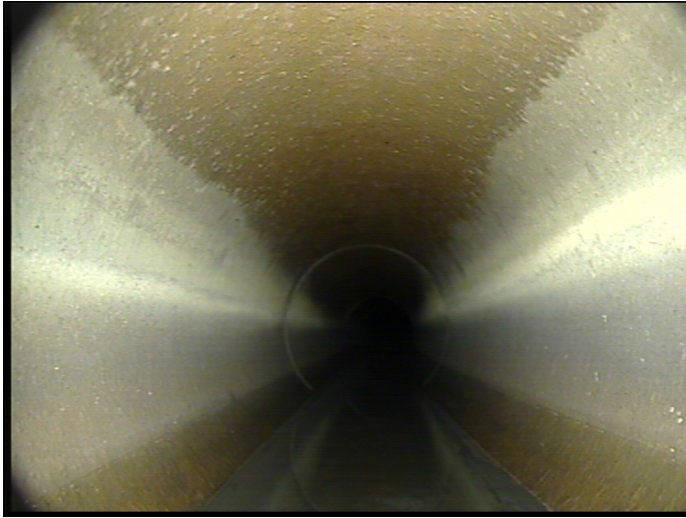
Code: **MWL**
Description: **Water Level**

Distance (ft): **.0**
Structural Grade: **0**
O&M Grade: **0**
Clock Start/From:
Clock To:
1st Value:
2nd Value:
Value Percent: **5.000**
Continuous Index:
Within 8" of Joint: **NO**
Remarks:

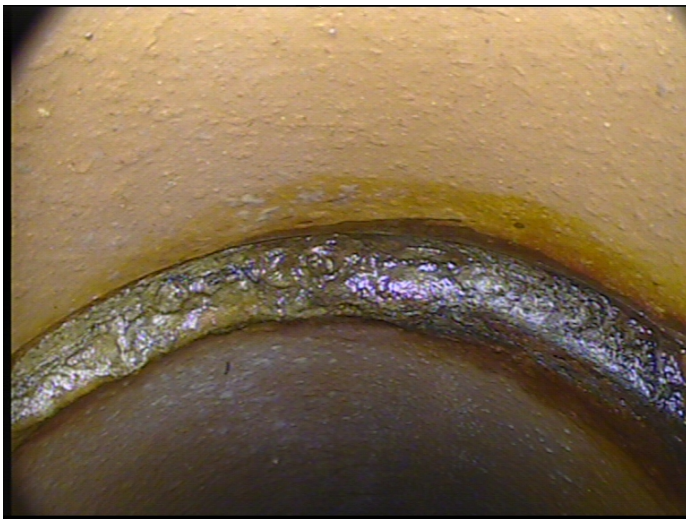
Code: **DAE**
Description: **Deposits Attached Encrustation**

Distance (ft): **25.6**
Structural Grade: **0**
O&M Grade: **2**
Clock Start/From: **7**
Clock To: **5**
1st Value:
2nd Value:
Value Percent: **5.000**
Continuous Index:
Within 8" of Joint: **YES**
Remarks:

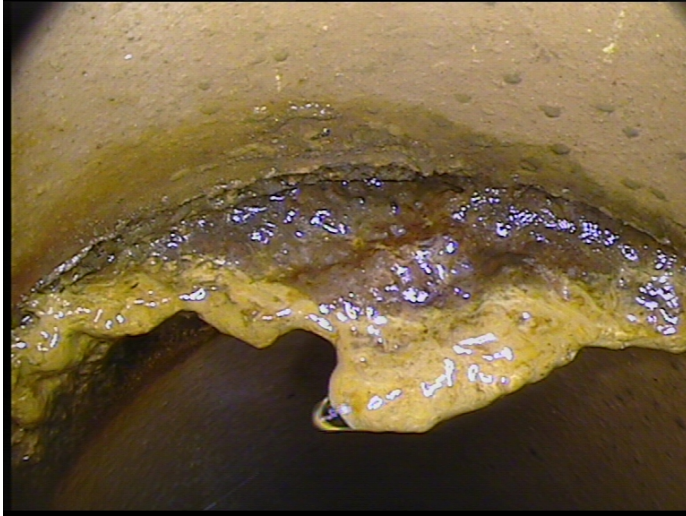
Code:	DAE
Description:	Deposits Attached Encrustation
Distance (ft):	33.7
Structural Grade:	0
O&M Grade:	2
Clock Start/From:	7
Clock To:	11
1st Value:	
2nd Value:	
Value Percent:	5.000
Continuous Index:	
Within 8" of Joint:	YES
Remarks:

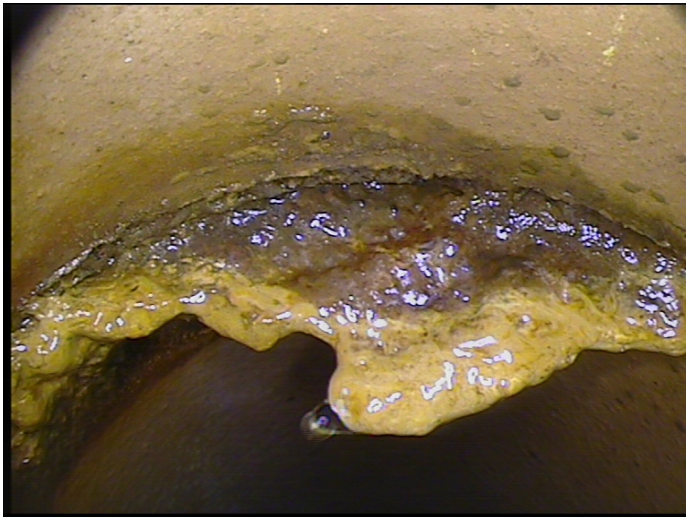
Code:	ID
Description:	Infil Dripper
Distance (ft):	33.7
Structural Grade:	0
O&M Grade:	3
Clock Start/From:	11
Clock To:	
1st Value:	
2nd Value:	
Value Percent:	
Continuous Index:	
Within 8" of Joint:	YES
Remarks:

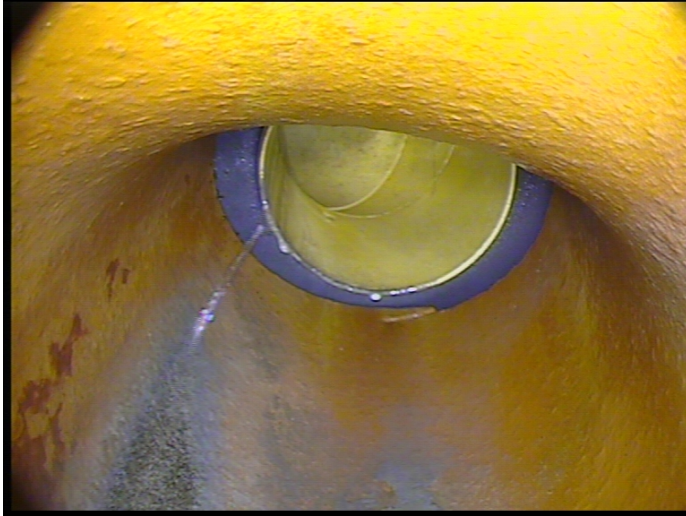
Code: **LU**
Description: **Alignment Up**

Distance (ft): **105.6**
Structural Grade: **0**
O&M Grade: **4**
Clock Start/From:
Clock To:
1st Value:
2nd Value:
Value Percent: **45.000**
Continuous Index:
Within 8" of Joint: **NO**
Remarks:

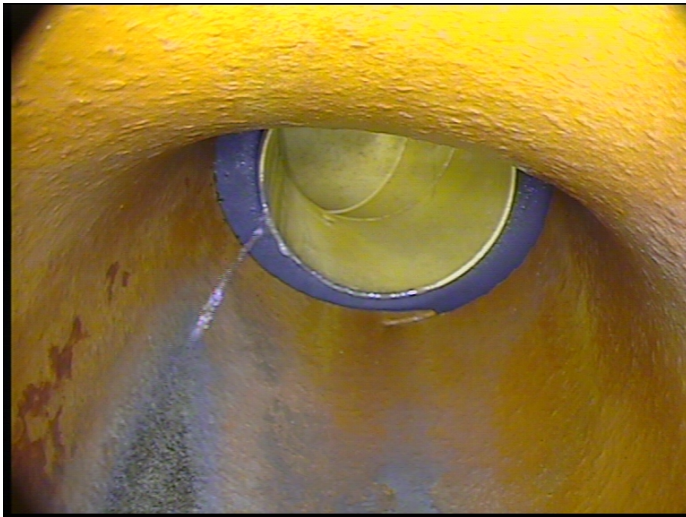
Code: **MGO**
Description: **General Observation**

Distance (ft): **105.6**
Structural Grade: **0**
O&M Grade: **0**
Clock Start/From:
Clock To:
1st Value:
2nd Value:
Value Percent:
Continuous Index:
Within 8" of Joint: **NO**
Remarks: **End of segment. Appears to be a service connection.**

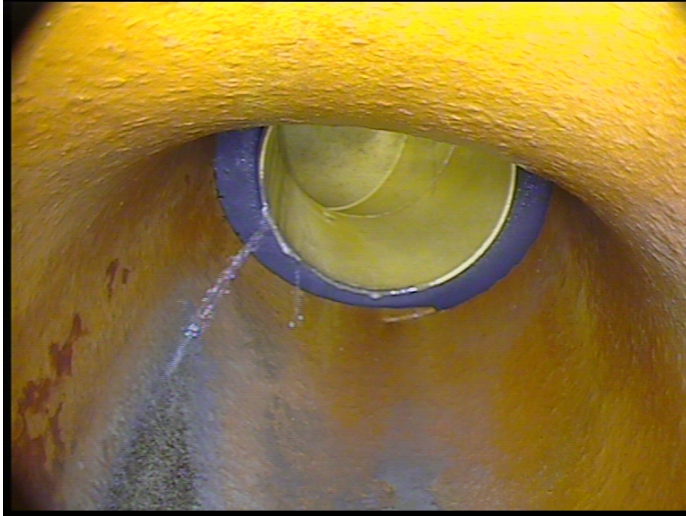
Code:	AMH
Description:	Manhole
Distance (ft):	105.6
Structural Grade:	0
O&M Grade:	0
Clock Start/From:	
Clock To:	
1st Value:	
2nd Value:	
Value Percent:	
Continuous Index:	
Within 8" of Joint:	NO
Remarks:	M-603-22
