Profile/Photo Observation Report

Date:	04/12/2018	Weather:		Coding:	PACP 6.0
Pipe Length (ft):		Owner:	City of Hobart	Pre Clean:	No Pre-Cleaning
P.O.#:	32-1	Surveyor:	M. Pielacha	PSR:	M-603-024-M-603-024
Customer:	City of Hobart	Clean Date:		Shape:	C

Street:	Off 40th Place	Flow Control:	Not Controlled
City:	Hobart, IN	Year Renewed:	
Location:	Light Highway	Tape/Media #:	DEP 32
Purpose:	Routine Assessment	Dia/Height:	6"
Use:	Sanitary	Material:	PVC
Drain Area:		Lining:	
Category:	NA		
Comment:			
Location Details:		Direction of Survey:	Upstream
US MH:	UNK-024	DS MH:	M-603-024
		Total Length Surveyed (ft):	12.5

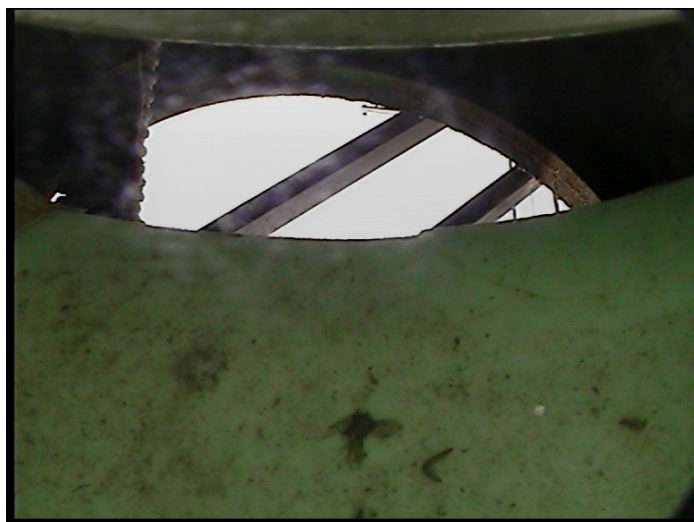
Code: **AMH**
Description: **Manhole**

Distance (ft): **.0**
Structural Grade: **0**
O&M Grade: **0**
Clock Start/From:
Clock To:
1st Value:
2nd Value:
Value Percent:
Continuous Index:
Within 8" of Joint: **NO**
Remarks: **M-603-024**

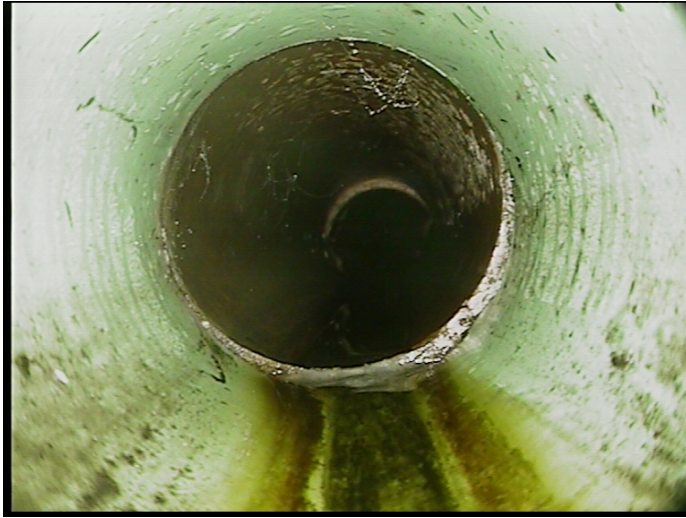
Code: **MWL**
Description: **Water Level**

Distance (ft): **.0**
Structural Grade: **0**
O&M Grade: **0**
Clock Start/From:
Clock To:
1st Value:
2nd Value:
Value Percent: **5.000**
Continuous Index:
Within 8" of Joint: **NO**
Remarks:

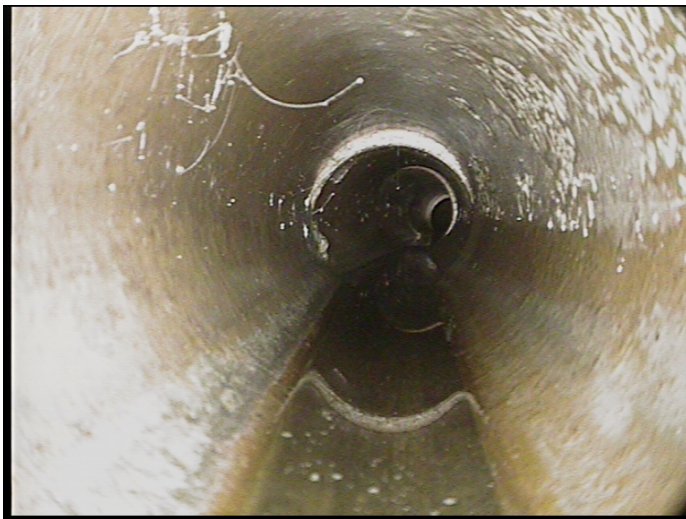
Code: **MMC**
Description: **Material Change**

Distance (ft): **2.9**
Structural Grade: **0**
O&M Grade: **0**
Clock Start/From:
Clock To:
1st Value:
2nd Value:
Value Percent:
Continuous Index:
Within 8" of Joint: **NO**
Remarks: **vcp**

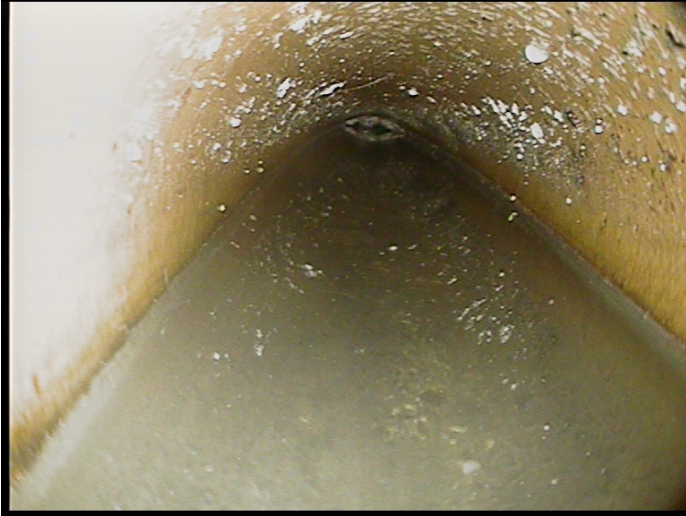
Code:	MSA
Description:	Abandoned Survey
Distance (ft):	12.5
Structural Grade:	0
O&M Grade:	0
Clock Start/From:	
Clock To:	
1st Value:	
2nd Value:	
Value Percent:	
Continuous Index:	
Within 8" of Joint:	NO
Remarks:	Sag + Sediment
