Profile/Photo Observation Report

Date:	04/12/2018	Weather:		Coding:	PACP 6.0
Pipe Length (ft):		Owner:	City of Hobart	Pre Clean:	No Pre-Cleaning
P.O.#:	32-1	Surveyor:	M. Pielacha	PSR:	M-603-024-M-603-024
Customer:	City of Hobart	Clean Date:		Shape:	C

Street:	Off 40th Place	Flow Control:	Not Controlled
City:	Hobart, IN	Year Renewed:	
Location:	Light Highway	Tape/Media #:	DEP 32
Purpose:	Routine Assessment	Dia/Height:	6"
Use:	Sanitary	Material:	PVC
Drain Area:		Lining:

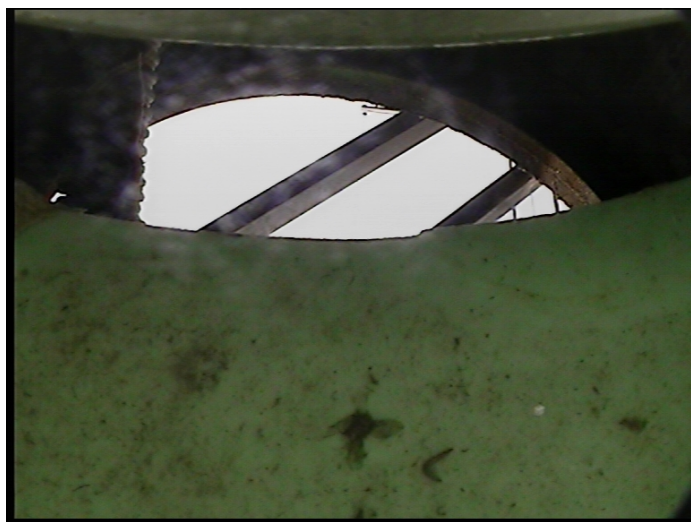
Code: **AMH**
Description: **Manhole**

Distance (ft): **.0**
Structural Grade: **0**
O&M Grade: **0**
Clock Start/From:
Clock To:
1st Value:
2nd Value:
Value Percent:
Continuous Index:
Within 8" of Joint: **NO**
Remarks: **M-603-024**

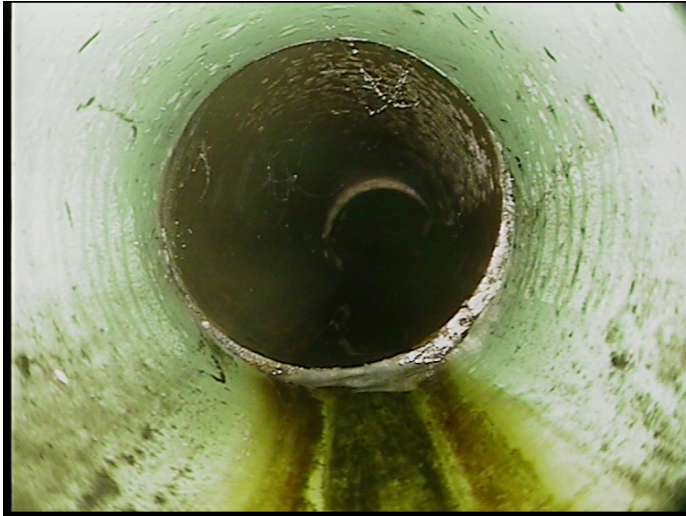
Code: **MWL**
Description: **Water Level**

Distance (ft): **.0**
Structural Grade: **0**
O&M Grade: **0**
Clock Start/From:
Clock To:
1st Value:
2nd Value:
Value Percent: **5.000**
Continuous Index:
Within 8" of Joint: **NO**
Remarks:

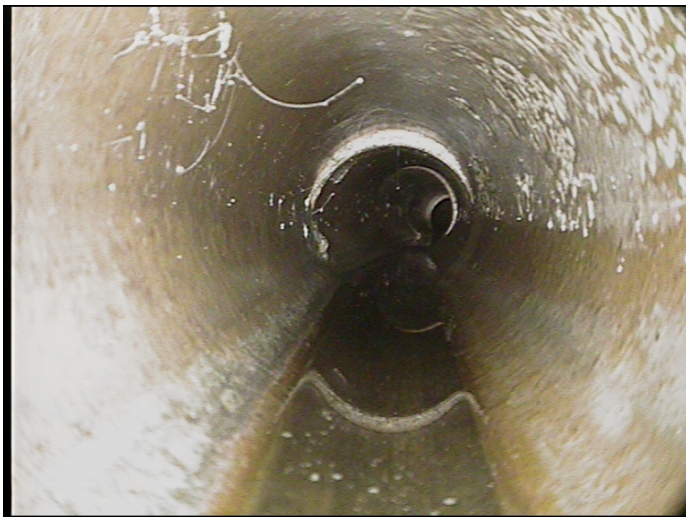
Code: **MMC**
Description: **Material Change**

Distance (ft): **2.9**
Structural Grade: **0**
O&M Grade: **0**
Clock Start/From:
Clock To:
1st Value:
2nd Value:
Value Percent:
Continuous Index:
Within 8" of Joint: **NO**
Remarks: **vcp**
