Profile/Photo Observation Report

Date:	02/20/2024	Weather:		Coding:	PACP 7.0
Pipe Length (ft):	190.5	Owner:	City of Hobart	Pre Clean:	Heavy Cleaning
P.O.#:	YES502259	Surveyor:	S. Bucklin	PSR:	M-603-026-M-603-025
Customer:	City of Hobart	Clean Date:	02/07/2022	Shape:	C

Street:	W 39TH PL	Flow Control:	Not Controlled
City:	Hobart, IN	Year Renewed:	
Location:	Yard	Tape/Media #:	
Purpose:	Sewer System Evaluation Survey (SS	Dia/Height:	8"
Use:	Sanitary Sewage Pipe	Material:	VCP
Drain Area:		Lining:	None
Category:	NA		
Comment:

Location Details:		Direction of Survey:	Upstream
US MH:	M-603-026	DS MH:	M-603-025
		Total Length Surveyed (ft):	91.4

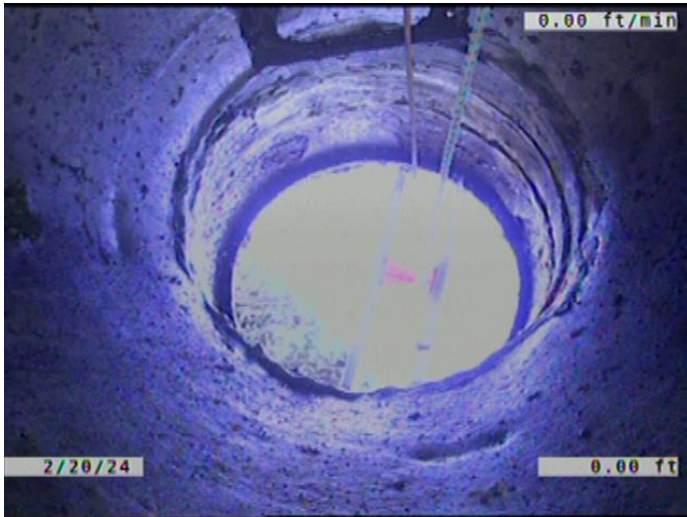
Code: **AMH**
Description: **Manhole**

Distance (ft): **.0**
Structural Grade: **0**
O&M Grade: **0**
Clock Start/From:
Clock To:
1st Value:
2nd Value:
Value Percent:
Continuous Index:
Within 8" of Joint: **NO**
Remarks: **M-603-025**

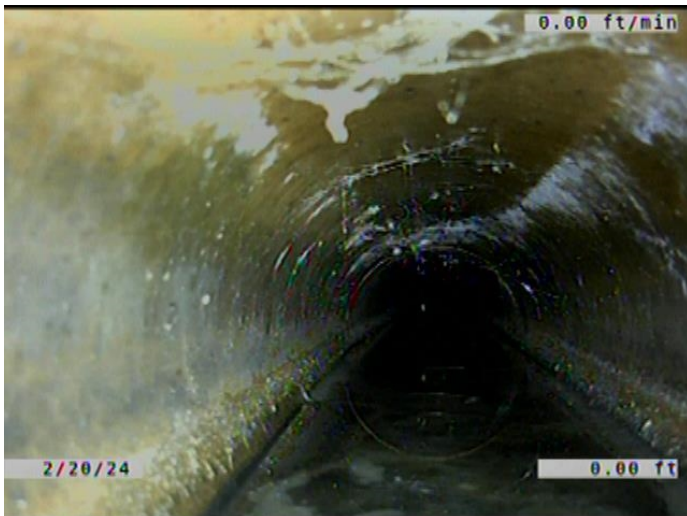
Code: **MWL**
Description: **Miscellaneous Water Level**

Distance (ft): **.0**
Structural Grade: **0**
O&M Grade: **0**
Clock Start/From:
Clock To:
1st Value:
2nd Value:
Value Percent: **5.000**
Continuous Index:
Within 8" of Joint: **NO**
Remarks:

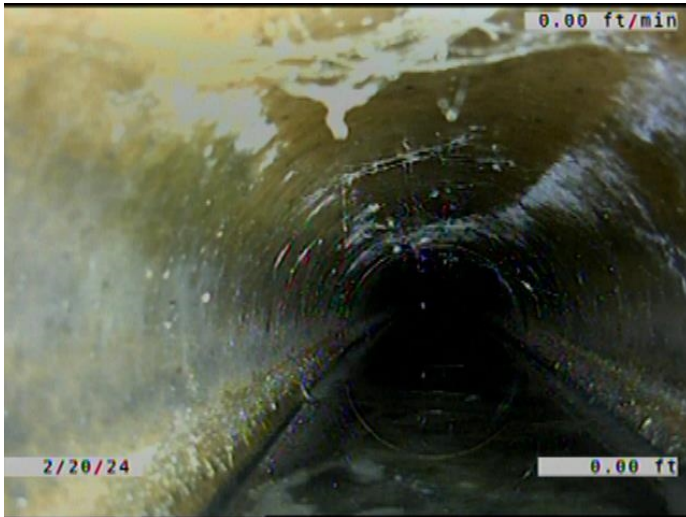
Code: **MWLS**
Description: **Miscellaneous Water Level Sag**

Distance (ft): **.0**
Structural Grade: **2**
O&M Grade: **0**
Clock Start/From:
Clock To:
1st Value:
2nd Value:
Value Percent: **20.000**
Continuous Index: **S01**
Within 8" of Joint: **NO**
Remarks: **`**

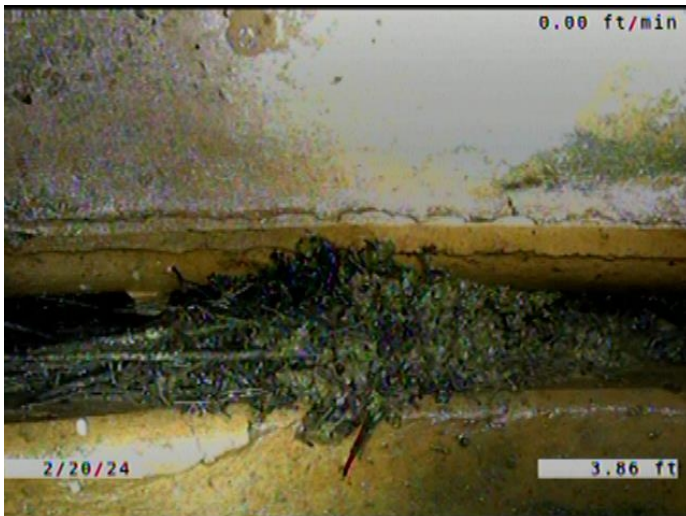
Code: **RFJ**
Description: **Roots Fine Joint**

Distance (ft): **3.9**
Structural Grade: **0**
O&M Grade: **1**
Clock Start/From: **9**
Clock To: **3**
1st Value:
2nd Value:
Value Percent:
Continuous Index:
Within 8" of Joint: **YES**
Remarks:

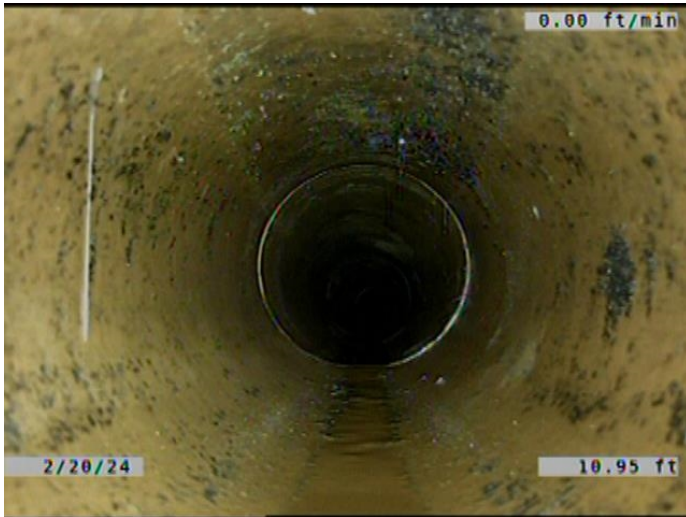
Code: **MWLS**
Description: **Miscellaneous Water Level Sag**

Distance (ft): **11.0**
Structural Grade: **2**
O&M Grade: **0**
Clock Start/From:
Clock To:
1st Value:
2nd Value:
Value Percent: **20.000**
Continuous Index: **F01**
Within 8" of Joint: **NO**
Remarks: `

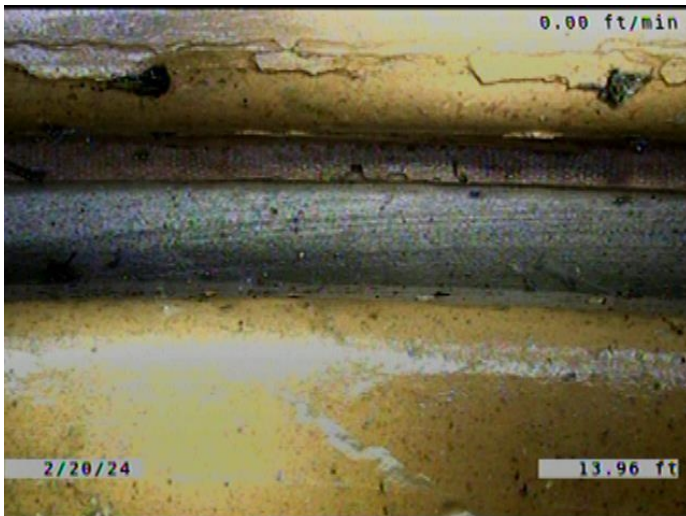
Code: **JAM**
Description: **Joint Angular Medium**

Distance (ft): **14.0**
Structural Grade: **3**
O&M Grade: **0**
Clock Start/From:
Clock To:
1st Value:
2nd Value:
Value Percent:
Continuous Index:
Within 8" of Joint: **NO**
Remarks:

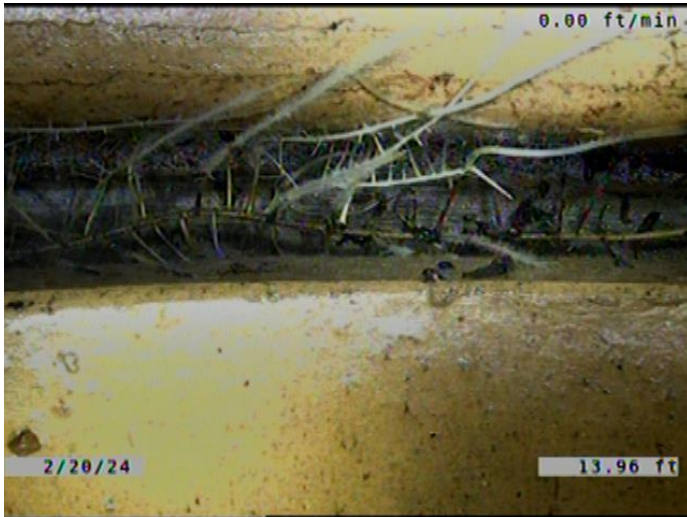
Code: **RFJ**
Description: **Roots Fine Joint**

Distance (ft): **14.0**
Structural Grade: **0**
O&M Grade: **1**
Clock Start/From: **2**
Clock To: **5**
1st Value:
2nd Value:
Value Percent:
Continuous Index:
Within 8" of Joint: **YES**
Remarks:

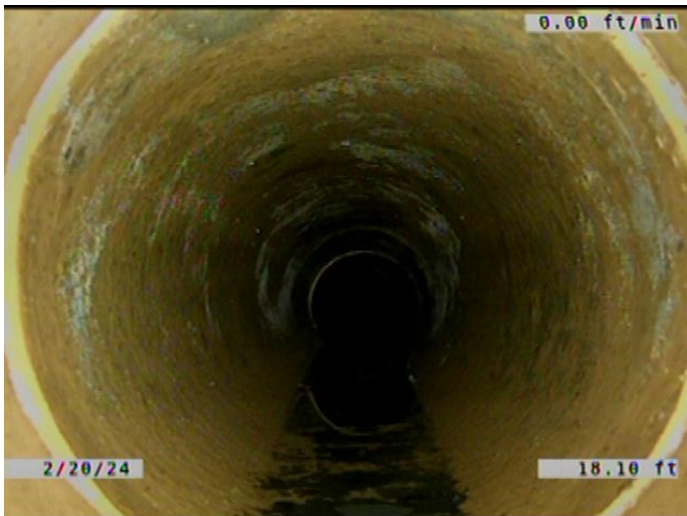
Code: **MWLS**
Description: **Miscellaneous Water Level Sag**

Distance (ft): **18.1**
Structural Grade: **2**
O&M Grade: **0**
Clock Start/From:
Clock To:
1st Value:
2nd Value:
Value Percent: **20.000**
Continuous Index: **S02**
Within 8" of Joint: **NO**
Remarks:

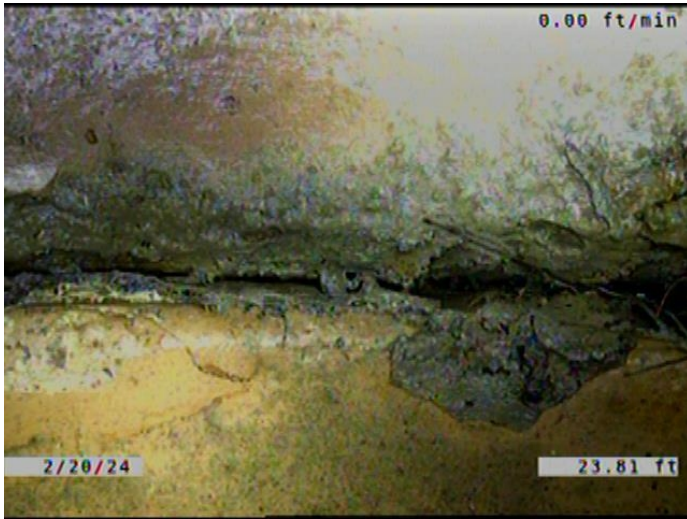
Code: **DAE**
Description: **Deposits Attached Encrustation**

Distance (ft): **23.8**
Structural Grade: **0**
O&M Grade: **2**
Clock Start/From: **7**
Clock To: **5**
1st Value:
2nd Value:
Value Percent: **5.000**
Continuous Index:
Within 8" of Joint: **YES**
Remarks:

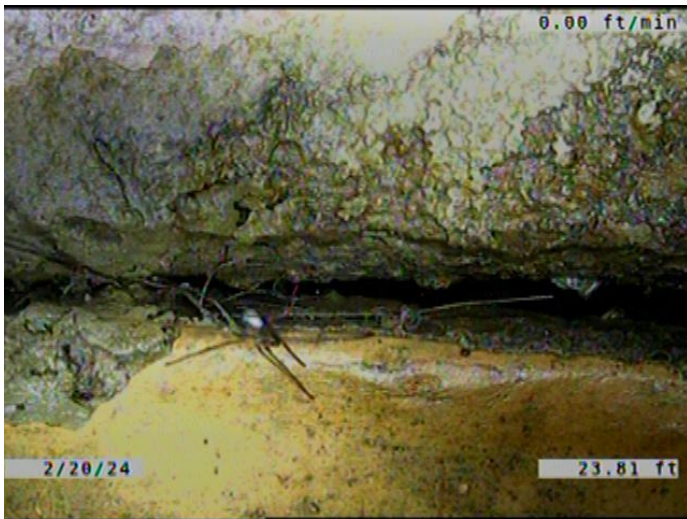
Code: **RFJ**
Description: **Roots Fine Joint**

Distance (ft): **23.8**
Structural Grade: **0**
O&M Grade: **1**
Clock Start/From: **7**
Clock To: **3**
1st Value:
2nd Value:
Value Percent:
Continuous Index:
Within 8" of Joint: **YES**
Remarks:

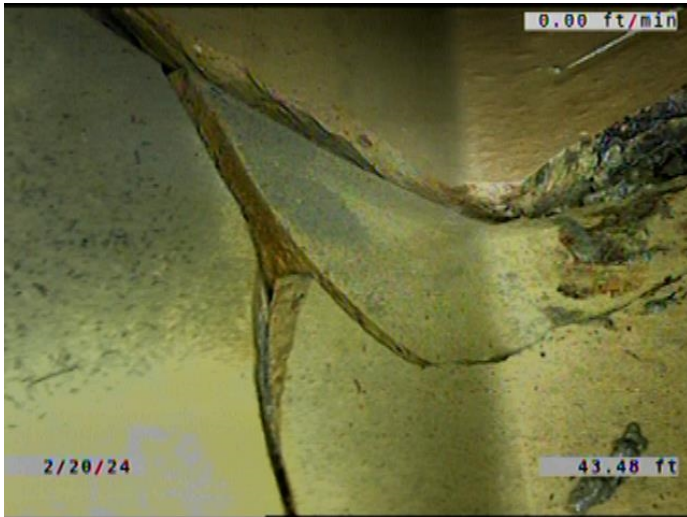
Code: **B**
Description: **Broken**

Distance (ft): **43.5**
Structural Grade: **4**
O&M Grade: **0**
Clock Start/From: **12**
Clock To: **12**
1st Value:
2nd Value:
Value Percent:
Continuous Index:
Within 8" of Joint: **YES**
Remarks:

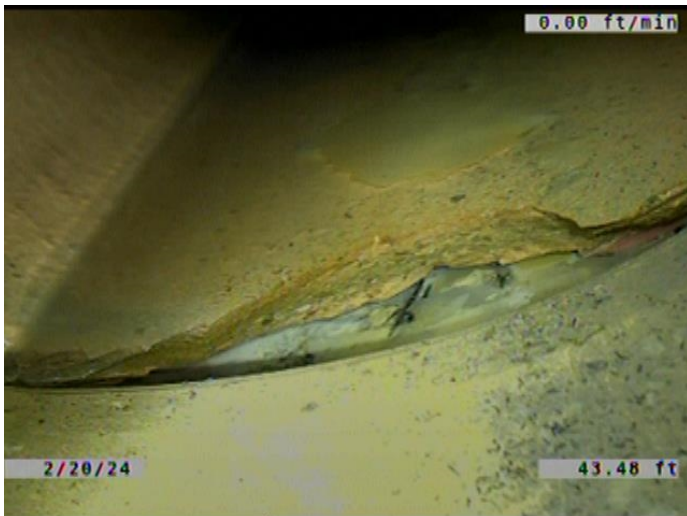
Code: **SMW**
Description: **Surface Damage Missing Wall**

Distance (ft): **43.5**
Structural Grade: **5**
O&M Grade: **0**
Clock Start/From: **6**
Clock To: **7**
1st Value:
2nd Value:
Value Percent:
Continuous Index:
Within 8" of Joint: **YES**
Remarks: **THE INSIDE OF THE JOINT.**

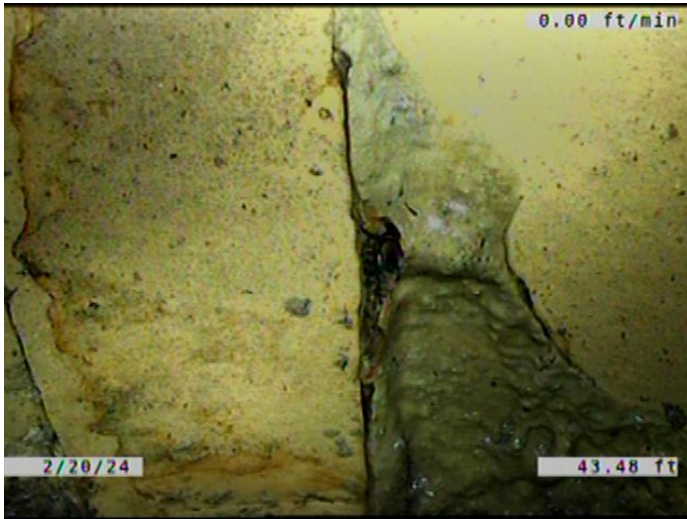
Code: **DAE**
Description: **Deposits Attached Encrustation**

Distance (ft): **43.5**
Structural Grade: **0**
O&M Grade: **2**
Clock Start/From: **7**
Clock To: **5**
1st Value:
2nd Value:
Value Percent: **5.000**
Continuous Index:
Within 8" of Joint: **YES**
Remarks:

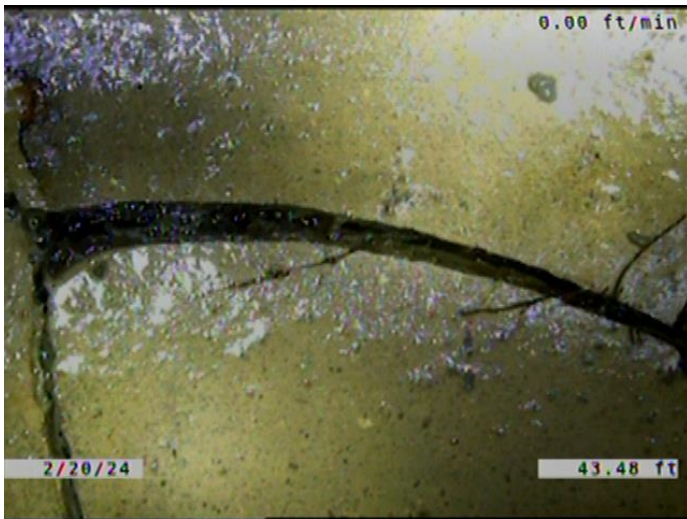
Code: **RFB**
Description: **Roots Fine Barrel**

Distance (ft): **43.5**
Structural Grade: **0**
O&M Grade: **2**
Clock Start/From: **10**
Clock To: **2**
1st Value:
2nd Value:
Value Percent:
Continuous Index:
Within 8" of Joint: **NO**
Remarks:

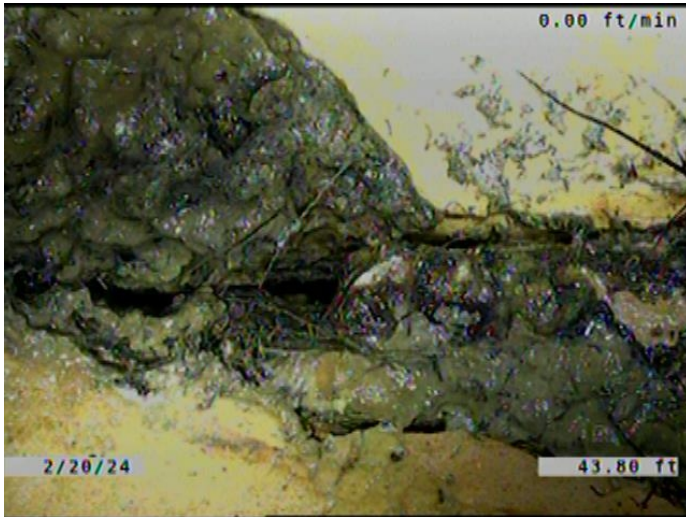
Code: **RFJ**
Description: **Roots Fine Joint**

Distance (ft): **43.8**
Structural Grade: **0**
O&M Grade: **1**
Clock Start/From: **7**
Clock To: **5**
1st Value:
2nd Value:
Value Percent:
Continuous Index:
Within 8" of Joint: **YES**
Remarks:

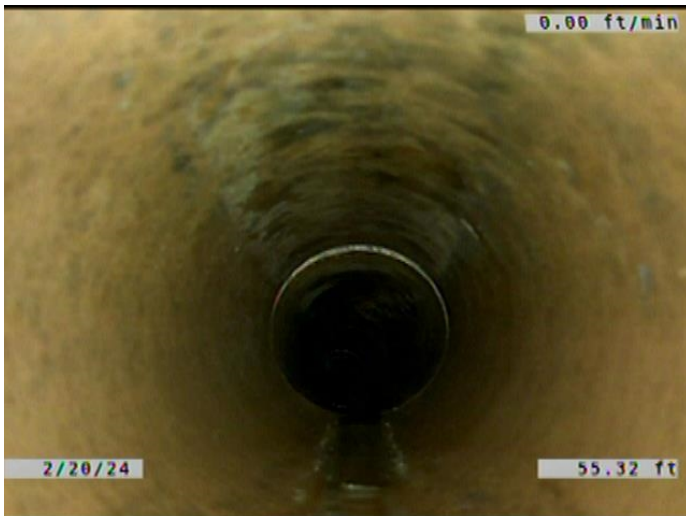
Code: **MWLS**
Description: **Miscellaneous Water Level Sag**

Distance (ft): **55.3**
Structural Grade: **2**
O&M Grade: **0**
Clock Start/From:
Clock To:
1st Value:
2nd Value:
Value Percent: **20.000**
Continuous Index: **F02**
Within 8" of Joint: **NO**
Remarks:

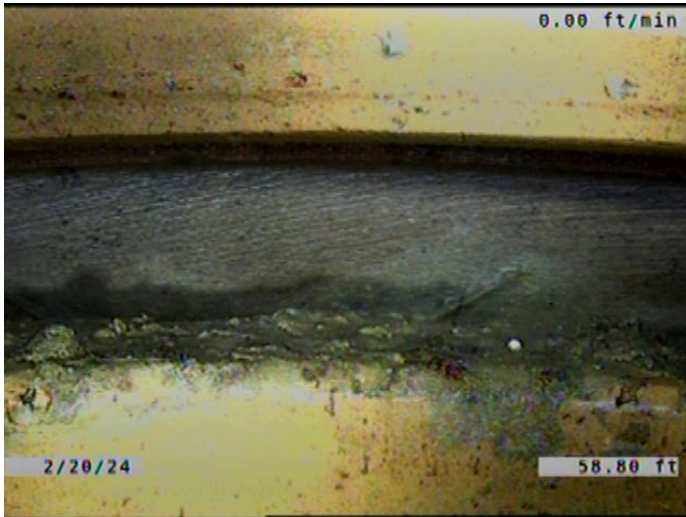
Code: **JAM**
Description: **Joint Angular Medium**

Distance (ft): **58.8**
Structural Grade: **3**
O&M Grade: **0**
Clock Start/From:
Clock To:
1st Value:
2nd Value:
Value Percent:
Continuous Index:
Within 8" of Joint: **NO**
Remarks:

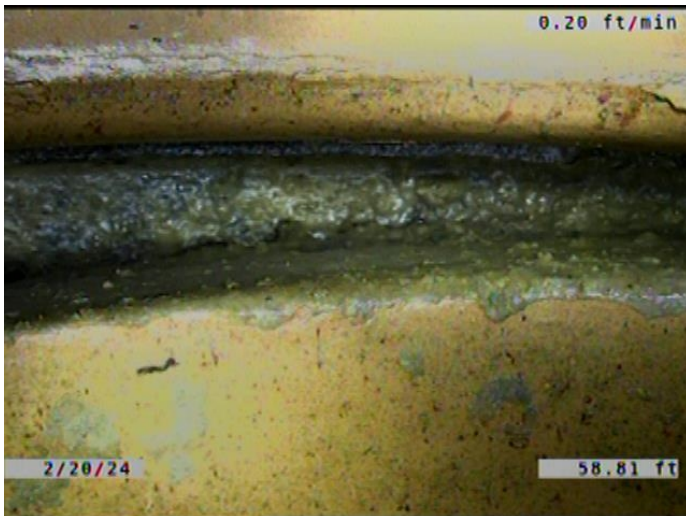
Code: **DAE**
Description: **Deposits Attached Encrustation**

Distance (ft): **58.8**
Structural Grade: **0**
O&M Grade: **2**
Clock Start/From: **7**
Clock To: **5**
1st Value:
2nd Value:
Value Percent: **5.000**
Continuous Index:
Within 8" of Joint: **YES**
Remarks:

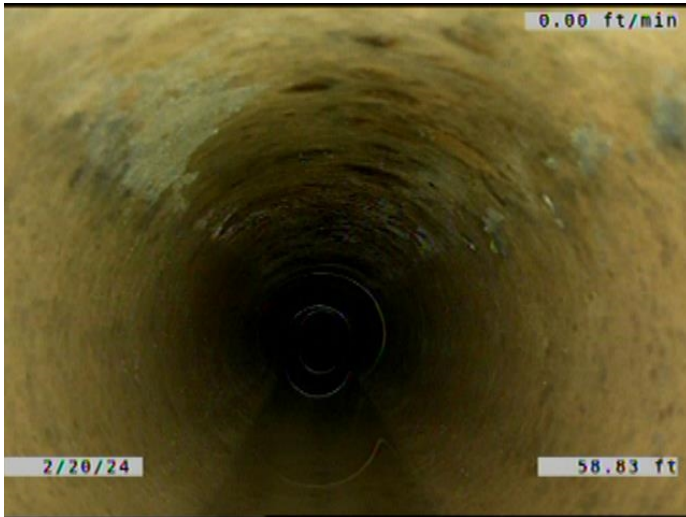
Code: **MWLS**
Description: **Miscellaneous Water Level Sag**

Distance (ft): **58.8**
Structural Grade: **2**
O&M Grade: **0**
Clock Start/From:
Clock To:
1st Value:
2nd Value:
Value Percent: **10.000**
Continuous Index: **S03**
Within 8" of Joint: **NO**
Remarks:

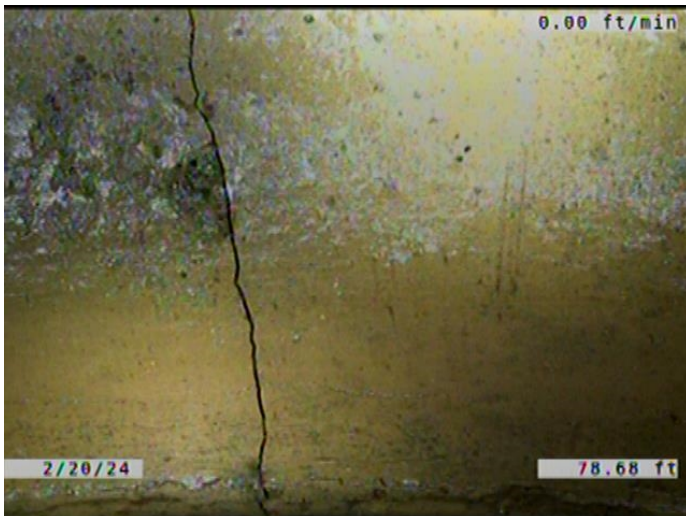
Code: **CS**
Description: **Crack Spiral**

Distance (ft): **78.7**
Structural Grade: **2**
O&M Grade: **0**
Clock Start/From: **11**
Clock To: **12**
1st Value:
2nd Value:
Value Percent:
Continuous Index:
Within 8" of Joint: **YES**
Remarks:

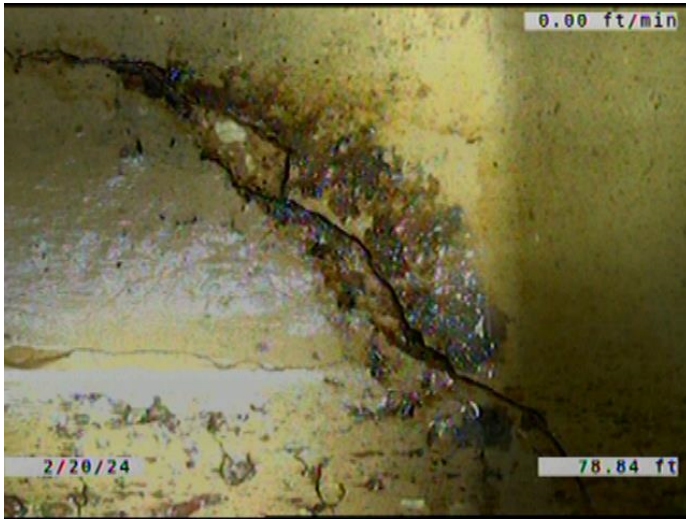
Code: **CM**
Description: **Crack Multiple**

Distance (ft): **78.8**
Structural Grade: **3**
O&M Grade: **0**
Clock Start/From: **2**
Clock To: **5**
1st Value:
2nd Value:
Value Percent:
Continuous Index:
Within 8" of Joint: **NO**
Remarks:

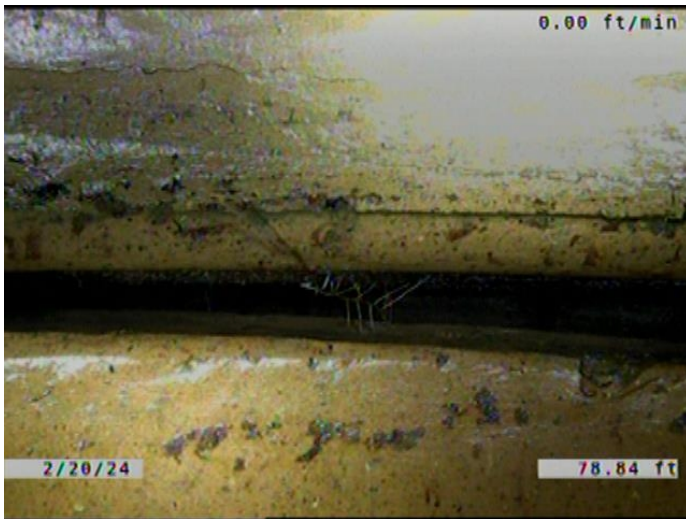
Code: **RFJ**
Description: **Roots Fine Joint**

Distance (ft): **78.8**
Structural Grade: **0**
O&M Grade: **1**
Clock Start/From: **10**
Clock To:
1st Value:
2nd Value:
Value Percent:
Continuous Index:
Within 8" of Joint: **YES**
Remarks:

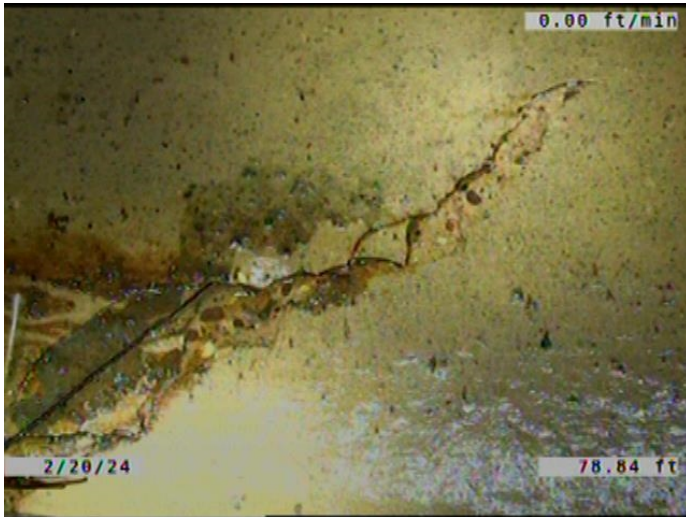
Code: **CM**
Description: **Crack Multiple**

Distance (ft): **78.8**
Structural Grade: **3**
O&M Grade: **0**
Clock Start/From: **8**
Clock To: **10**
1st Value:
2nd Value:
Value Percent:
Continuous Index:
Within 8" of Joint: **YES**
Remarks:

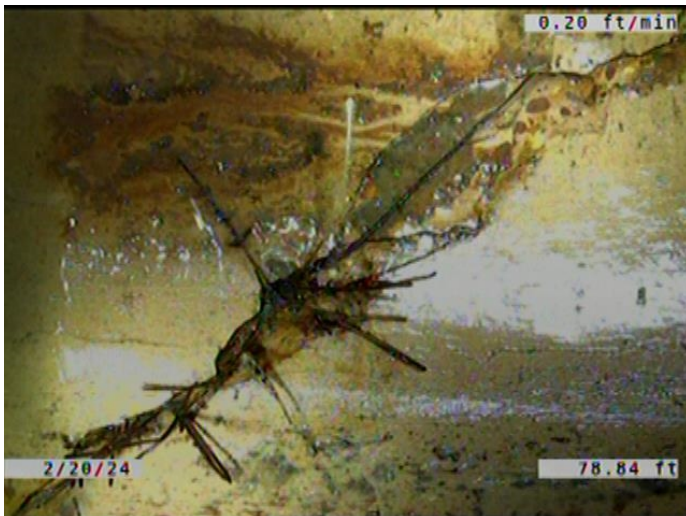
Code: **RFB**
Description: **Roots Fine Barrel**

Distance (ft): **78.8**
Structural Grade: **0**
O&M Grade: **2**
Clock Start/From: **8**
Clock To: **9**
1st Value:
2nd Value:
Value Percent:
Continuous Index:
Within 8" of Joint: **NO**
Remarks:

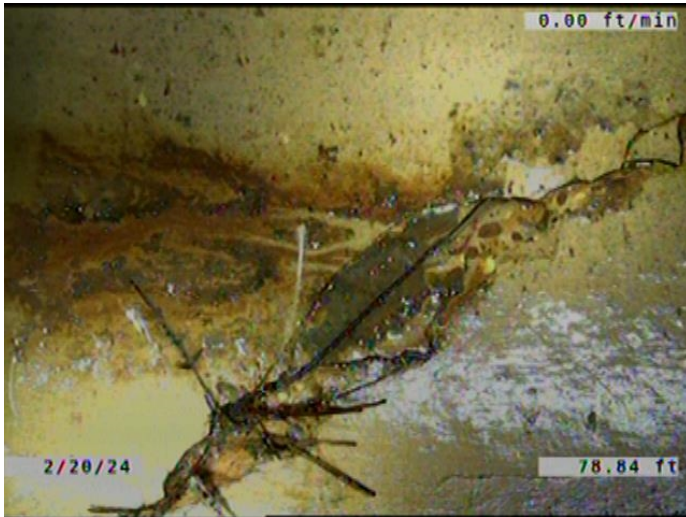
Code: **DAE**
Description: **Deposits Attached Encrustation**

Distance (ft): **78.8**
Structural Grade: **0**
O&M Grade: **2**
Clock Start/From: **8**
Clock To: **4**
1st Value:
2nd Value:
Value Percent: **5.000**
Continuous Index:
Within 8" of Joint: **YES**
Remarks:

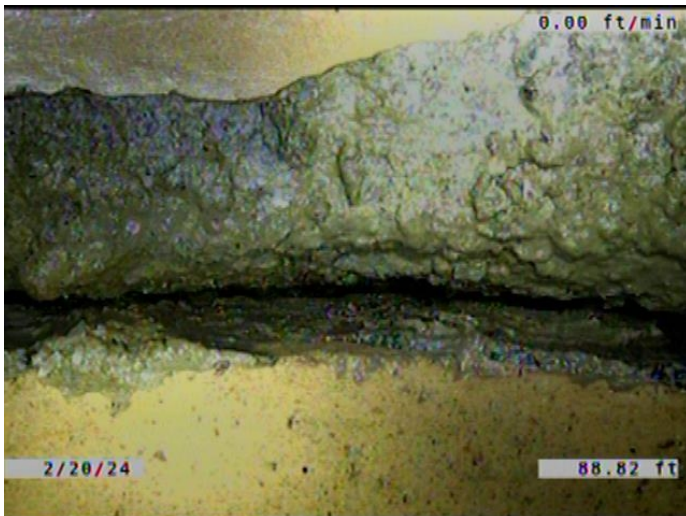
Code: **DAE**
Description: **Deposits Attached Encrustation**

Distance (ft): **88.8**
Structural Grade: **0**
O&M Grade: **2**
Clock Start/From: **7**
Clock To: **5**
1st Value:
2nd Value:
Value Percent: **5.000**
Continuous Index:
Within 8" of Joint: **YES**
Remarks:

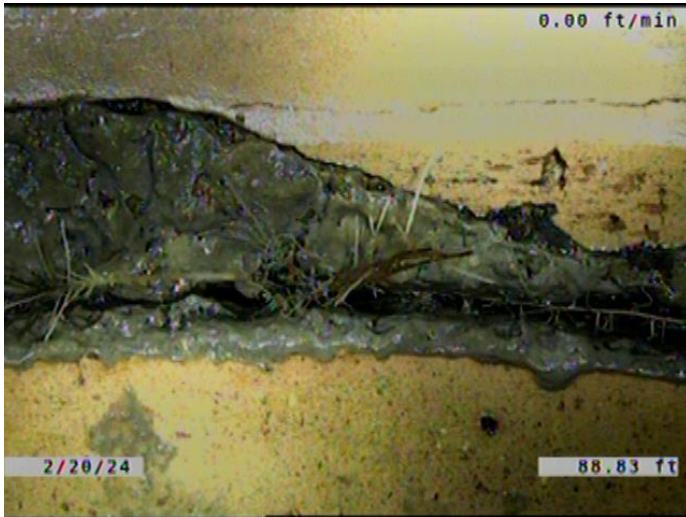
Code: **RFJ**
Description: **Roots Fine Joint**

Distance (ft): **88.8**
Structural Grade: **0**
O&M Grade: **1**
Clock Start/From: **10**
Clock To: **4**
1st Value:
2nd Value:
Value Percent:
Continuous Index:
Within 8" of Joint: **YES**
Remarks:

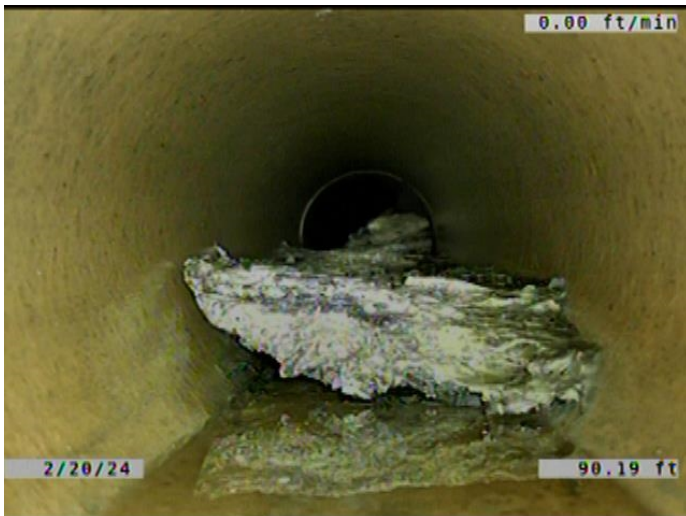
Code: **DSC**
Description: **Deposits Settled Hard/Compacted**

Distance (ft): **90.2**
Structural Grade: **0**
O&M Grade: **4**
Clock Start/From: **4**
Clock To: **8**
1st Value:
2nd Value:
Value Percent: **25.000**
Continuous Index:
Within 8" of Joint: **YES**
Remarks:

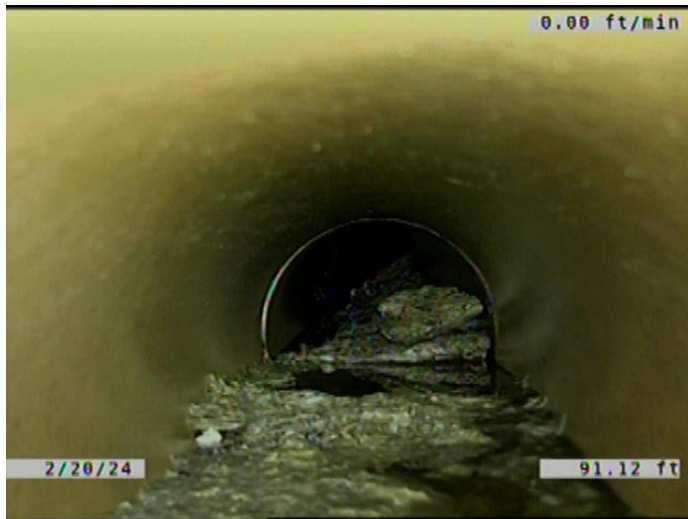
Code: **MWLS**
 Description: **Miscellaneous Water Level Sag**

Distance (ft): **91.1**
 Structural Grade: **2**
 O&M Grade: **0**
 Clock Start/From:
 Clock To:
 1st Value:
 2nd Value:
 Value Percent: **10.000**
 Continuous Index: **F03**
 Within 8" of Joint: **NO**
 Remarks:

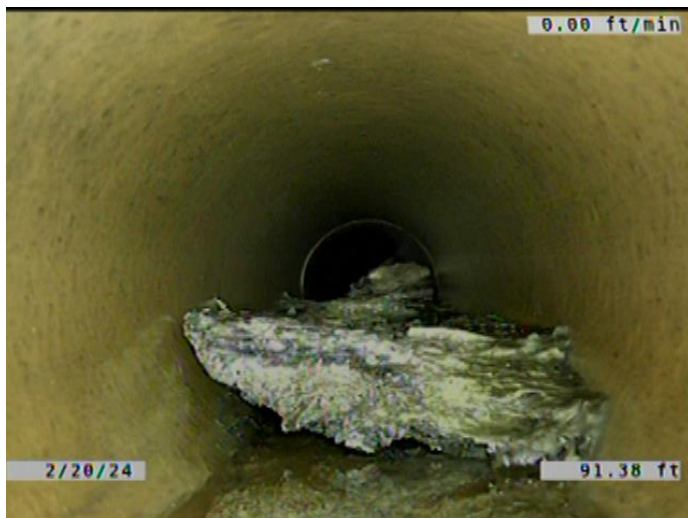
Code: **MSA**
 Description: **Miscellaneous Survey Abandoned**

Distance (ft): **91.4**
 Structural Grade: **0**
 O&M Grade: **0**
 Clock Start/From:
 Clock To:
 1st Value:
 2nd Value:
 Value Percent:
 Continuous Index:
 Within 8" of Joint: **NO**
 Remarks: **CAMERA CANT MAKE IT PAST ENCRUSTATION.**
