## Profile/Photo Observation Report

Street:	<b>W 40th ave</b>	Flow Control:	<b>Not Controlled</b>
City:	<b>Hobart, IN</b>	Year Renewed:	
Location:	<b>Other</b>	Tape/Media #:	
Purpose:	<b>Not Known</b>	Dia/Height:	<b>8"</b>
Use:	<b>Sanitary</b>	Material:	<b>VCP</b>
Drain Area:	<b>NA</b>	Lining:	
Category:	<b>NA</b>		
Comment:

Location Details:		Direction of Survey:	<b>Upstream</b>
US MH:	<b>M-603-026</b>	DS MH:	<b>M-603-025</b>
		Total Length Surveyed (ft):	<b>19.1</b>

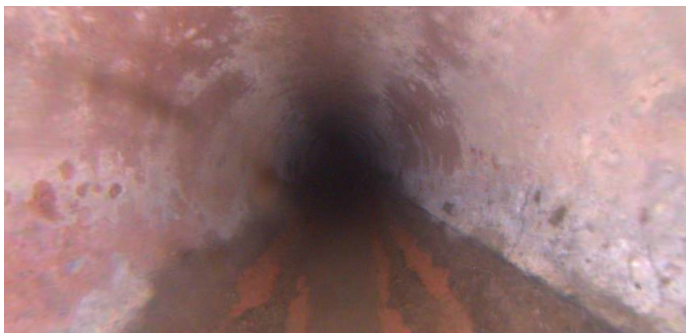
Code: **AMH**  
Description: **Manhole**

Distance (ft): **.0**  
Structural Grade: **0**  
O&M Grade: **0**  
Clock Start/From:  
Clock To:  
1st Value:  
2nd Value:  
Value Percent:  
Continuous Index:  
Within 8" of Joint: **NO**  
Remarks: **M-603-026**

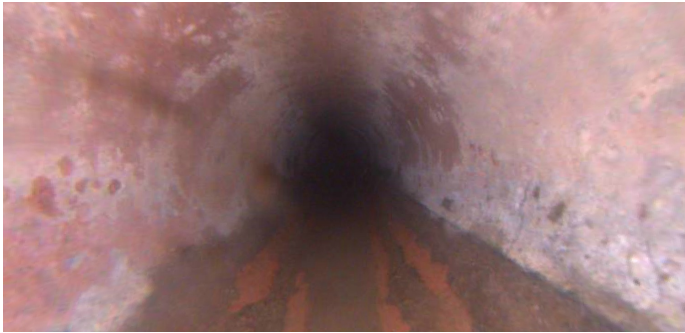
Code:	<b>MWL</b>
Description:	<b>Water Level</b>

Distance (ft):	<b>.0</b>
Structural Grade:	<b>0</b>
O&M Grade:	<b>0</b>
Clock Start/From:	
Clock To:	
1st Value:	
2nd Value:	
Value Percent:	<b>5.000</b>
Continuous Index:	
Within 8" of Joint:	<b>NO</b>
Remarks:

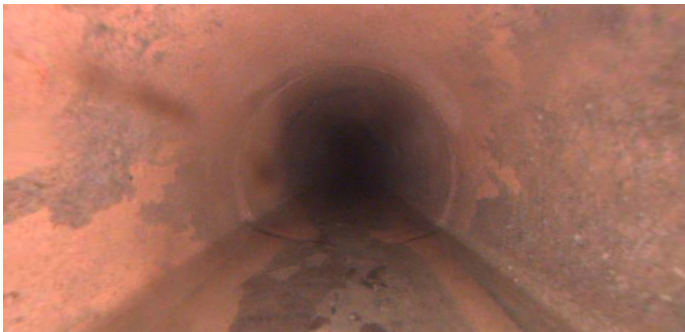
Code:	<b>MSA</b>
Description:	<b>Abandoned Survey</b>

Distance (ft):	<b>19.1</b>
Structural Grade:	<b>0</b>
O&M Grade:	<b>0</b>
Clock Start/From:	
Clock To:	
1st Value:	
2nd Value:	
Value Percent:	
Continuous Index:	
Within 8" of Joint:	<b>NO</b>
Remarks:	<b>debris under water</b>
