## Profile/Photo Observation Report

Street:	<b>OFF W 39TH PL</b>	Flow Control:	<b>Not Controlled</b>
City:	<b>Hobart, IN</b>	Year Renewed:	
Location:	<b>Other</b>	Tape/Media #:	
Purpose:	<b>Not Known</b>	Dia/Height:	<b>8"</b>
Use:	<b>Sanitary</b>	Material:	<b>VCP</b>
Drain Area:	<b>NA</b>	Lining:	
Category:	<b>NA</b>		
Comment:

Location Details:		Direction of Survey:	<b>Downstream</b>
US MH:	<b>M-603-026</b>	DS MH:	<b>M-603-025</b>
		Total Length Surveyed (ft):	<b>5.8</b>

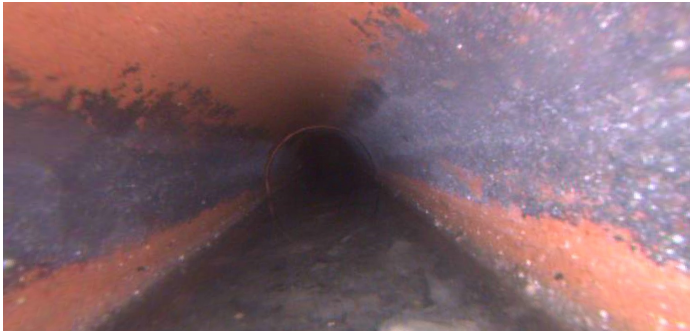
Code: AMH

Description: Manhole

Remarks: M-603-026

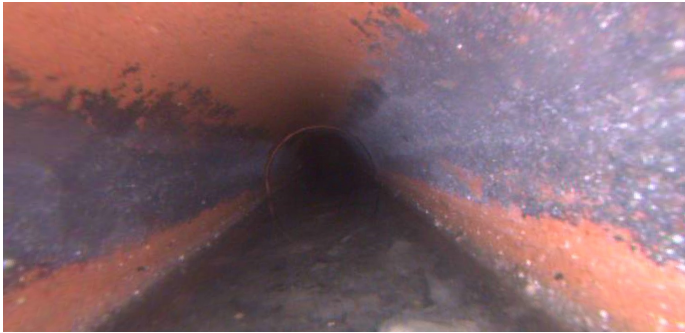
Code:	<b>MWL</b>
Description:	<b>Water Level</b>

Distance (ft):	<b>.0</b>
Structural Grade:	<b>0</b>
O&M Grade:	<b>0</b>
Clock Start/From:	
Clock To:	
1st Value:	
2nd Value:	
Value Percent:	<b>30.000</b>
Continuous Index:	
Within 8" of Joint:	<b>NO</b>
Remarks:

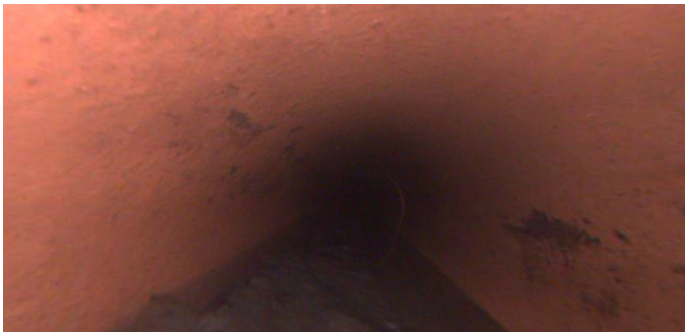
Code:	<b>MSA</b>
Description:	<b>Abandoned Survey</b>

Distance (ft):	<b>5.8</b>
Structural Grade:	<b>0</b>
O&M Grade:	<b>0</b>
Clock Start/From:	
Clock To:	
1st Value:	
2nd Value:	
Value Percent:	
Continuous Index:	
Within 8" of Joint:	<b>NO</b>
Remarks:	<b>debris under water</b>
