## Profile/Photo Observation Report

Street:	<b>W 40th ave</b>	Flow Control:	<b>Not Controlled</b>
City:	<b>Hobart, IN</b>	Year Renewed:	
Location:	<b>Other</b>	Tape/Media #:	
Purpose:	<b>Not Known</b>	Dia/Height:	<b>8"</b>
Use:	<b>Sanitary</b>	Material:	<b>VCP</b>
Drain Area:	<b>NA</b>	Lining:	
Category:	<b>NA</b>		
Comment:

Location Details:		Direction of Survey:	<b>Downstream</b>
US MH:	<b>M-603-026</b>	DS MH:	<b>M-603-025</b>
		Total Length Surveyed (ft):	<b>5.8</b>

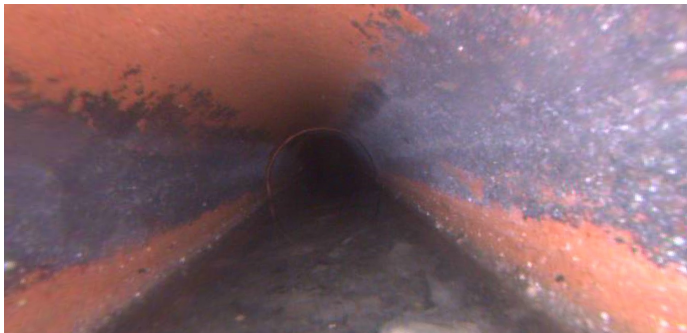
Code: **AMH**  
Description: **Manhole**

Distance (ft): **.0**  
Structural Grade: **0**  
O&M Grade: **0**  
Clock Start/From:  
Clock To:  
1st Value:  
2nd Value:  
Value Percent:  
Continuous Index:  
Within 8" of Joint: **NO**  
Remarks: **M-603-026**

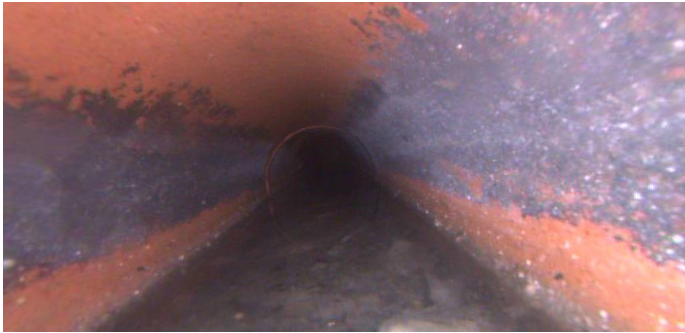
Code:	<b>MWL</b>
Description:	<b>Water Level</b>

Distance (ft):	<b>.0</b>
Structural Grade:	<b>0</b>
O&M Grade:	<b>0</b>
Clock Start/From:	
Clock To:	
1st Value:	
2nd Value:	
Value Percent:	<b>30.000</b>
Continuous Index:	
Within 8" of Joint:	<b>NO</b>
Remarks:

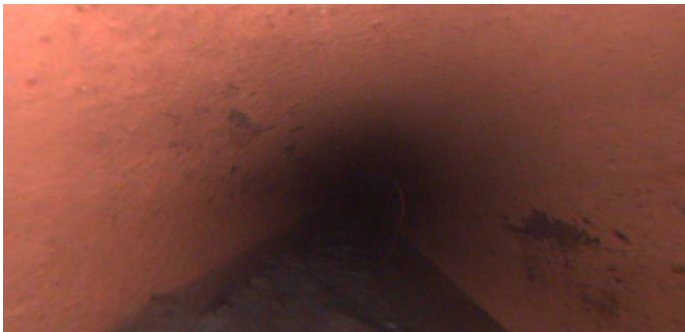
Code:	<b>MSA</b>
Description:	<b>Abandoned Survey</b>

Distance (ft):	<b>5.8</b>
Structural Grade:	<b>0</b>
O&M Grade:	<b>0</b>
Clock Start/From:	
Clock To:	
1st Value:	
2nd Value:	
Value Percent:	
Continuous Index:	
Within 8" of Joint:	<b>NO</b>
Remarks:	<b>debris under water</b>
