Profile/Photo Observation Report

Date:	04/11/2018	Weather:		Coding:	PACP 6.0
Pipe Length (ft):	176.3	Owner:	NA	Pre Clean:	Not Known
P.O.#:		Surveyor:	Jen Costello	PSR:	P-603-027-026
Customer:		Clean Date:	01/01/1900	Shape:	C

Street:	OFF W 39TH PL	Flow Control:	Not Controlled
City:	Hobart, IN	Year Renewed:	
Location:	Other	Tape/Media #:	
Purpose:	Not Known	Dia/Height:	8"
Use:	Sanitary	Material:	VCP
Drain Area:	NA	Lining:	
Category:	NA		
Comment:

Location Details:		Direction of Survey:	Downstream
US MH:	M-603-026	DS MH:	M-603-027
		Total Length Surveyed (ft):	98.8

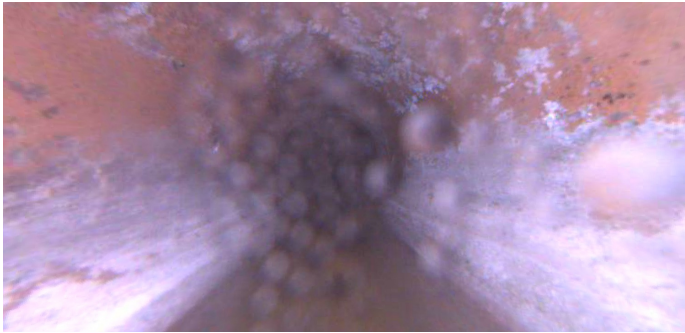
Code:	MWL
Description:	Water Level

Distance (ft):	.0
Structural Grade:	0
O&M Grade:	0
Clock Start/From:	
Clock To:	
1st Value:	
2nd Value:	
Value Percent:	10.000
Continuous Index:	
Within 8" of Joint:	NO
Remarks:

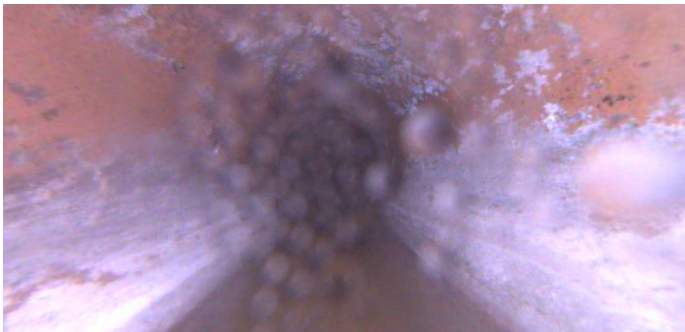
Code:	DAGS
Description:	Deposits Attached Grease

Distance (ft):	.0
Structural Grade:	0
O&M Grade:	2
Clock Start/From:	8
Clock To:	4
1st Value:	
2nd Value:	
Value Percent:	5.000
Continuous Index:	S01
Within 8" of Joint:	NO
Remarks:

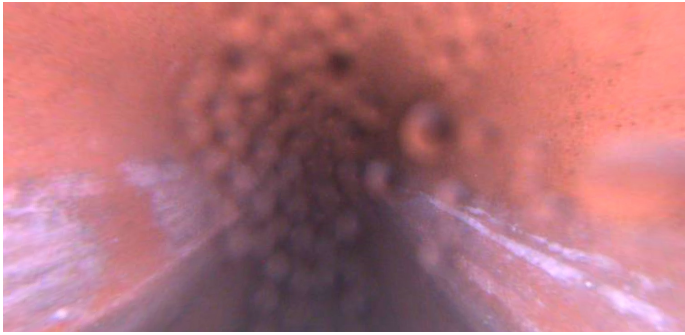
Code: **DAGS**
Description: **Deposits Attached Grease**

Distance (ft): **10.2**
Structural Grade: **0**
O&M Grade: **2**
Clock Start/From: **8**
Clock To: **4**
1st Value:
2nd Value:
Value Percent: **5.000**
Continuous Index: **F01**
Within 8" of Joint: **NO**
Remarks:

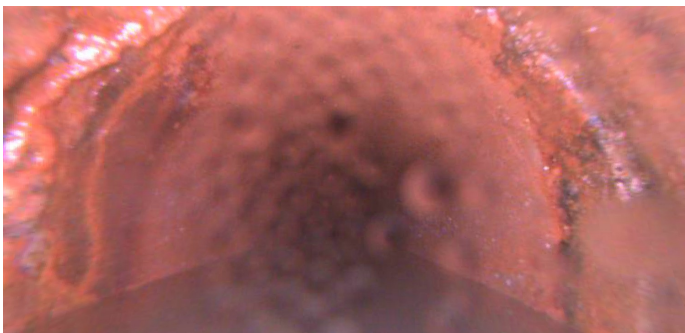
Code: **IW**
Description: **Infil Weeper**

Distance (ft): **27.0**
Structural Grade: **0**
O&M Grade: **2**
Clock Start/From: **8**
Clock To: **4**
1st Value:
2nd Value:
Value Percent:
Continuous Index:
Within 8" of Joint: **YES**
Remarks:

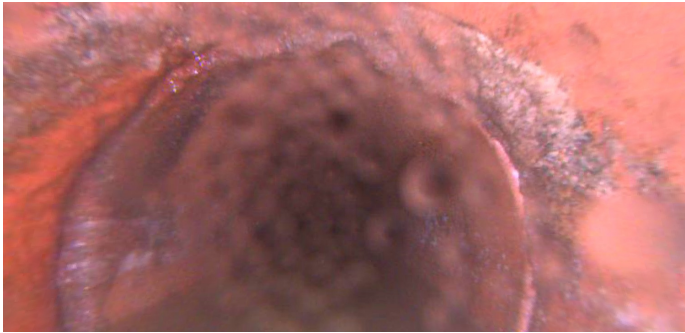
Code: **IW**
Description: **Infil Weeper**

Distance (ft): **41.6**
Structural Grade: **0**
O&M Grade: **2**
Clock Start/From: **8**
Clock To: **4**
1st Value:
2nd Value:
Value Percent:
Continuous Index:
Within 8" of Joint: **YES**
Remarks:

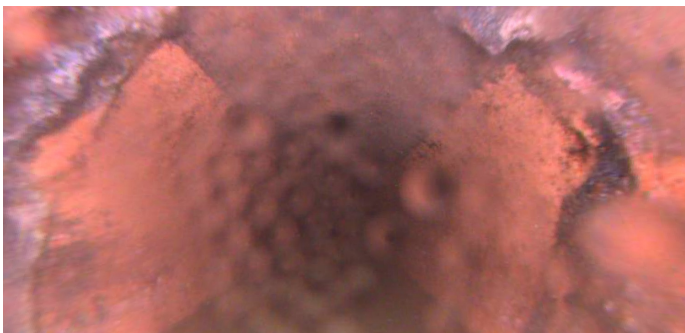
Code: **DAE**
Description: **Deposits Attached Encrustation**

Distance (ft): **46.7**
Structural Grade: **0**
O&M Grade: **2**
Clock Start/From: **8**
Clock To: **4**
1st Value:
2nd Value:
Value Percent: **5.000**
Continuous Index:
Within 8" of Joint: **YES**
Remarks:

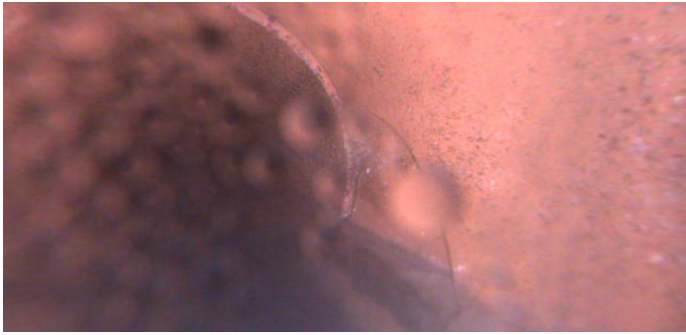
Code: **FS**
Description: **Fracture Spiral**

Distance (ft): **80.9**
Structural Grade: **3**
O&M Grade: **0**
Clock Start/From: **3**
Clock To: **5**
1st Value:
2nd Value:
Value Percent:
Continuous Index:
Within 8" of Joint: **YES**
Remarks:

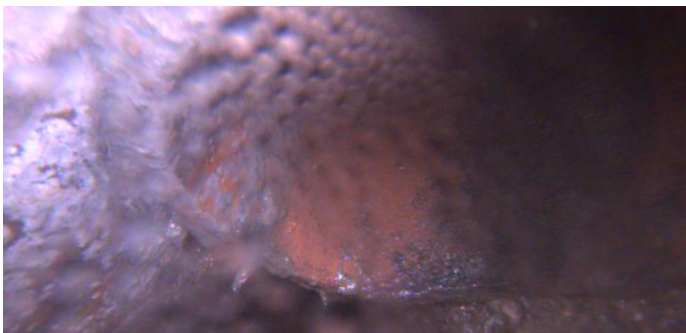
Code: **TBI**
Description: **Tap Break-in Intruding**

Distance (ft): **97.3**
Structural Grade: **0**
O&M Grade: **2**
Clock Start/From: **12**
Clock To:
1st Value: **4.000**
2nd Value: **1.000**
Value Percent:
Continuous Index:
Within 8" of Joint:
Remarks:

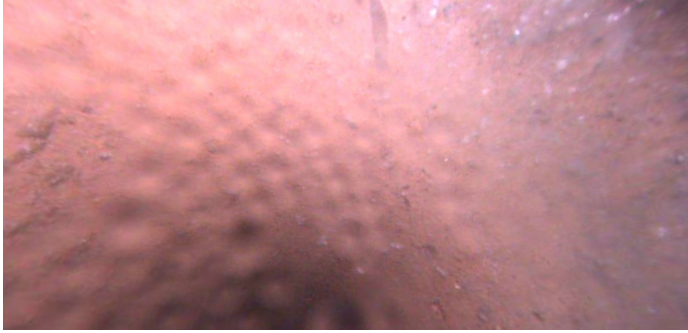
Code:	MSA
Description:	Abandoned Survey
Distance (ft):	98.8
Structural Grade:	0
O&M Grade:	0
Clock Start/From:	
Clock To:	
1st Value:	
2nd Value:	
Value Percent:	
Continuous Index:	
Within 8" of Joint:	NO
Remarks:	tbi
