## Profile/Photo Observation Report

Street:	<b>W 40th ave</b>	Flow Control:	<b>Not Controlled</b>
City:	<b>Hobart, IN</b>	Year Renewed:	
Location:	<b>Other</b>	Tape/Media #:	
Purpose:	<b>Not Known</b>	Dia/Height:	<b>8"</b>
Use:	<b>Sanitary</b>	Material:	<b>VCP</b>
Drain Area:	<b>NA</b>	Lining:	
Category:	<b>NA</b>		
Comment:

Location Details:		Direction of Survey:	<b>Downstream</b>
US MH:	<b>M-603-026</b>	DS MH:	<b>M-603-027</b>
		Total Length Surveyed (ft):	<b>98.8</b>

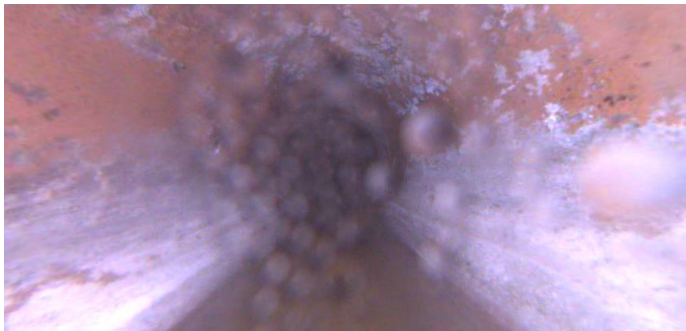
Code: **AMH**  
Description: **Manhole**

Distance (ft): **.0**  
Structural Grade: **0**  
O&M Grade: **0**  
Clock Start/From:  
Clock To:  
1st Value:  
2nd Value:  
Value Percent:  
Continuous Index:  
Within 8" of Joint: **NO**  
Remarks: **M-603-026**

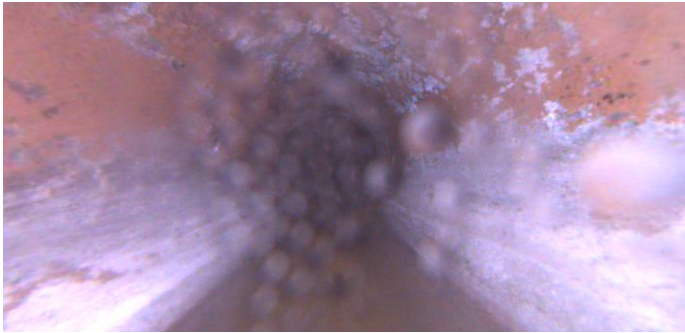
Code:	<b>MWL</b>
Description:	<b>Water Level</b>

Distance (ft):	<b>.0</b>
Structural Grade:	<b>0</b>
O&M Grade:	<b>0</b>
Clock Start/From:	
Clock To:	
1st Value:	
2nd Value:	
Value Percent:	<b>10.000</b>
Continuous Index:	
Within 8" of Joint:	<b>NO</b>
Remarks:

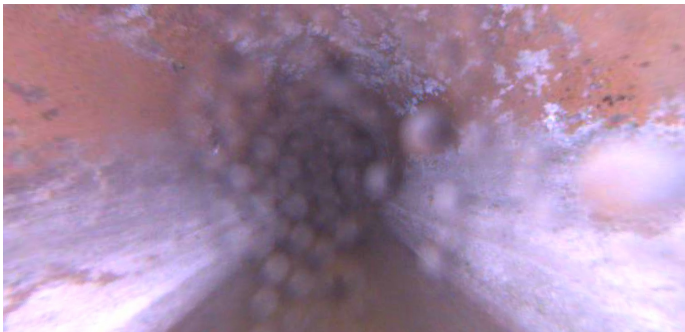
Code:	<b>DAGS</b>
Description:	<b>Deposits Attached Grease</b>

Distance (ft):	<b>.0</b>
Structural Grade:	<b>0</b>
O&M Grade:	<b>2</b>
Clock Start/From:	<b>8</b>
Clock To:	<b>4</b>
1st Value:	
2nd Value:	
Value Percent:	<b>5.000</b>
Continuous Index:	<b>S01</b>
Within 8" of Joint:	<b>NO</b>
Remarks:

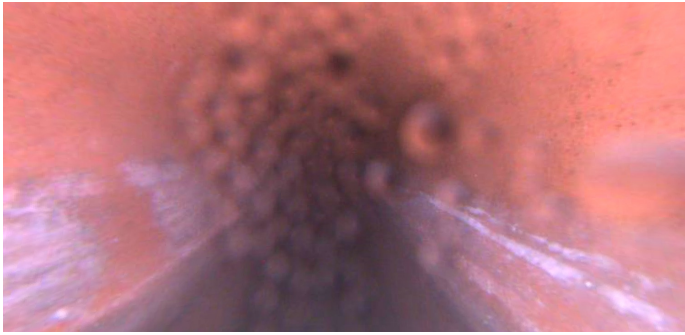
Code: **DAGS**  
Description: **Deposits Attached Grease**

Distance (ft): **10.2**  
Structural Grade: **0**  
O&M Grade: **2**  
Clock Start/From: **8**  
Clock To: **4**  
1st Value:  
2nd Value:  
Value Percent: **5.000**  
Continuous Index: **F01**  
Within 8" of Joint: **NO**  
Remarks:

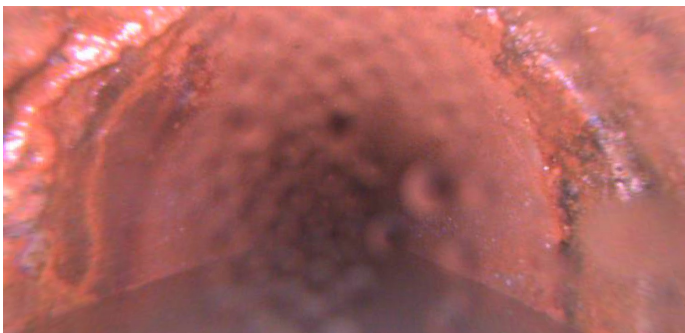
Code: **IW**  
Description: **Infil Weeper**

Distance (ft): **27.0**  
Structural Grade: **0**  
O&M Grade: **2**  
Clock Start/From: **8**  
Clock To: **4**  
1st Value:  
2nd Value:  
Value Percent:  
Continuous Index:  
Within 8" of Joint: **YES**  
Remarks:

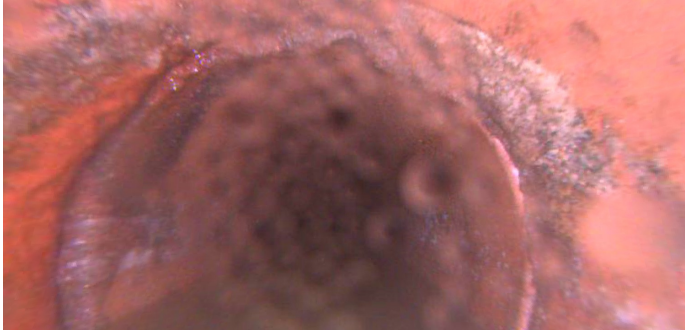
Code: **IW**  
Description: **Infil Weeper**

Distance (ft): **41.6**  
Structural Grade: **0**  
O&M Grade: **2**  
Clock Start/From: **8**  
Clock To: **4**  
1st Value:  
2nd Value:  
Value Percent:  
Continuous Index:  
Within 8" of Joint: **YES**  
Remarks:

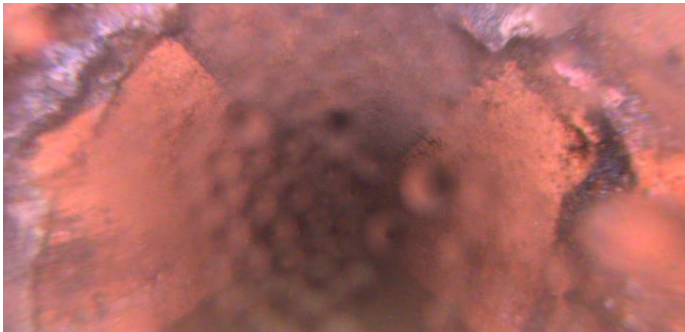
Code: **DAE**  
Description: **Deposits Attached Encrustation**

Distance (ft): **46.7**  
Structural Grade: **0**  
O&M Grade: **2**  
Clock Start/From: **8**  
Clock To: **4**  
1st Value:  
2nd Value:  
Value Percent: **5.000**  
Continuous Index:  
Within 8" of Joint: **YES**  
Remarks:

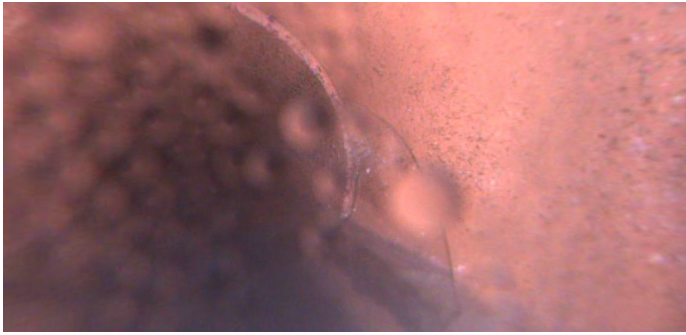
Code: **FS**  
Description: **Fracture Spiral**

Distance (ft): **80.9**  
Structural Grade: **3**  
O&M Grade: **0**  
Clock Start/From: **3**  
Clock To: **5**  
1st Value:  
2nd Value:  
Value Percent:  
Continuous Index:  
Within 8" of Joint: **YES**  
Remarks:

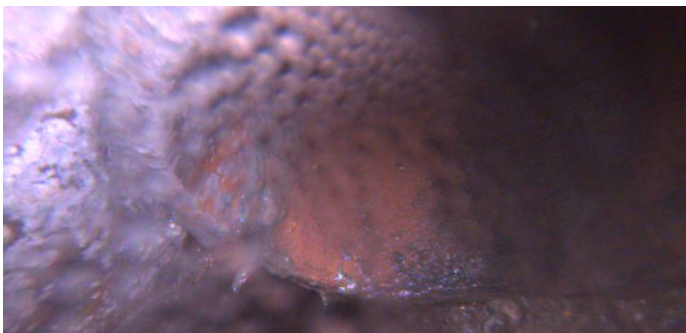
Code: **TBI**  
Description: **Tap Break-in Intruding**

Distance (ft): **97.3**  
Structural Grade: **0**  
O&M Grade: **2**  
Clock Start/From: **12**  
Clock To:  
1st Value: **4.000**  
2nd Value: **1.000**  
Value Percent:  
Continuous Index:  
Within 8" of Joint:  
Remarks:

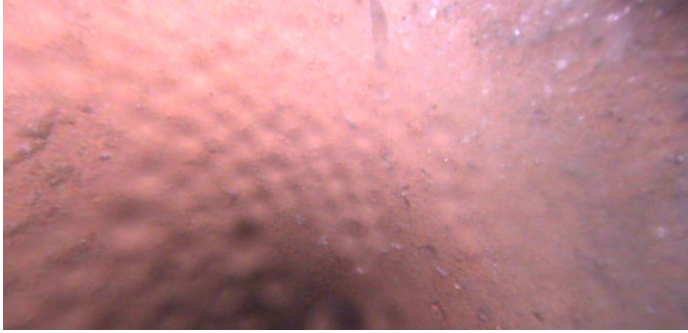
Code:	<b>MSA</b>
Description:	<b>Abandoned Survey</b>
Distance (ft):	<b>98.8</b>
Structural Grade:	<b>0</b>
O&M Grade:	<b>0</b>
Clock Start/From:	
Clock To:	
1st Value:	
2nd Value:	
Value Percent:	
Continuous Index:	
Within 8" of Joint:	<b>NO</b>
Remarks:	<b>tbi</b>
