Profile/Photo Observation Report

Date:	04/27/2018	Weather:		Coding:	PACP 6.0
Pipe Length (ft):		Owner:	City of Hobart	Pre Clean:	No Pre-Cleaning
P.O.#:	114	Surveyor:	M. Pielacha	PSR:	P-603-030-031
Customer:	City of Hobart	Clean Date:		Shape:	C

Street:	Cressmoor Park	Flow Control:	Not Controlled
City:	Hobart, IN	Year Renewed:	
Location:	Light Highway	Tape/Media #:	DEP 114
Purpose:	Routine Assessment	Dia/Height:	6"
Use:	Sanitary	Material:	PVC
Drain Area:		Lining:	
Category:	NA		
Comment:	YES501824 Submittal 2		
Location Details:		Direction of Survey:	Upstream
US MH:	M-603-030	DS MH:	M-603-032
		Total Length Surveyed (ft):	5.1

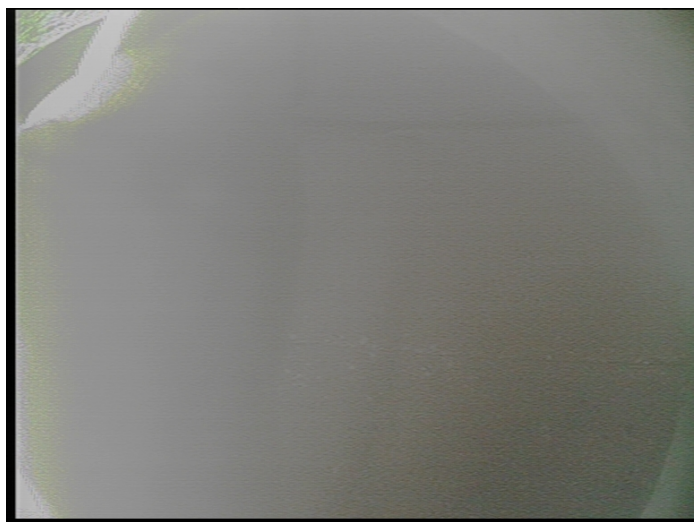
Code: **AMH**
 Description: **Manhole**

Distance (ft): **.0**
 Structural Grade: **0**
 O&M Grade: **0**
 Clock Start/From:
 Clock To:
 1st Value:
 2nd Value:
 Value Percent:
 Continuous Index:
 Within 8" of Joint: **NO**
 Remarks: **M-603-032**

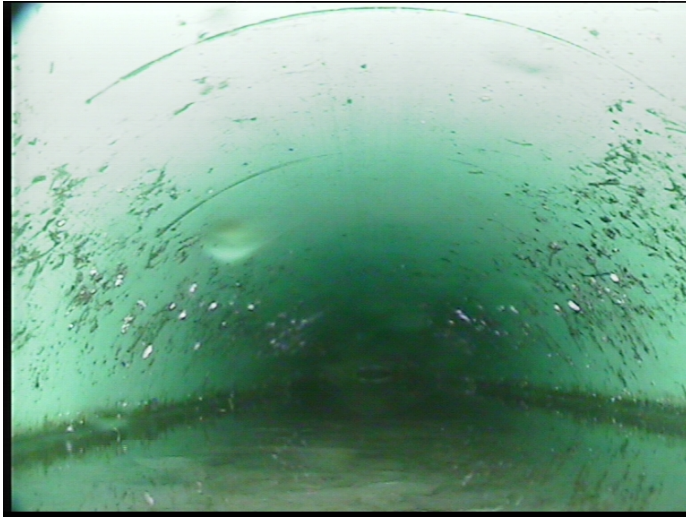
Code: **MWL**
Description: **Water Level**

Distance (ft): **.0**
Structural Grade: **0**
O&M Grade: **0**
Clock Start/From:
Clock To:
1st Value:
2nd Value:
Value Percent: **25.000**
Continuous Index:
Within 8" of Joint: **NO**
Remarks:

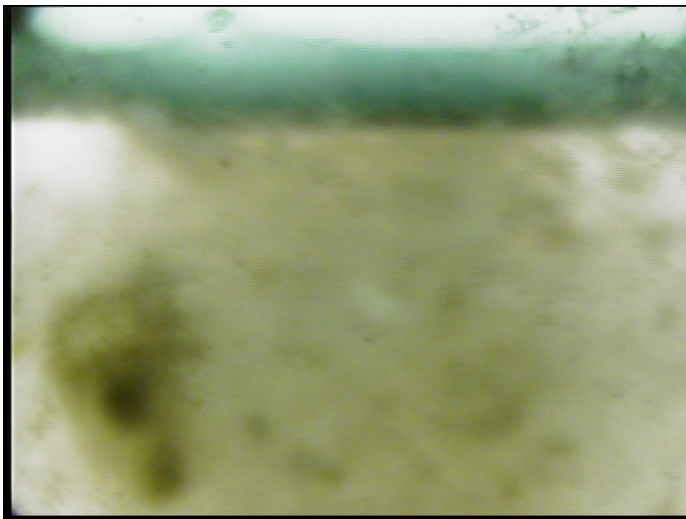
Code: **MCU**
Description: **Camera Underwater**

Distance (ft): **4.0**
Structural Grade: **0**
O&M Grade: **4**
Clock Start/From:
Clock To:
1st Value:
2nd Value:
Value Percent:
Continuous Index:
Within 8" of Joint: **NO**
Remarks:

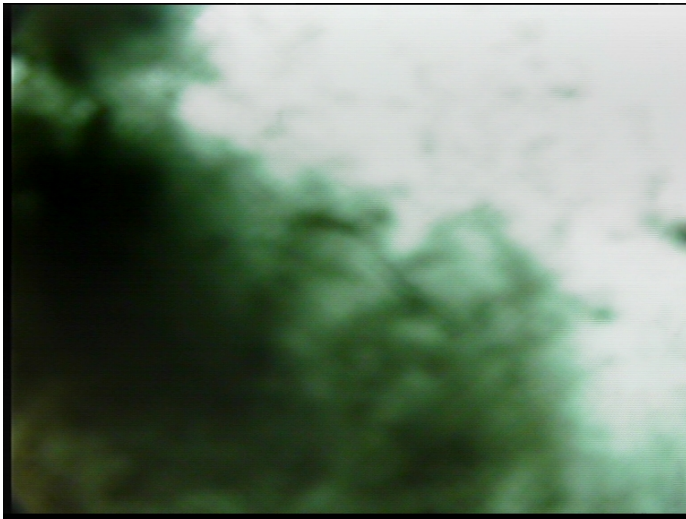
Code:	MSA
Description:	Abandoned Survey
Distance (ft):	5.1
Structural Grade:	0
O&M Grade:	0
Clock Start/From:	
Clock To:	
1st Value:	
2nd Value:	
Value Percent:	
Continuous Index:	
Within 8" of Joint:	NO
Remarks:	sediment/high water level
