Profile/Pl	noto Observation	Report			RedZone
Date:	04/27/2018	Weather: Owner:	City of Hohor	Coding: t Pre Clean:	PACP 6.0
Pipe Length (f P.O.#:	115	Surveyor:	City of Hobar M. Pielacha	PSR:	No Pre-Cleaning P-603-030-031
Customer:	City of Hobart	Clean Date		Shape:	C
Street:	Cressmoor Park		Flow Control:	Not Controlle	d
City:	Hobart, IN		Year Renewed:		
Location:	Light Highway		Tape/Media #:	DEP 115	
Purpose:	Routine Assessme	nt	Dia/Height:	6"	
Use:	Sanitary		Material:	VCP	
Drain Area:			Lining:		
Category:	NA				
Comment:	YES501824 Submit	al 2			
Location Deta	ils:		Direction of Su	rvey: Downstream	
US MH:	M-603-030	DS MH:	M-603-031	Total Length Surveyed (f	t): 1.5
O&M Index:	3.00	O&M Quick	: 31	00 O&M Rating:	3.00
Structural Index	c 0.00	Structural C	uick: OC	00 Structural Rating	0.00
Overall Index:	3.00	Overall Qui	ck: 31	.00 Overall Rating:	3.00

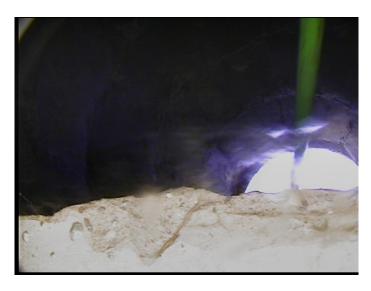
ode: escription:	AMH Manhole
Di	stance (ft):	.0
St	ructural Grade:	0
08	&M Grade:	0
Clo	ock Start/From:	
Clo	ock To:	
1s	t Value:	
2n	d Value:	
Va	lue Percent:	
Со	ontinuous Index:	
W	ithin 8" of Joint:	NO
Re	emarks:	M-603-030

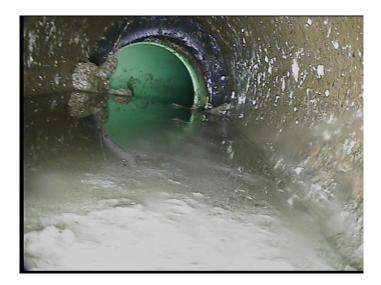
Code:	MWL
Description:	Water Level
Distance (ft)	0
Distance (ft):	.0
Structural Grade:	0
O&M Grade:	0
Clock Start/From:	
Clock To:	
1st Value:	
2nd Value:	
Value Percent:	5.000
Continuous Index:	
Within 8" of Joint:	NO
Remarks:

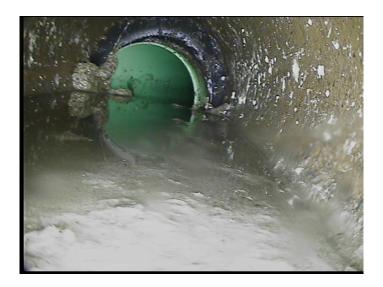
Code: Description:	DSF Deposits Settled Fine
Distance (ft):	.0
Structural Grade:	0
O&M Grade:	3
Clock Start/From:	5
Clock To:	7
1st Value:	
2nd Value:	
Value Percent:	15.000
Continuous Index:	
Within 8" of Joint:	NO
Remarks:

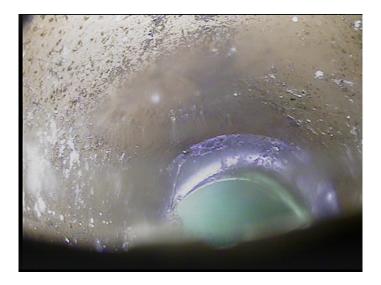
Code: Description:	MSA Abandoned Survey
Distance (ft):	1.5
Structural Grade:	0
O&M Grade:	0
Clock Start/From:	
Clock To:	
1st Value:	
2nd Value:	
Value Percent:	
Continuous Index:	
Within 8" of Joint:	NO
Remarks:	sediment
