## Profile/Photo Observation Report

Date:	<b>04/27/2018</b>	Weather:		Coding:	<b>PACP 6.0</b>
Pipe Length (ft):		Owner:	<b>City of Hobart</b>	Pre Clean:	<b>No Pre-Cleaning</b>
P.O.#:	<b>117</b>	Surveyor:	<b>M. Pielacha</b>	PSR:	<b>P-603-032-033</b>
Customer:	<b>City of Hobart</b>	Clean Date:		Shape:	<b>C</b>

Street:	<b>Cressmoor Park</b>	Flow Control:	<b>Not Controlled</b>
City:	<b>Hobart, IN</b>	Year Renewed:	
Location:	<b>Light Highway</b>	Tape/Media #:	<b>DEP 117</b>
Purpose:	<b>Routine Assessment</b>	Dia/Height:	<b>6"</b>
Use:	<b>Sanitary</b>	Material:	<b>VCP</b>
Drain Area:		Lining:	
Category:	<b>NA</b>		
Comment:	<b>YES501824 Submittal 2</b>		
Location Details:		Direction of Survey:	<b>Downstream</b>
US MH:	<b>M-603-032</b>	DS MH:	<b>M-603-033</b>
		Total Length Surveyed (ft):	<b>32.5</b>

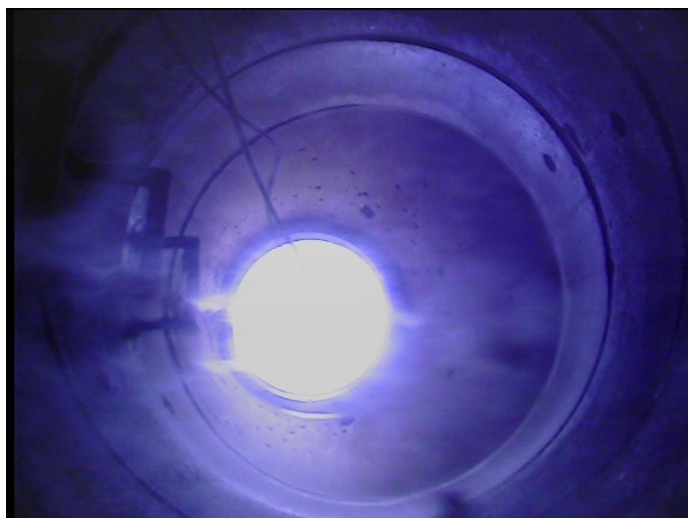
Code: **AMH**  
Description: **Manhole**

Distance (ft): **.0**  
Structural Grade: **0**  
O&M Grade: **0**  
Clock Start/From:  
Clock To:  
1st Value:  
2nd Value:  
Value Percent:  
Continuous Index:  
Within 8" of Joint: **NO**  
Remarks: **M-603-032**

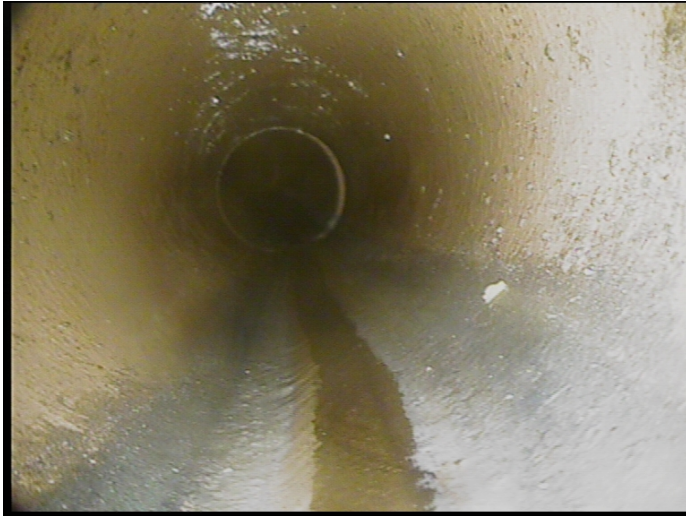
Code: **MWL**  
Description: **Water Level**

Distance (ft): **.0**  
Structural Grade: **0**  
O&M Grade: **0**  
Clock Start/From:  
Clock To:  
1st Value:  
2nd Value:  
Value Percent: **5.000**  
Continuous Index:  
Within 8" of Joint: **NO**  
Remarks:

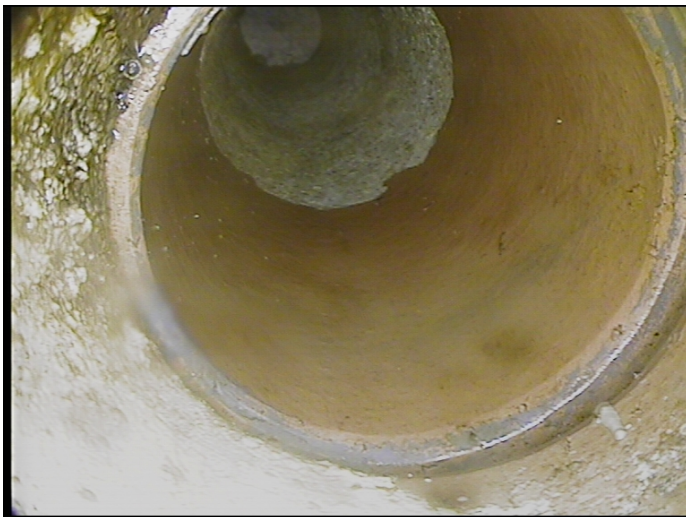
Code: **TFC**  
Description: **Tap Factory Capped**

Distance (ft): **15.1**  
Structural Grade: **0**  
O&M Grade: **0**  
Clock Start/From: **12**  
Clock To:  
1st Value: **4.000**  
2nd Value:  
Value Percent:  
Continuous Index:  
Within 8" of Joint: **NO**  
Remarks:

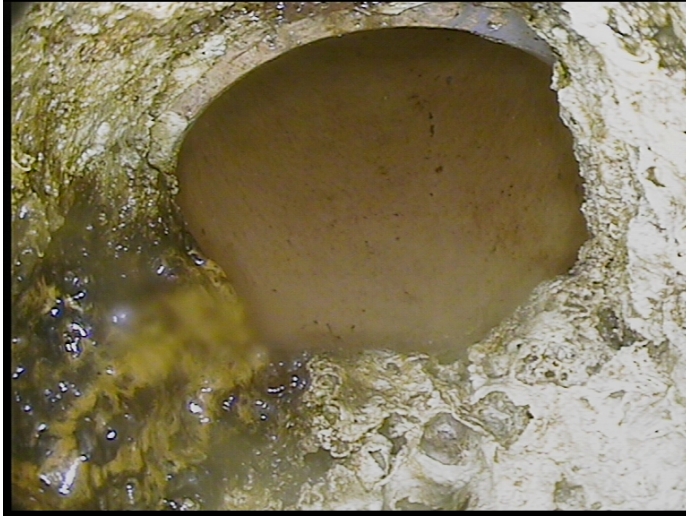
Code: **TF**  
Description: **Tap Factory**

Distance (ft): **26.8**  
Structural Grade: **0**  
O&M Grade: **0**  
Clock Start/From: **12**  
Clock To:  
1st Value: **4.000**  
2nd Value:  
Value Percent:  
Continuous Index:  
Within 8" of Joint: **NO**  
Remarks:

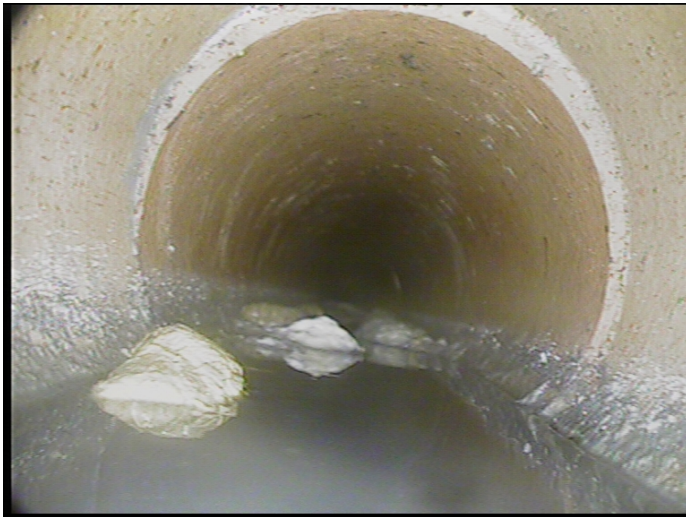
Code: **DSF**  
Description: **Deposits Settled Fine**

Distance (ft): **32.3**  
Structural Grade: **0**  
O&M Grade: **2**  
Clock Start/From: **5**  
Clock To: **7**  
1st Value:  
2nd Value:  
Value Percent: **10.000**  
Continuous Index:  
Within 8" of Joint: **NO**  
Remarks:

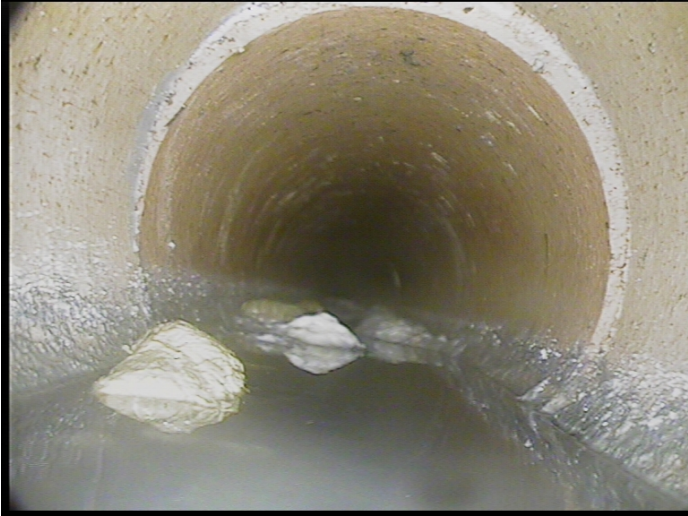
Code:	MSA
Description:	Abandoned Survey
Distance (ft):	32.3
Structural Grade:	0
O&M Grade:	0
Clock Start/From:	
Clock To:	
1st Value:	
2nd Value:	
Value Percent:	
Continuous Index:	
Within 8" of Joint:	NO
Remarks:	sediment/fine debris
