Profile/Photo Observation Report

Date:	04/12/2018	Weather:		Coding:	PACP 6.0
Pipe Length (ft):		Owner:	City of Hobart	Pre Clean:	No Pre-Cleaning
P.O.#:	37-1	Surveyor:	M. Pielacha	PSR:	M-603-036-M-603-035
Customer:	City of Hobart	Clean Date:		Shape:	C

Street:	Off 37th Avenue	Flow Control:	Not Controlled
City:	Hobart, IN	Year Renewed:	
Location:	Light Highway	Tape/Media #:	DEP 37
Purpose:	Routine Assessment	Dia/Height:	6"
Use:	Sanitary	Material:	VCP
Drain Area:		Lining:	
Category:	NA		
Comment:			
Location Details:		Direction of Survey:	Upstream
US MH:	M-603-036	DS MH:	M-603-035
		Total Length Surveyed (ft):	101.4

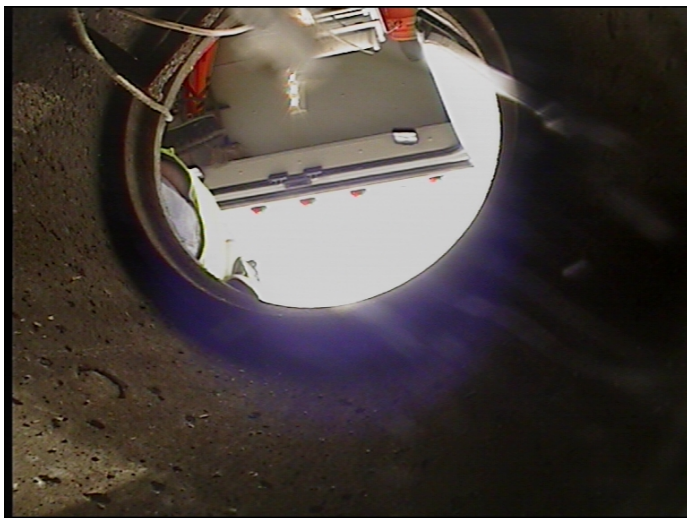
Code: **AMH**
Description: **Manhole**

Distance (ft): **.0**
Structural Grade: **0**
O&M Grade: **0**
Clock Start/From:
Clock To:
1st Value:
2nd Value:
Value Percent:
Continuous Index:
Within 8" of Joint: **NO**
Remarks: **M-603-035**

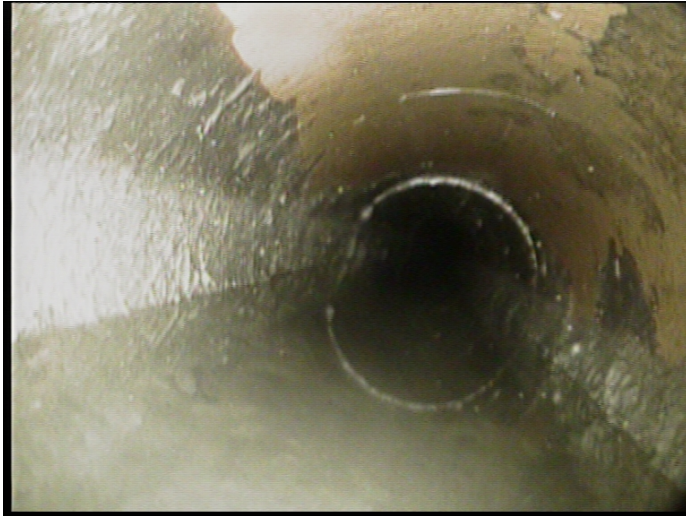
Code: **MWL**
Description: **Water Level**

Distance (ft): **.0**
Structural Grade: **0**
O&M Grade: **0**
Clock Start/From:
Clock To:
1st Value:
2nd Value:
Value Percent: **10.000**
Continuous Index:
Within 8" of Joint: **NO**
Remarks:

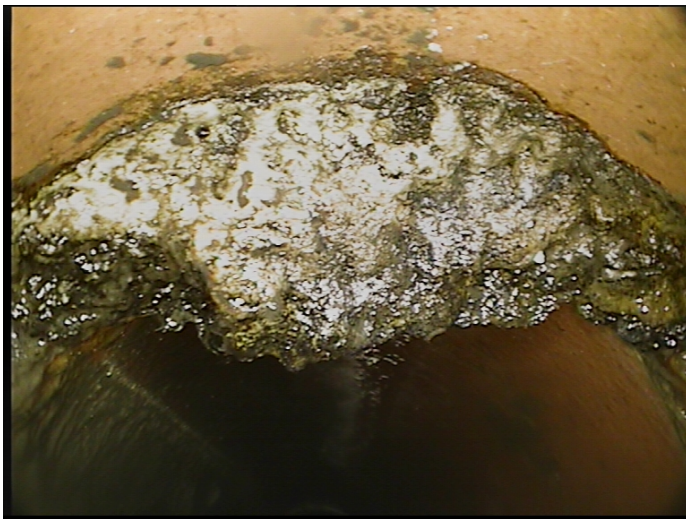
Code: **DAE**
Description: **Deposits Attached Encrustation**

Distance (ft): **90.7**
Structural Grade: **0**
O&M Grade: **2**
Clock Start/From: **9**
Clock To: **11**
1st Value:
2nd Value:
Value Percent: **10.000**
Continuous Index:
Within 8" of Joint: **YES**
Remarks:

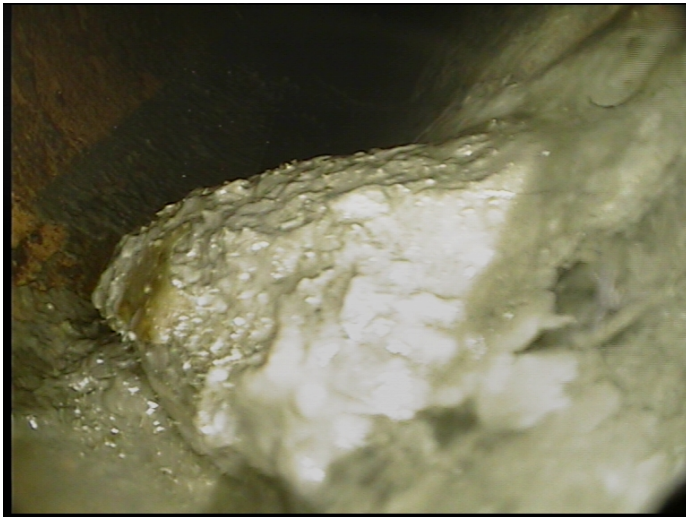
Code:	DAE
Description:	Deposits Attached Encrustation
Distance (ft):	99.0
Structural Grade:	0
O&M Grade:	3
Clock Start/From:	7
Clock To:	9
1st Value:	
2nd Value:	
Value Percent:	15.000
Continuous Index:	
Within 8" of Joint:	YES
Remarks:

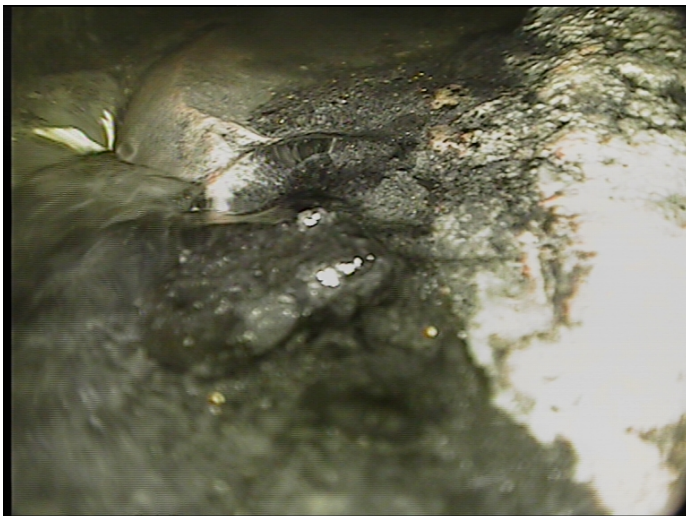
Code:	MSA
Description:	Abandoned Survey
Distance (ft):	101.1
Structural Grade:	0
O&M Grade:	0
Clock Start/From:	
Clock To:	
1st Value:	
2nd Value:	
Value Percent:	
Continuous Index:	
Within 8" of Joint:	NO
Remarks:	debris
