## Profile/Photo Observation Report

Date:	<b>04/12/2018</b>	Weather:		Coding:	<b>PACP 6.0</b>
Pipe Length (ft):		Owner:	<b>City of Hobart</b>	Pre Clean:	<b>No Pre-Cleaning</b>
P.O.#:	<b>37-1</b>	Surveyor:	<b>M. Pielacha</b>	PSR:	<b>M-603-036-M-603-035</b>
Customer:	<b>City of Hobart</b>	Clean Date:		Shape:	<b>C</b>

Street:	<b>Off 37th Avenue</b>	Flow Control:	<b>Not Controlled</b>
City:	<b>Hobart, IN</b>	Year Renewed:	
Location:	<b>Light Highway</b>	Tape/Media #:	<b>DEP 37</b>
Purpose:	<b>Routine Assessment</b>	Dia/Height:	<b>6"</b>
Use:	<b>Sanitary</b>	Material:	<b>VCP</b>
Drain Area:		Lining:	
Category:	<b>NA</b>		
Comment:			
Location Details:		Direction of Survey:	<b>Upstream</b>
US MH:	<b>M-603-036</b>	DS MH:	<b>M-603-035</b>
		Total Length Surveyed (ft):	<b>101.4</b>

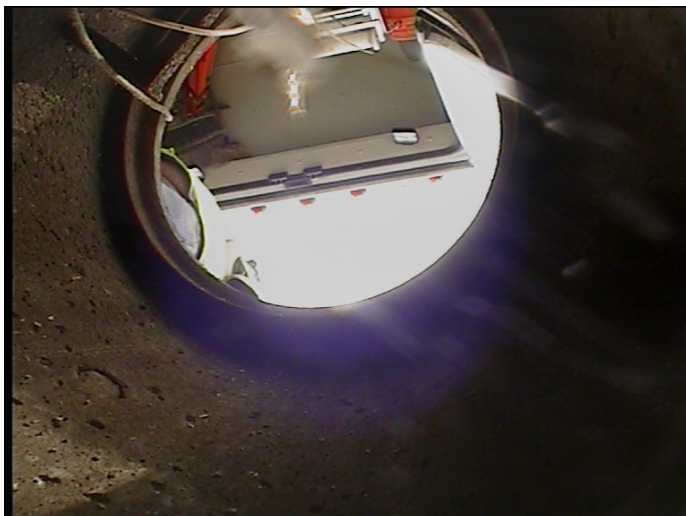
Code: **AMH**  
 Description: **Manhole**

Distance (ft): **.0**  
 Structural Grade: **0**  
 O&M Grade: **0**  
 Clock Start/From:  
 Clock To:  
 1st Value:  
 2nd Value:  
 Value Percent:  
 Continuous Index:  
 Within 8" of Joint: **NO**  
 Remarks: **M-603-035**
