Profile/Photo Observation Report

Profile/Photo Observation Report							
Date: Pipe Length (ft) P.O.#: Customer:	04/12/2018): 36-1 City of Hobart	Weather: Owner: Surveyor: Clean Date:	City of Hobai M. Pielacha	rt	J	PACP 6.0 No Pre-Cleaning M-603-037-M-603-036 C	
Street:	Off 37th Avenue	Cican Date.	Flow Control:		Not Controlled		
City:	Hobart, IN		Year Renewed	:	Not controlled		
Location:	Light Highway		Tape/Media #:	-	DEP 36		
Purpose:	Routine Assessment		Dia/Height:		6"		
Use:	Sanitary		Material:		VCP		
Drain Area:			Lining:				
Category:	NA						
Comment:							
Location Detail	S:		Direction of Su	ırvey:	Upstream		
US MH:	M-603-037	DS MH:	M-603-036	To	otal Length Surveyed (ft):	2.1	
O&M Index:	0.00	O&M Quick:	00	000	O&M Rating:	0.00	
Structural Index:	0.00	Structural Q		000	Structural Rating:	0.00	
Overall Index:	0.00	Overall Quic		000	Overall Rating:	0.00	
	-	_ ,	-

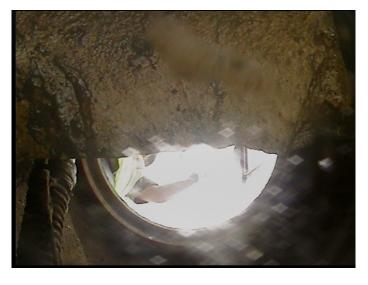
AMH

Description: Manhole Distance (ft): .0 Structural Grade: 0 O&M Grade: 0 Clock Start/From: Clock To: 1st Value: 2nd Value: Value Percent: Continuous Index: Within 8" of Joint: NO Remarks: M-603-036

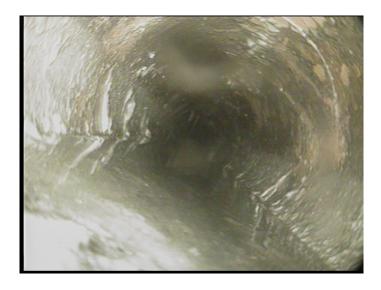
Code: MWL

Description: **Water Level**

Distance (ft): .0 Structural Grade: 0 O&M Grade: 0

10.000

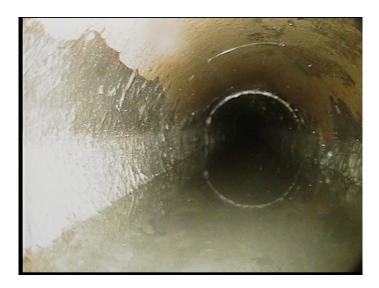
MSA

Description: **Abandoned Survey**

Distance (ft): 2.1 Structural Grade: 0 O&M Grade: 0

Remarks: sediment
