Profile/Photo Observation Report

Date:	04/23/2018	Weather:		Coding:	PACP 6.0
Pipe Length (ft):	180.4	Owner:	NA	Pre Clean:	Not Known
P.O.#:		Surveyor:	Jen Costello	PSR:	P-604-002-001
Customer:		Clean Date:	01/01/1900	Shape:	C

Street:	S LAKE PARK AVE & W CLEVELAND A	Flow Control:	Not Controlled
City:	Hobart, IN	Year Renewed:	
Location:	Other	Tape/Media #:	
Purpose:	Not Known	Dia/Height:	10"
Use:	Sanitary	Material:	VCP
Drain Area:	NA	Lining:	
Category:	NA		
Comment:

Location Details:		Direction of Survey:	Downstream
US MH:	M-604-002	DS MH:	M-604-001
		Total Length Surveyed (ft):	14.2

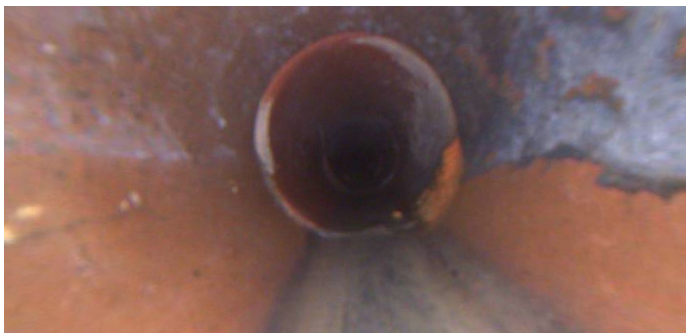
Code: **AMH**
Description: **Manhole**

Distance (ft): **.0**
Structural Grade: **0**
O&M Grade: **0**
Clock Start/From:
Clock To:
1st Value:
2nd Value:
Value Percent:
Continuous Index:
Within 8" of Joint: **NO**
Remarks: **M-604-002**

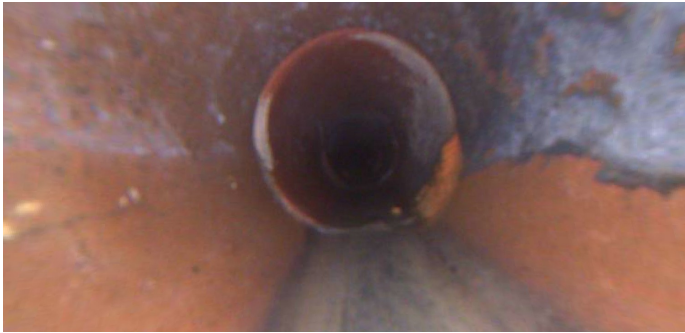
Code:	MWL
Description:	Water Level

Distance (ft):	.0
Structural Grade:	0
O&M Grade:	0
Clock Start/From:	
Clock To:	
1st Value:	
2nd Value:	
Value Percent:	5.000
Continuous Index:	
Within 8" of Joint:	NO
Remarks:

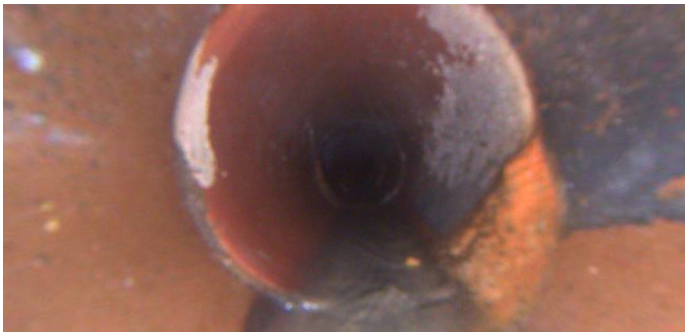
Code:	DAE
Description:	Deposits Attached Encrustation

Distance (ft):	2.0
Structural Grade:	0
O&M Grade:	2
Clock Start/From:	3
Clock To:	4
1st Value:	
2nd Value:	
Value Percent:	5.000
Continuous Index:	
Within 8" of Joint:	YES
Remarks:

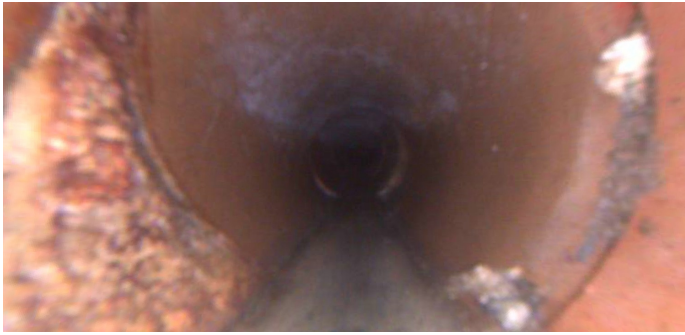
Code: **DAE**
Description: **Deposits Attached Encrustation**

Distance (ft): **4.1**
Structural Grade: **0**
O&M Grade: **2**
Clock Start/From: **7**
Clock To: **9**
1st Value:
2nd Value:
Value Percent: **10.000**
Continuous Index:
Within 8" of Joint: **YES**
Remarks:

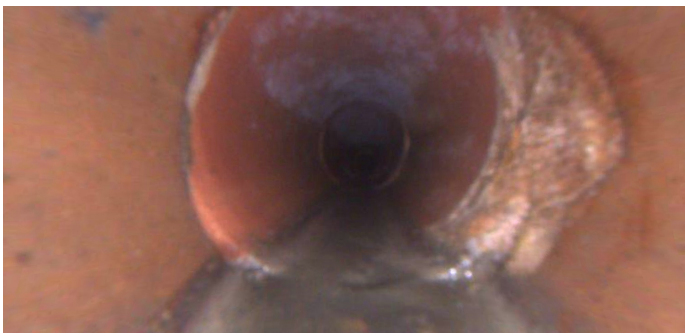
Code: **DAE**
Description: **Deposits Attached Encrustation**

Distance (ft): **5.7**
Structural Grade: **0**
O&M Grade: **2**
Clock Start/From: **1**
Clock To: **4**
1st Value:
2nd Value:
Value Percent: **5.000**
Continuous Index:
Within 8" of Joint: **YES**
Remarks:

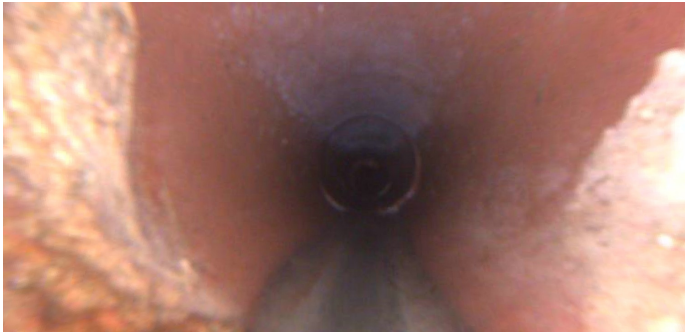
Code: **DAE**
Description: **Deposits Attached Encrustation**

Distance (ft): **8.2**
Structural Grade: **0**
O&M Grade: **2**
Clock Start/From: **8**
Clock To: **4**
1st Value:
2nd Value:
Value Percent: **5.000**
Continuous Index:
Within 8" of Joint: **YES**
Remarks:

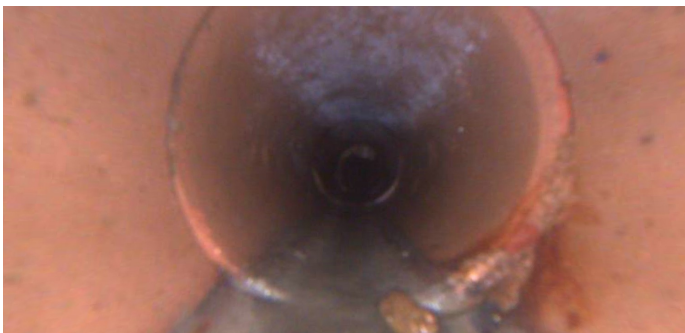
Code: **IW**
Description: **Infil Weeper**

Distance (ft): **9.9**
Structural Grade: **0**
O&M Grade: **2**
Clock Start/From: **3**
Clock To: **5**
1st Value:
2nd Value:
Value Percent:
Continuous Index:
Within 8" of Joint: **YES**
Remarks:

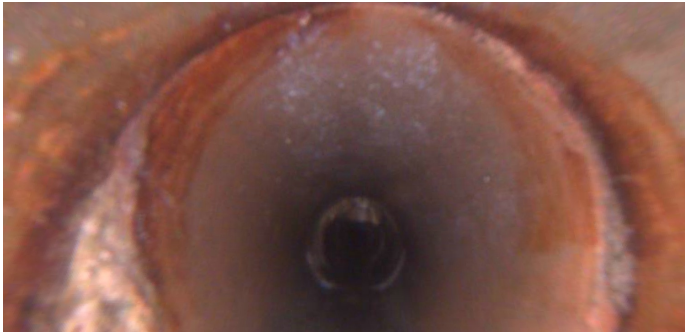
Code: **IS**
Description: **Infil Stain**

Distance (ft): **12.0**
Structural Grade: **0**
O&M Grade: **0**
Clock Start/From: **8**
Clock To: **4**
1st Value:
2nd Value:
Value Percent:
Continuous Index:
Within 8" of Joint: **YES**
Remarks:

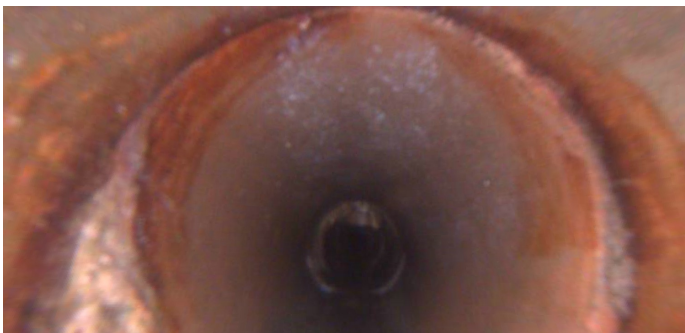
Code: **DAE**
Description: **Deposits Attached Encrustation**

Distance (ft): **12.0**
Structural Grade: **0**
O&M Grade: **2**
Clock Start/From: **7**
Clock To: **9**
1st Value:
2nd Value:
Value Percent: **5.000**
Continuous Index:
Within 8" of Joint: **YES**
Remarks:

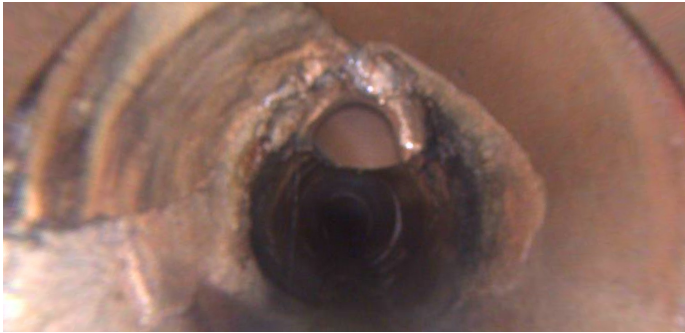
Code: **FM**
Description: **Fracture Multiple**

Distance (ft): **14.2**
Structural Grade: **4**
O&M Grade: **0**
Clock Start/From: **9**
Clock To: **12**
1st Value:
2nd Value:
Value Percent:
Continuous Index:
Within 8" of Joint: **YES**
Remarks:

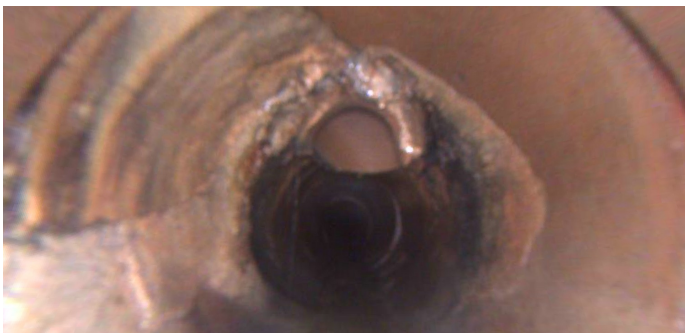
Code: **IW**
Description: **Infil Weeper**

Distance (ft): **14.2**
Structural Grade: **0**
O&M Grade: **2**
Clock Start/From: **8**
Clock To: **12**
1st Value:
2nd Value:
Value Percent:
Continuous Index:
Within 8" of Joint:
Remarks:
