Profile/Photo Observation Report

Street:	W Cleveland Ave.	Flow Control:	Not Controlled
City:	Hobart, IN	Year Renewed:	
Location:	Other	Tape/Media #:	
Purpose:	Not Known	Dia/Height:	10"
Use:	Sanitary	Material:	VCP
Drain Area:	NA	Lining:	
Category:	NA		
Comment:

Location Details:		Direction of Survey:	Downstream
US MH:	M-604-002	DS MH:	M-604-001
		Total Length Surveyed (ft):	14.2

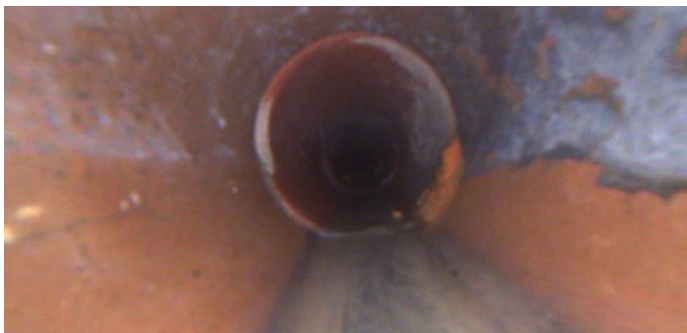
Code: **AMH**
 Description: **Manhole**
 Distance (ft): **.0**
 Structural Grade: **0**
 O&M Grade: **0**
 Clock Start/From:
 Clock To:
 1st Value:
 2nd Value:
 Value Percent:
 Continuous Index:
 Within 8" of Joint: **NO**
 Remarks: **M-604-002**

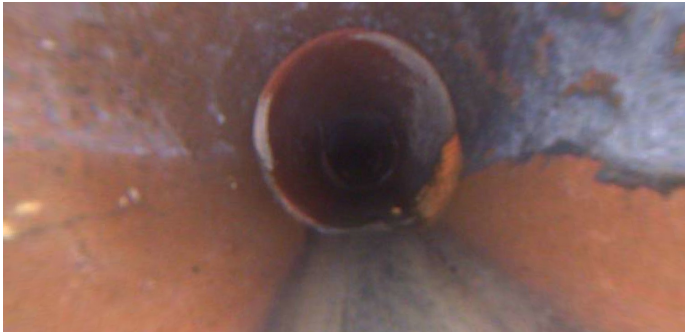
Code:	MWL
Description:	Water Level

Distance (ft):	.0
Structural Grade:	0
O&M Grade:	0
Clock Start/From:	
Clock To:	
1st Value:	
2nd Value:	
Value Percent:	5.000
Continuous Index:	
Within 8" of Joint:	NO
Remarks:

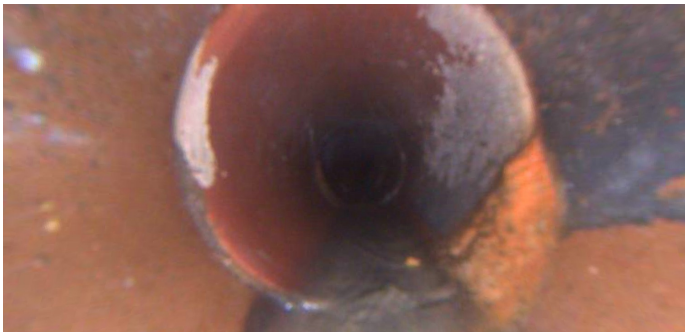
Code:	DAE
Description:	Deposits Attached Encrustation

Distance (ft):	2.0
Structural Grade:	0
O&M Grade:	2
Clock Start/From:	3
Clock To:	4
1st Value:	
2nd Value:	
Value Percent:	5.000
Continuous Index:	
Within 8" of Joint:	YES
Remarks:

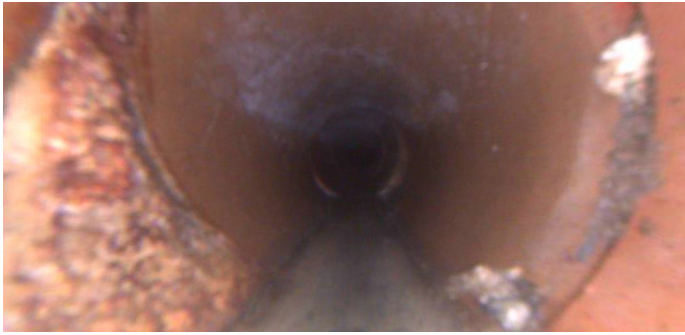
Code: **DAE**
Description: **Deposits Attached Encrustation**

Distance (ft): **4.1**
Structural Grade: **0**
O&M Grade: **2**
Clock Start/From: **7**
Clock To: **9**
1st Value:
2nd Value:
Value Percent: **10.000**
Continuous Index:
Within 8" of Joint: **YES**
Remarks:

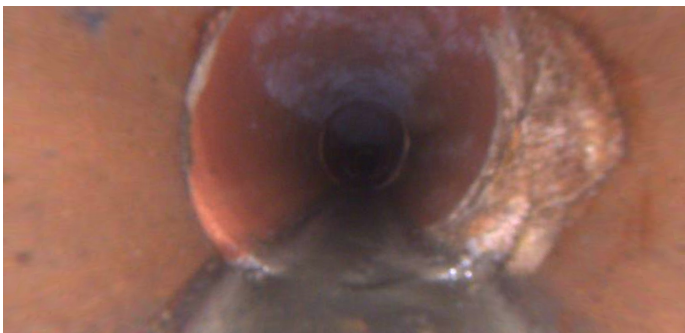
Code: **DAE**
Description: **Deposits Attached Encrustation**

Distance (ft): **5.7**
Structural Grade: **0**
O&M Grade: **2**
Clock Start/From: **1**
Clock To: **4**
1st Value:
2nd Value:
Value Percent: **5.000**
Continuous Index:
Within 8" of Joint: **YES**
Remarks:

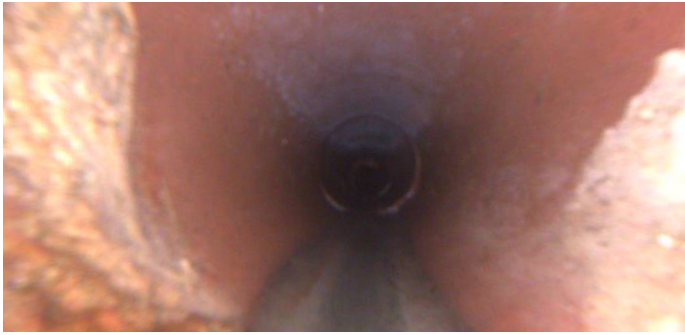
Code: **DAE**
Description: **Deposits Attached Encrustation**

Distance (ft): **8.2**
Structural Grade: **0**
O&M Grade: **2**
Clock Start/From: **8**
Clock To: **4**
1st Value:
2nd Value:
Value Percent: **5.000**
Continuous Index:
Within 8" of Joint: **YES**
Remarks:

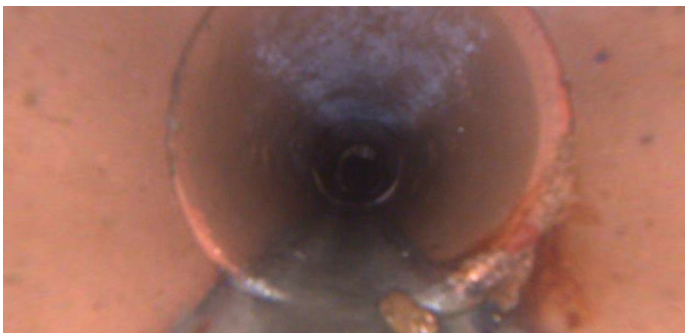
Code: **IW**
Description: **Infil Weeper**

Distance (ft): **9.9**
Structural Grade: **0**
O&M Grade: **2**
Clock Start/From: **3**
Clock To: **5**
1st Value:
2nd Value:
Value Percent:
Continuous Index:
Within 8" of Joint: **YES**
Remarks:

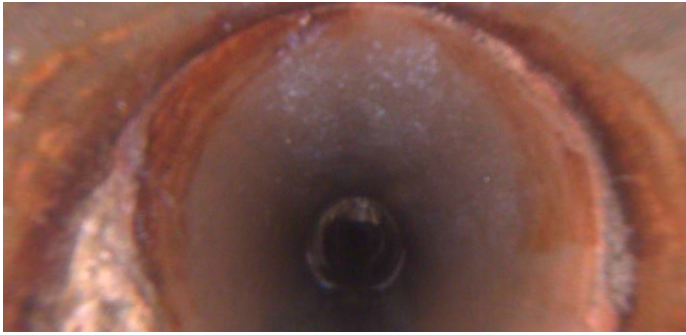
Code: **IS**
Description: **Infil Stain**

Distance (ft): **12.0**
Structural Grade: **0**
O&M Grade: **0**
Clock Start/From: **8**
Clock To: **4**
1st Value:
2nd Value:
Value Percent:
Continuous Index:
Within 8" of Joint: **YES**
Remarks:

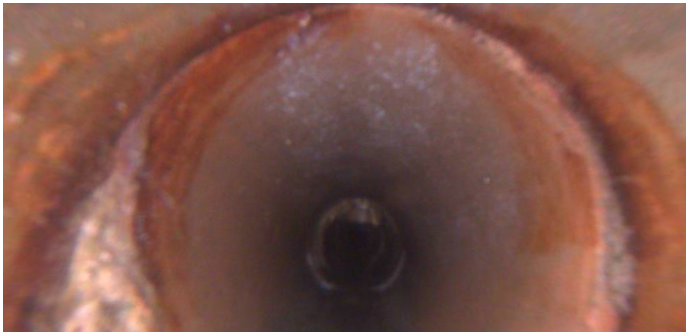
Code: **DAE**
Description: **Deposits Attached Encrustation**

Distance (ft): **12.0**
Structural Grade: **0**
O&M Grade: **2**
Clock Start/From: **7**
Clock To: **9**
1st Value:
2nd Value:
Value Percent: **5.000**
Continuous Index:
Within 8" of Joint: **YES**
Remarks:

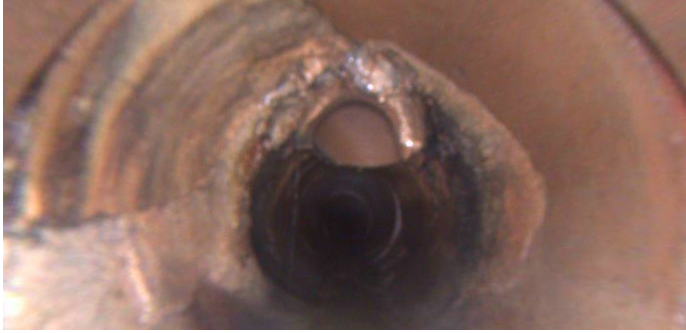
Code: **FM**
Description: **Fracture Multiple**

Distance (ft): **14.2**
Structural Grade: **4**
O&M Grade: **0**
Clock Start/From: **9**
Clock To: **12**
1st Value:
2nd Value:
Value Percent:
Continuous Index:
Within 8" of Joint: **YES**
Remarks:

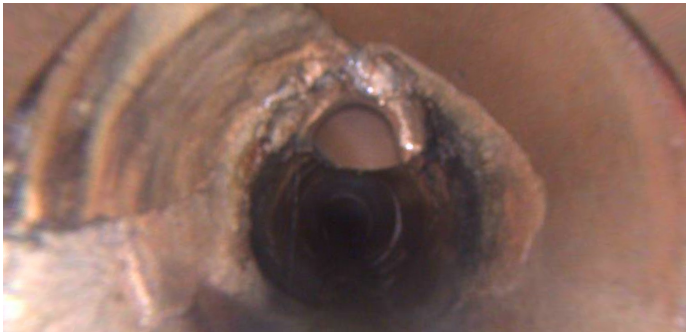
Code: **IW**
Description: **Infil Weeper**

Distance (ft): **14.2**
Structural Grade: **0**
O&M Grade: **2**
Clock Start/From: **8**
Clock To: **12**
1st Value:
2nd Value:
Value Percent:
Continuous Index:
Within 8" of Joint:
Remarks:
