Profile/Photo Observation Report

Street:	S LAKE PARK AVE & W CLEVELAND A	Flow Control:	Not Controlled
City:	Hobart, IN	Year Renewed:	
Location:	Other	Tape/Media #:	
Purpose:	Not Known	Dia/Height:	10"
Use:	Sanitary	Material:	CP
Drain Area:	NA	Lining:	
Category:	NA		
Comment:

Location Details:		Direction of Survey:	Upstream
US MH:	M-604-002	DS MH:	M-604-001
		Total Length Surveyed (ft):	6.2

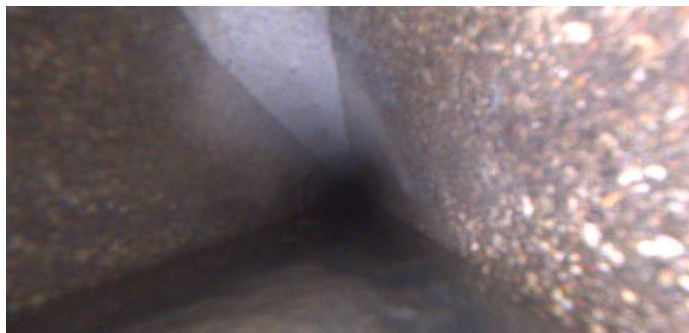
Code: **AMH**
Description: **Manhole**

Distance (ft): **.0**
Structural Grade: **0**
O&M Grade: **0**
Clock Start/From:
Clock To:
1st Value:
2nd Value:
Value Percent:
Continuous Index:
Within 8" of Joint: **NO**
Remarks: **M-604-001**

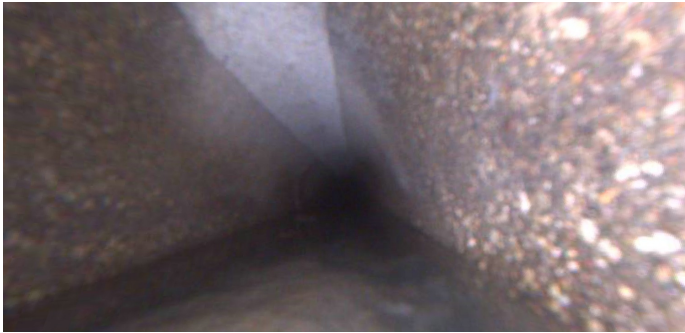
Code:	MWL
Description:	Water Level

Distance (ft):	.0
Structural Grade:	0
O&M Grade:	0
Clock Start/From:	
Clock To:	
1st Value:	
2nd Value:	
Value Percent:	30.000
Continuous Index:	
Within 8" of Joint:	NO
Remarks:

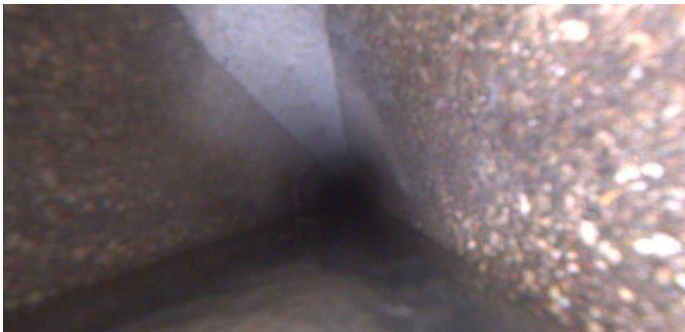
Code:	SAP
Description:	Surface Aggregate Projecting

Distance (ft):	.0
Structural Grade:	3
O&M Grade:	0
Clock Start/From:	8
Clock To:	4
1st Value:	
2nd Value:	
Value Percent:	
Continuous Index:	S01
Within 8" of Joint:	
Remarks:

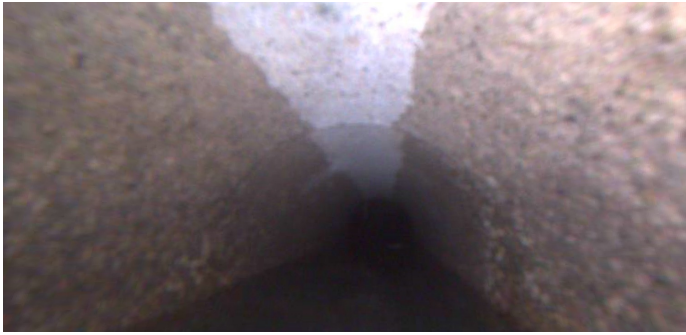
Code: **MSA**
Description: **Abandoned Survey**

Distance (ft): **6.2**
Structural Grade: **0**
O&M Grade: **0**
Clock Start/From:
Clock To:
1st Value:
2nd Value:
Value Percent:
Continuous Index:
Within 8" of Joint: **NO**
Remarks: **debris under water**

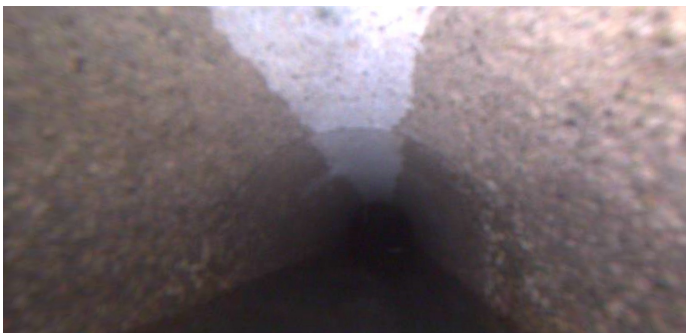
Code: **SAP**
Description: **Surface Aggregate Projecting**

Distance (ft): **6.2**
Structural Grade: **3**
O&M Grade: **0**
Clock Start/From: **8**
Clock To: **4**
1st Value:
2nd Value:
Value Percent:
Continuous Index: **F01**
Within 8" of Joint:
Remarks:
