Profile/Photo Observation Report

Date:	11/14/2021	Weather:		Coding:	PACP 7.0
Pipe Length (ft):	178.0	Owner:	City of Hobart	Pre Clean:	Heavy Cleaning
P.O.#:	YES502259	Surveyor:	S. Bucklin	PSR:	P-604-002-001
Customer:	City of Hobart	Clean Date:	11/13/2021	Shape:	C

Street:	West Cleveland Street	Flow Control:	Not Controlled
City:	Hobart, IN	Year Renewed:	
Location:	Local rural streets with light traffic, t	Tape/Media #:	
Purpose:	Routine Assessment	Dia/Height:	10"
Use:	Sanitary Sewage Pipe	Material:	VCP
Drain Area:		Lining:	None
Category:	NA		
Comment:			
Location Details:		Direction of Survey:	Downstream
US MH:	M-604-002	DS MH:	M-604-001
		Total Length Surveyed (ft):	178.0

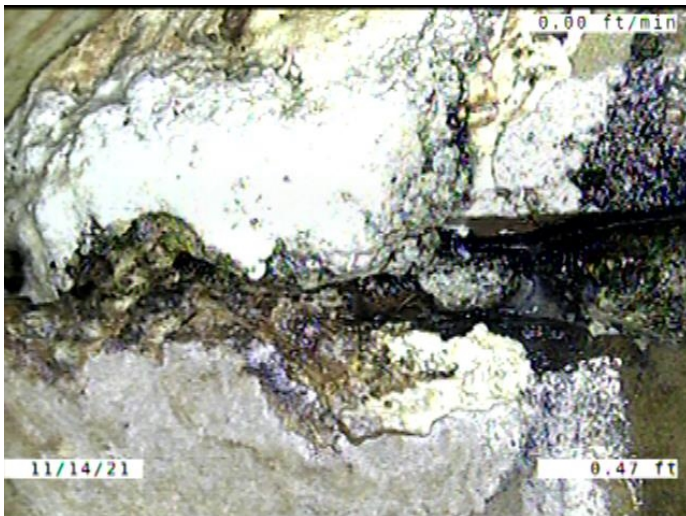
Code: **DAE**
 Description: **Deposits Attached Encrustation**

Distance (ft): **.5**
 Structural Grade: **0**
 O&M Grade: **2**
 Clock Start/From: **5**
 Clock To: **1**
 1st Value:
 2nd Value:
 Value Percent: **5.000**
 Continuous Index:
 Within 8" of Joint: **YES**
 Remarks:

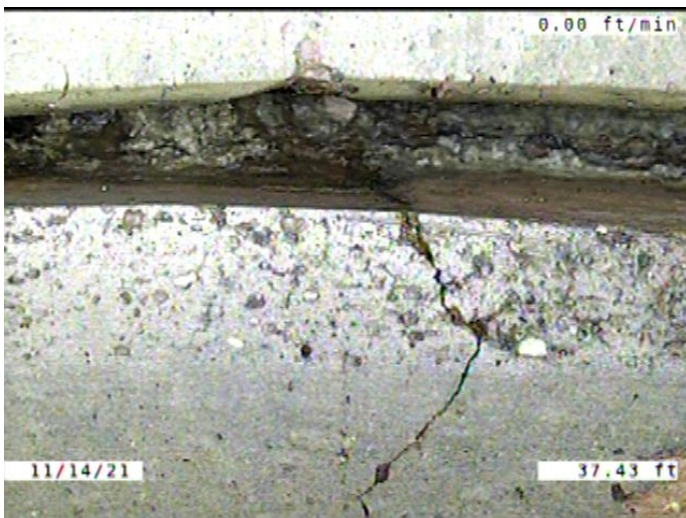
Code: **CM**
 Description: **Crack Multiple**

Distance (ft): **37.4**
 Structural Grade: **3**
 O&M Grade: **0**
 Clock Start/From: **8**
 Clock To: **2**
 1st Value:
 2nd Value:
 Value Percent:
 Continuous Index:
 Within 8" of Joint: **YES**
 Remarks:

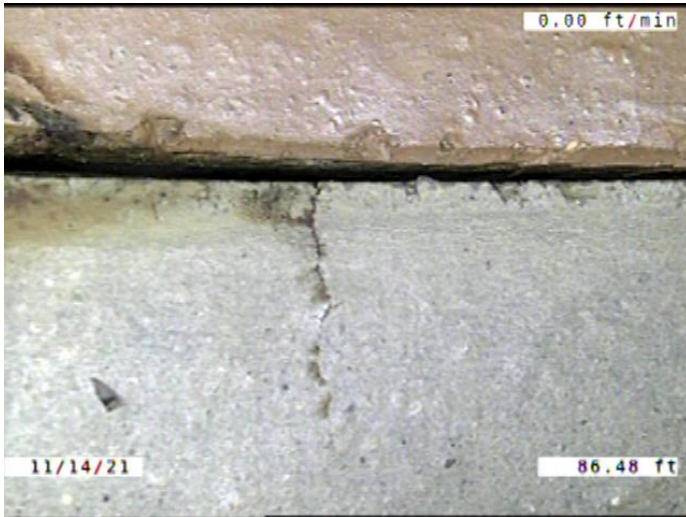
Code: **CL**
Description: **Crack Longitudinal**

Distance (ft): **86.5**
Structural Grade: **2**
O&M Grade: **0**
Clock Start/From: **10**
Clock To:
1st Value:
2nd Value:
Value Percent:
Continuous Index:
Within 8" of Joint: **YES**
Remarks:

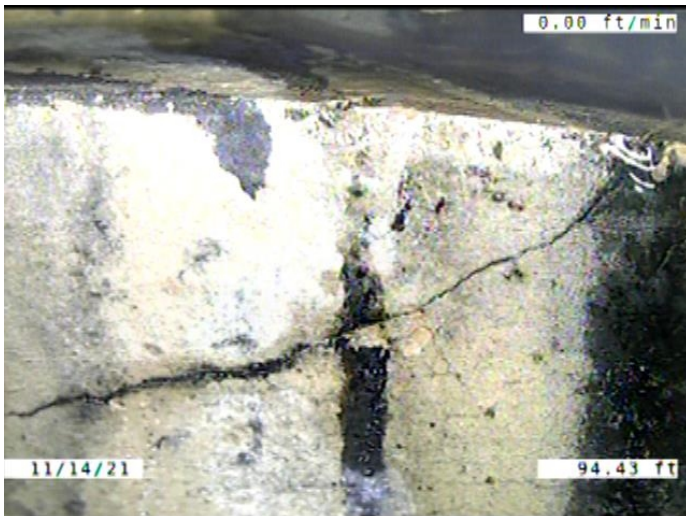
Code: **FM**
Description: **Fracture Multiple**

Distance (ft): **94.4**
Structural Grade: **4**
O&M Grade: **0**
Clock Start/From: **11**
Clock To: **5**
1st Value:
2nd Value:
Value Percent:
Continuous Index:
Within 8" of Joint: **YES**
Remarks:

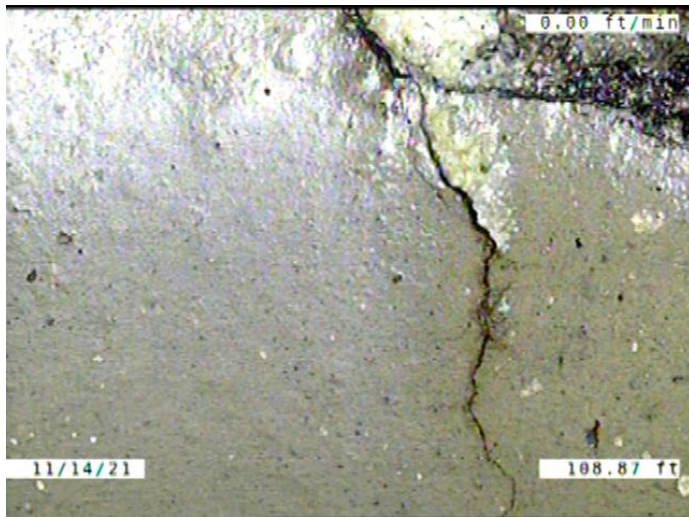
Code: **CL**
 Description: **Crack Longitudinal**

Distance (ft): **108.9**
 Structural Grade: **2**
 O&M Grade: **0**
 Clock Start/From: **1**
 Clock To:
 1st Value:
 2nd Value:
 Value Percent:
 Continuous Index:
 Within 8" of Joint: **YES**
 Remarks:

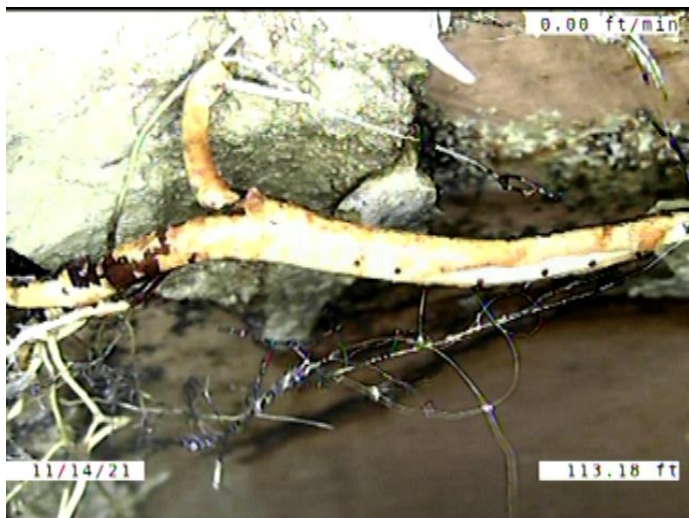
Code: **OBZ**
 Description: **Obstruction Other**

Distance (ft): **113.2**
 Structural Grade: **0**
 O&M Grade: **2**
 Clock Start/From: **6**
 Clock To: **10**
 1st Value:
 2nd Value:
 Value Percent: **5.000**
 Continuous Index:
 Within 8" of Joint: **YES**
 Remarks: **ROOT THAT HAS BEEN CUT**

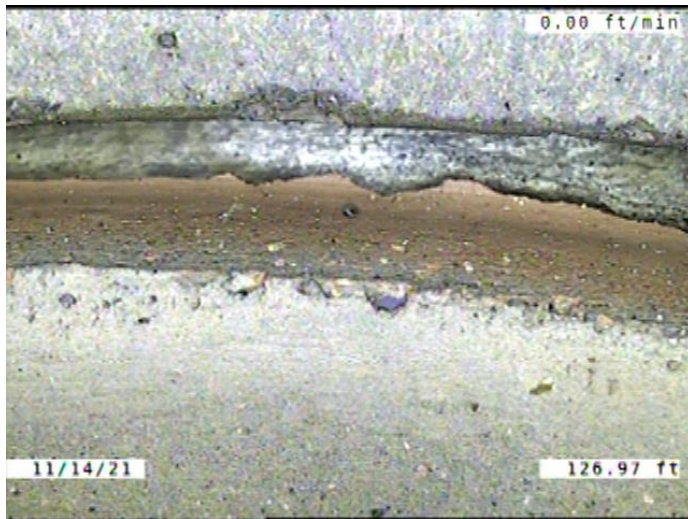
Code: **SMW**
 Description: **Surface Damage Missing Wall**

Distance (ft): **127.0**
 Structural Grade: **5**
 O&M Grade: **0**
 Clock Start/From: **11**
 Clock To: **4**
 1st Value:
 2nd Value:
 Value Percent:
 Continuous Index:
 Within 8" of Joint: **YES**
 Remarks:

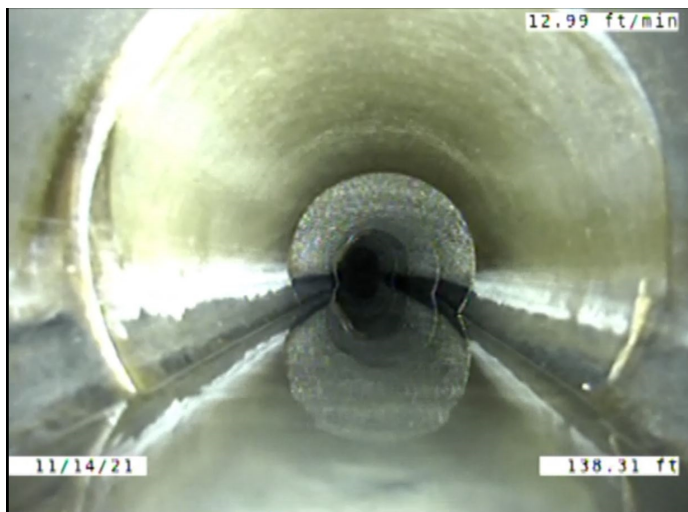
Code: **IS**
 Description: **Infiltration Stain**

Distance (ft): **138.3**
 Structural Grade: **0**
 O&M Grade: **1**
 Clock Start/From: **7**
 Clock To: **5**
 1st Value:
 2nd Value:
 Value Percent:
 Continuous Index: **F03**
 Within 8" of Joint: **YES**
 Remarks: **Wandering**

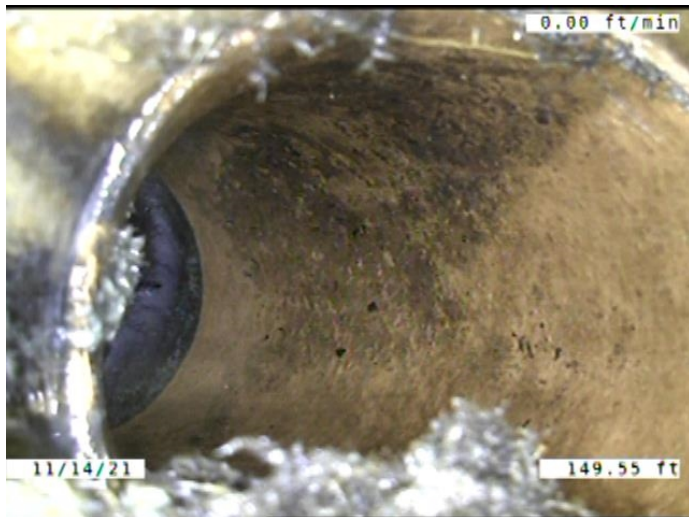
Code:	TBI
Description:	Tap Break-in Intruding
Distance (ft):	149.6
Structural Grade:	0
O&M Grade:	2
Clock Start/From:	11
Clock To:	
1st Value:	6.000
2nd Value:	1.000
Value Percent:	
Continuous Index:	
Within 8" of Joint:	YES
Remarks:	CONSTANTLY RUNNING WATER. ROOTS GROWING FROM THE JOINT

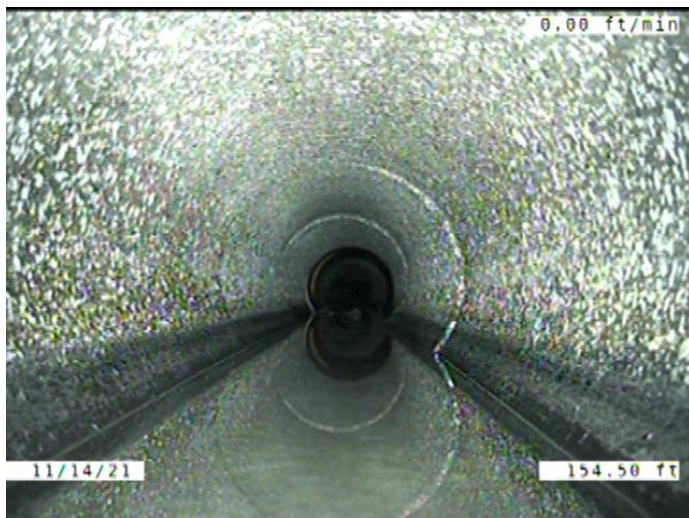
Code:	DAE
Description:	Deposits Attached Encrustation
Distance (ft):	154.5
Structural Grade:	0
O&M Grade:	2
Clock Start/From:	7
Clock To:	5
1st Value:	
2nd Value:	
Value Percent:	5.000
Continuous Index:	F01
Within 8" of Joint:	YES
Remarks:

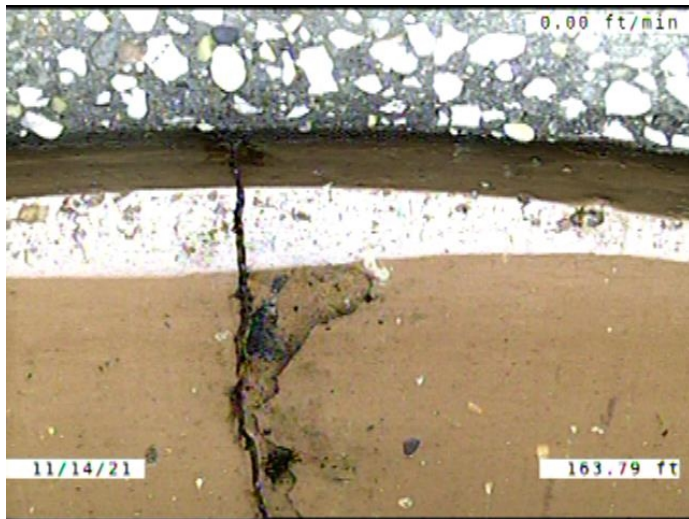
Code: **FS**
 Description: **Fracture Spiral**

Distance (ft): **163.8**
 Structural Grade: **3**
 O&M Grade: **0**
 Clock Start/From: **12**
 Clock To: **1**
 1st Value:
 2nd Value:
 Value Percent:
 Continuous Index:
 Within 8" of Joint: **YES**
 Remarks:

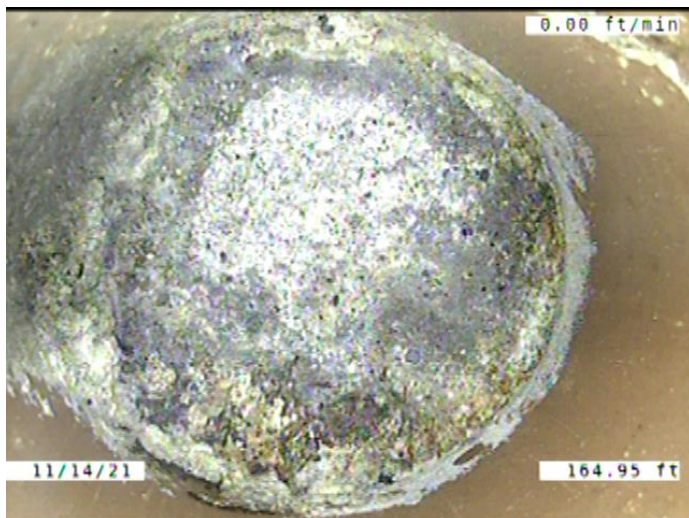
Code: **TFD**
 Description: **Tap Factory Defective**

Distance (ft): **164.9**
 Structural Grade: **0**
 O&M Grade: **3**
 Clock Start/From: **10**
 Clock To:
 1st Value: **4.000**
 2nd Value:
 Value Percent:
 Continuous Index:
 Within 8" of Joint: **YES**
 Remarks: **CAPPED. ENCRUSTATION AROUND THE CAP.**

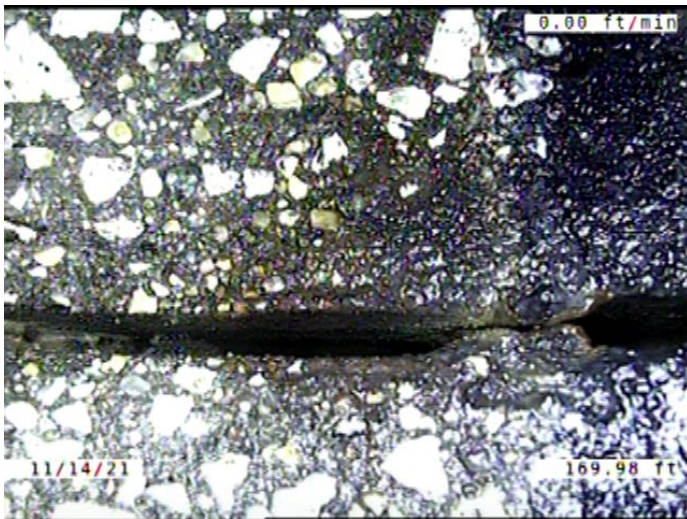
Code: **ISJ**
Description: **Infiltration Stain Joint**

Distance (ft): **170.0**
Structural Grade: **0**
O&M Grade: **1**
Clock Start/From: **8**
Clock To: **9**
1st Value:
2nd Value:
Value Percent:
Continuous Index:
Within 8" of Joint: **YES**
Remarks:
