# Profile/Photo Observation Report

Date:	<b>11/14/2021</b>	Weather:		Coding:	<b>PACP 7.0</b>
Pipe Length (ft):	<b>178.0</b>	Owner:	<b>City of Hobart</b>	Pre Clean:	<b>Heavy Cleaning</b>
P.O.#:	<b>YES502259</b>	Surveyor:	<b>S. Bucklin</b>	PSR:	<b>P-604-002-001</b>
Customer:	<b>City of Hobart</b>	Clean Date:	<b>11/13/2021</b>	Shape:	<b>C</b>

Street:	<b>West Cleveland Street</b>	Flow Control:	<b>Not Controlled</b>
City:	<b>Hobart, IN</b>	Year Renewed:	
Location:	<b>Local rural streets with light traffic, t</b>	Tape/Media #:	
Purpose:	<b>Routine Assessment</b>	Dia/Height:	<b>10"</b>
Use:	<b>Sanitary Sewage Pipe</b>	Material:	<b>VCP</b>
Drain Area:		Lining:	<b>None</b>
Category:	<b>NA</b>		
Comment:			
Location Details:		Direction of Survey:	<b>Downstream</b>
US MH:	<b>M-604-002</b>	DS MH:	<b>M-604-001</b>
		Total Length Surveyed (ft):	<b>178.0</b>

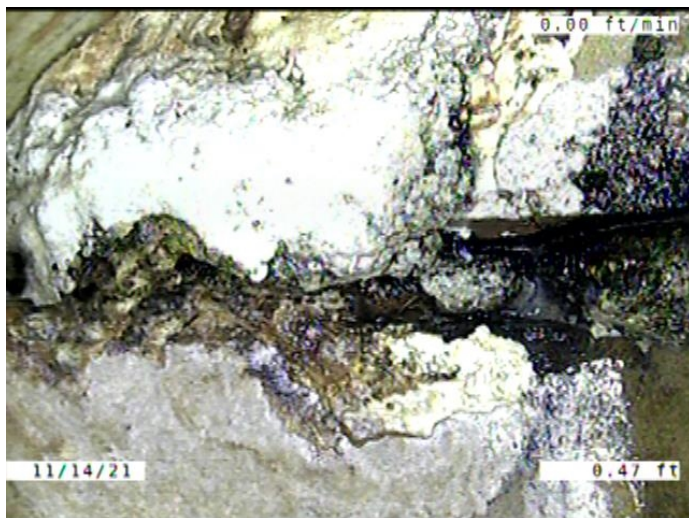
Code: **DAE**  
 Description: **Deposits Attached Encrustation**

Distance (ft): **.5**  
 Structural Grade: **0**  
 O&M Grade: **2**  
 Clock Start/From: **5**  
 Clock To: **1**  
 1st Value:  
 2nd Value:  
 Value Percent: **5.000**  
 Continuous Index:  
 Within 8" of Joint: **YES**  
 Remarks:

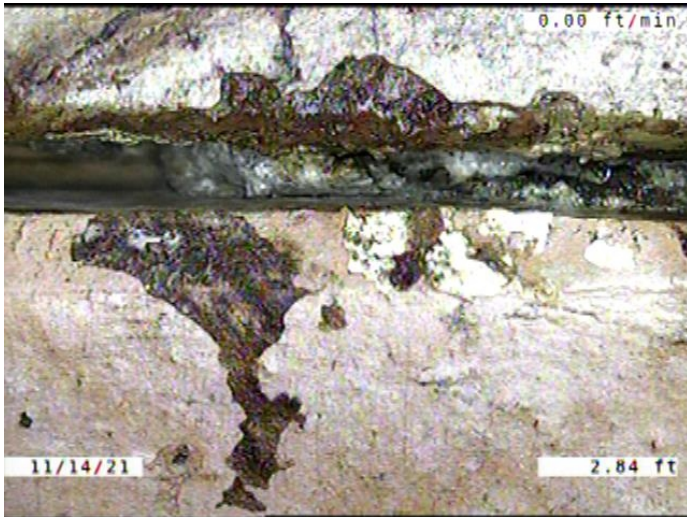
Code: **DAE**  
 Description: **Deposits Attached Encrustation**

Distance (ft): **2.8**  
 Structural Grade: **0**  
 O&M Grade: **2**  
 Clock Start/From: **7**  
 Clock To: **5**  
 1st Value:  
 2nd Value:  
 Value Percent: **5.000**  
 Continuous Index: **S01**  
 Within 8" of Joint: **YES**  
 Remarks:

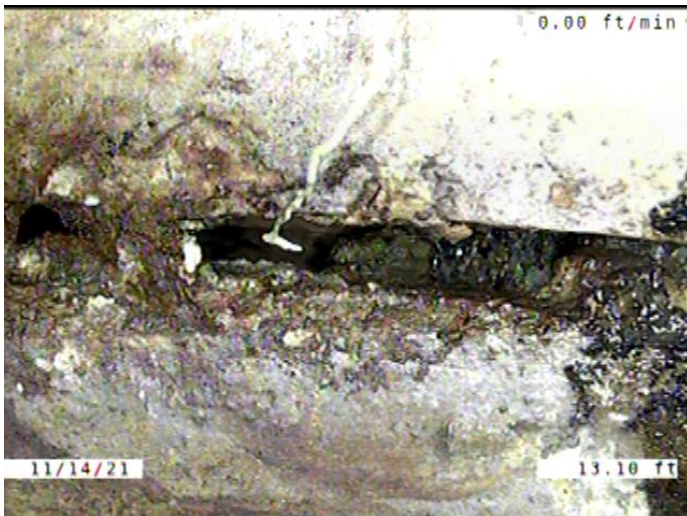
Code: **RFJ**  
 Description: **Roots Fine Joint**

Distance (ft): **13.1**  
 Structural Grade: **0**  
 O&M Grade: **1**  
 Clock Start/From: **8**  
 Clock To:  
 1st Value:  
 2nd Value:  
 Value Percent:  
 Continuous Index:  
 Within 8" of Joint: **YES**  
 Remarks:

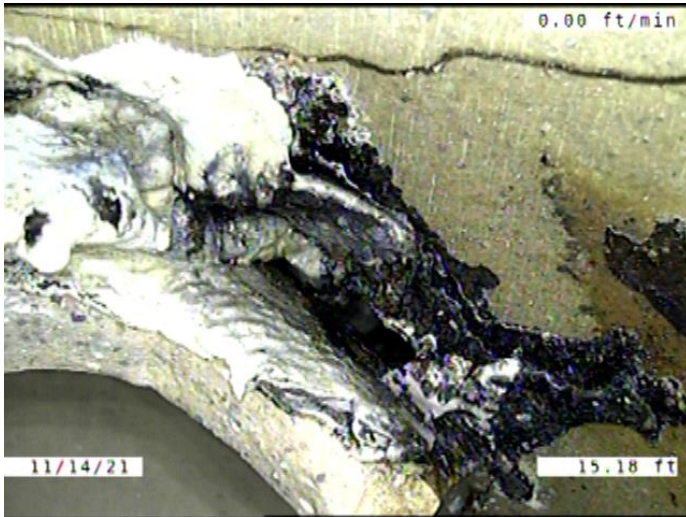
Code: **FM**  
 Description: **Fracture Multiple**

Distance (ft): **15.2**  
 Structural Grade: **4**  
 O&M Grade: **0**  
 Clock Start/From: **11**  
 Clock To: **3**  
 1st Value:  
 2nd Value:  
 Value Percent:  
 Continuous Index:  
 Within 8" of Joint: **YES**  
 Remarks:

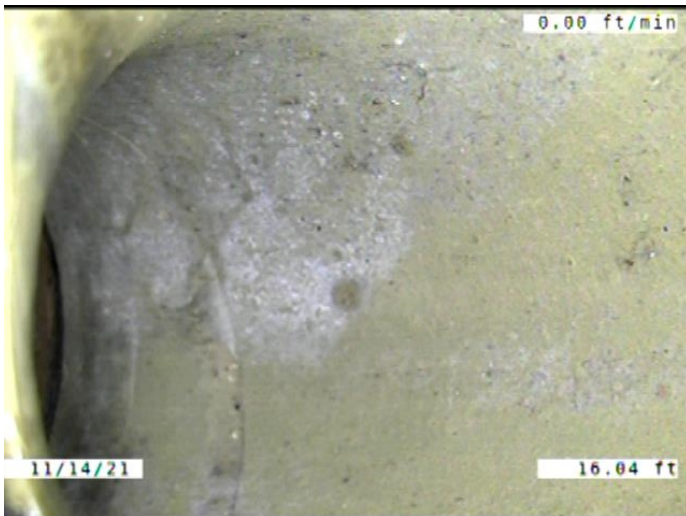
Code: **TBI**  
 Description: **Tap Break-in Intruding**

Distance (ft): **16.0**  
 Structural Grade: **0**  
 O&M Grade: **2**  
 Clock Start/From: **12**  
 Clock To:  
 1st Value: **6.000**  
 2nd Value: **1.000**  
 Value Percent:  
 Continuous Index:  
 Within 8" of Joint: **YES**  
 Remarks:

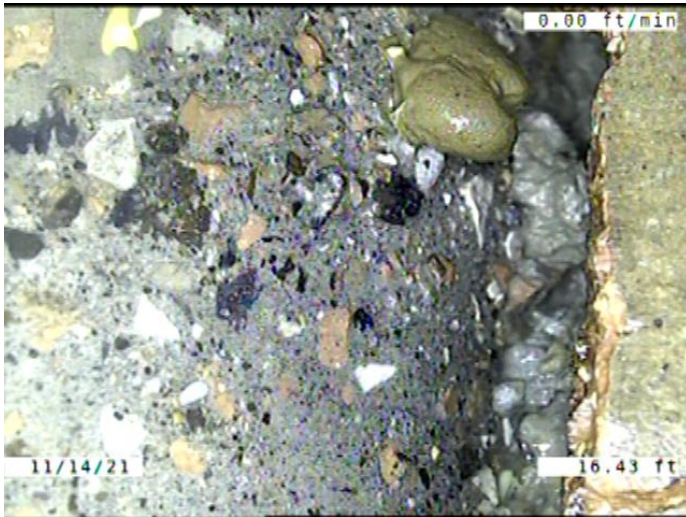
Code: **HSV**  
Description: **Hole Soil Visible**

Distance (ft): **16.4**  
Structural Grade: **5**  
O&M Grade: **0**  
Clock Start/From: **4**  
Clock To: **7**  
1st Value:  
2nd Value:  
Value Percent:  
Continuous Index:  
Within 8" of Joint: **YES**  
Remarks:

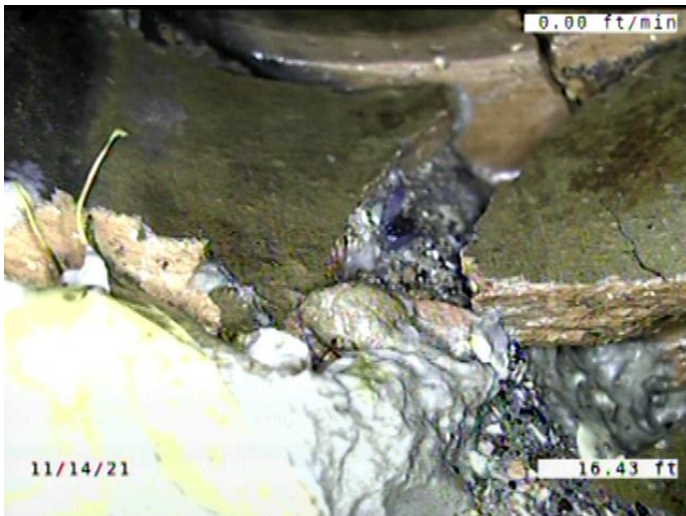
Code: **BVV**  
Description: **Broken Void Visible**

Distance (ft): **16.4**  
Structural Grade: **5**  
O&M Grade: **0**  
Clock Start/From: **3**  
Clock To: **10**  
1st Value:  
2nd Value:  
Value Percent:  
Continuous Index:  
Within 8" of Joint: **YES**  
Remarks: **SOIL VISIBLE TOO**

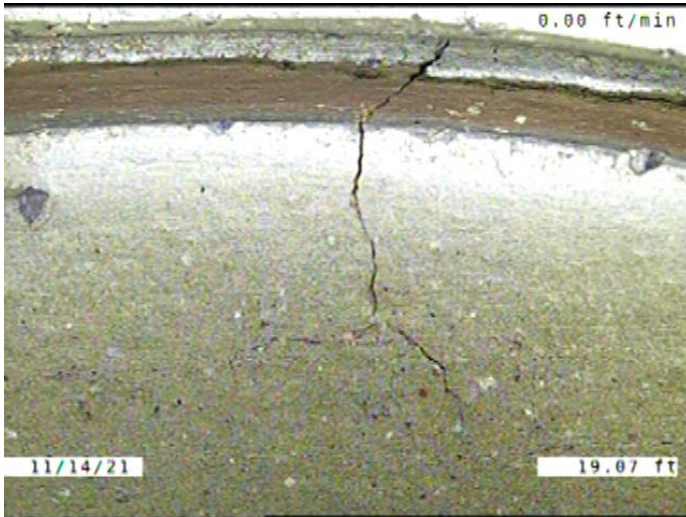
Code: **CM**  
 Description: **Crack Multiple**

Distance (ft): **19.1**  
 Structural Grade: **3**  
 O&M Grade: **0**  
 Clock Start/From: **11**  
 Clock To: **4**  
 1st Value:  
 2nd Value:  
 Value Percent:  
 Continuous Index:  
 Within 8" of Joint: **YES**  
 Remarks:

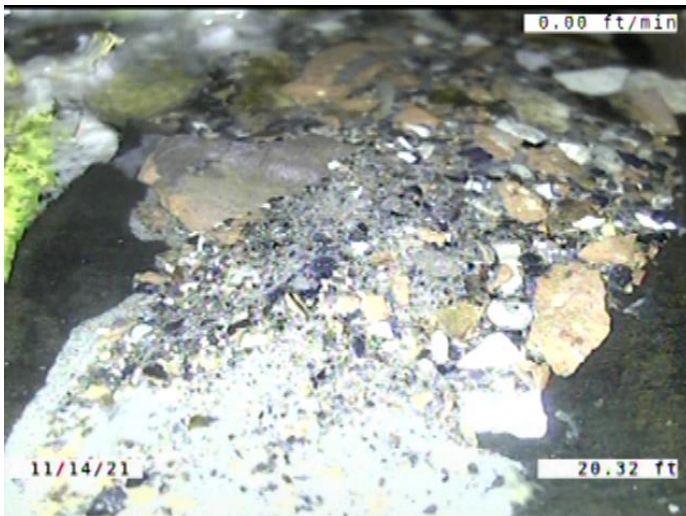
Code: **DSF**  
 Description: **Deposits Settled Fine**

Distance (ft): **20.3**  
 Structural Grade: **0**  
 O&M Grade: **2**  
 Clock Start/From: **5**  
 Clock To: **7**  
 1st Value:  
 2nd Value:  
 Value Percent: **5.000**  
 Continuous Index: **S02**  
 Within 8" of Joint: **YES**  
 Remarks:

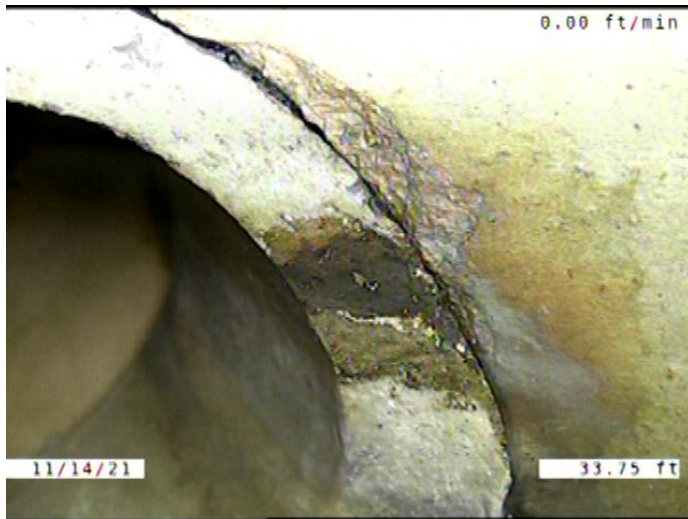
Code: **SSS**  
Description: **Surface Damage Surface Spalling**

Distance (ft): **33.7**  
Structural Grade: **2**  
O&M Grade: **0**  
Clock Start/From: **11**  
Clock To: **3**  
1st Value:  
2nd Value:  
Value Percent:  
Continuous Index:  
Within 8" of Joint: **YES**  
Remarks:

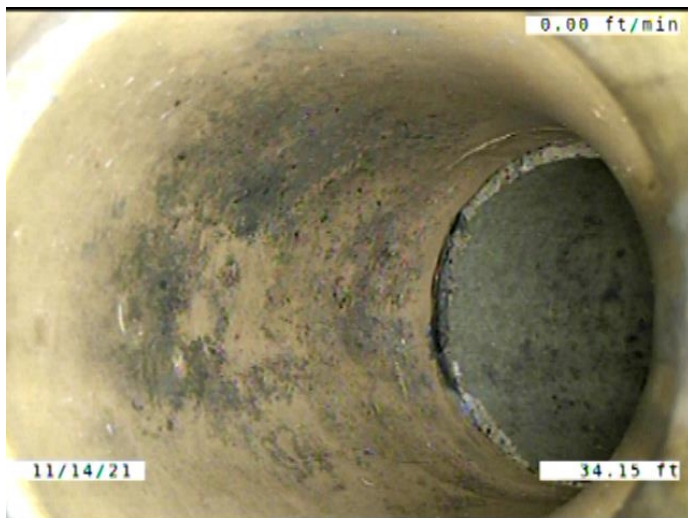
Code: **TBI**  
Description: **Tap Break-in Intruding**

Distance (ft): **34.2**  
Structural Grade: **0**  
O&M Grade: **2**  
Clock Start/From: **1**  
Clock To:  
1st Value: **6.000**  
2nd Value: **1.000**  
Value Percent:  
Continuous Index:  
Within 8" of Joint: **YES**  
Remarks:

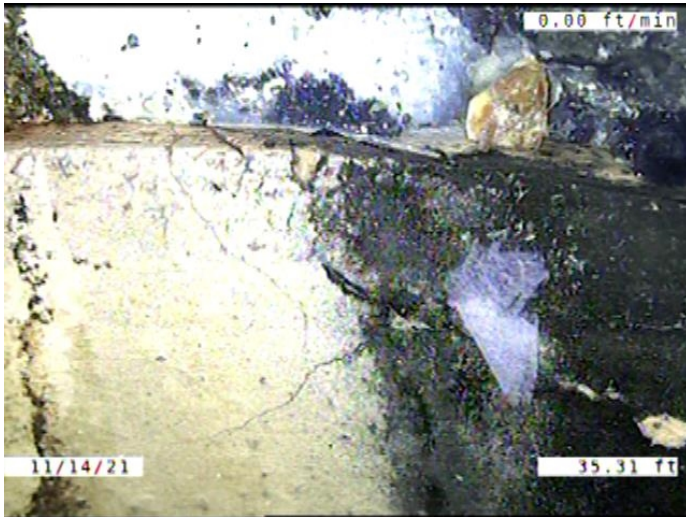
Code: **CM**  
 Description: **Crack Multiple**

Distance (ft): **35.3**  
 Structural Grade: **3**  
 O&M Grade: **0**  
 Clock Start/From: **2**  
 Clock To: **10**  
 1st Value:  
 2nd Value:  
 Value Percent:  
 Continuous Index:  
 Within 8" of Joint: **YES**  
 Remarks:

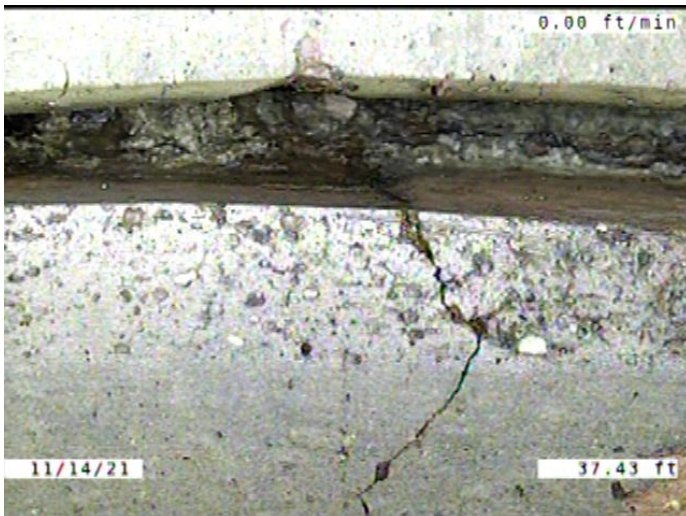
Code: **CM**  
 Description: **Crack Multiple**

Distance (ft): **37.4**  
 Structural Grade: **3**  
 O&M Grade: **0**  
 Clock Start/From: **8**  
 Clock To: **2**  
 1st Value:  
 2nd Value:  
 Value Percent:  
 Continuous Index:  
 Within 8" of Joint: **YES**  
 Remarks:

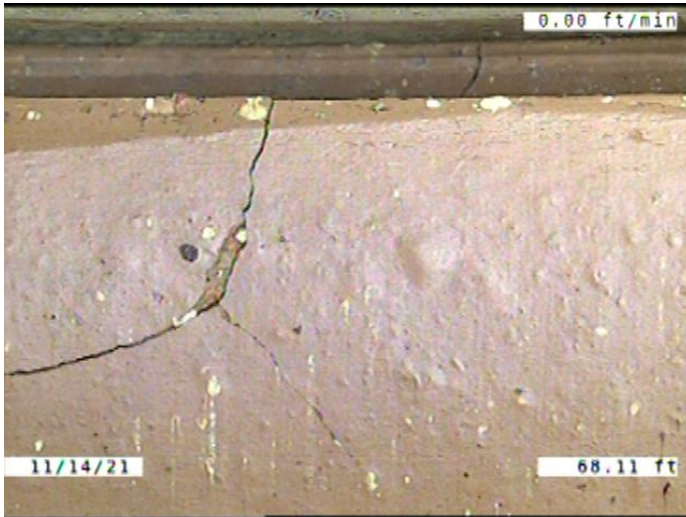
Code: **CM**  
Description: **Crack Multiple**

Distance (ft): **68.1**  
Structural Grade: **3**  
O&M Grade: **0**  
Clock Start/From: **10**  
Clock To: **2**  
1st Value:  
2nd Value:  
Value Percent:  
Continuous Index:  
Within 8" of Joint: **YES**  
Remarks:

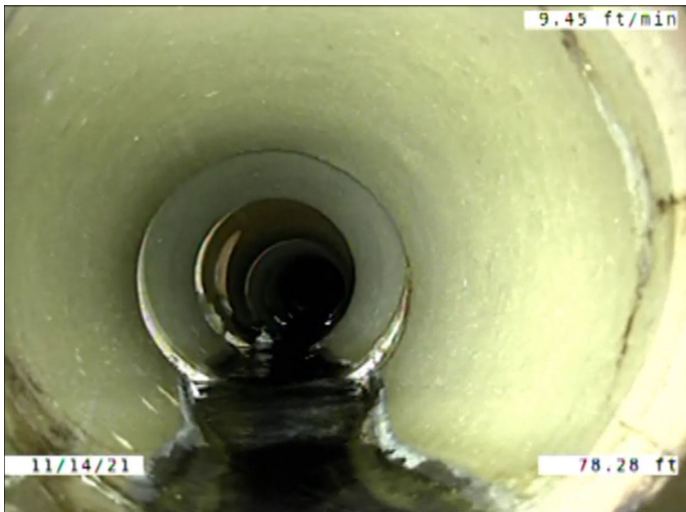
Code: **IS**  
Description: **Infiltration Stain**

Distance (ft): **78.3**  
Structural Grade: **0**  
O&M Grade: **1**  
Clock Start/From: **7**  
Clock To: **5**  
1st Value:  
2nd Value:  
Value Percent:  
Continuous Index: **S03**  
Within 8" of Joint: **YES**  
Remarks: **Wandering**

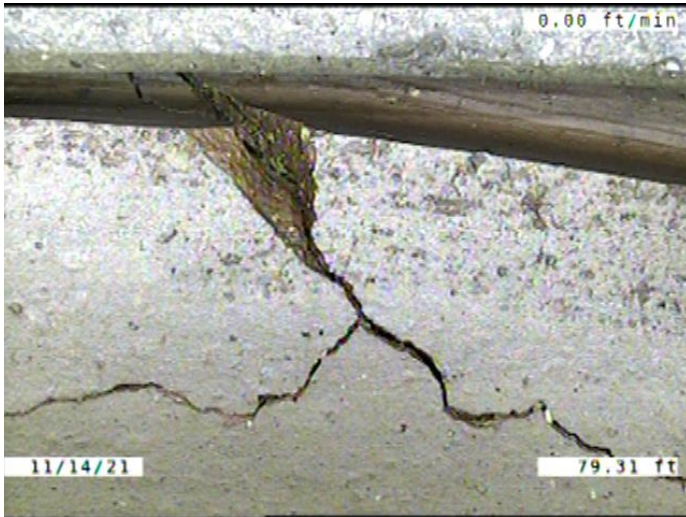
Code: **B**  
 Description: **Broken**

Distance (ft): **79.3**  
 Structural Grade: **4**  
 O&M Grade: **0**  
 Clock Start/From: **8**  
 Clock To: **5**  
 1st Value:  
 2nd Value:  
 Value Percent:  
 Continuous Index:  
 Within 8" of Joint: **YES**  
 Remarks:

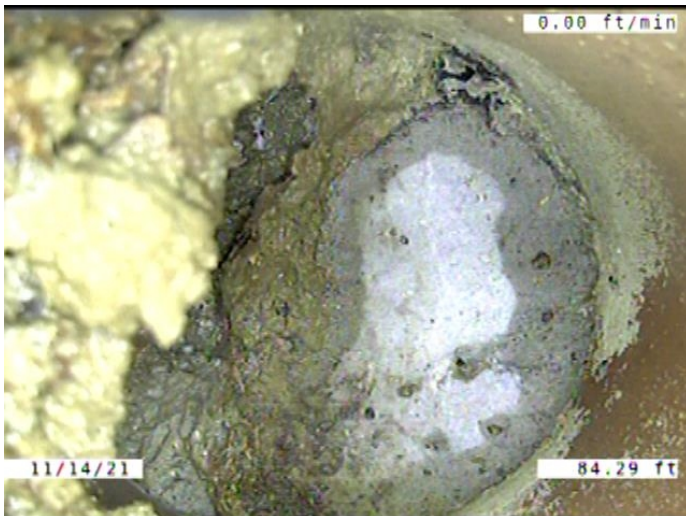
Code: **TFD**  
 Description: **Tap Factory Defective**

Distance (ft): **84.3**  
 Structural Grade: **0**  
 O&M Grade: **3**  
 Clock Start/From: **9**  
 Clock To:  
 1st Value: **4.000**  
 2nd Value:  
 Value Percent:  
 Continuous Index:  
 Within 8" of Joint: **YES**  
 Remarks: **CAPPED. ENCRUSTATION AROUND THE CAP.**

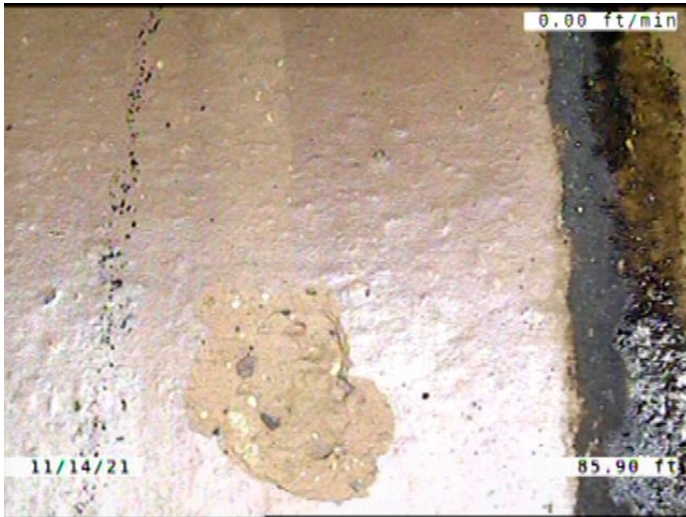
85.9	SSS	Surface Damage Surface Spalling	1414	S 2
86.5	CM	Crack Multiple	1462	S 3
86.5	CL	Crack Longitudinal	1487	S 2
94.4	FM	Fracture Multiple	1641	S 4
108.9	CL	Crack Longitudinal	1756	S 2

Code: **SSS**  
Description: **Surface Damage Surface Spalling**

Distance (ft): **85.9**  
Structural Grade: **2**  
O&M Grade: **0**  
Clock Start/From: **8**  
Clock To:  
1st Value:  
2nd Value:  
Value Percent:  
Continuous Index:  
Within 8" of Joint: **NO**  
Remarks:

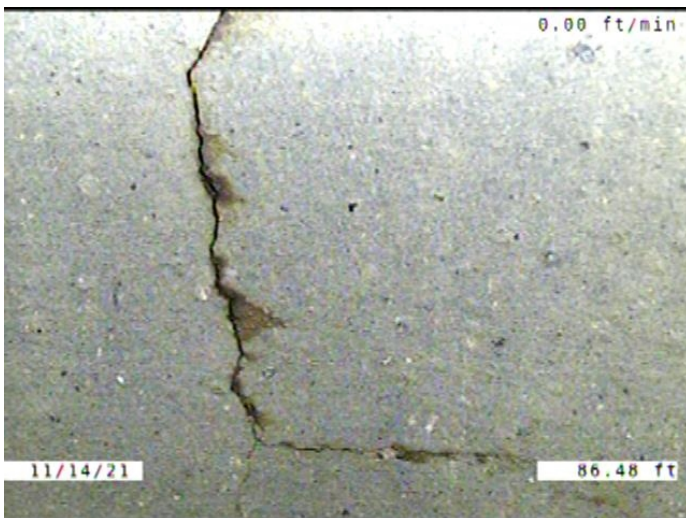
Code: **CM**  
Description: **Crack Multiple**

Distance (ft): **86.5**  
Structural Grade: **3**  
O&M Grade: **0**  
Clock Start/From: **1**  
Clock To: **4**  
1st Value:  
2nd Value:  
Value Percent:  
Continuous Index:  
Within 8" of Joint: **YES**  
Remarks:

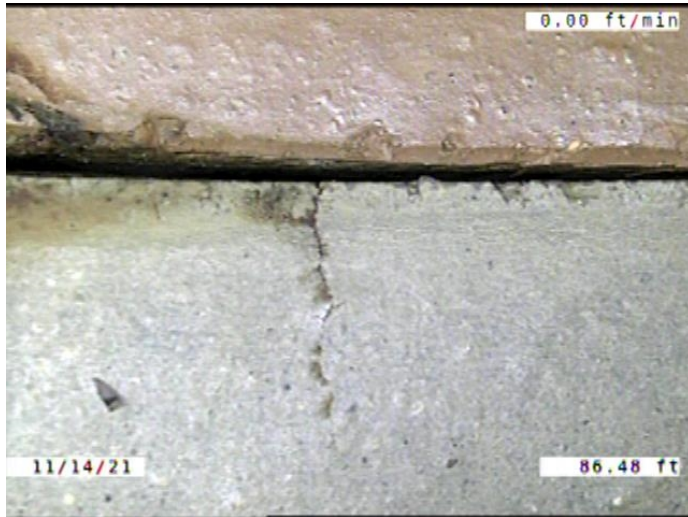
Code: **CL**  
 Description: **Crack Longitudinal**

Distance (ft): **86.5**  
 Structural Grade: **2**  
 O&M Grade: **0**  
 Clock Start/From: **10**  
 Clock To:  
 1st Value:  
 2nd Value:  
 Value Percent:  
 Continuous Index:  
 Within 8" of Joint: **YES**  
 Remarks:

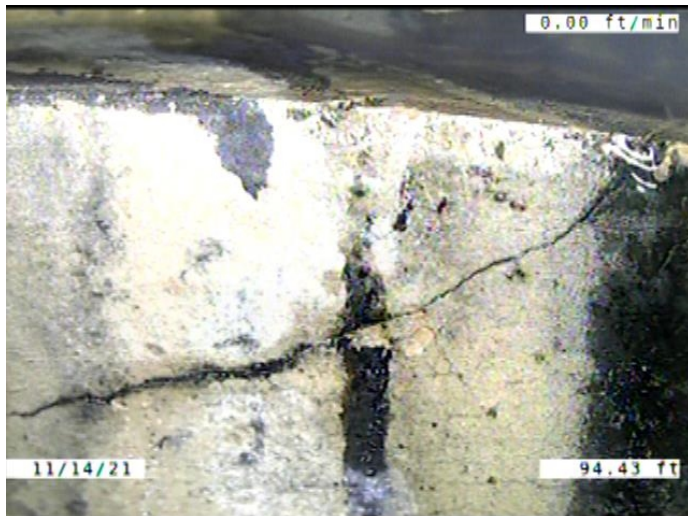
Code: **FM**  
 Description: **Fracture Multiple**

Distance (ft): **94.4**  
 Structural Grade: **4**  
 O&M Grade: **0**  
 Clock Start/From: **11**  
 Clock To: **5**  
 1st Value:  
 2nd Value:  
 Value Percent:  
 Continuous Index:  
 Within 8" of Joint: **YES**  
 Remarks:

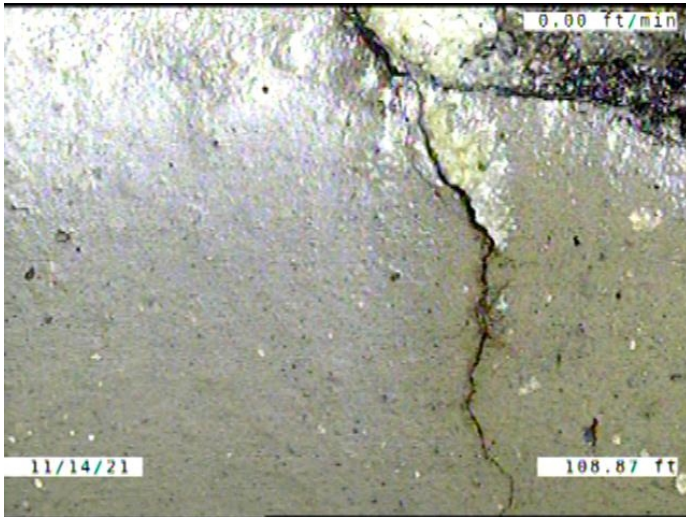
Code: **CL**  
 Description: **Crack Longitudinal**

Distance (ft): **108.9**  
 Structural Grade: **2**  
 O&M Grade: **0**  
 Clock Start/From: **1**  
 Clock To:  
 1st Value:  
 2nd Value:  
 Value Percent:  
 Continuous Index:  
 Within 8" of Joint: **YES**  
 Remarks:

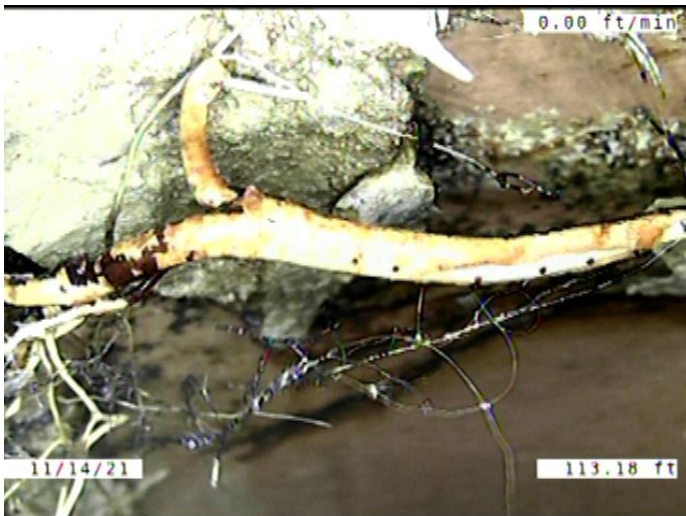
Code: **OBZ**  
 Description: **Obstruction Other**

Distance (ft): **113.2**  
 Structural Grade: **0**  
 O&M Grade: **2**  
 Clock Start/From: **6**  
 Clock To: **10**  
 1st Value:  
 2nd Value:  
 Value Percent: **5.000**  
 Continuous Index:  
 Within 8" of Joint: **YES**  
 Remarks: **ROOT THAT HAS BEEN CUT**

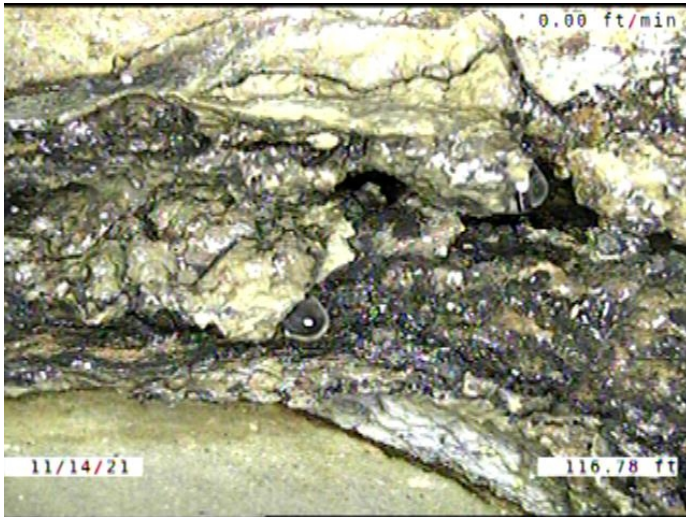
Code: **IDJ**  
 Description: **Infiltration Dripper Joint**

Distance (ft): **116.8**  
 Structural Grade: **0**  
 O&M Grade: **3**  
 Clock Start/From: **1**  
 Clock To: **2**  
 1st Value:  
 2nd Value:  
 Value Percent:  
 Continuous Index:  
 Within 8" of Joint: **YES**  
 Remarks:

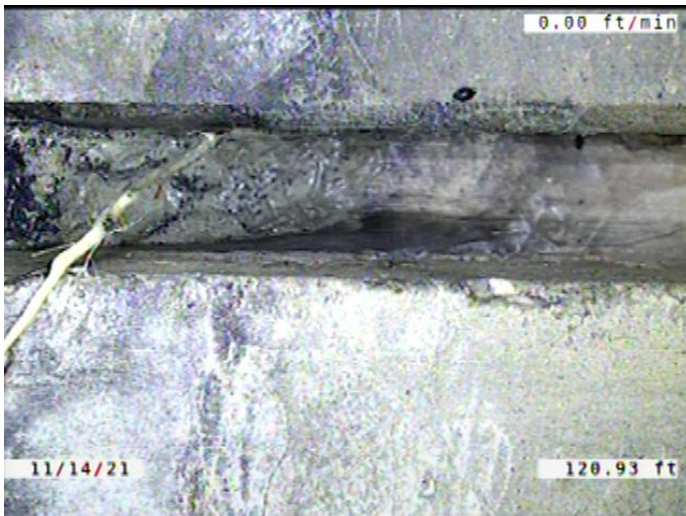
Code: **RFJ**  
 Description: **Roots Fine Joint**

Distance (ft): **120.9**  
 Structural Grade: **0**  
 O&M Grade: **1**  
 Clock Start/From: **9**  
 Clock To:  
 1st Value:  
 2nd Value:  
 Value Percent:  
 Continuous Index:  
 Within 8" of Joint: **YES**  
 Remarks:

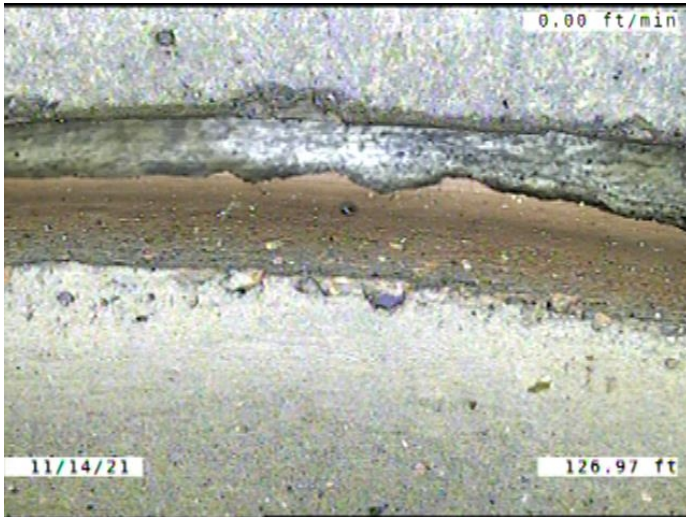
Code: **SMW**  
 Description: **Surface Damage Missing Wall**

Distance (ft): **127.0**  
 Structural Grade: **5**  
 O&M Grade: **0**  
 Clock Start/From: **11**  
 Clock To: **4**  
 1st Value:  
 2nd Value:  
 Value Percent:  
 Continuous Index:  
 Within 8" of Joint: **YES**  
 Remarks:

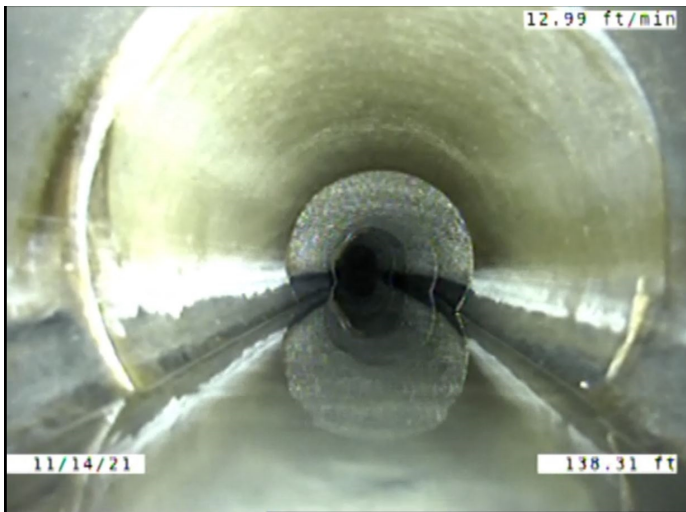
Code: **IS**  
 Description: **Infiltration Stain**

Distance (ft): **138.3**  
 Structural Grade: **0**  
 O&M Grade: **1**  
 Clock Start/From: **7**  
 Clock To: **5**  
 1st Value:  
 2nd Value:  
 Value Percent:  
 Continuous Index: **F03**  
 Within 8" of Joint: **YES**  
 Remarks: **Wandering**

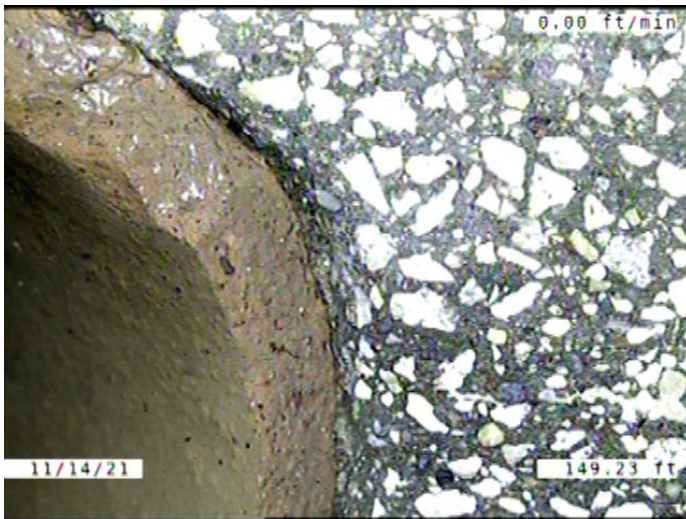
Code: **B**  
 Description: **Broken**

Distance (ft): **149.2**  
 Structural Grade: **4**  
 O&M Grade: **0**  
 Clock Start/From: **9**  
 Clock To: **12**  
 1st Value:  
 2nd Value:  
 Value Percent:  
 Continuous Index:  
 Within 8" of Joint: **YES**  
 Remarks:

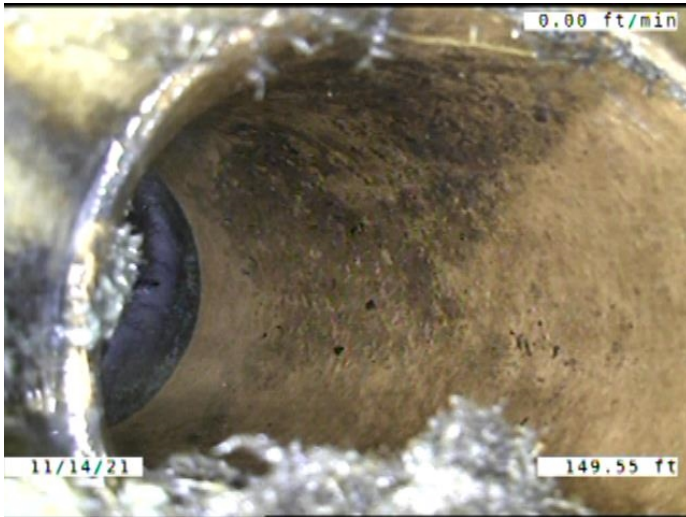
Code:	<b>TBI</b>
Description:	<b>Tap Break-in Intruding</b>
Distance (ft):	<b>149.6</b>
Structural Grade:	<b>0</b>
O&M Grade:	<b>2</b>
Clock Start/From:	<b>11</b>
Clock To:	
1st Value:	<b>6.000</b>
2nd Value:	<b>1.000</b>
Value Percent:	
Continuous Index:	
Within 8" of Joint:	<b>YES</b>
Remarks:	<b>CONSTANTLY RUNNING WATER. ROOTS GROWING FROM THE JOINT</b>

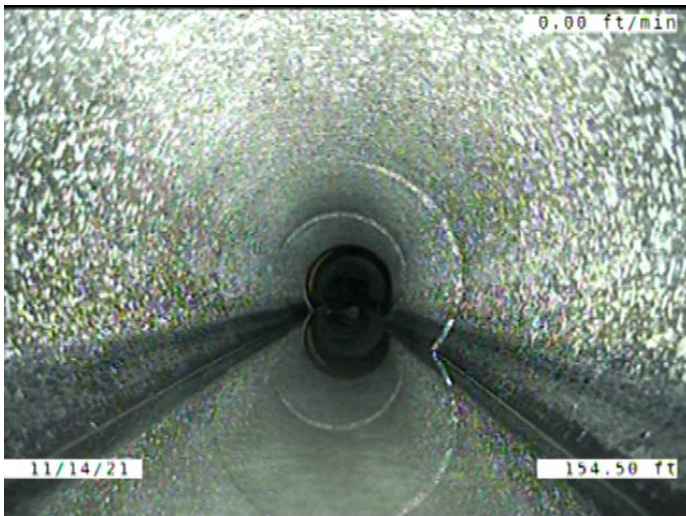
Code:	<b>DAE</b>
Description:	<b>Deposits Attached Encrustation</b>
Distance (ft):	<b>154.5</b>
Structural Grade:	<b>0</b>
O&M Grade:	<b>2</b>
Clock Start/From:	<b>7</b>
Clock To:	<b>5</b>
1st Value:	
2nd Value:	
Value Percent:	<b>5.000</b>
Continuous Index:	<b>F01</b>
Within 8" of Joint:	<b>YES</b>
Remarks:

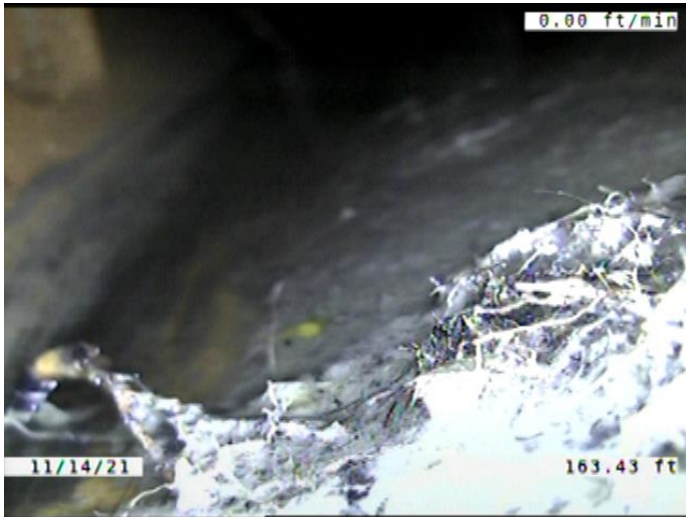
Code: **OBZ**  
 Description: **Obstruction Other**

Distance (ft): **163.4**  
 Structural Grade: **0**  
 O&M Grade: **2**  
 Clock Start/From: **5**  
 Clock To: **8**  
 1st Value:  
 2nd Value:  
 Value Percent: **5.000**  
 Continuous Index:  
 Within 8" of Joint: **YES**  
 Remarks: **ROOT THAT HAS BEEN CUT**

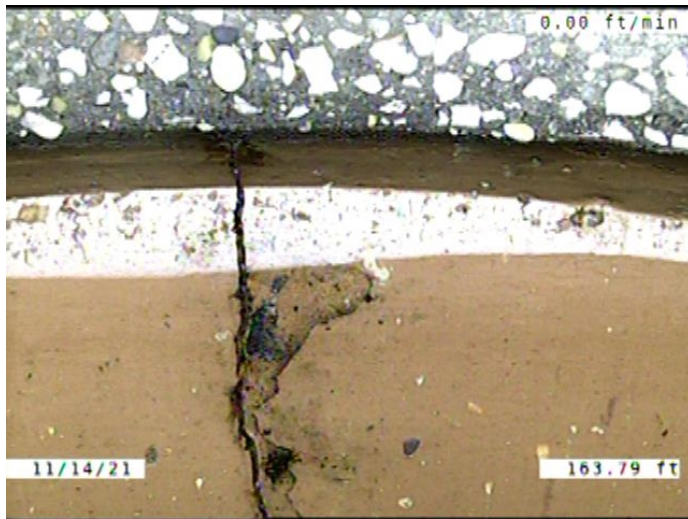
Code: **FS**  
 Description: **Fracture Spiral**

Distance (ft): **163.8**  
 Structural Grade: **3**  
 O&M Grade: **0**  
 Clock Start/From: **12**  
 Clock To: **1**  
 1st Value:  
 2nd Value:  
 Value Percent:  
 Continuous Index:  
 Within 8" of Joint: **YES**  
 Remarks:

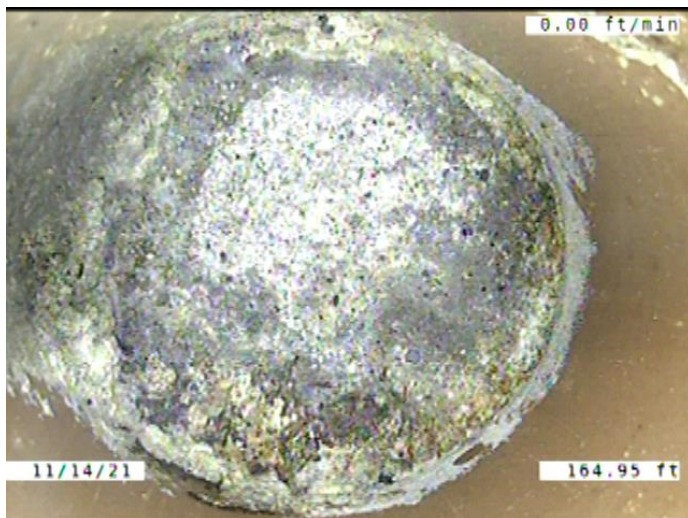
Code: **TFD**  
 Description: **Tap Factory Defective**

Distance (ft): **164.9**  
 Structural Grade: **0**  
 O&M Grade: **3**  
 Clock Start/From: **10**  
 Clock To:  
 1st Value: **4.000**  
 2nd Value:  
 Value Percent:  
 Continuous Index:  
 Within 8" of Joint: **YES**  
 Remarks: **CAPPED. ENCRUSTATION AROUND THE CAP.**

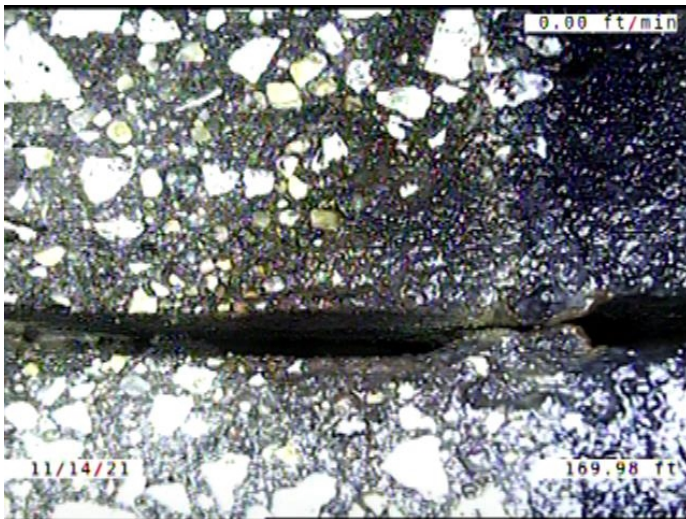
Code: **ISJ**  
 Description: **Infiltration Stain Joint**

Distance (ft): **170.0**  
 Structural Grade: **0**  
 O&M Grade: **1**  
 Clock Start/From: **8**  
 Clock To: **9**  
 1st Value:  
 2nd Value:  
 Value Percent:  
 Continuous Index:  
 Within 8" of Joint: **YES**  
 Remarks:

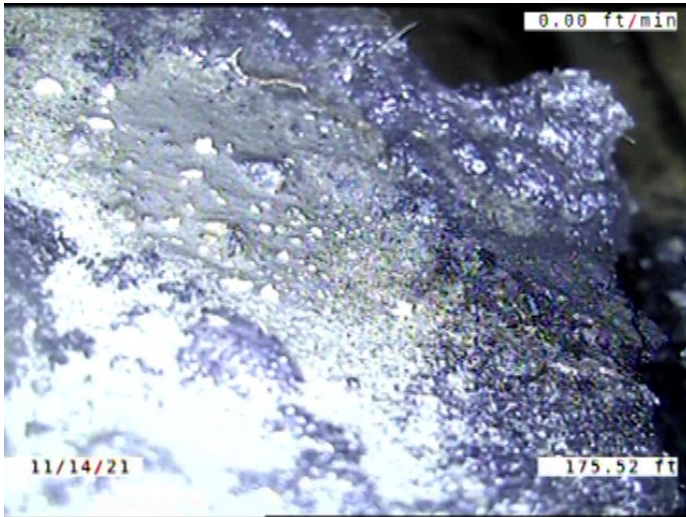
Code: **OBN**  
 Description: **Obstruction Construction Debris**

Distance (ft): **175.5**  
 Structural Grade: **0**  
 O&M Grade: **2**  
 Clock Start/From: **4**  
 Clock To: **8**  
 1st Value:  
 2nd Value:  
 Value Percent: **10.000**  
 Continuous Index:  
 Within 8" of Joint: **YES**  
 Remarks:

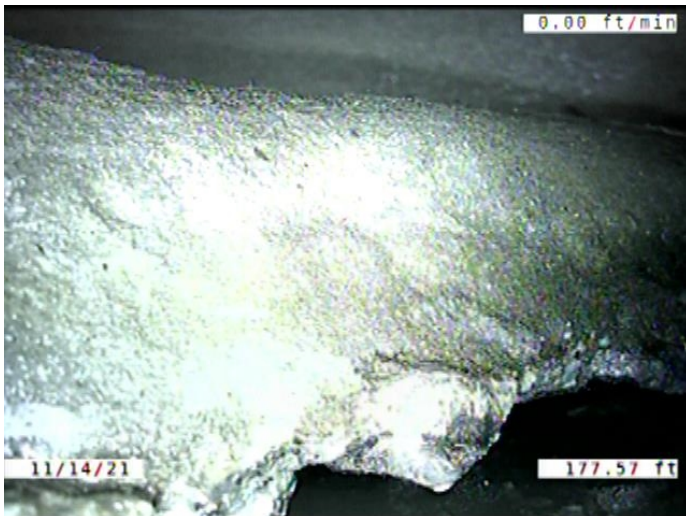
Code: **DSF**  
 Description: **Deposits Settled Fine**

Distance (ft): **177.6**  
 Structural Grade: **0**  
 O&M Grade: **2**  
 Clock Start/From: **5**  
 Clock To: **7**  
 1st Value:  
 2nd Value:  
 Value Percent: **5.000**  
 Continuous Index: **F02**  
 Within 8" of Joint: **YES**  
 Remarks:
