Profile/Photo Observation Report

Date:	04/23/2018	Weather:		Coding:	PACP 6.0
Pipe Length (ft):	273.1	Owner:	NA	Pre Clean:	Not Known
P.O.#:		Surveyor:	Jen Costello	PSR:	P-604-003-002
Customer:		Clean Date:	01/01/1900	Shape:	C

Street:	W CLEVELAND AVE & BEVERLY LN	Flow Control:	Not Controlled
City:	Hobart, IN	Year Renewed:	
Location:	Other	Tape/Media #:	
Purpose:	Not Known	Dia/Height:	10"
Use:	Sanitary	Material:	VCP
Drain Area:	NA	Lining:	
Category:	NA		
Comment:

Location Details:		Direction of Survey:	Upstream
US MH:	M-604-003	DS MH:	M-604-002
		Total Length Surveyed (ft):	63.8

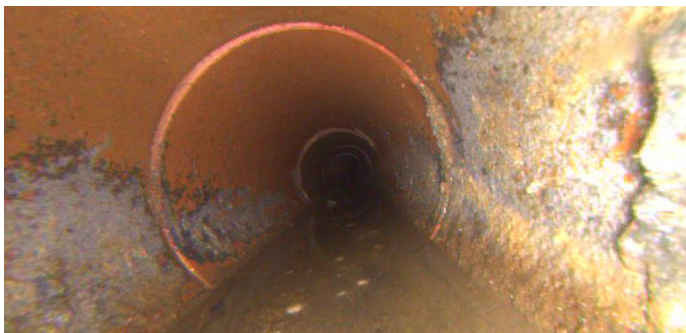
Code: **AMH**
Description: **Manhole**

Distance (ft): **.0**
Structural Grade: **0**
O&M Grade: **0**
Clock Start/From:
Clock To:
1st Value:
2nd Value:
Value Percent:
Continuous Index:
Within 8" of Joint: **NO**
Remarks: **M-604-002**

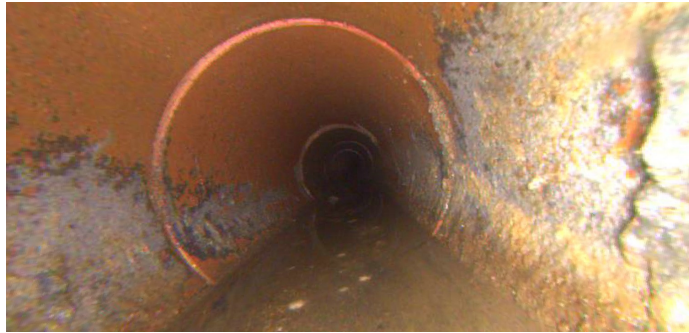
Code: **MWL**
Description: **Water Level**

Distance (ft): **.0**
Structural Grade: **0**
O&M Grade: **0**
Clock Start/From:
Clock To:
1st Value:
2nd Value:
Value Percent: **5.000**
Continuous Index:
Within 8" of Joint: **NO**
Remarks:

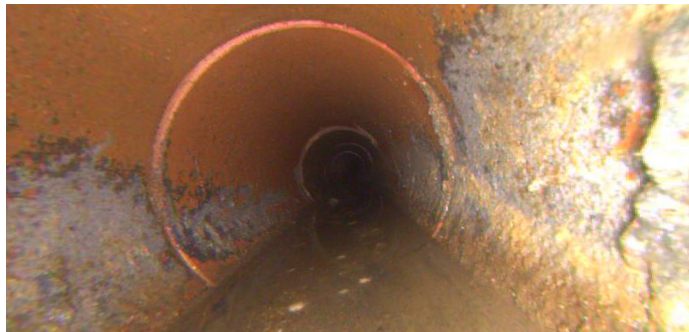
Code: **DAGS**
Description: **Deposits Attached Grease**

Distance (ft): **.0**
Structural Grade: **0**
O&M Grade: **2**
Clock Start/From: **8**
Clock To: **4**
1st Value:
2nd Value:
Value Percent: **5.000**
Continuous Index:
Within 8" of Joint: **NO**
Remarks:

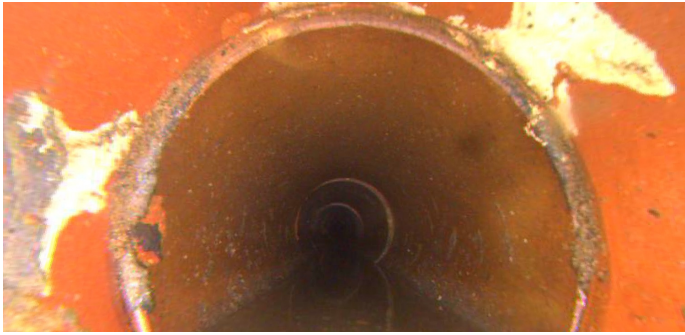
Code: **DAE**
Description: **Deposits Attached Encrustation**

Distance (ft): **3.7**
Structural Grade: **0**
O&M Grade: **2**
Clock Start/From: **8**
Clock To: **4**
1st Value:
2nd Value:
Value Percent: **5.000**
Continuous Index: **S01**
Within 8" of Joint: **YES**
Remarks:

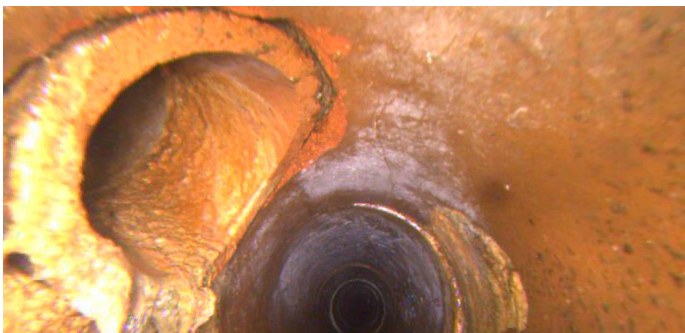
Code: **TBI**
Description: **Tap Break-in Intruding**

Distance (ft): **11.0**
Structural Grade: **0**
O&M Grade: **2**
Clock Start/From: **10**
Clock To:
1st Value: **4.000**
2nd Value: **1.000**
Value Percent:
Continuous Index:
Within 8" of Joint:
Remarks:

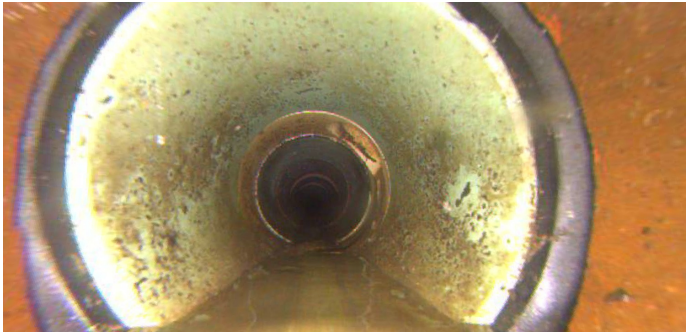
Code: **DAE**
Description: **Deposits Attached Encrustation**

Distance (ft): **15.3**
Structural Grade: **0**
O&M Grade: **2**
Clock Start/From: **8**
Clock To: **4**
1st Value:
2nd Value:
Value Percent: **5.000**
Continuous Index: **F01**
Within 8" of Joint: **YES**
Remarks:

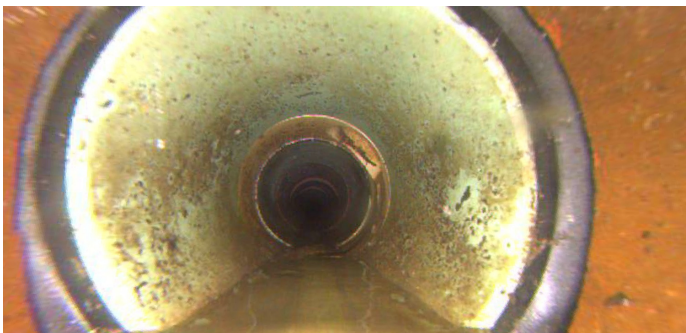
Code: **MMC**
Description: **Material Change**

Distance (ft): **15.3**
Structural Grade: **0**
O&M Grade: **0**
Clock Start/From:
Clock To:
1st Value:
2nd Value:
Value Percent:
Continuous Index:
Within 8" of Joint: **NO**
Remarks: **PVC**

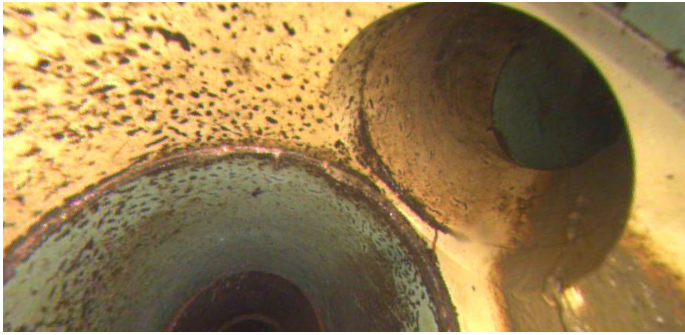
Code: **TFA**
Description: **Tap Factory Active**

Distance (ft): **16.8**
Structural Grade: **0**
O&M Grade: **0**
Clock Start/From: **2**
Clock To:
1st Value: **4.000**
2nd Value:
Value Percent:
Continuous Index:
Within 8" of Joint:
Remarks:

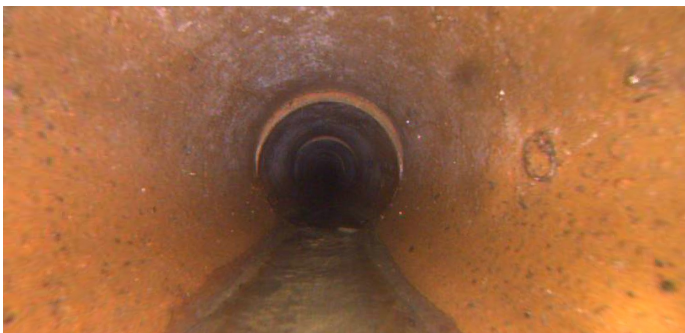
Code: **MMC**
Description: **Material Change**

Distance (ft): **18.6**
Structural Grade: **0**
O&M Grade: **0**
Clock Start/From:
Clock To:
1st Value:
2nd Value:
Value Percent:
Continuous Index:
Within 8" of Joint: **NO**
Remarks: **vcp**

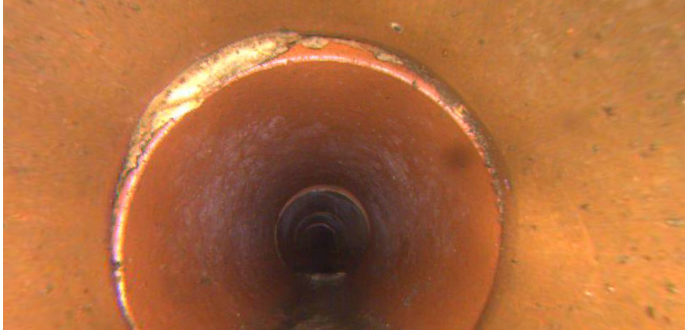
Code: **DAE**
Description: **Deposits Attached Encrustation**

Distance (ft): **33.7**
Structural Grade: **0**
O&M Grade: **2**
Clock Start/From: **9**
Clock To: **12**
1st Value:
2nd Value:
Value Percent: **5.000**
Continuous Index:
Within 8" of Joint: **YES**
Remarks:

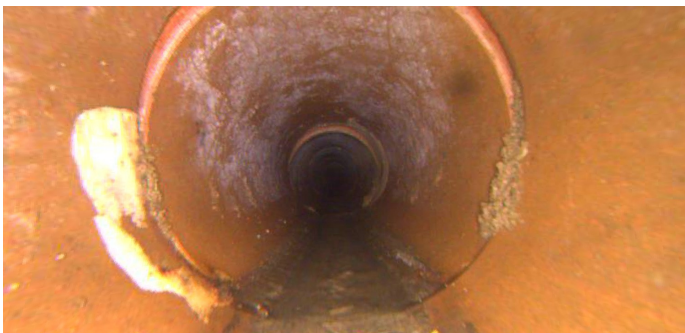
Code: **DAE**
Description: **Deposits Attached Encrustation**

Distance (ft): **47.8**
Structural Grade: **0**
O&M Grade: **2**
Clock Start/From: **8**
Clock To: **4**
1st Value:
2nd Value:
Value Percent: **5.000**
Continuous Index:
Within 8" of Joint: **YES**
Remarks:

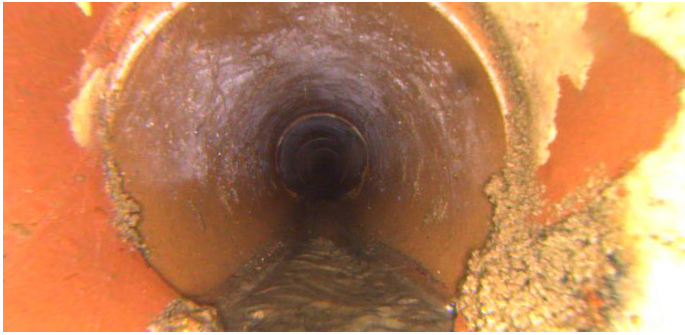
Code: **DAE**
Description: **Deposits Attached Encrustation**

Distance (ft): **49.8**
Structural Grade: **0**
O&M Grade: **2**
Clock Start/From: **8**
Clock To: **4**
1st Value:
2nd Value:
Value Percent: **5.000**
Continuous Index: **S02**
Within 8" of Joint: **YES**
Remarks:

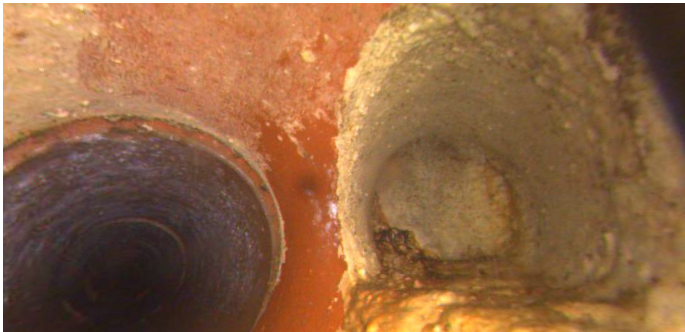
Code: **TFC**
Description: **Tap Factory Capped**

Distance (ft): **58.4**
Structural Grade: **0**
O&M Grade: **0**
Clock Start/From: **3**
Clock To:
1st Value: **4.000**
2nd Value:
Value Percent:
Continuous Index:
Within 8" of Joint:
Remarks:

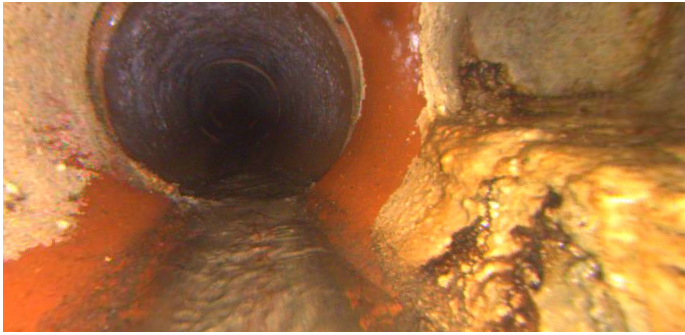
Code: **DAE**
Description: **Deposits Attached Encrustation**

Distance (ft): **58.4**
Structural Grade: **0**
O&M Grade: **2**
Clock Start/From: **3**
Clock To: **4**
1st Value:
2nd Value:
Value Percent: **5.000**
Continuous Index:
Within 8" of Joint: **NO**
Remarks:

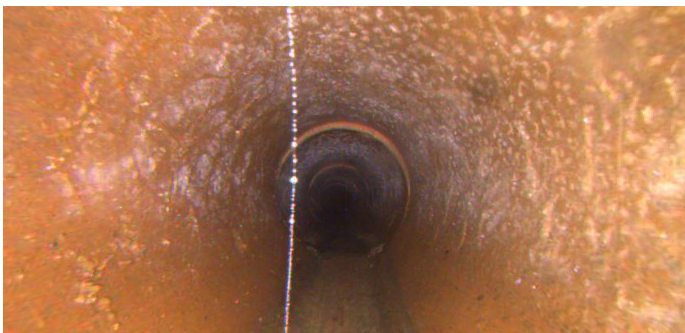
Code: **DAE**
Description: **Deposits Attached Encrustation**

Distance (ft): **63.8**
Structural Grade: **0**
O&M Grade: **2**
Clock Start/From: **8**
Clock To: **4**
1st Value:
2nd Value:
Value Percent: **5.000**
Continuous Index: **F02**
Within 8" of Joint: **YES**
Remarks:

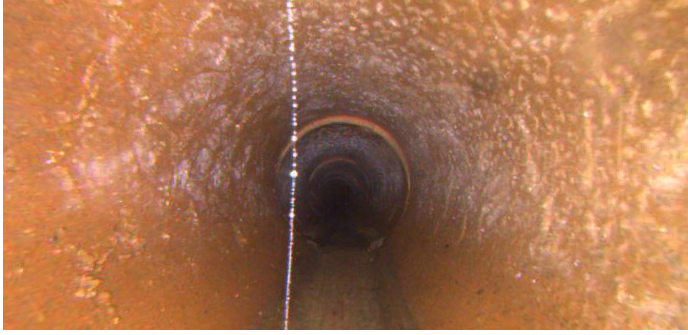
Code:	MSA
Description:	Abandoned Survey
Distance (ft):	63.8
Structural Grade:	0
O&M Grade:	0
Clock Start/From:	
Clock To:	
1st Value:	
2nd Value:	
Value Percent:	
Continuous Index:	
Within 8" of Joint:	NO
Remarks:	dae
