## Profile/Photo Observation Report

Date:	<b>04/23/2018</b>	Weather:		Coding:	<b>PACP 6.0</b>
Pipe Length (ft):	<b>273.1</b>	Owner:	<b>NA</b>	Pre Clean:	<b>Not Known</b>
P.O.#:		Surveyor:	<b>Jen Costello</b>	PSR:	<b>P-604-003-002</b>
Customer:		Clean Date:	<b>01/01/1900</b>	Shape:	<b>C</b>

Street:	<b>W Cleveland Ave.</b>	Flow Control:	<b>Not Controlled</b>
City:	<b>Hobart, IN</b>	Year Renewed:	
Location:	<b>Other</b>	Tape/Media #:	
Purpose:	<b>Not Known</b>	Dia/Height:	<b>10"</b>
Use:	<b>Sanitary</b>	Material:	<b>VCP</b>
Drain Area:	<b>NA</b>	Lining:	
Category:	<b>NA</b>		
Comment:

Location Details:		Direction of Survey:	<b>Upstream</b>
US MH:	<b>M-604-003</b>	DS MH:	<b>M-604-002</b>
		Total Length Surveyed (ft):	<b>63.8</b>

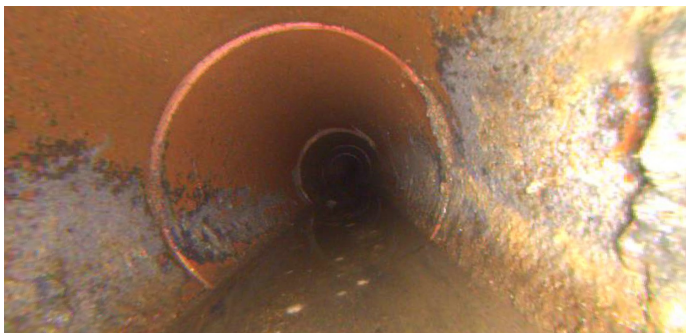
Code: **AMH**  
Description: **Manhole**

Distance (ft): **.0**  
Structural Grade: **0**  
O&M Grade: **0**  
Clock Start/From:  
Clock To:  
1st Value:  
2nd Value:  
Value Percent:  
Continuous Index:  
Within 8" of Joint: **NO**  
Remarks: **M-604-002**

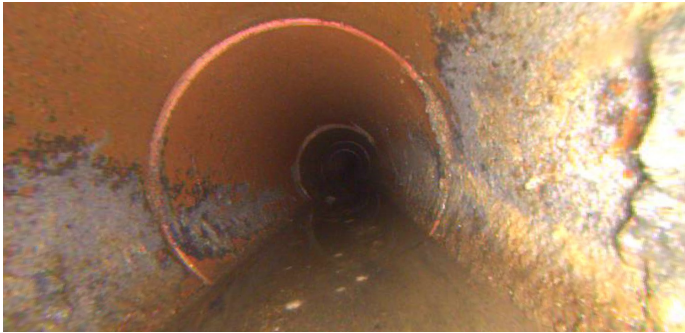
Code:	<b>MWL</b>
Description:	<b>Water Level</b>

Distance (ft):	<b>.0</b>
Structural Grade:	<b>0</b>
O&M Grade:	<b>0</b>
Clock Start/From:	
Clock To:	
1st Value:	
2nd Value:	
Value Percent:	<b>5.000</b>
Continuous Index:	
Within 8" of Joint:	<b>NO</b>
Remarks:

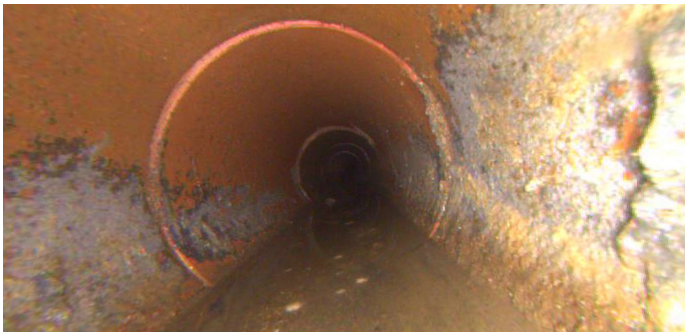
Code:	<b>DAGS</b>
Description:	<b>Deposits Attached Grease</b>

Distance (ft):	<b>.0</b>
Structural Grade:	<b>0</b>
O&M Grade:	<b>2</b>
Clock Start/From:	<b>8</b>
Clock To:	<b>4</b>
1st Value:	
2nd Value:	
Value Percent:	<b>5.000</b>
Continuous Index:	
Within 8" of Joint:	<b>NO</b>
Remarks:

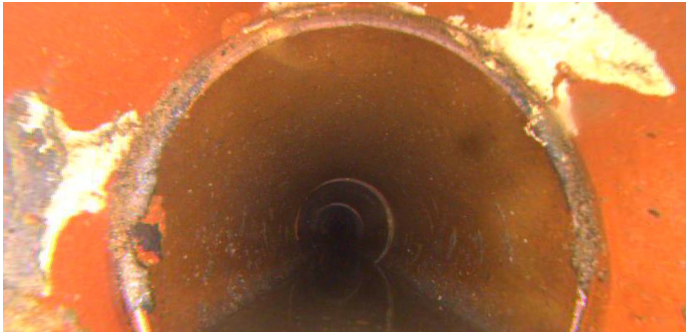
Code: **DAE**  
Description: **Deposits Attached Encrustation**

Distance (ft): **3.7**  
Structural Grade: **0**  
O&M Grade: **2**  
Clock Start/From: **8**  
Clock To: **4**  
1st Value:  
2nd Value:  
Value Percent: **5.000**  
Continuous Index: **S01**  
Within 8" of Joint: **YES**  
Remarks:

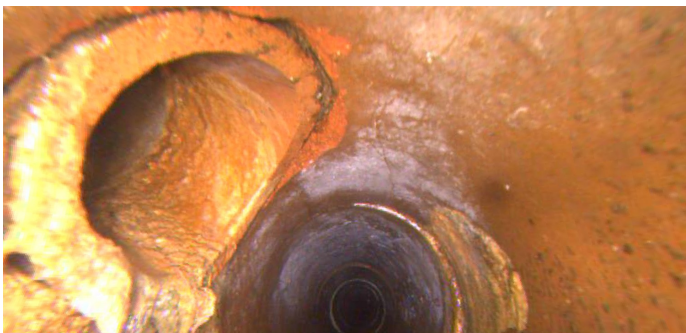
Code: **TBI**  
Description: **Tap Break-in Intruding**

Distance (ft): **11.0**  
Structural Grade: **0**  
O&M Grade: **2**  
Clock Start/From: **10**  
Clock To:  
1st Value: **4.000**  
2nd Value: **1.000**  
Value Percent:  
Continuous Index:  
Within 8" of Joint:  
Remarks:

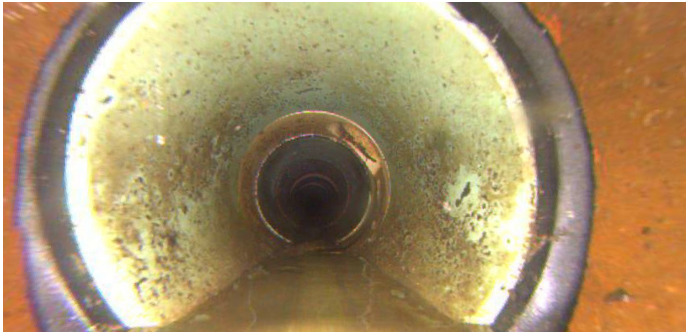
Code: **DAE**  
Description: **Deposits Attached Encrustation**

Distance (ft): **15.3**  
Structural Grade: **0**  
O&M Grade: **2**  
Clock Start/From: **8**  
Clock To: **4**  
1st Value:  
2nd Value:  
Value Percent: **5.000**  
Continuous Index: **F01**  
Within 8" of Joint: **YES**  
Remarks:

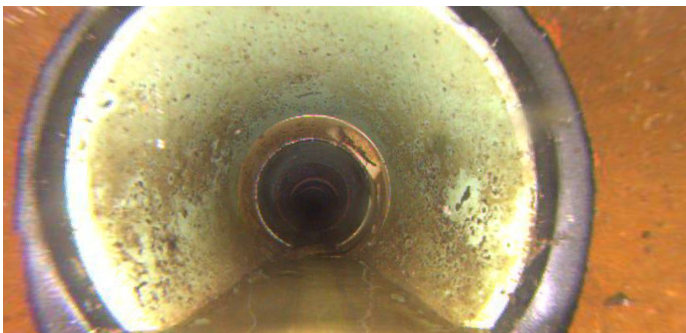
Code: **MMC**  
Description: **Material Change**

Distance (ft): **15.3**  
Structural Grade: **0**  
O&M Grade: **0**  
Clock Start/From:  
Clock To:  
1st Value:  
2nd Value:  
Value Percent:  
Continuous Index:  
Within 8" of Joint: **NO**  
Remarks: **PVC**

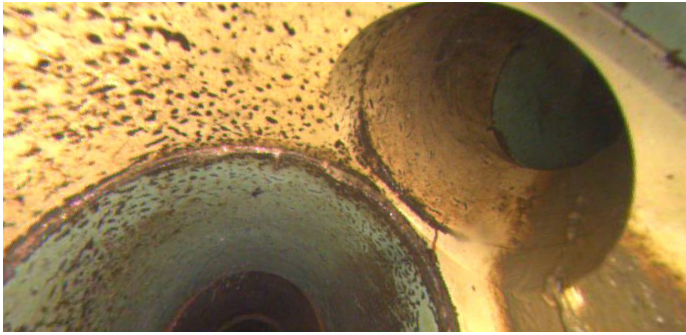
Code: **TFA**  
Description: **Tap Factory Active**

Distance (ft): **16.8**  
Structural Grade: **0**  
O&M Grade: **0**  
Clock Start/From: **2**  
Clock To:  
1st Value: **4.000**  
2nd Value:  
Value Percent:  
Continuous Index:  
Within 8" of Joint:  
Remarks:

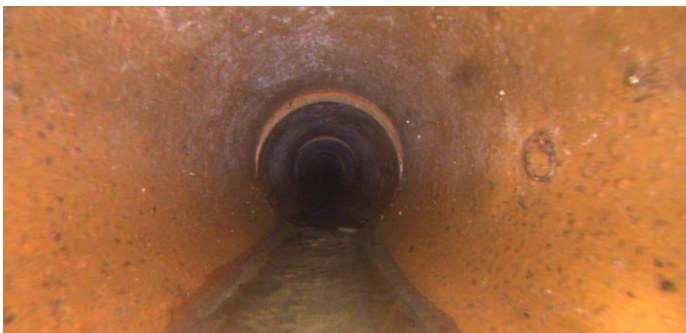
Code: **MMC**  
Description: **Material Change**

Distance (ft): **18.6**  
Structural Grade: **0**  
O&M Grade: **0**  
Clock Start/From:  
Clock To:  
1st Value:  
2nd Value:  
Value Percent:  
Continuous Index:  
Within 8" of Joint: **NO**  
Remarks: **vcp**

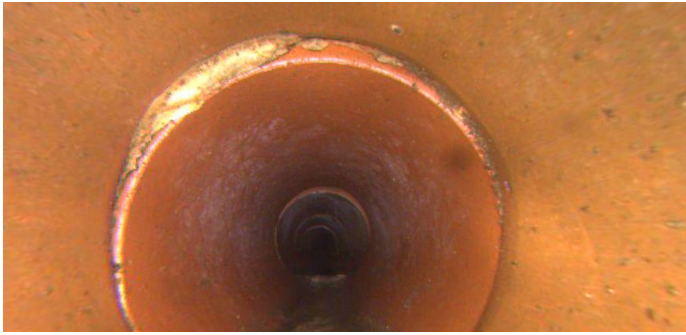
Code: **DAE**  
Description: **Deposits Attached Encrustation**

Distance (ft): **33.7**  
Structural Grade: **0**  
O&M Grade: **2**  
Clock Start/From: **9**  
Clock To: **12**  
1st Value:  
2nd Value:  
Value Percent: **5.000**  
Continuous Index:  
Within 8" of Joint: **YES**  
Remarks:

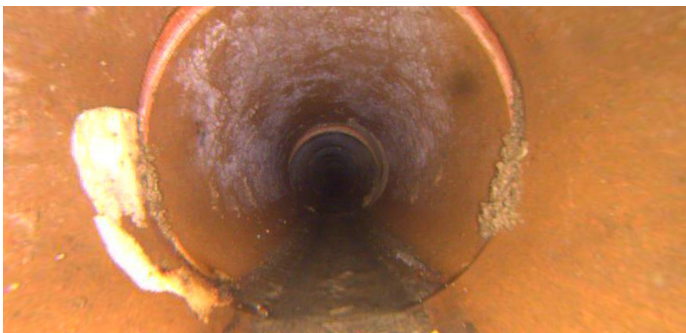
Code: **DAE**  
Description: **Deposits Attached Encrustation**

Distance (ft): **47.8**  
Structural Grade: **0**  
O&M Grade: **2**  
Clock Start/From: **8**  
Clock To: **4**  
1st Value:  
2nd Value:  
Value Percent: **5.000**  
Continuous Index:  
Within 8" of Joint: **YES**  
Remarks:

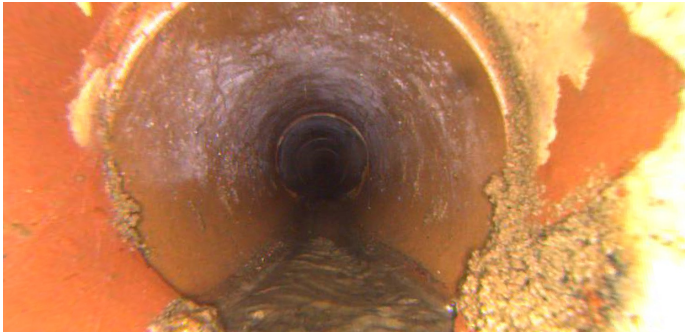
Code: **DAE**  
Description: **Deposits Attached Encrustation**

Distance (ft): **49.8**  
Structural Grade: **0**  
O&M Grade: **2**  
Clock Start/From: **8**  
Clock To: **4**  
1st Value:  
2nd Value:  
Value Percent: **5.000**  
Continuous Index: **S02**  
Within 8" of Joint: **YES**  
Remarks:

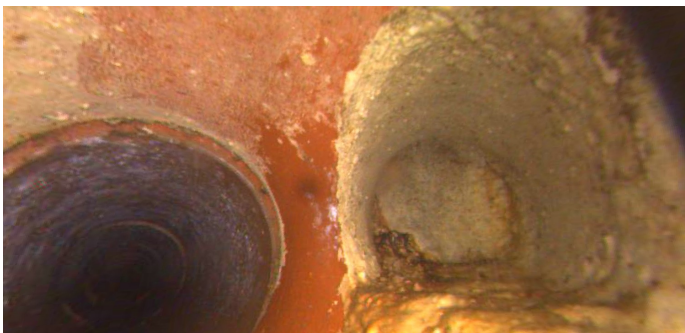
Code: **TFC**  
Description: **Tap Factory Capped**

Distance (ft): **58.4**  
Structural Grade: **0**  
O&M Grade: **0**  
Clock Start/From: **3**  
Clock To:  
1st Value: **4.000**  
2nd Value:  
Value Percent:  
Continuous Index:  
Within 8" of Joint:  
Remarks:

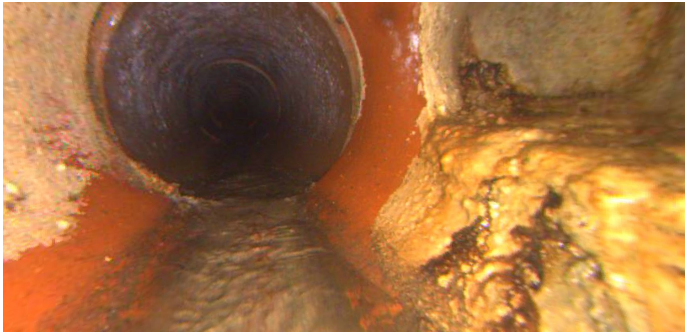
Code: **DAE**  
Description: **Deposits Attached Encrustation**

Distance (ft): **58.4**  
Structural Grade: **0**  
O&M Grade: **2**  
Clock Start/From: **3**  
Clock To: **4**  
1st Value:  
2nd Value:  
Value Percent: **5.000**  
Continuous Index:  
Within 8" of Joint: **NO**  
Remarks:

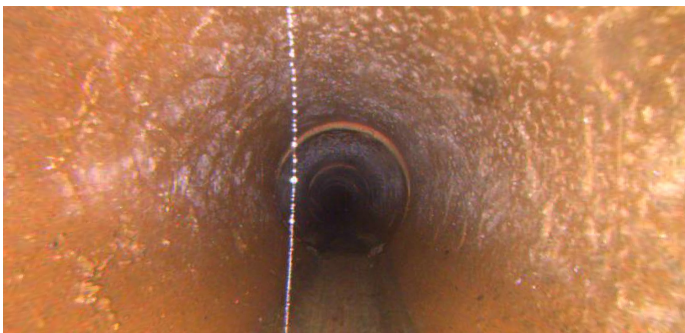
Code: **DAE**  
Description: **Deposits Attached Encrustation**

Distance (ft): **63.8**  
Structural Grade: **0**  
O&M Grade: **2**  
Clock Start/From: **8**  
Clock To: **4**  
1st Value:  
2nd Value:  
Value Percent: **5.000**  
Continuous Index: **F02**  
Within 8" of Joint: **YES**  
Remarks:

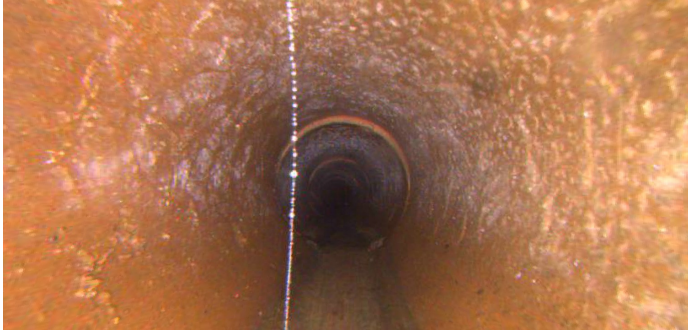
Code:	<b>MSA</b>
Description:	<b>Abandoned Survey</b>
Distance (ft):	<b>63.8</b>
Structural Grade:	<b>0</b>
O&M Grade:	<b>0</b>
Clock Start/From:	
Clock To:	
1st Value:	
2nd Value:	
Value Percent:	
Continuous Index:	
Within 8" of Joint:	<b>NO</b>
Remarks:	<b>dae</b>
