Profile/Photo Observation Report

Date:	11/13/2021	Weather:		Coding:	PACP 7.0
Pipe Length (ft):	273.0	Owner:	City of Hobart	Pre Clean:	Heavy Cleaning
P.O.#:	YES502259	Surveyor:	Steven Bucklin	PSR:	P-604-003-002
Customer:	City of Hobart, IN (Red	Clean Date:	11/13/2021	Shape:	C

Street:	West Cleveland Avenue	Flow Control:	Not Controlled
City:	City of Hobart	Year Renewed:	
Location:	Local rural streets with light traffic, t	Tape/Media #:	
Purpose:	Routine Assessment	Dia/Height:	10"
Use:	Sanitary Sewage Pipe	Material:	VCP
Drain Area:		Lining:	None
Category:	NA		
Comment:			
Location Details:		Direction of Survey:	Downstream
US MH:	M-604-003	DS MH:	M-604-002
		Total Length Surveyed (ft):	84.0

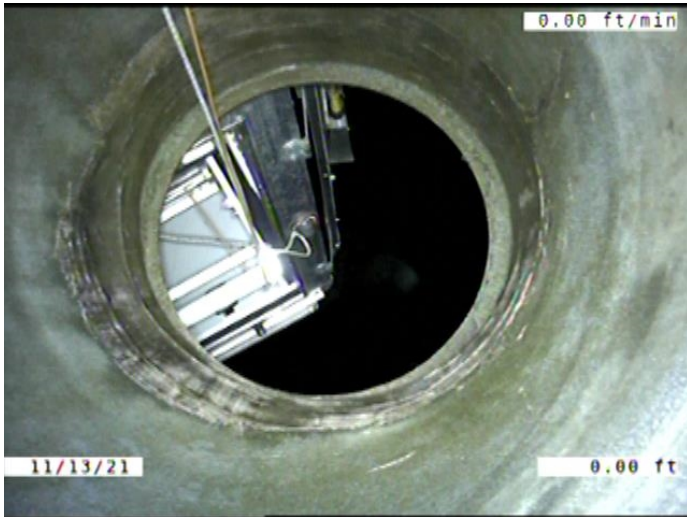
Code: **AMH**
Description: **Manhole**

Distance (ft): **.0**
Structural Grade: **0**
O&M Grade: **0**
Clock Start/From:
Clock To:
1st Value:
2nd Value:
Value Percent:
Continuous Index:
Within 8" of Joint: **NO**
Remarks: **M-604-003**

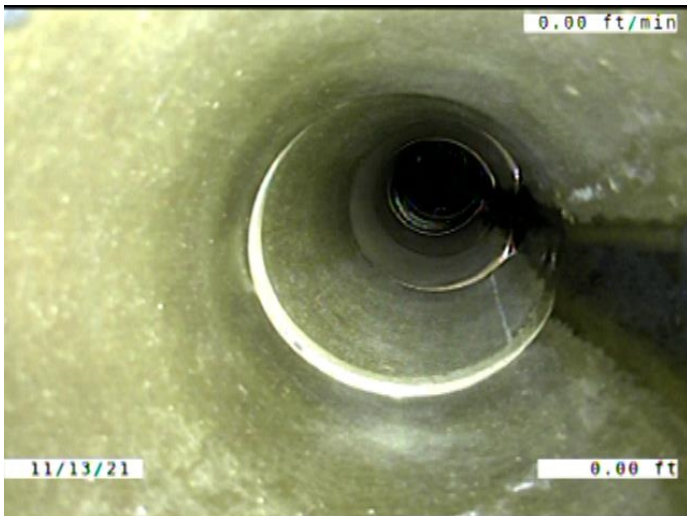
Code: **MWL**
Description: **Miscellaneous Water Level**

Distance (ft): **.0**
Structural Grade: **0**
O&M Grade: **0**
Clock Start/From:
Clock To:
1st Value:
2nd Value:
Value Percent: **5.000**
Continuous Index:
Within 8" of Joint: **NO**
Remarks:

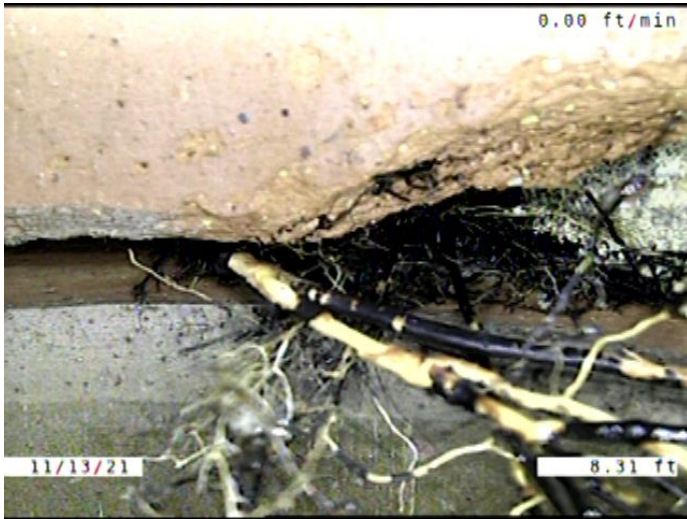
Code: **RMJ**
Description: **Roots Medium Joint**

Distance (ft): **8.3**
Structural Grade: **0**
O&M Grade: **3**
Clock Start/From: **8**
Clock To: **4**
1st Value:
2nd Value:
Value Percent: **5.000**
Continuous Index:
Within 8" of Joint: **YES**
Remarks:

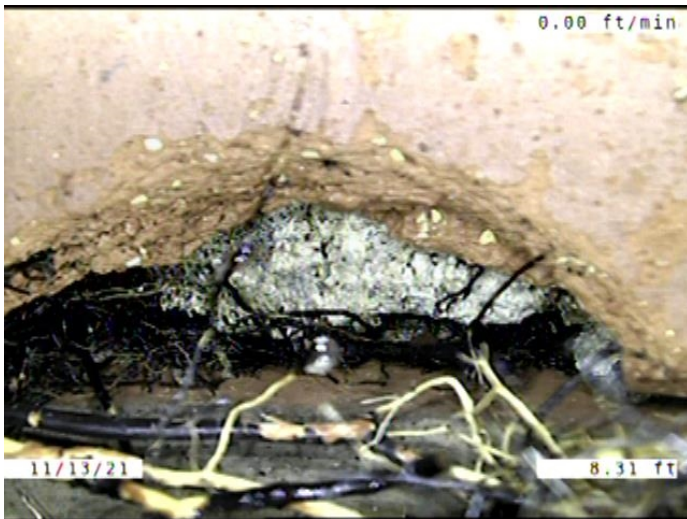
Code: **SMW**
Description: **Surface Damage Missing Wall**

Distance (ft): **8.3**
Structural Grade: **5**
O&M Grade: **0**
Clock Start/From: **3**
Clock To: **4**
1st Value:
2nd Value:
Value Percent:
Continuous Index:
Within 8" of Joint: **YES**
Remarks:

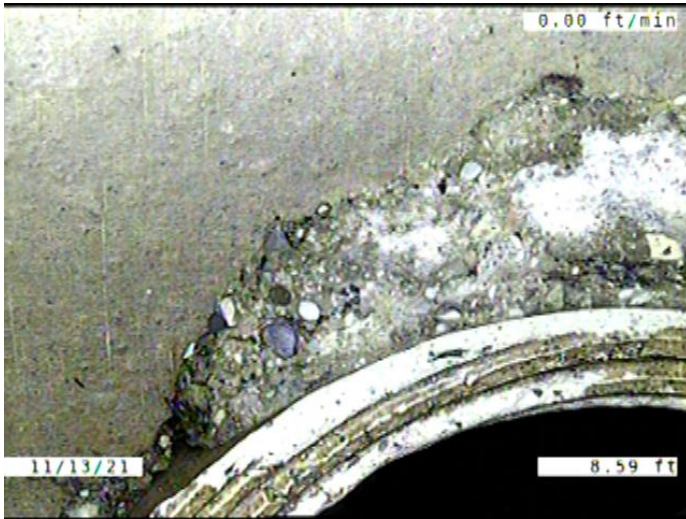
Code: **RPP**
 Description: **Point Repair Patch**

Distance (ft): **8.6**
 Structural Grade: **0**
 O&M Grade: **0**
 Clock Start/From: **8**
 Clock To: **12**
 1st Value:
 2nd Value:
 Value Percent:
 Continuous Index:
 Within 8" of Joint: **YES**
 Remarks: **Concrete**

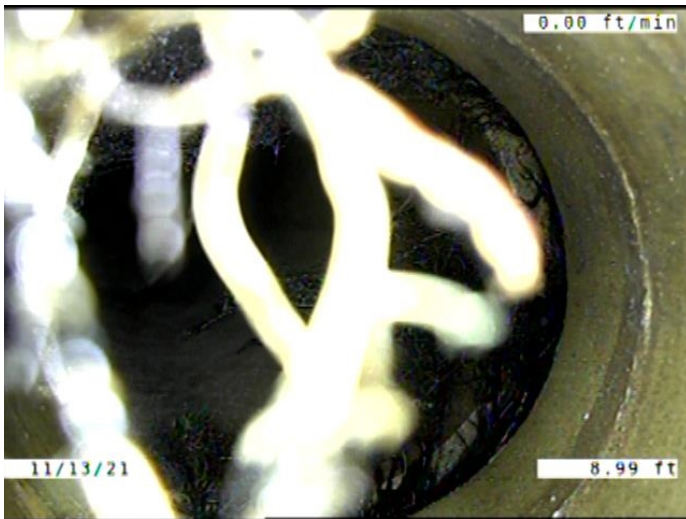
Code: **TBI**
 Description: **Tap Break-in Intruding**

Distance (ft): **9.0**
 Structural Grade: **0**
 O&M Grade: **2**
 Clock Start/From: **10**
 Clock To:
 1st Value: **6.000**
 2nd Value: **1.000**
 Value Percent:
 Continuous Index:
 Within 8" of Joint: **YES**
 Remarks: **ROOTS GROWING IN THE JOINTS**

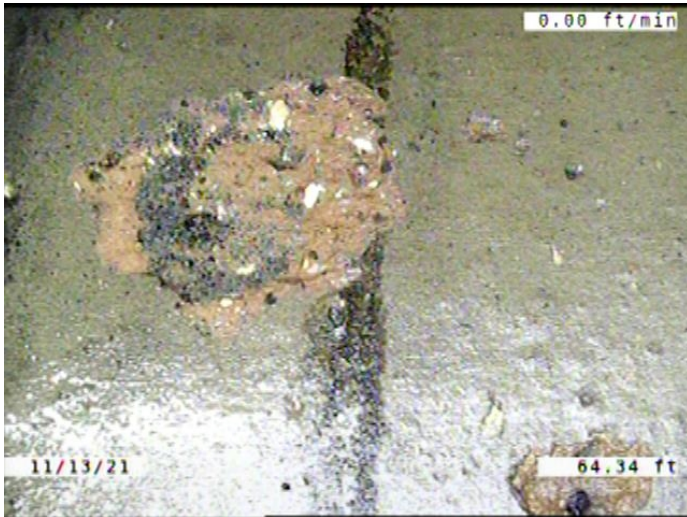
Code: **SSS**
 Description: **Surface Damage Surface Spalling**

Distance (ft): **64.3**
 Structural Grade: **2**
 O&M Grade: **0**
 Clock Start/From: **5**
 Clock To:
 1st Value:
 2nd Value:
 Value Percent:
 Continuous Index:
 Within 8" of Joint: **YES**
 Remarks:

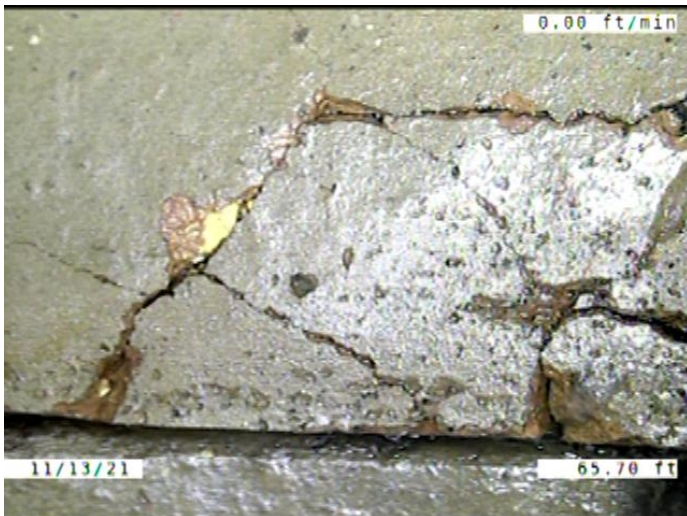
Code: **FM**
 Description: **Fracture Multiple**

Distance (ft): **65.7**
 Structural Grade: **4**
 O&M Grade: **0**
 Clock Start/From: **4**
 Clock To: **9**
 1st Value:
 2nd Value:
 Value Percent:
 Continuous Index:
 Within 8" of Joint: **YES**
 Remarks:

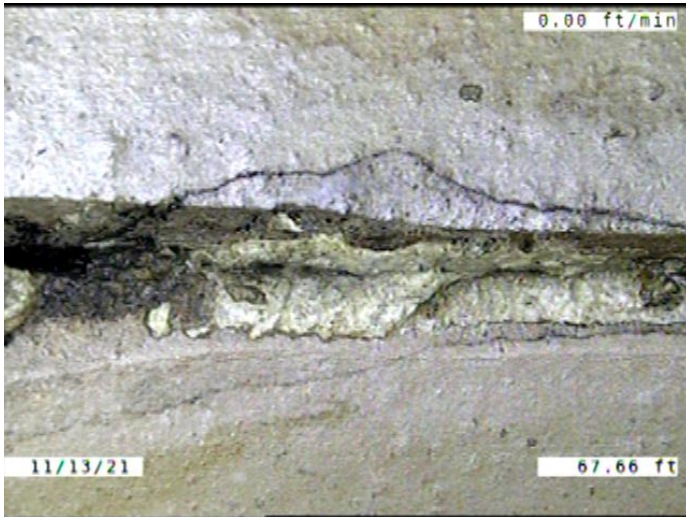
Code: **DAE**
Description: **Deposits Attached Encrustation**

Distance (ft): **67.7**
Structural Grade: **0**
O&M Grade: **2**
Clock Start/From: **9**
Clock To: **3**
1st Value:
2nd Value:
Value Percent: **5.000**
Continuous Index:
Within 8" of Joint: **YES**
Remarks:

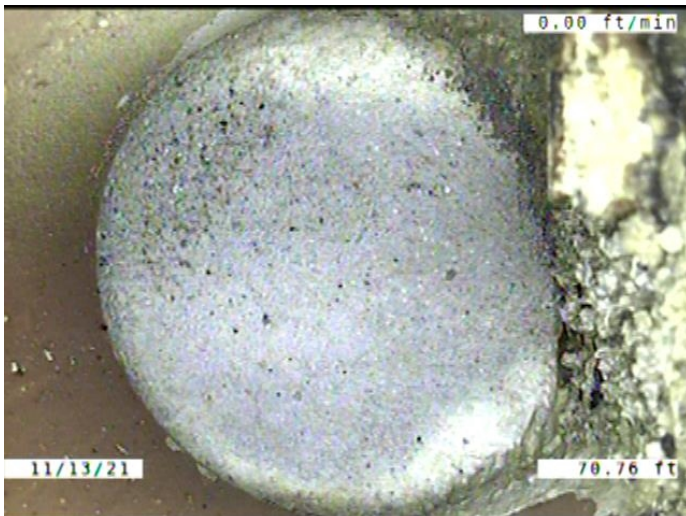
Code: **TFC**
Description: **Tap Factory Capped**

Distance (ft): **70.8**
Structural Grade: **0**
O&M Grade: **0**
Clock Start/From: **3**
Clock To:
1st Value: **6.000**
2nd Value:
Value Percent:
Continuous Index:
Within 8" of Joint: **YES**
Remarks: **ENCrustATION AROUND THE CAP**

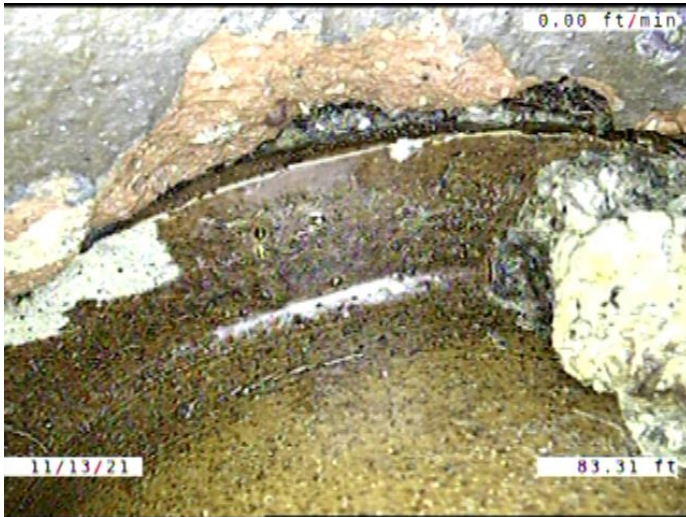
Code:	SSS
Description:	Surface Damage Surface Spalling
Distance (ft):	83.3
Structural Grade:	2
O&M Grade:	0
Clock Start/From:	8
Clock To:	12
1st Value:	
2nd Value:	
Value Percent:	
Continuous Index:	
Within 8" of Joint:	YES
Remarks:

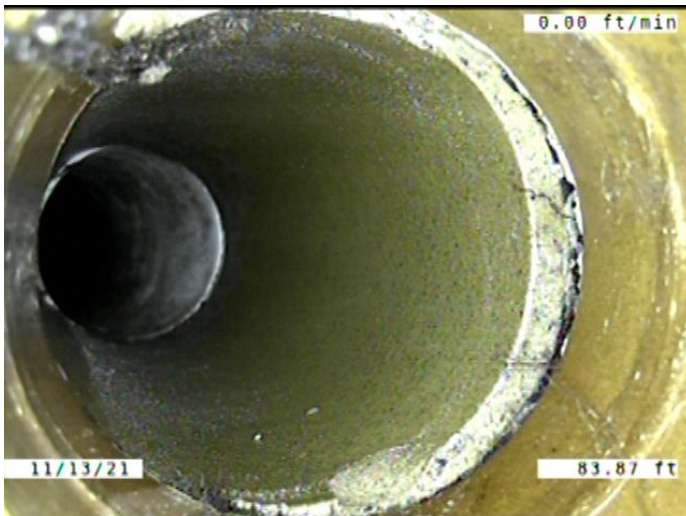
Code:	TBI
Description:	Tap Break-in Intruding
Distance (ft):	83.9
Structural Grade:	0
O&M Grade:	2
Clock Start/From:	10
Clock To:	
1st Value:	6.000
2nd Value:	3.000
Value Percent:	
Continuous Index:	
Within 8" of Joint:	YES
Remarks:
