Profile/Photo Observation Report

Date:	11/13/2021	Weather:		Coding:	PACP 7.0
Pipe Length (ft):	273.0	Owner:	City of Hobart	Pre Clean:	Heavy Cleaning
P.O.#:	YES502259	Surveyor:	Steven Bucklin	PSR:	P-604-003-002
Customer:	City of Hobart, IN (Red	Clean Date:	11/13/2021	Shape:	C

Street:	West Cleveland Avenue	Flow Control:	Not Controlled
City:	City of Hobart	Year Renewed:	
Location:	Local rural streets with light traffic, t	Tape/Media #:	
Purpose:	Routine Assessment	Dia/Height:	10"
Use:	Sanitary Sewage Pipe	Material:	VCP
Drain Area:		Lining:	None
Category:	NA		
Comment:			
Location Details:		Direction of Survey:	Downstream
US MH:	M-604-003	DS MH:	M-604-002
		Total Length Surveyed (ft):	84.0

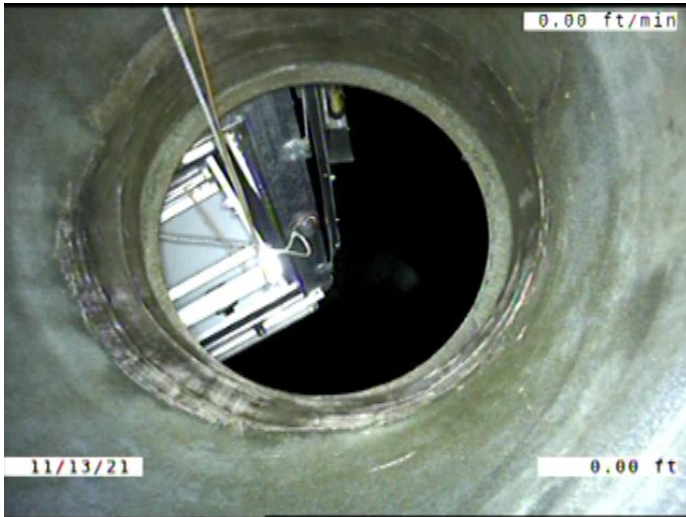
Code: **AMH**
Description: **Manhole**

Distance (ft): **.0**
Structural Grade: **0**
O&M Grade: **0**
Clock Start/From:
Clock To:
1st Value:
2nd Value:
Value Percent:
Continuous Index:
Within 8" of Joint: **NO**
Remarks: **M-604-003**

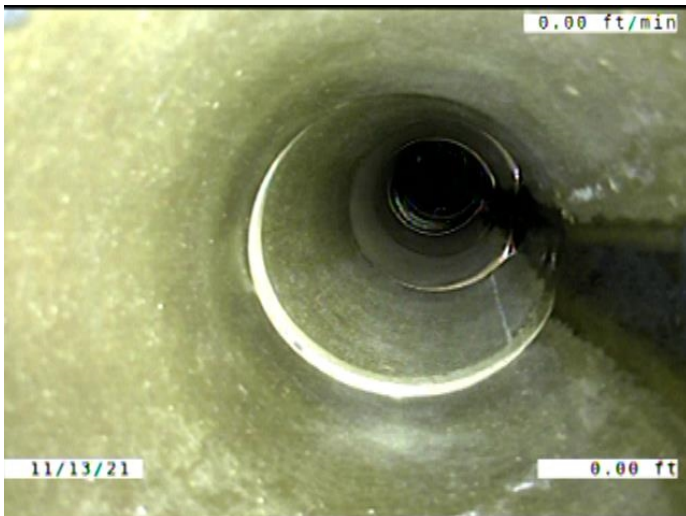
Code: **MWL**
Description: **Miscellaneous Water Level**

Distance (ft): **.0**
Structural Grade: **0**
O&M Grade: **0**
Clock Start/From:
Clock To:
1st Value:
2nd Value:
Value Percent: **5.000**
Continuous Index:
Within 8" of Joint: **NO**
Remarks:

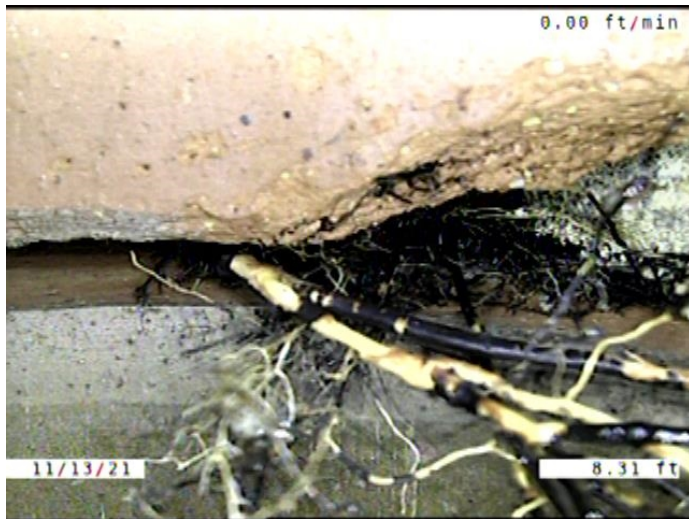
Code: **RMJ**
 Description: **Roots Medium Joint**

Distance (ft): **8.3**
 Structural Grade: **0**
 O&M Grade: **3**
 Clock Start/From: **8**
 Clock To: **4**
 1st Value:
 2nd Value:
 Value Percent: **5.000**
 Continuous Index:
 Within 8" of Joint: **YES**
 Remarks:

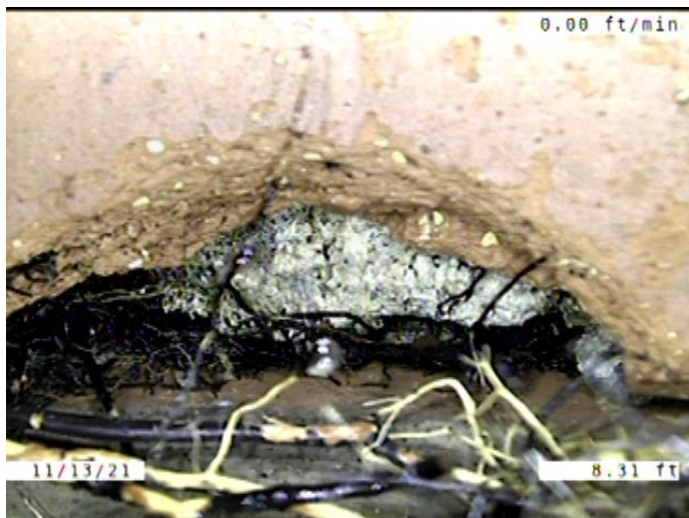
Code: **SMW**
 Description: **Surface Damage Missing Wall**

Distance (ft): **8.3**
 Structural Grade: **5**
 O&M Grade: **0**
 Clock Start/From: **3**
 Clock To: **4**
 1st Value:
 2nd Value:
 Value Percent:
 Continuous Index:
 Within 8" of Joint: **YES**
 Remarks:

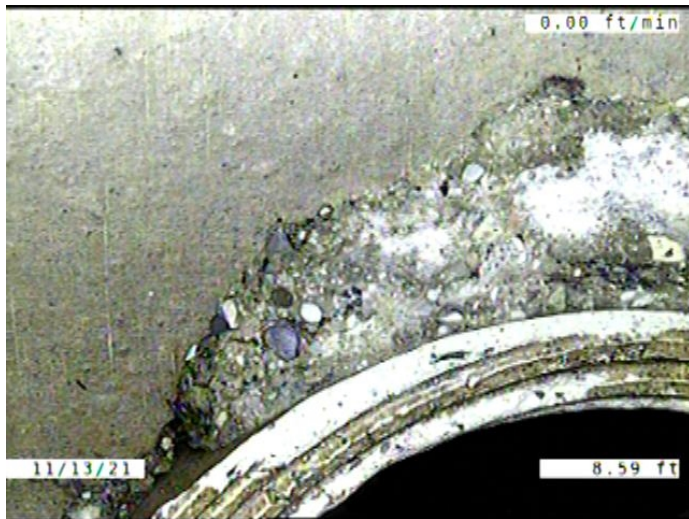
Code: **RPP**
 Description: **Point Repair Patch**

Distance (ft): **8.6**
 Structural Grade: **0**
 O&M Grade: **0**
 Clock Start/From: **8**
 Clock To: **12**
 1st Value:
 2nd Value:
 Value Percent:
 Continuous Index:
 Within 8" of Joint: **YES**
 Remarks: **Concrete**

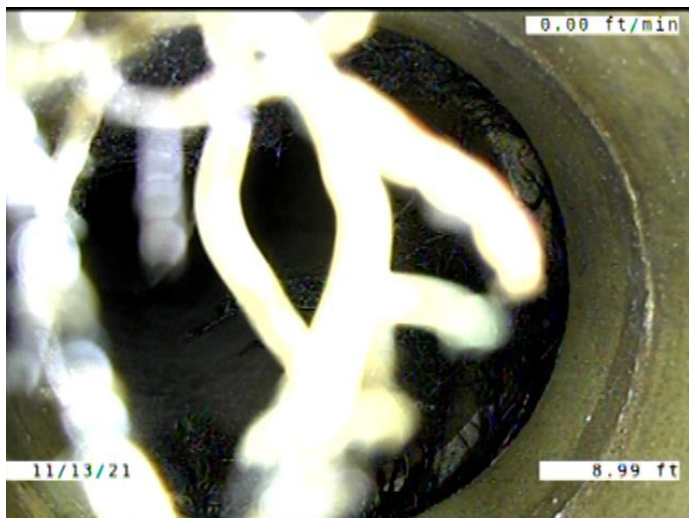
Code: **TBI**
 Description: **Tap Break-in Intruding**

Distance (ft): **9.0**
 Structural Grade: **0**
 O&M Grade: **2**
 Clock Start/From: **10**
 Clock To:
 1st Value: **6.000**
 2nd Value: **1.000**
 Value Percent:
 Continuous Index:
 Within 8" of Joint: **YES**
 Remarks: **ROOTS GROWING IN THE JOINTS**

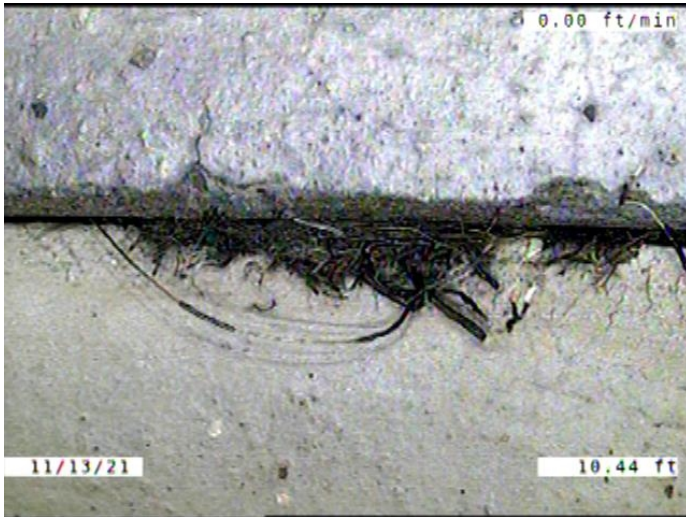
Code: **RFJ**
 Description: **Roots Fine Joint**

Distance (ft): **10.4**
 Structural Grade: **0**
 O&M Grade: **1**
 Clock Start/From: **2**
 Clock To: **4**
 1st Value:
 2nd Value:
 Value Percent:
 Continuous Index:
 Within 8" of Joint: **YES**
 Remarks:

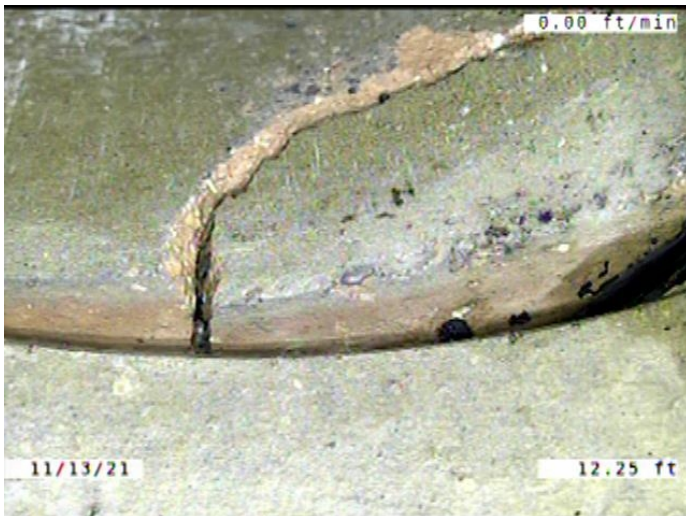
Code: **B**
 Description: **Broken**

Distance (ft): **12.2**
 Structural Grade: **4**
 O&M Grade: **0**
 Clock Start/From: **4**
 Clock To: **8**
 1st Value:
 2nd Value:
 Value Percent:
 Continuous Index:
 Within 8" of Joint: **YES**
 Remarks:

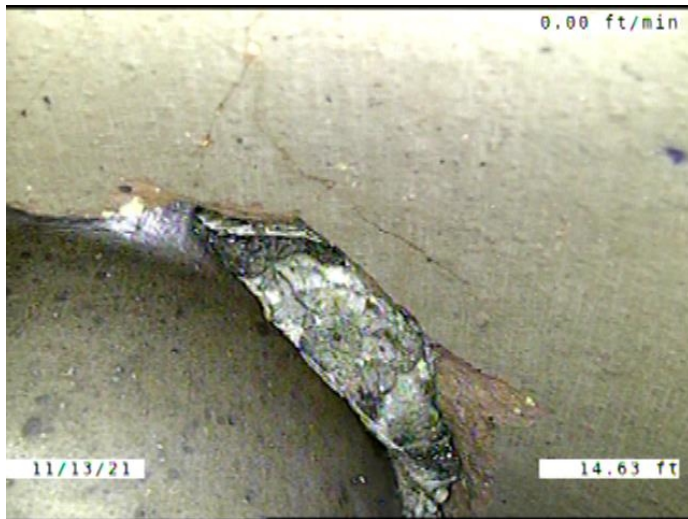
Code: **B**
 Description: **Broken**

Distance (ft): **14.6**
 Structural Grade: **4**
 O&M Grade: **0**
 Clock Start/From: **12**
 Clock To: **3**
 1st Value:
 2nd Value:
 Value Percent:
 Continuous Index:
 Within 8" of Joint: **YES**
 Remarks:

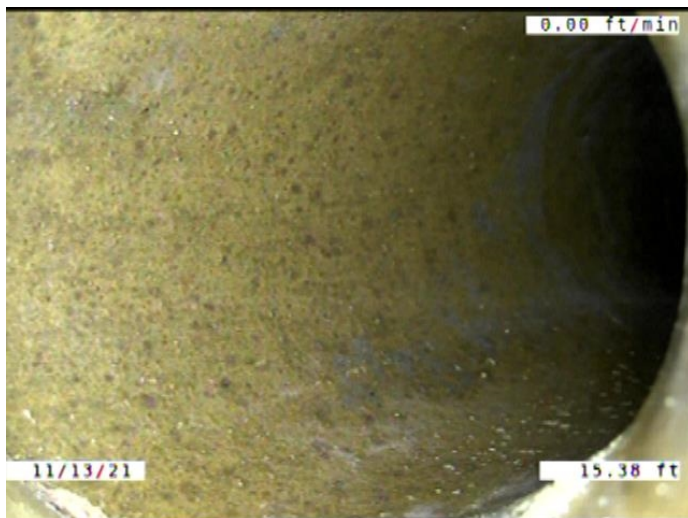
Code: **TBI**
 Description: **Tap Break-in Intruding**

Distance (ft): **15.4**
 Structural Grade: **0**
 O&M Grade: **2**
 Clock Start/From: **2**
 Clock To:
 1st Value: **6.000**
 2nd Value: **3.000**
 Value Percent:
 Continuous Index:
 Within 8" of Joint: **YES**
 Remarks:

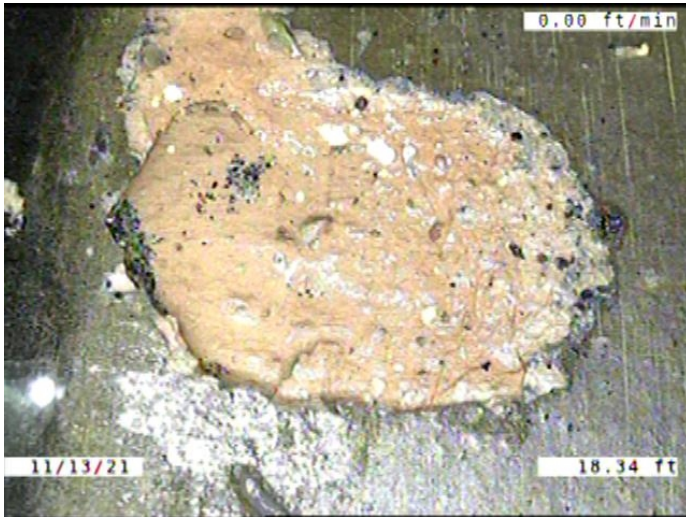
Code: **SSS**
 Description: **Surface Damage Surface Spalling**

Distance (ft): **18.3**
 Structural Grade: **2**
 O&M Grade: **0**
 Clock Start/From: **5**
 Clock To:
 1st Value:
 2nd Value:
 Value Percent:
 Continuous Index:
 Within 8" of Joint: **YES**
 Remarks:

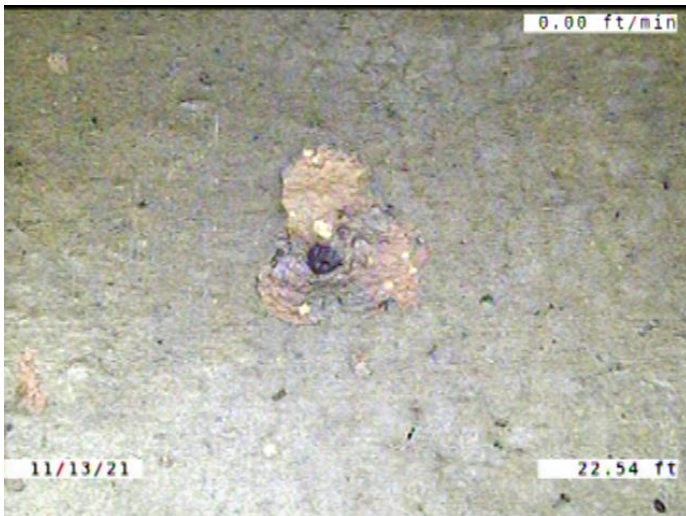
Code: **SSS**
 Description: **Surface Damage Surface Spalling**

Distance (ft): **22.5**
 Structural Grade: **2**
 O&M Grade: **0**
 Clock Start/From: **4**
 Clock To:
 1st Value:
 2nd Value:
 Value Percent:
 Continuous Index:
 Within 8" of Joint: **YES**
 Remarks:

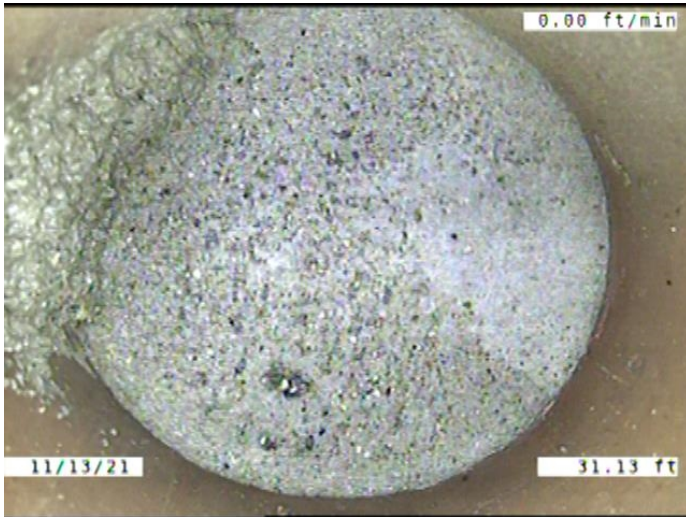
Code: **TFC**
 Description: **Tap Factory Capped**

Distance (ft): **31.1**
 Structural Grade: **0**
 O&M Grade: **0**
 Clock Start/From: **10**
 Clock To:
 1st Value: **6.000**
 2nd Value:
 Value Percent:
 Continuous Index:
 Within 8" of Joint: **YES**
 Remarks:

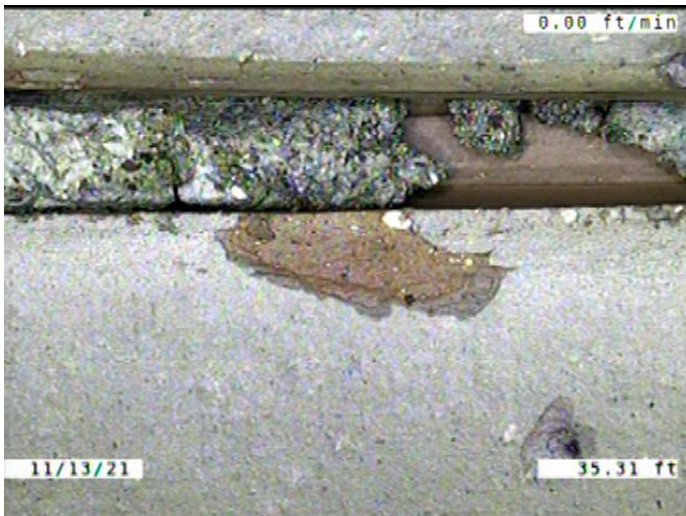
Code: **SSS**
 Description: **Surface Damage Surface Spalling**

Distance (ft): **35.3**
 Structural Grade: **2**
 O&M Grade: **0**
 Clock Start/From: **1**
 Clock To:
 1st Value:
 2nd Value:
 Value Percent:
 Continuous Index:
 Within 8" of Joint: **YES**
 Remarks:

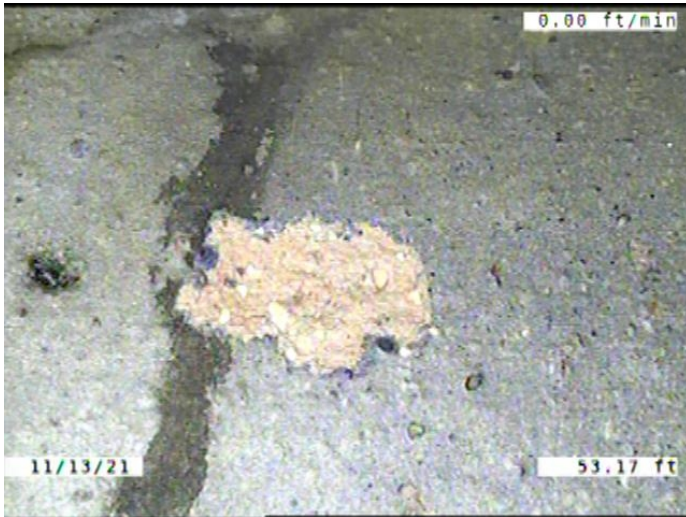
Code: **SSS**
 Description: **Surface Damage Surface Spalling**

Distance (ft): **53.2**
 Structural Grade: **2**
 O&M Grade: **0**
 Clock Start/From: **4**
 Clock To:
 1st Value:
 2nd Value:
 Value Percent:
 Continuous Index:
 Within 8" of Joint: **YES**
 Remarks:

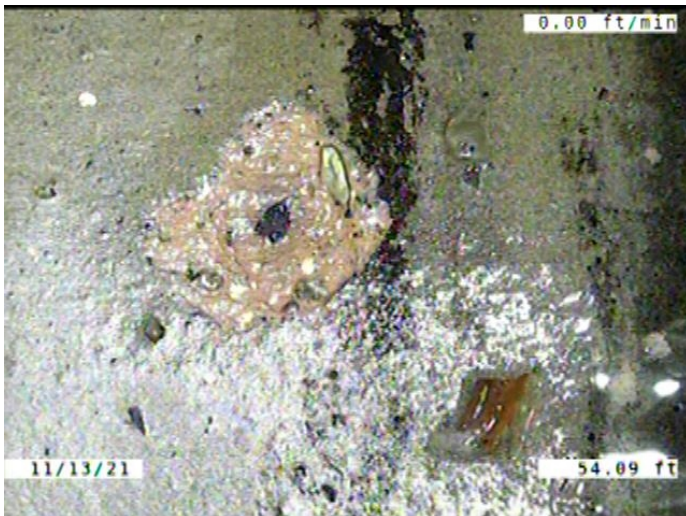
Code: **SSS**
 Description: **Surface Damage Surface Spalling**

Distance (ft): **54.1**
 Structural Grade: **2**
 O&M Grade: **0**
 Clock Start/From: **7**
 Clock To:
 1st Value:
 2nd Value:
 Value Percent:
 Continuous Index:
 Within 8" of Joint: **YES**
 Remarks:

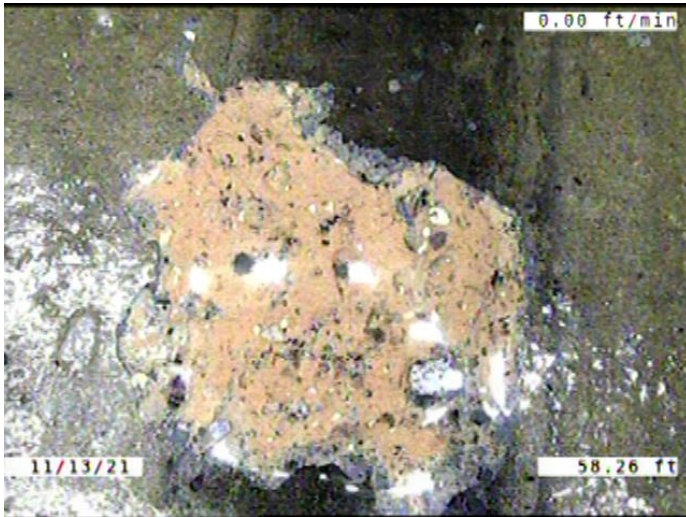
Code: **SSS**
 Description: **Surface Damage Surface Spalling**

Distance (ft): **58.3**
 Structural Grade: **2**
 O&M Grade: **0**
 Clock Start/From: **6**
 Clock To:
 1st Value:
 2nd Value:
 Value Percent:
 Continuous Index:
 Within 8" of Joint: **YES**
 Remarks:

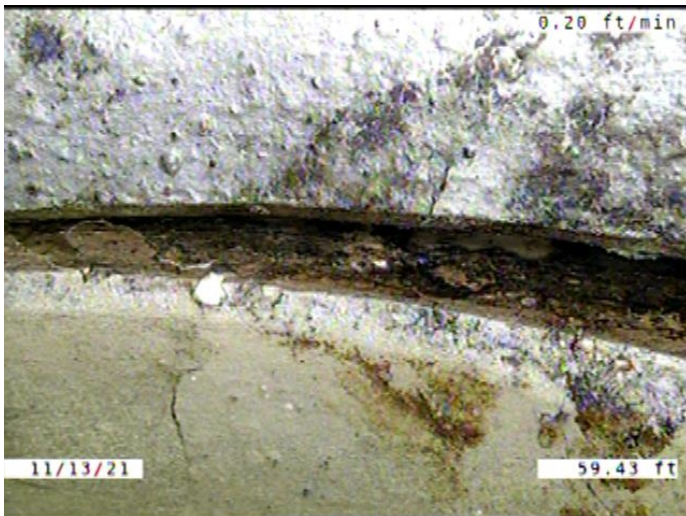
Code: **ISJ**
 Description: **Infiltration Stain Joint**

Distance (ft): **59.4**
 Structural Grade: **0**
 O&M Grade: **1**
 Clock Start/From: **2**
 Clock To: **5**
 1st Value:
 2nd Value:
 Value Percent:
 Continuous Index:
 Within 8" of Joint: **YES**
 Remarks:

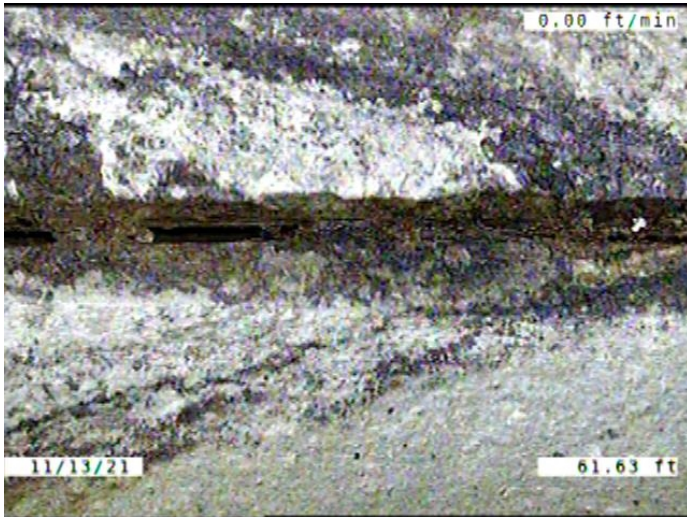
Code: **DAE**
 Description: **Deposits Attached Encrustation**

Distance (ft): **61.6**
 Structural Grade: **0**
 O&M Grade: **2**
 Clock Start/From: **8**
 Clock To: **4**
 1st Value:
 2nd Value:
 Value Percent: **5.000**
 Continuous Index:
 Within 8" of Joint: **YES**
 Remarks:

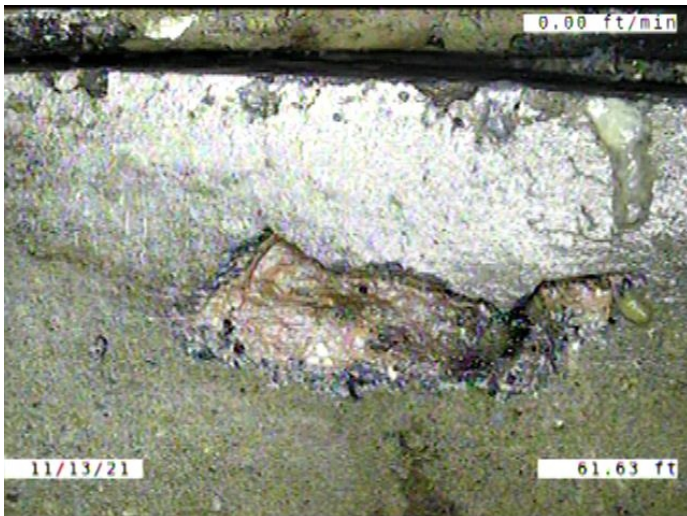
Code: **SSS**
 Description: **Surface Damage Surface Spalling**

Distance (ft): **61.6**
 Structural Grade: **2**
 O&M Grade: **0**
 Clock Start/From: **4**
 Clock To: **5**
 1st Value:
 2nd Value:
 Value Percent:
 Continuous Index:
 Within 8" of Joint: **YES**
 Remarks:

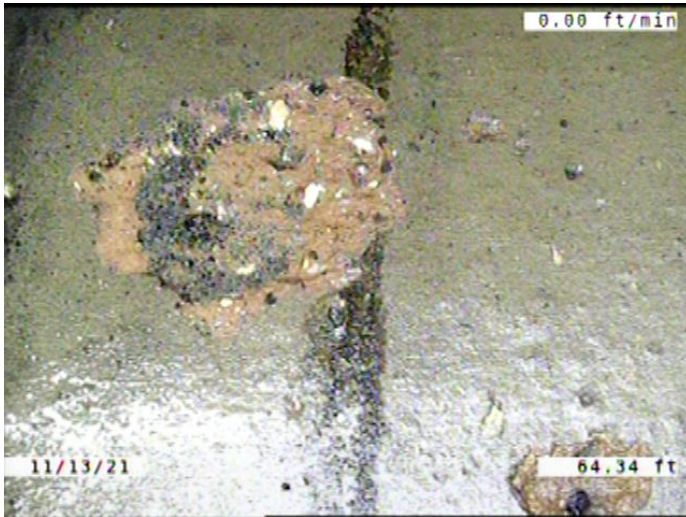
Code: **SSS**
 Description: **Surface Damage Surface Spalling**

Distance (ft): **64.3**
 Structural Grade: **2**
 O&M Grade: **0**
 Clock Start/From: **5**
 Clock To:
 1st Value:
 2nd Value:
 Value Percent:
 Continuous Index:
 Within 8" of Joint: **YES**
 Remarks:

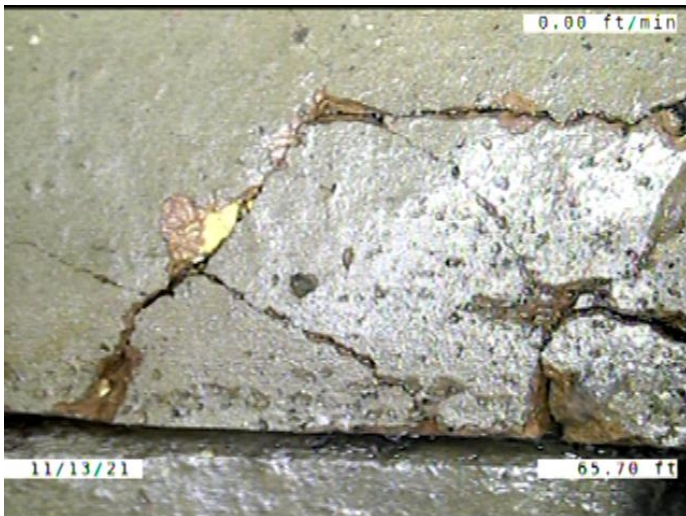
Code: **FM**
 Description: **Fracture Multiple**

Distance (ft): **65.7**
 Structural Grade: **4**
 O&M Grade: **0**
 Clock Start/From: **4**
 Clock To: **9**
 1st Value:
 2nd Value:
 Value Percent:
 Continuous Index:
 Within 8" of Joint: **YES**
 Remarks:

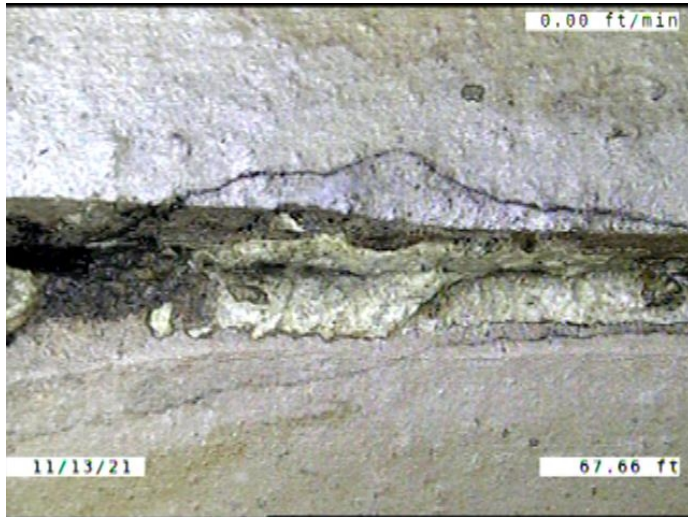
Code: **DAE**
 Description: **Deposits Attached Encrustation**

Distance (ft): **67.7**
 Structural Grade: **0**
 O&M Grade: **2**
 Clock Start/From: **9**
 Clock To: **3**
 1st Value:
 2nd Value:
 Value Percent: **5.000**
 Continuous Index:
 Within 8" of Joint: **YES**
 Remarks:

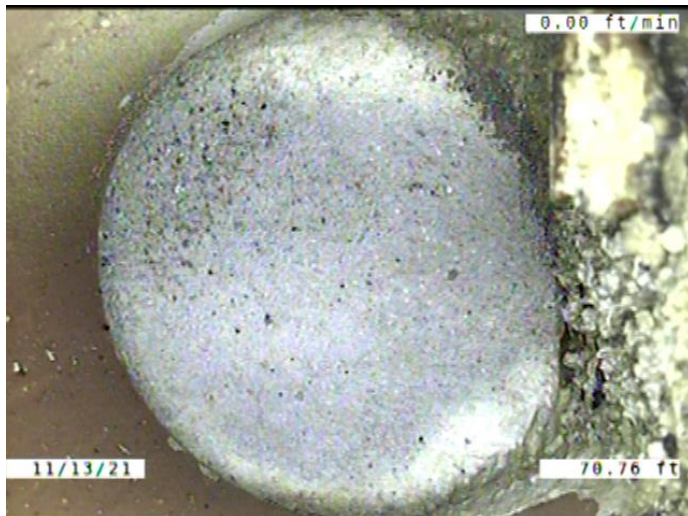
Code: **TFC**
 Description: **Tap Factory Capped**

Distance (ft): **70.8**
 Structural Grade: **0**
 O&M Grade: **0**
 Clock Start/From: **3**
 Clock To:
 1st Value: **6.000**
 2nd Value:
 Value Percent:
 Continuous Index:
 Within 8" of Joint: **YES**
 Remarks: **ENCrustation AROUND THE CAP**

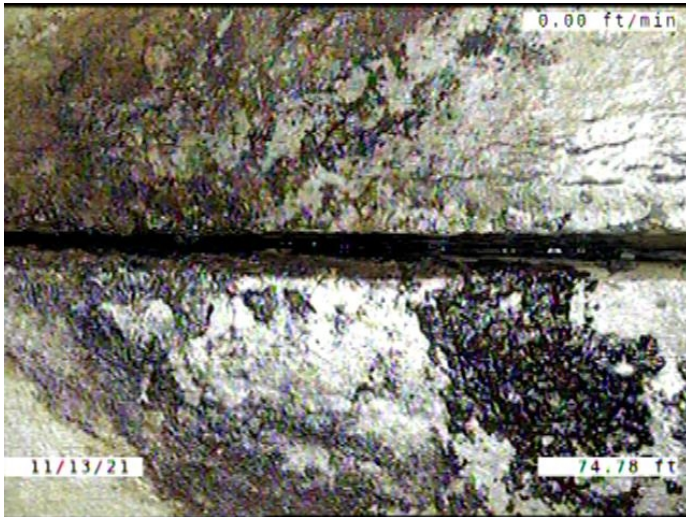
Code: **DAE**
 Description: **Deposits Attached Encrustation**

Distance (ft): **74.8**
 Structural Grade: **0**
 O&M Grade: **2**
 Clock Start/From: **7**
 Clock To: **9**
 1st Value:
 2nd Value:
 Value Percent: **5.000**
 Continuous Index:
 Within 8" of Joint: **YES**
 Remarks:

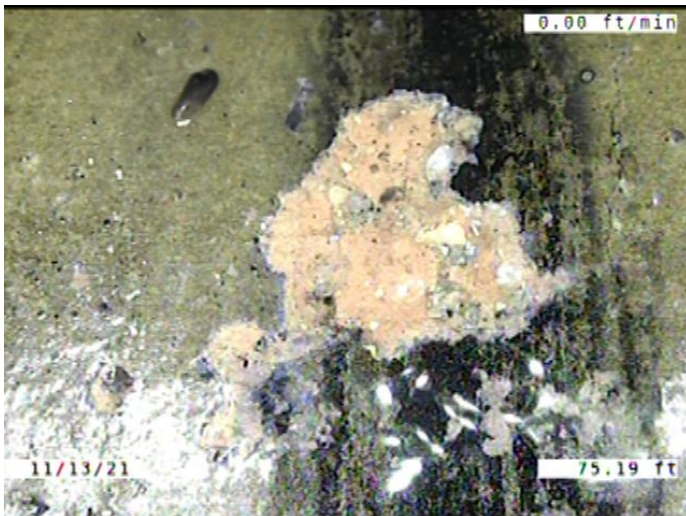
Code: **SSS**
 Description: **Surface Damage Surface Spalling**

Distance (ft): **75.2**
 Structural Grade: **2**
 O&M Grade: **0**
 Clock Start/From: **6**
 Clock To: **7**
 1st Value:
 2nd Value:
 Value Percent:
 Continuous Index:
 Within 8" of Joint: **YES**
 Remarks:

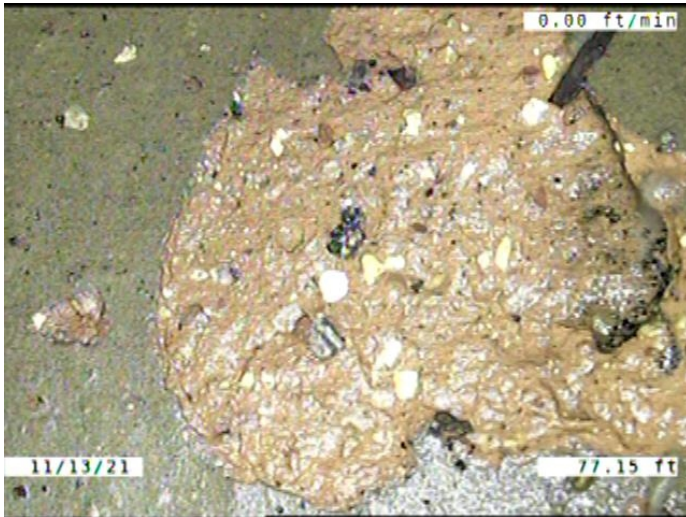
Code: **SSS**
 Description: **Surface Damage Surface Spalling**

Distance (ft): **77.1**
 Structural Grade: **2**
 O&M Grade: **0**
 Clock Start/From: **4**
 Clock To: **8**
 1st Value:
 2nd Value:
 Value Percent:
 Continuous Index:
 Within 8" of Joint: **YES**
 Remarks:

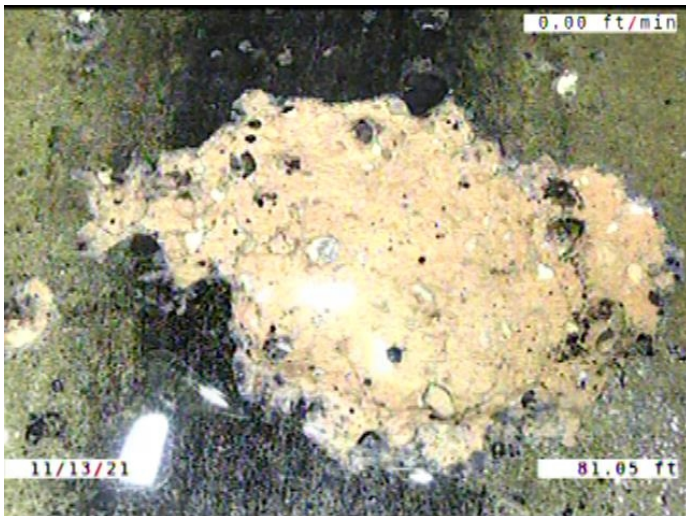
Code: **SSS**
 Description: **Surface Damage Surface Spalling**

Distance (ft): **81.0**
 Structural Grade: **2**
 O&M Grade: **0**
 Clock Start/From: **5**
 Clock To: **7**
 1st Value:
 2nd Value:
 Value Percent:
 Continuous Index:
 Within 8" of Joint: **YES**
 Remarks:

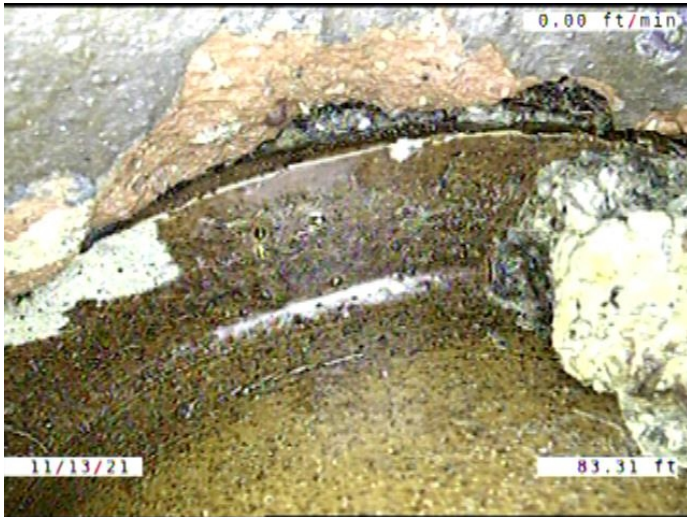
Code: **SSS**
 Description: **Surface Damage Surface Spalling**

Distance (ft): **83.3**
 Structural Grade: **2**
 O&M Grade: **0**
 Clock Start/From: **8**
 Clock To: **12**
 1st Value:
 2nd Value:
 Value Percent:
 Continuous Index:
 Within 8" of Joint: **YES**
 Remarks:

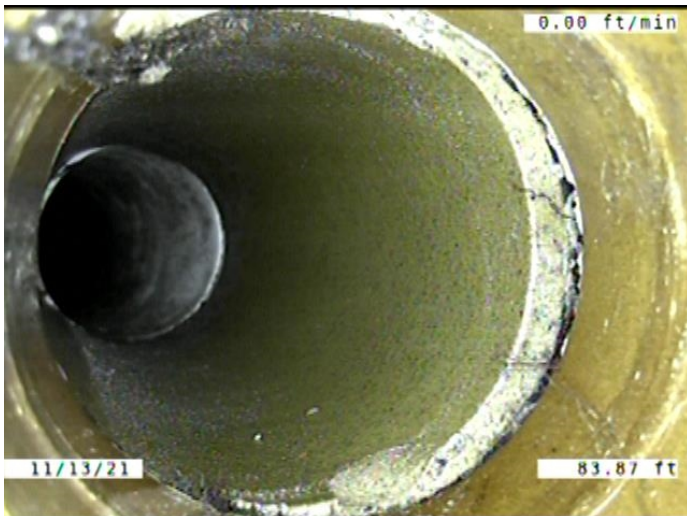
Code: **TBI**
 Description: **Tap Break-in Intruding**

Distance (ft): **83.9**
 Structural Grade: **0**
 O&M Grade: **2**
 Clock Start/From: **10**
 Clock To:
 1st Value: **6.000**
 2nd Value: **3.000**
 Value Percent:
 Continuous Index:
 Within 8" of Joint: **YES**
 Remarks:

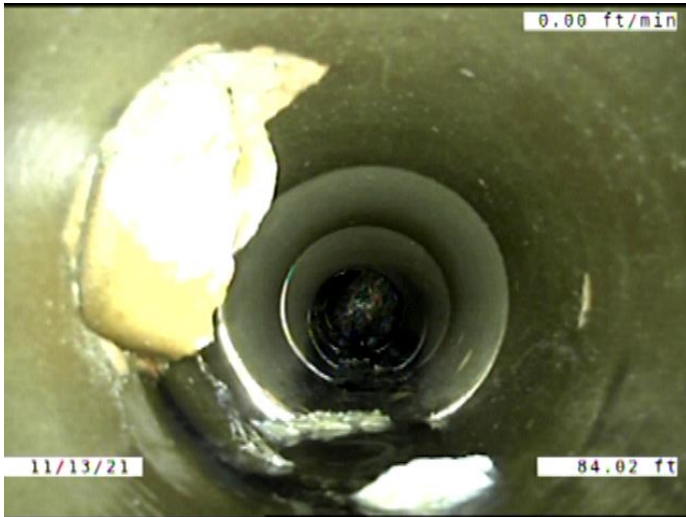
Code:	MSA
Description:	Miscellaneous Survey Abandoned
Distance (ft):	84.0
Structural Grade:	0
O&M Grade:	0
Clock Start/From:	
Clock To:	
1st Value:	
2nd Value:	
Value Percent:	
Continuous Index:	
Within 8" of Joint:	NO
Remarks:	CAMERA CANT MAKE IT PAST PROTRUDING TAP.
