Profile/Photo Observation Report

Date:	11/14/2021	Weather:		Coding:	PACP 7.0
Pipe Length (ft):	273.0	Owner:	City of Hobart	Pre Clean:	Heavy Cleaning
P.O.#:	YES502259	Surveyor:	S. Bucklin	PSR:	P-604-003-002
Customer:	City of Hobart	Clean Date:	11/13/2021	Shape:	C

Street:	West Cleveland Avenue	Flow Control:	Not Controlled
City:	Hobart, IN	Year Renewed:	
Location:	Local rural streets with light traffic, t	Tape/Media #:	
Purpose:	Routine Assessment	Dia/Height:	10"
Use:	Sanitary Sewage Pipe	Material:	VCP
Drain Area:		Lining:	None
Category:	NA		
Comment:			
Location Details:		Direction of Survey:	Upstream
US MH:	M-604-003	DS MH:	M-604-002
		Total Length Surveyed (ft):	186.6

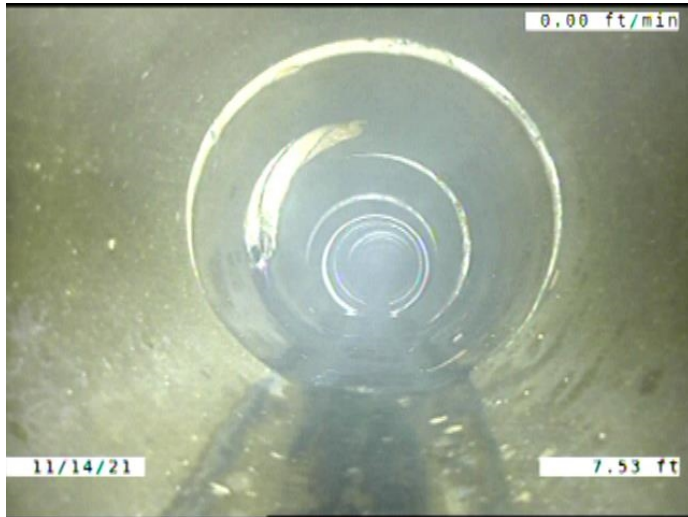
Code: **CM**
Description: **Crack Multiple**

Distance (ft): **7.5**
Structural Grade: **3**
O&M Grade: **0**
Clock Start/From: **5**
Clock To: **7**
1st Value:
2nd Value:
Value Percent:
Continuous Index: **F01**
Within 8" of Joint: **YES**
Remarks:

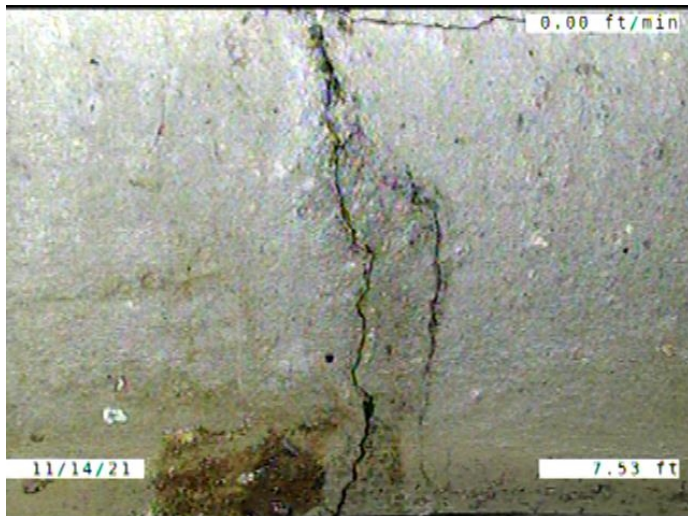
Code: **CM**
Description: **Crack Multiple**

Distance (ft): **7.5**
Structural Grade: **3**
O&M Grade: **0**
Clock Start/From: **12**
Clock To: **12**
1st Value:
2nd Value:
Value Percent:
Continuous Index: **S02**
Within 8" of Joint: **YES**
Remarks:

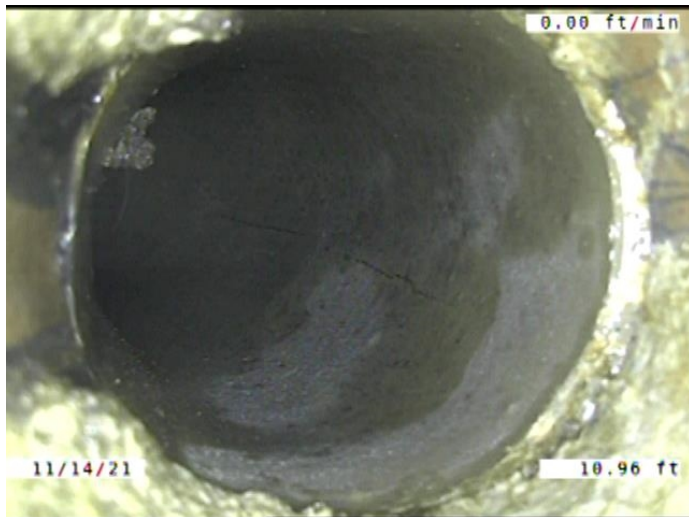
Code: **TBI**
 Description: **Tap Break-in Intruding**

Distance (ft): **11.0**
 Structural Grade: **0**
 O&M Grade: **2**
 Clock Start/From: **10**
 Clock To:
 1st Value: **6.000**
 2nd Value: **1.000**
 Value Percent:
 Continuous Index:
 Within 8" of Joint: **YES**
 Remarks: **CONSTANTLY RUNNING WATER.**

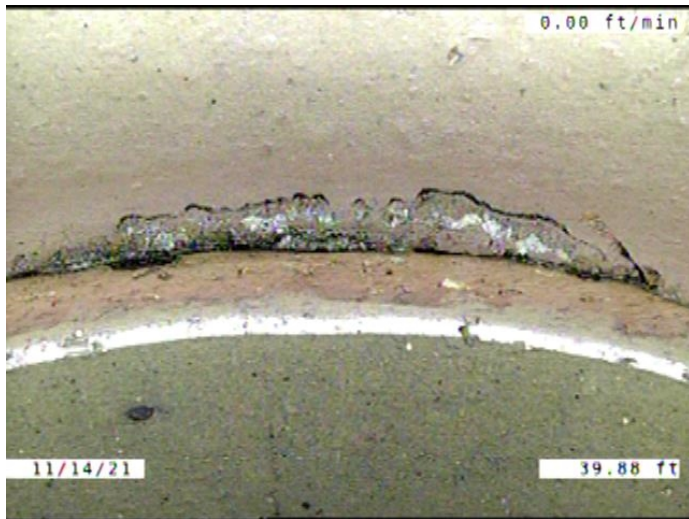
Code: **JOM**
Description: **Joint Offset Medium**

Distance (ft): **39.9**
Structural Grade: **3**
O&M Grade: **0**
Clock Start/From:
Clock To:
1st Value:
2nd Value:
Value Percent:
Continuous Index:
Within 8" of Joint: **NO**
Remarks:

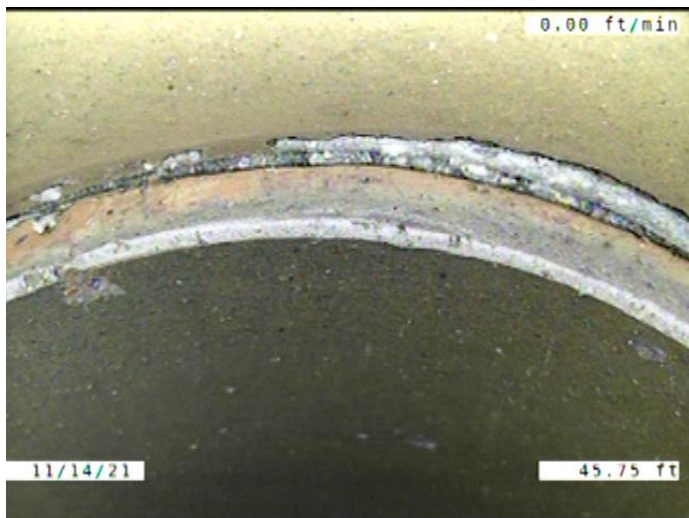
Code: **JOM**
Description: **Joint Offset Medium**

Distance (ft): **45.8**
Structural Grade: **3**
O&M Grade: **0**
Clock Start/From:
Clock To:
1st Value:
2nd Value:
Value Percent:
Continuous Index:
Within 8" of Joint: **NO**
Remarks:

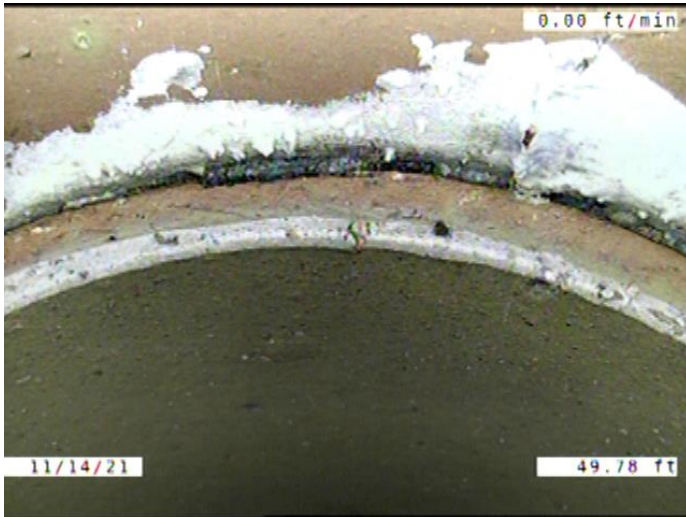
Code: **JOM**
 Description: **Joint Offset Medium**

Distance (ft): **49.8**
 Structural Grade: **3**
 O&M Grade: **0**
 Clock Start/From:
 Clock To:
 1st Value:
 2nd Value:
 Value Percent:
 Continuous Index:
 Within 8" of Joint: **NO**
 Remarks:

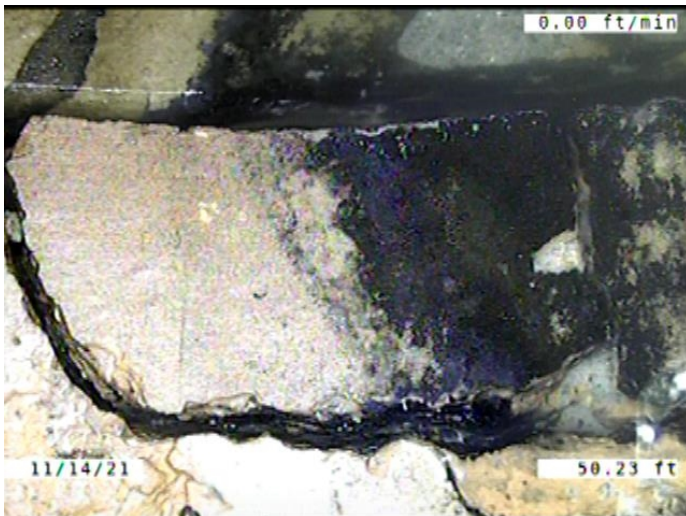
Code: **B**
 Description: **Broken**

Distance (ft): **50.2**
 Structural Grade: **4**
 O&M Grade: **0**
 Clock Start/From: **12**
 Clock To: **8**
 1st Value:
 2nd Value:
 Value Percent:
 Continuous Index:
 Within 8" of Joint: **YES**
 Remarks:

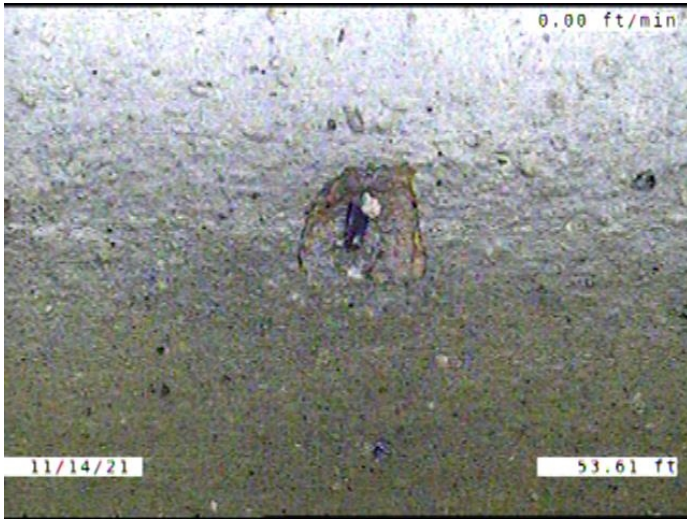
Code: **SSS**
Description: **Surface Damage Surface Spalling**

Distance (ft): **53.6**
Structural Grade: **2**
O&M Grade: **0**
Clock Start/From: **12**
Clock To:
1st Value:
2nd Value:
Value Percent:
Continuous Index:
Within 8" of Joint: **NO**
Remarks:

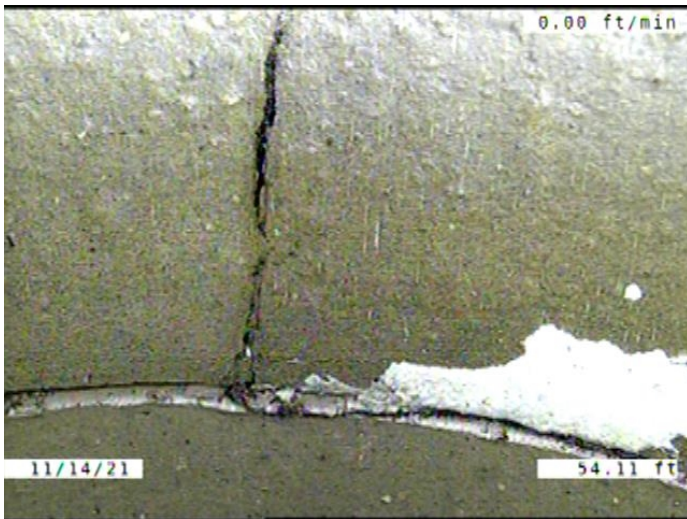
Code: **CM**
Description: **Crack Multiple**

Distance (ft): **54.1**
Structural Grade: **3**
O&M Grade: **0**
Clock Start/From: **2**
Clock To: **3**
1st Value:
2nd Value:
Value Percent:
Continuous Index:
Within 8" of Joint: **YES**
Remarks:

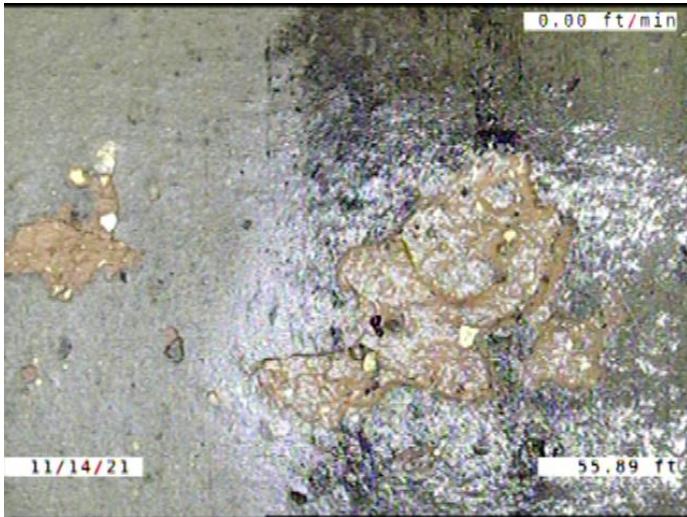
Code: **SSS**
Description: **Surface Damage Surface Spalling**

Distance (ft): **55.9**
Structural Grade: **2**
O&M Grade: **0**
Clock Start/From: **7**
Clock To: **8**
1st Value:
2nd Value:
Value Percent:
Continuous Index:
Within 8" of Joint: **NO**
Remarks:

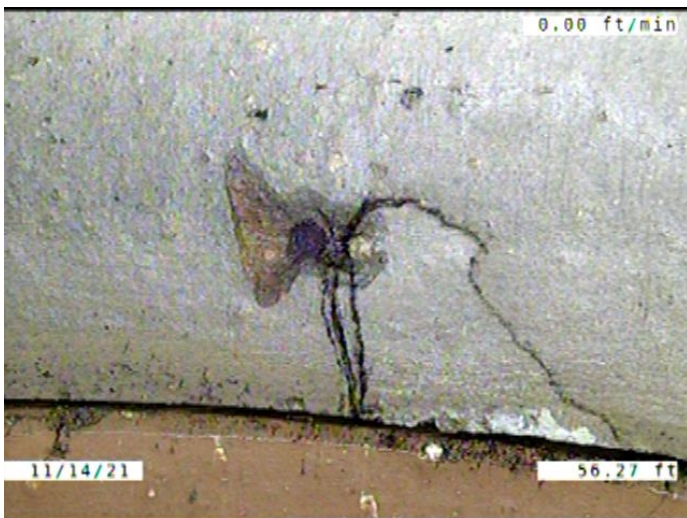
Code: **SSS**
Description: **Surface Damage Surface Spalling**

Distance (ft): **56.3**
Structural Grade: **2**
O&M Grade: **0**
Clock Start/From: **3**
Clock To:
1st Value:
2nd Value:
Value Percent:
Continuous Index:
Within 8" of Joint: **YES**
Remarks:

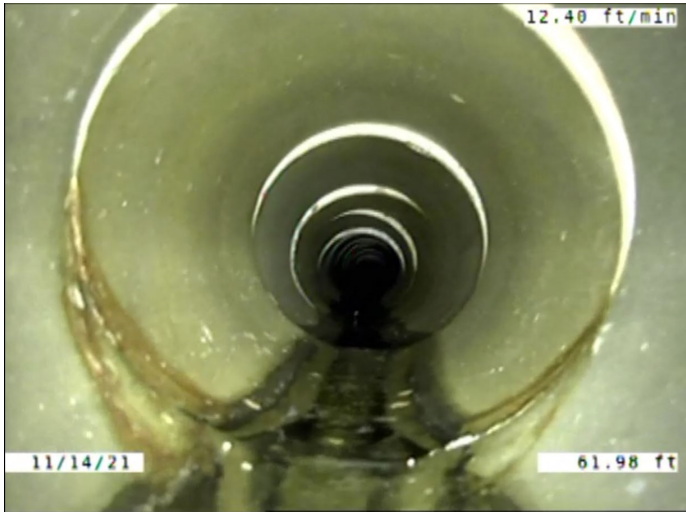
Code: **IS**
Description: **Infiltration Stain**

Distance (ft): **61.9**
Structural Grade: **0**
O&M Grade: **1**
Clock Start/From: **7**
Clock To: **9**
1st Value:
2nd Value:
Value Percent:
Continuous Index:
Within 8" of Joint: **YES**
Remarks:

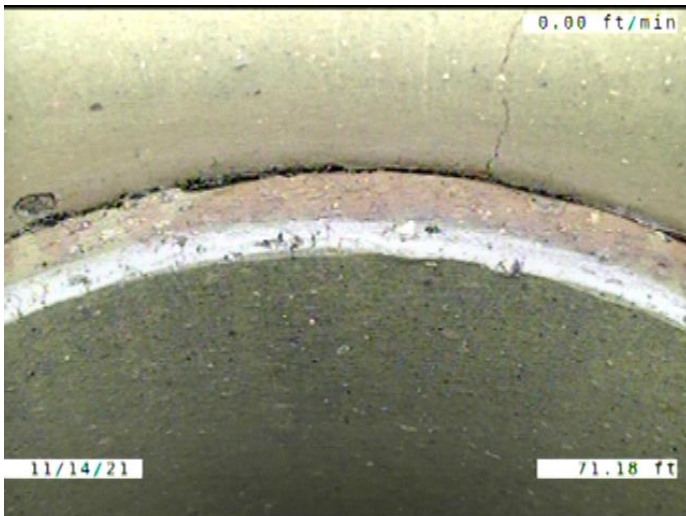
Code: **JOM**
Description: **Joint Offset Medium**

Distance (ft): **71.2**
Structural Grade: **3**
O&M Grade: **0**
Clock Start/From:
Clock To:
1st Value:
2nd Value:
Value Percent:
Continuous Index:
Within 8" of Joint: **NO**
Remarks:

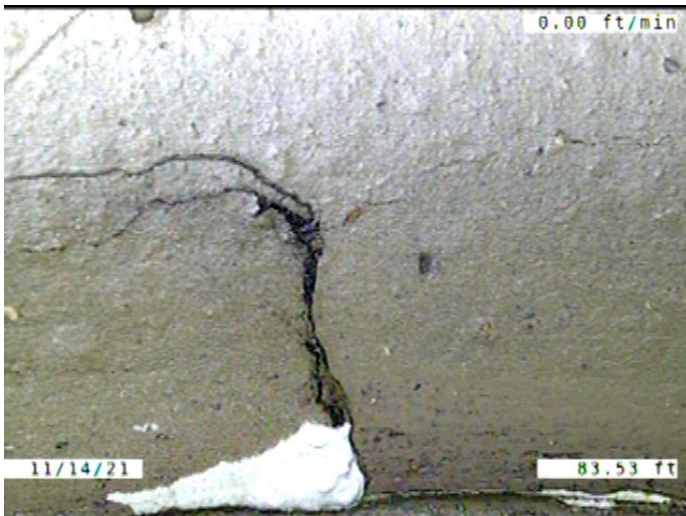
Code: **CM**
Description: **Crack Multiple**

Distance (ft): **83.5**
Structural Grade: **3**
O&M Grade: **0**
Clock Start/From: **9**
Clock To: **12**
1st Value:
2nd Value:
Value Percent:
Continuous Index:
Within 8" of Joint: **YES**
Remarks:

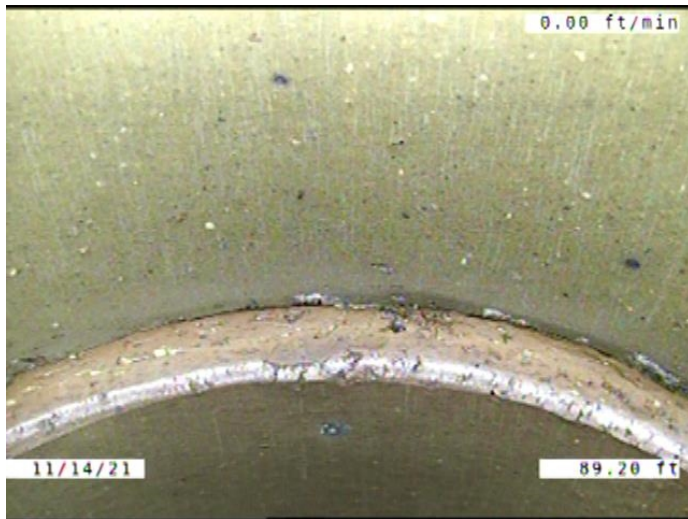
Code: **JOM**
 Description: **Joint Offset Medium**

Distance (ft): **89.2**
 Structural Grade: **3**
 O&M Grade: **0**
 Clock Start/From:
 Clock To:
 1st Value:
 2nd Value:
 Value Percent:
 Continuous Index:
 Within 8" of Joint: **NO**
 Remarks:

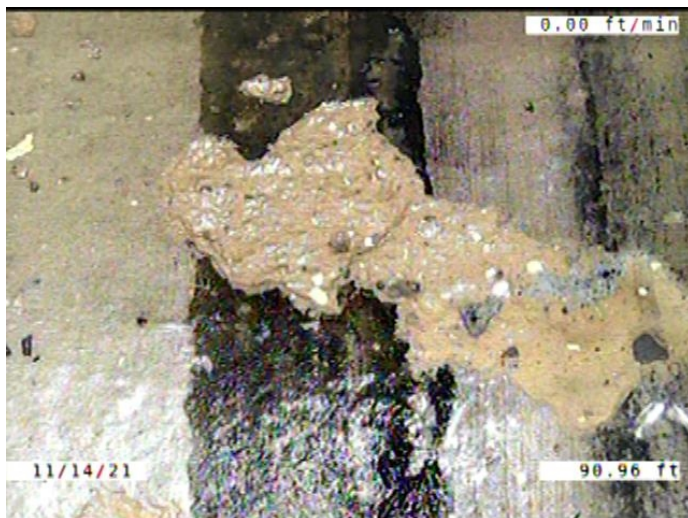
Code: **SSS**
 Description: **Surface Damage Surface Spalling**

Distance (ft): **91.0**
 Structural Grade: **2**
 O&M Grade: **0**
 Clock Start/From: **6**
 Clock To: **8**
 1st Value:
 2nd Value:
 Value Percent:
 Continuous Index:
 Within 8" of Joint: **NO**
 Remarks:

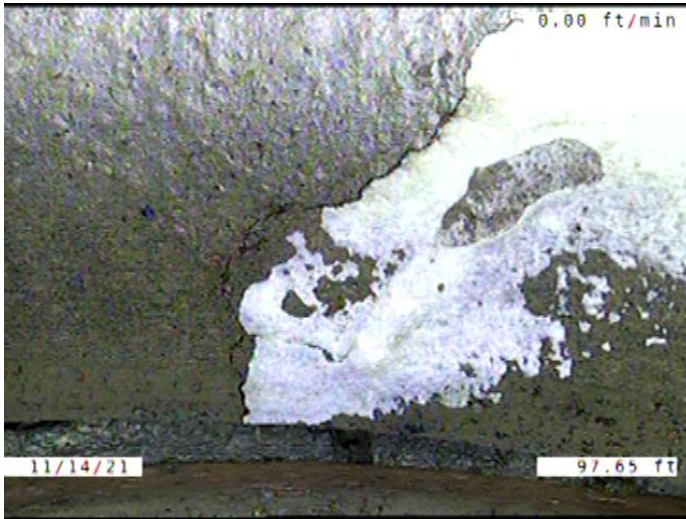
Code: **CM**
Description: **Crack Multiple**

Distance (ft): **97.6**
Structural Grade: **3**
O&M Grade: **0**
Clock Start/From: **2**
Clock To: **3**
1st Value:
2nd Value:
Value Percent:
Continuous Index:
Within 8" of Joint: **YES**
Remarks:

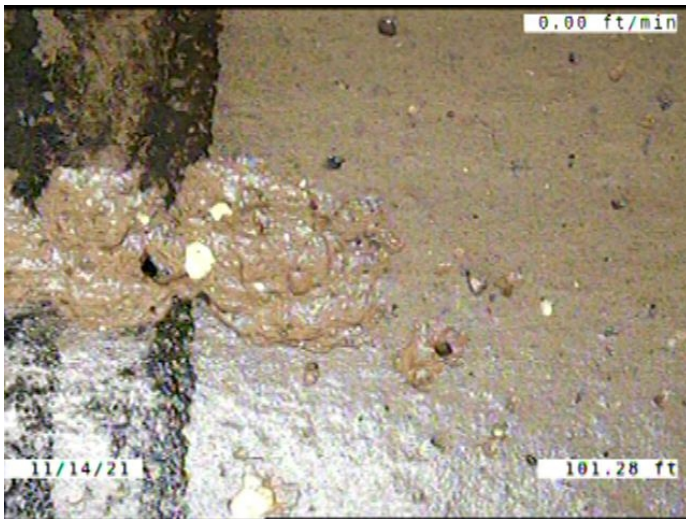
Code: **SSS**
Description: **Surface Damage Surface Spalling**

Distance (ft): **101.3**
Structural Grade: **2**
O&M Grade: **0**
Clock Start/From: **12**
Clock To: **12**
1st Value:
2nd Value:
Value Percent:
Continuous Index: **S04**
Within 8" of Joint: **YES**
Remarks:

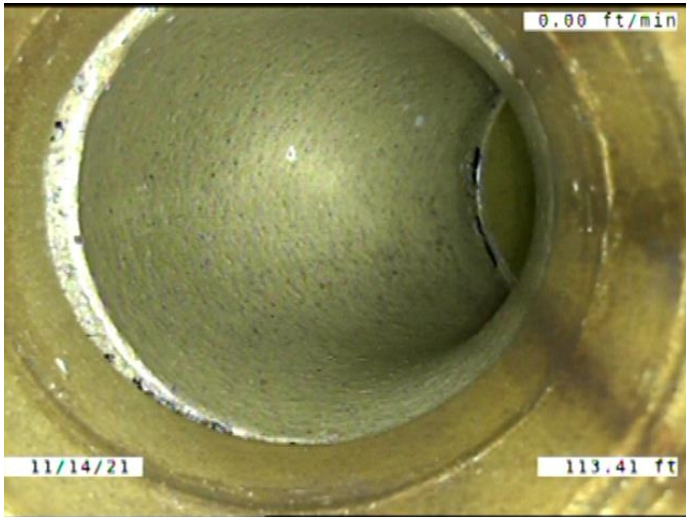
Code: **TBI**
 Description: **Tap Break-in Intruding**

Distance (ft): **113.4**
 Structural Grade: **0**
 O&M Grade: **2**
 Clock Start/From: **1**
 Clock To:
 1st Value: **6.000**
 2nd Value: **1.000**
 Value Percent:
 Continuous Index:
 Within 8" of Joint: **YES**
 Remarks:

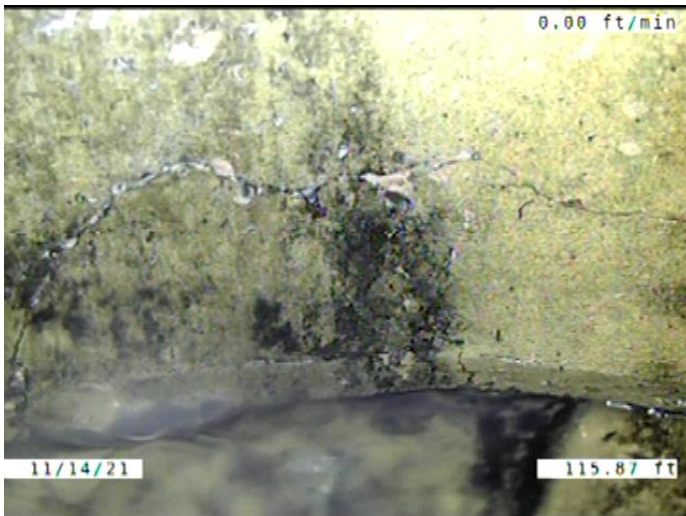
Code: **FM**
 Description: **Fracture Multiple**

Distance (ft): **115.9**
 Structural Grade: **4**
 O&M Grade: **0**
 Clock Start/From: **6**
 Clock To: **10**
 1st Value:
 2nd Value:
 Value Percent:
 Continuous Index:
 Within 8" of Joint: **YES**
 Remarks:

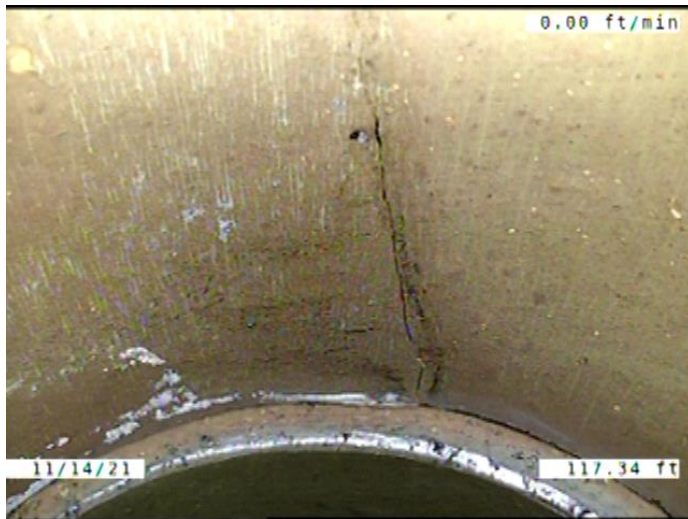
Code: **CM**
Description: **Crack Multiple**

Distance (ft): **117.3**
Structural Grade: **3**
O&M Grade: **0**
Clock Start/From: **10**
Clock To: **12**
1st Value:
2nd Value:
Value Percent:
Continuous Index:
Within 8" of Joint: **YES**
Remarks:

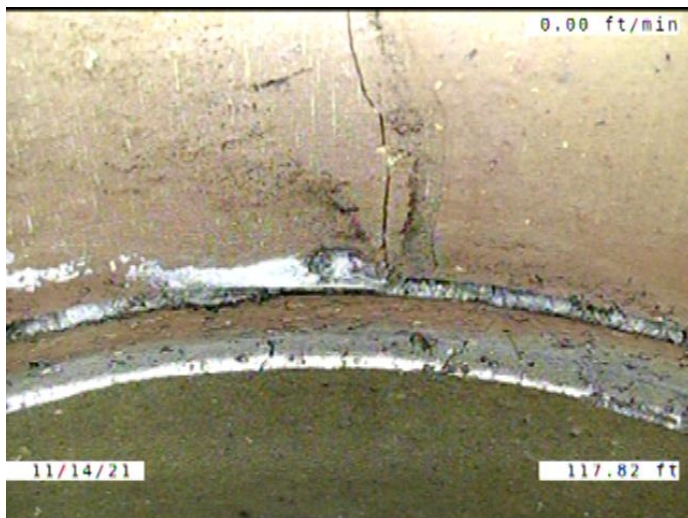
Code: **JOM**
Description: **Joint Offset Medium**

Distance (ft): **117.8**
Structural Grade: **3**
O&M Grade: **0**
Clock Start/From:
Clock To:
1st Value:
2nd Value:
Value Percent:
Continuous Index:
Within 8" of Joint: **NO**
Remarks:

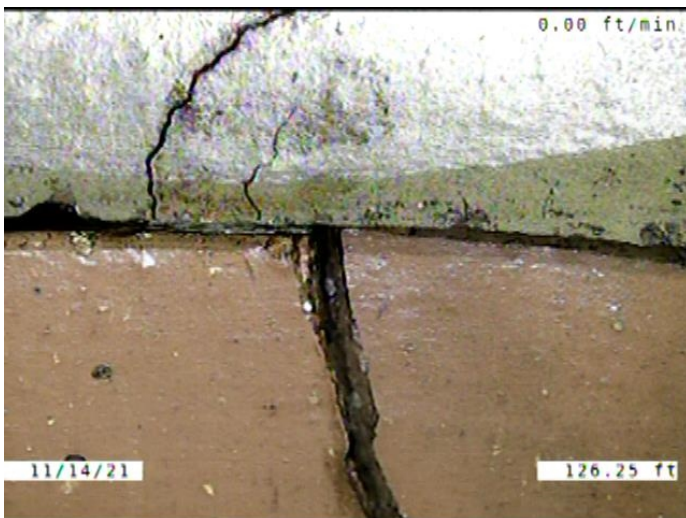
Code: **B**
Description: **Broken**

Distance (ft): **126.2**
Structural Grade: **4**
O&M Grade: **0**
Clock Start/From: **4**
Clock To: **9**
1st Value:
2nd Value:
Value Percent:
Continuous Index:
Within 8" of Joint: **YES**
Remarks:

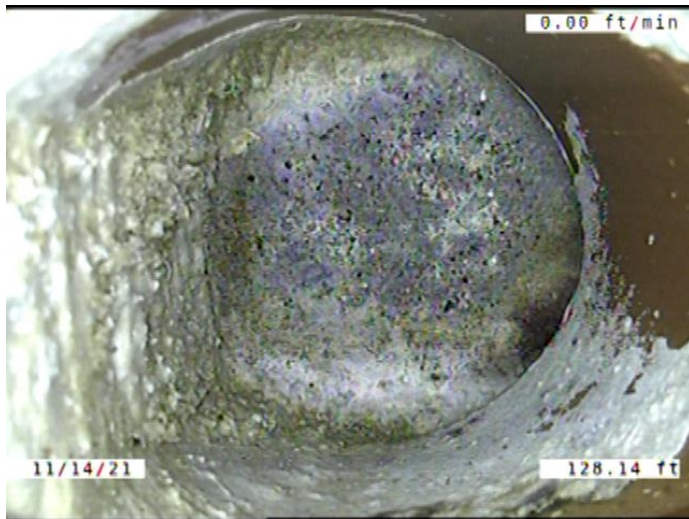
Code: **TFD**
Description: **Tap Factory Defective**

Distance (ft): **128.1**
Structural Grade: **0**
O&M Grade: **3**
Clock Start/From: **10**
Clock To:
1st Value: **4.000**
2nd Value:
Value Percent:
Continuous Index:
Within 8" of Joint: **YES**
Remarks: **CAPPED. ENCRUSTATION AROUND THE CAP.**

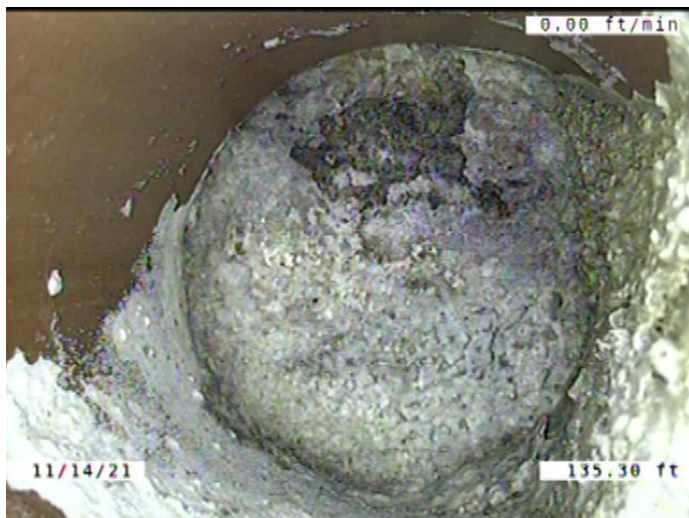
Code: **TFD**
Description: **Tap Factory Defective**

Distance (ft): **135.3**
Structural Grade: **0**
O&M Grade: **3**
Clock Start/From: **2**
Clock To:
1st Value: **4.000**
2nd Value:
Value Percent:
Continuous Index:
Within 8" of Joint: **YES**
Remarks: **CAPPED. ENCRUSTATION AROUND THE CAP.**

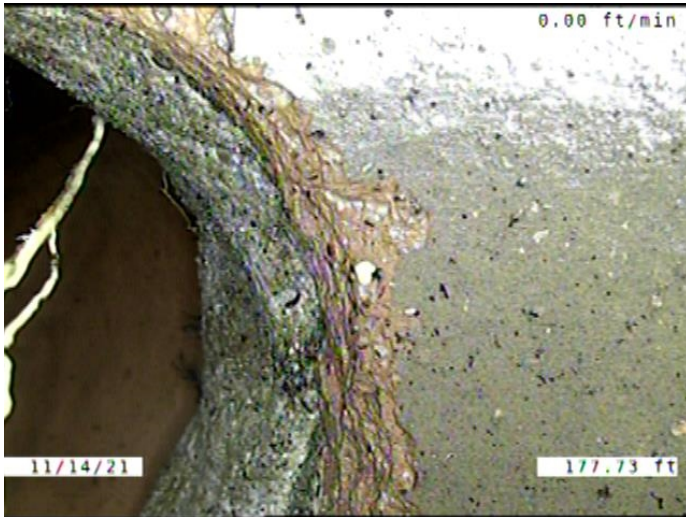
Code: **SSS**
 Description: **Surface Damage Surface Spalling**

Distance (ft): **177.7**
 Structural Grade: **2**
 O&M Grade: **0**
 Clock Start/From: **10**
 Clock To: **12**
 1st Value:
 2nd Value:
 Value Percent:
 Continuous Index:
 Within 8" of Joint: **YES**
 Remarks:

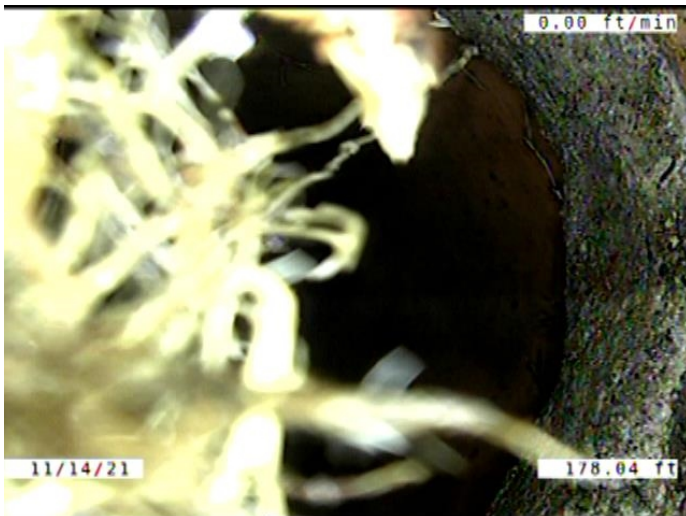
Code: **TBD**
 Description: **Tap Break-in/Hammer Defective**

Distance (ft): **178.0**
 Structural Grade: **0**
 O&M Grade: **3**
 Clock Start/From: **11**
 Clock To:
 1st Value: **4.000**
 2nd Value:
 Value Percent:
 Continuous Index:
 Within 8" of Joint: **YES**
 Remarks: **ROOTS GROWING FROM THE TAP CONNECTION**

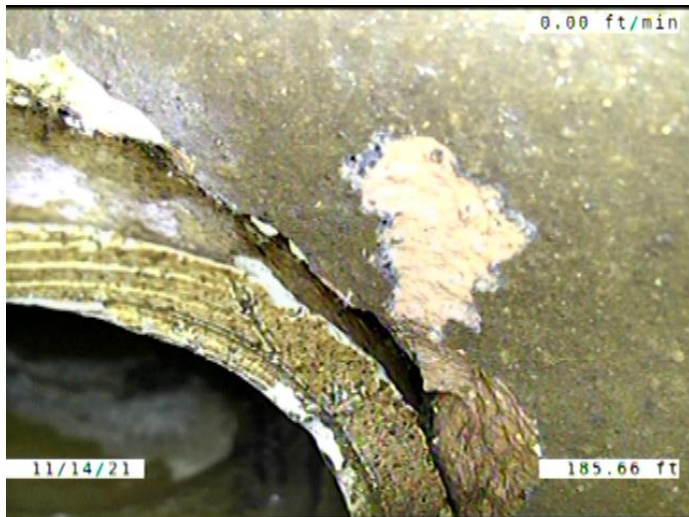
Code: **B**
 Description: **Broken**

Distance (ft): **185.7**
 Structural Grade: **4**
 O&M Grade: **0**
 Clock Start/From: **12**
 Clock To: **3**
 1st Value:
 2nd Value:
 Value Percent:
 Continuous Index:
 Within 8" of Joint: **YES**
 Remarks:

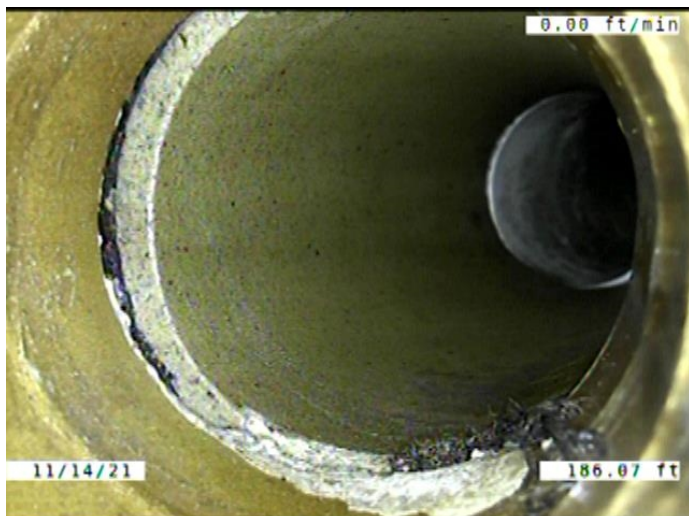
Code: **TBI**
 Description: **Tap Break-in Intruding**

Distance (ft): **186.1**
 Structural Grade: **0**
 O&M Grade: **2**
 Clock Start/From: **2**
 Clock To:
 1st Value: **6.000**
 2nd Value: **3.000**
 Value Percent:
 Continuous Index:
 Within 8" of Joint: **YES**
 Remarks: **CONSTANTLY RUNNING WATER.
 ROOTS GROWING FROM THE JOINT.**

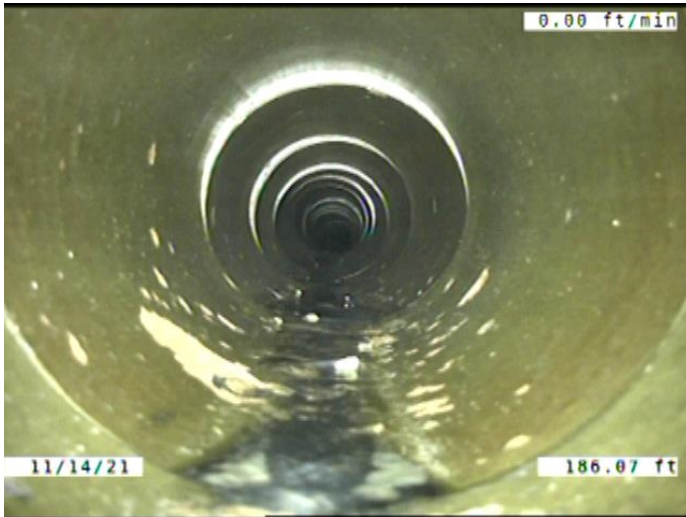
Code: **DAE**
Description: **Deposits Attached Encrustation**

Distance (ft): **186.1**
Structural Grade: **0**
O&M Grade: **2**
Clock Start/From: **9**
Clock To: **4**
1st Value:
2nd Value:
Value Percent: **5.000**
Continuous Index: **F03**
Within 8" of Joint: **YES**
Remarks:

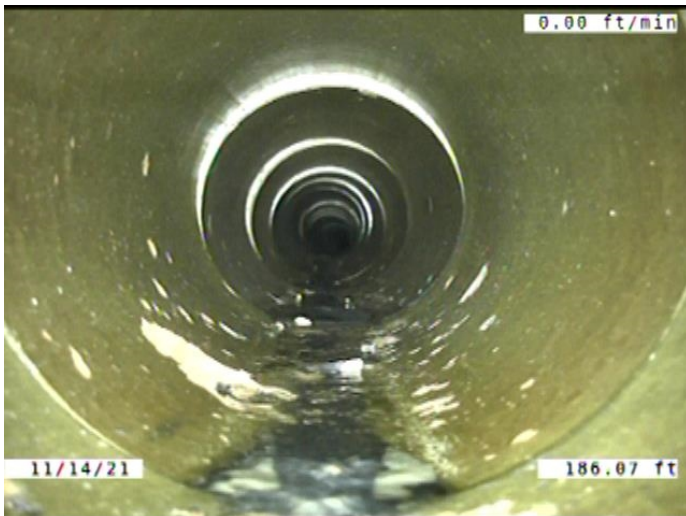
Code: **SSS**
Description: **Surface Damage Surface Spalling**

Distance (ft): **186.1**
Structural Grade: **2**
O&M Grade: **0**
Clock Start/From: **12**
Clock To: **12**
1st Value:
2nd Value:
Value Percent:
Continuous Index: **F04**
Within 8" of Joint: **YES**
Remarks:
