Profile/Photo Observation Report

Date:	11/14/2021	Weather:		Coding:	PACP 7.0
Pipe Length (ft):	273.0	Owner:	City of Hobart	Pre Clean:	Heavy Cleaning
P.O.#:	YES502259	Surveyor:	S. Bucklin	PSR:	P-604-003-002
Customer:	City of Hobart	Clean Date:	11/13/2021	Shape:	C

Street:	West Cleveland Avenue	Flow Control:	Not Controlled
City:	Hobart, IN	Year Renewed:	
Location:	Local rural streets with light traffic, t	Tape/Media #:	
Purpose:	Routine Assessment	Dia/Height:	10"
Use:	Sanitary Sewage Pipe	Material:	VCP
Drain Area:		Lining:	None
Category:	NA		
Comment:			
Location Details:		Direction of Survey:	Upstream
US MH:	M-604-003	DS MH:	M-604-002
		Total Length Surveyed (ft):	186.6

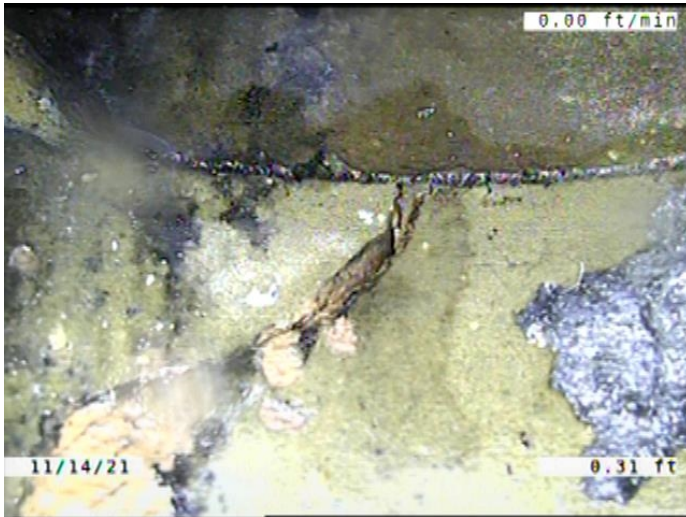
Code: **B**
 Description: **Broken**

Distance (ft): **.3**
 Structural Grade: **4**
 O&M Grade: **0**
 Clock Start/From: **4**
 Clock To: **8**
 1st Value:
 2nd Value:
 Value Percent:
 Continuous Index:
 Within 8" of Joint: **YES**
 Remarks:

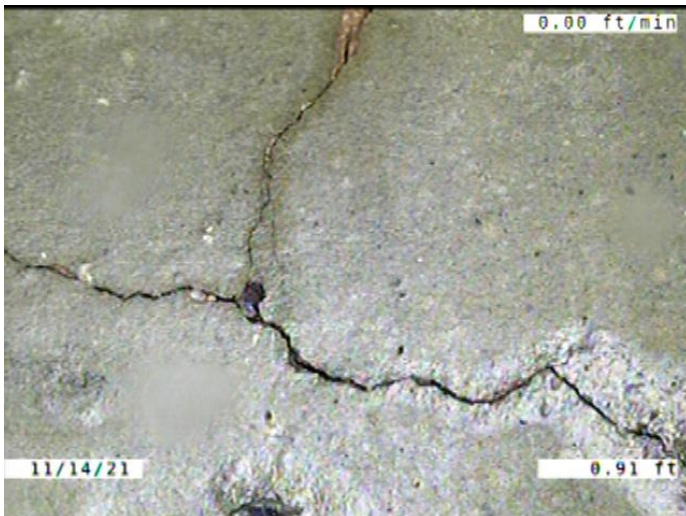
Code: **FM**
 Description: **Fracture Multiple**

Distance (ft): **.9**
 Structural Grade: **4**
 O&M Grade: **0**
 Clock Start/From: **12**
 Clock To: **12**
 1st Value:
 2nd Value:
 Value Percent:
 Continuous Index:
 Within 8" of Joint: **YES**
 Remarks:

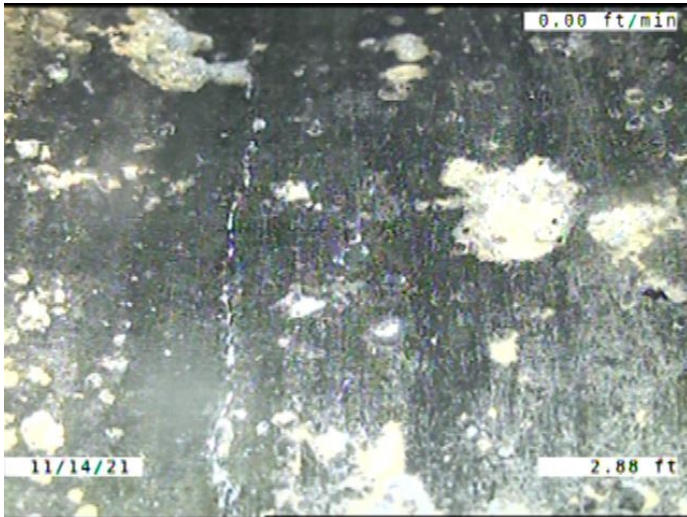
Code: **CM**
 Description: **Crack Multiple**

Distance (ft): **2.9**
 Structural Grade: **3**
 O&M Grade: **0**
 Clock Start/From: **5**
 Clock To: **7**
 1st Value:
 2nd Value:
 Value Percent:
 Continuous Index: **S01**
 Within 8" of Joint: **YES**
 Remarks:

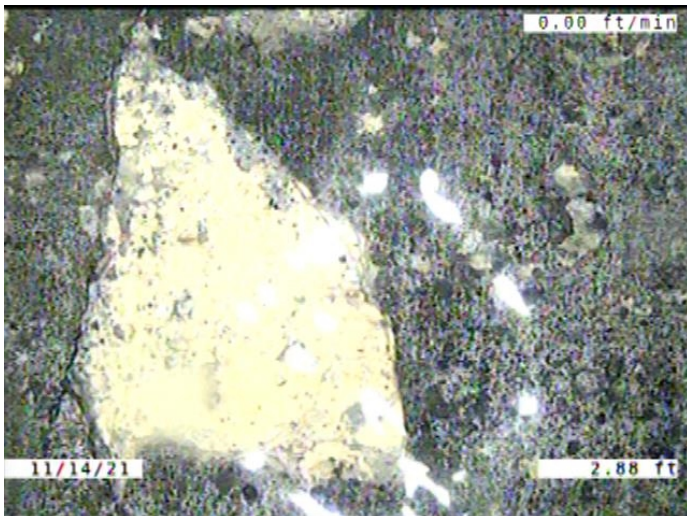
Code: **SSS**
 Description: **Surface Damage Surface Spalling**

Distance (ft): **2.9**
 Structural Grade: **2**
 O&M Grade: **0**
 Clock Start/From: **4**
 Clock To: **9**
 1st Value:
 2nd Value:
 Value Percent:
 Continuous Index:
 Within 8" of Joint: **YES**
 Remarks:

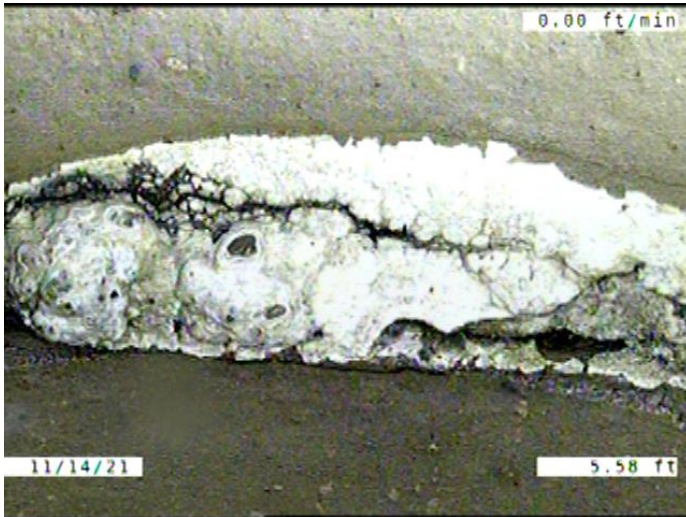
Code: **DAE**
 Description: **Deposits Attached Encrustation**

Distance (ft): **5.6**
 Structural Grade: **0**
 O&M Grade: **2**
 Clock Start/From: **9**
 Clock To: **4**
 1st Value:
 2nd Value:
 Value Percent: **5.000**
 Continuous Index: **S03**
 Within 8" of Joint: **YES**
 Remarks:

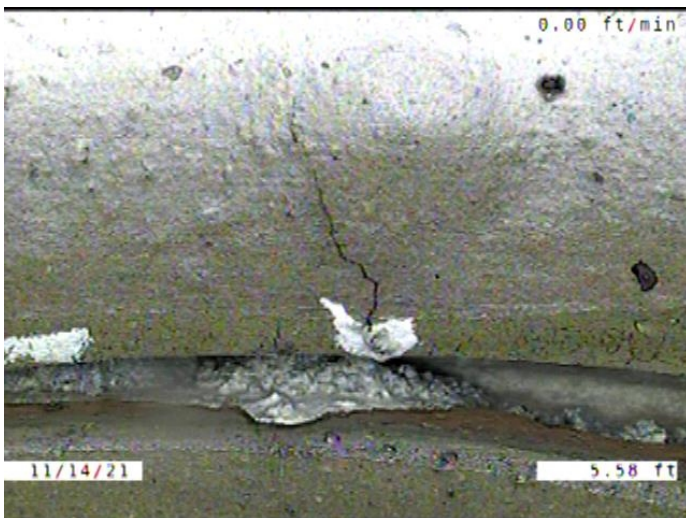
Code: **CL**
 Description: **Crack Longitudinal**

Distance (ft): **5.6**
 Structural Grade: **2**
 O&M Grade: **0**
 Clock Start/From: **12**
 Clock To:
 1st Value:
 2nd Value:
 Value Percent:
 Continuous Index:
 Within 8" of Joint: **YES**
 Remarks:

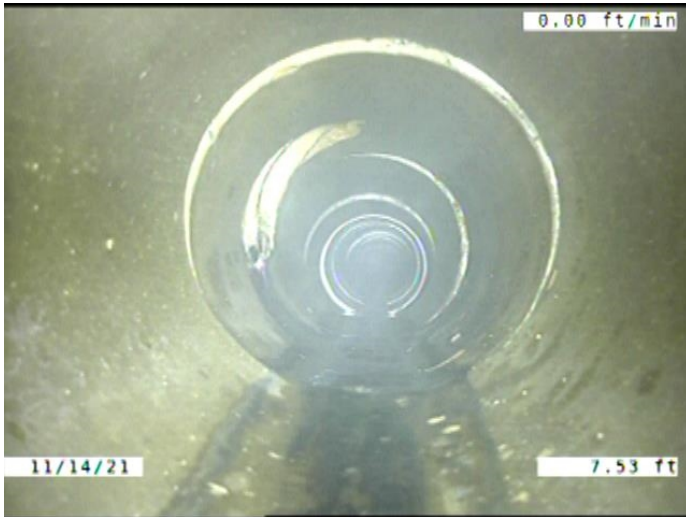
Code: **CM**
Description: **Crack Multiple**

Distance (ft): **7.5**
Structural Grade: **3**
O&M Grade: **0**
Clock Start/From: **5**
Clock To: **7**
1st Value:
2nd Value:
Value Percent:
Continuous Index: **F01**
Within 8" of Joint: **YES**
Remarks:

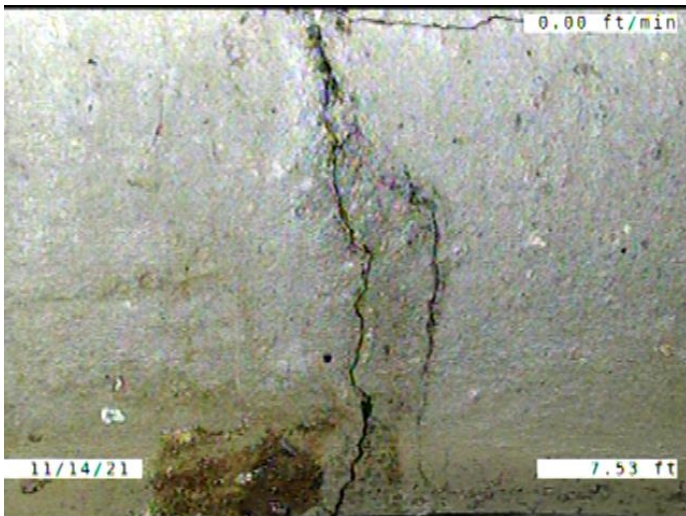
Code: **CM**
Description: **Crack Multiple**

Distance (ft): **7.5**
Structural Grade: **3**
O&M Grade: **0**
Clock Start/From: **12**
Clock To: **12**
1st Value:
2nd Value:
Value Percent:
Continuous Index: **S02**
Within 8" of Joint: **YES**
Remarks:

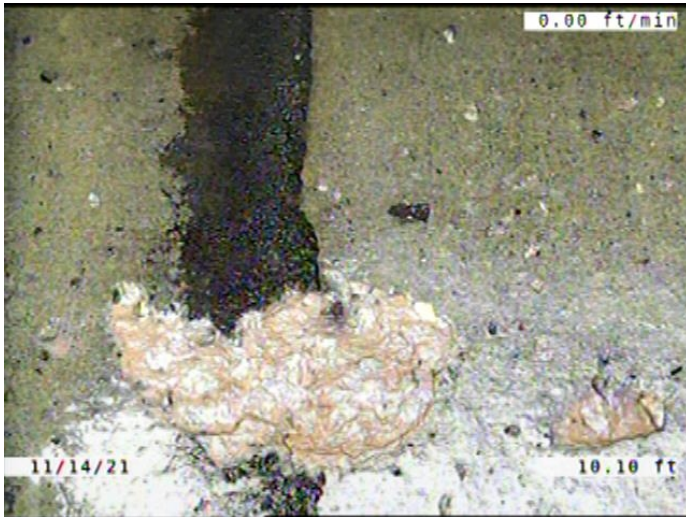
Code: **SSS**
Description: **Surface Damage Surface Spalling**

Distance (ft): **10.1**
Structural Grade: **2**
O&M Grade: **0**
Clock Start/From: **5**
Clock To:
1st Value:
2nd Value:
Value Percent:
Continuous Index:
Within 8" of Joint: **YES**
Remarks:

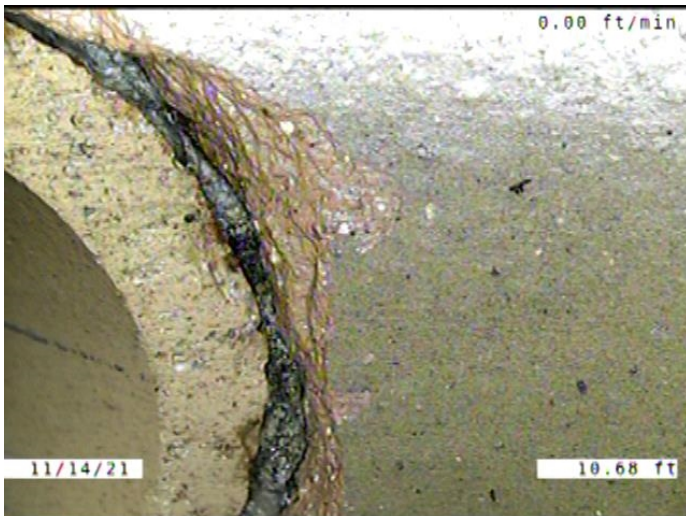
Code: **SSS**
Description: **Surface Damage Surface Spalling**

Distance (ft): **10.7**
Structural Grade: **2**
O&M Grade: **0**
Clock Start/From: **9**
Clock To: **12**
1st Value:
2nd Value:
Value Percent:
Continuous Index:
Within 8" of Joint: **YES**
Remarks:

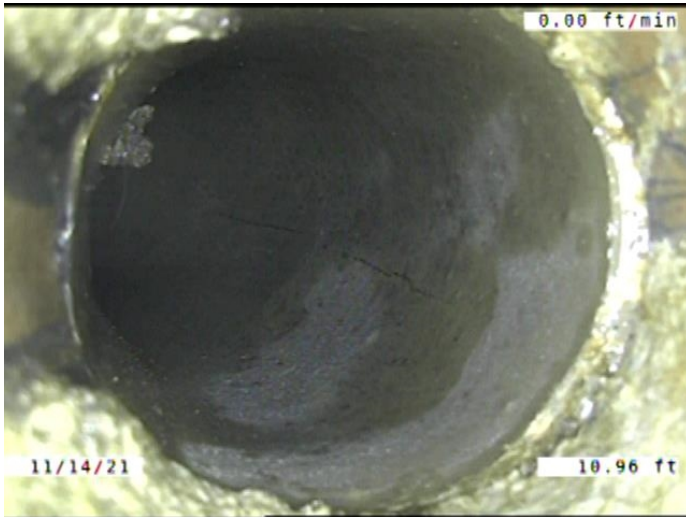
Code: **TBI**
Description: **Tap Break-in Intruding**

Distance (ft): **11.0**
Structural Grade: **0**
O&M Grade: **2**
Clock Start/From: **10**
Clock To:
1st Value: **6.000**
2nd Value: **1.000**
Value Percent:
Continuous Index:
Within 8" of Joint: **YES**
Remarks: **CONSTANTLY RUNNING WATER.**

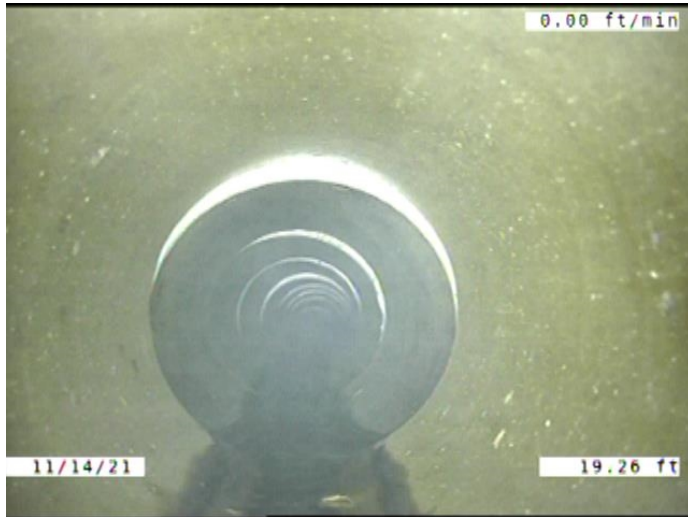
Code: **CM**
Description: **Crack Multiple**

Distance (ft): **19.3**
Structural Grade: **3**
O&M Grade: **0**
Clock Start/From: **12**
Clock To: **12**
1st Value:
2nd Value:
Value Percent:
Continuous Index: **F02**
Within 8" of Joint: **YES**
Remarks:

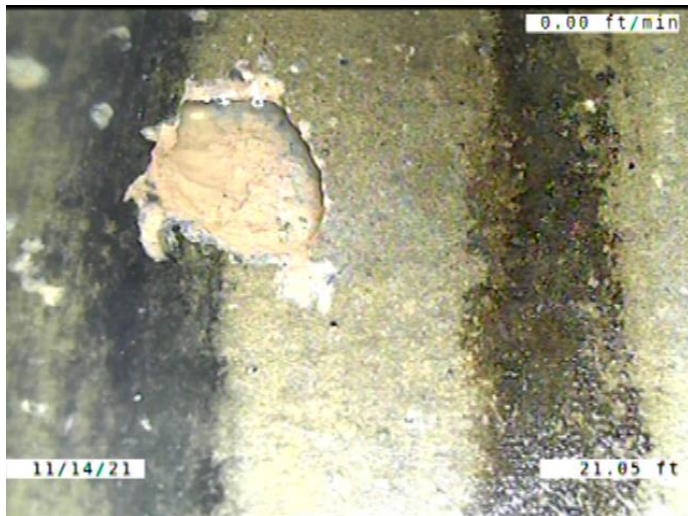
Code: **SSS**
Description: **Surface Damage Surface Spalling**

Distance (ft): **21.0**
Structural Grade: **2**
O&M Grade: **0**
Clock Start/From: **5**
Clock To:
1st Value:
2nd Value:
Value Percent:
Continuous Index:
Within 8" of Joint: **YES**
Remarks:

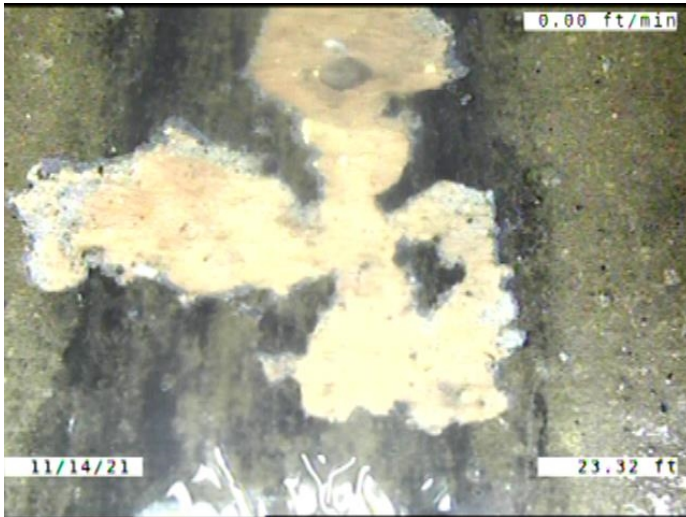
Code: **SSS**
Description: **Surface Damage Surface Spalling**

Distance (ft): **23.3**
Structural Grade: **2**
O&M Grade: **0**
Clock Start/From: **4**
Clock To: **6**
1st Value:
2nd Value:
Value Percent:
Continuous Index:
Within 8" of Joint: **YES**
Remarks:

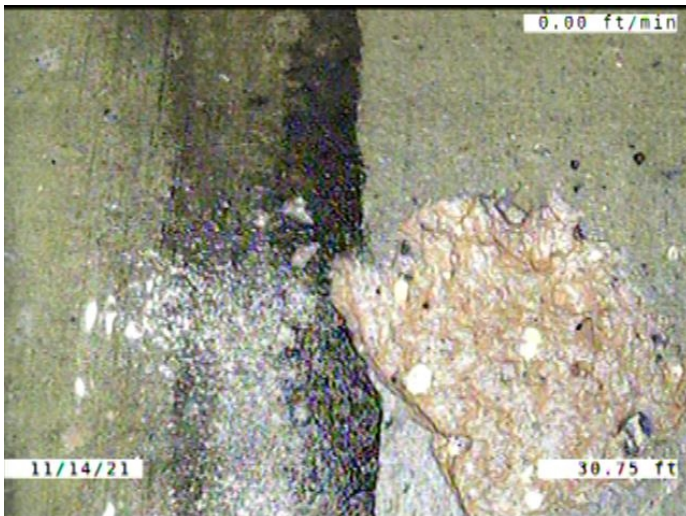
Code: **SSS**
Description: **Surface Damage Surface Spalling**

Distance (ft): **30.8**
Structural Grade: **2**
O&M Grade: **0**
Clock Start/From: **4**
Clock To: **8**
1st Value:
2nd Value:
Value Percent:
Continuous Index:
Within 8" of Joint: **YES**
Remarks:

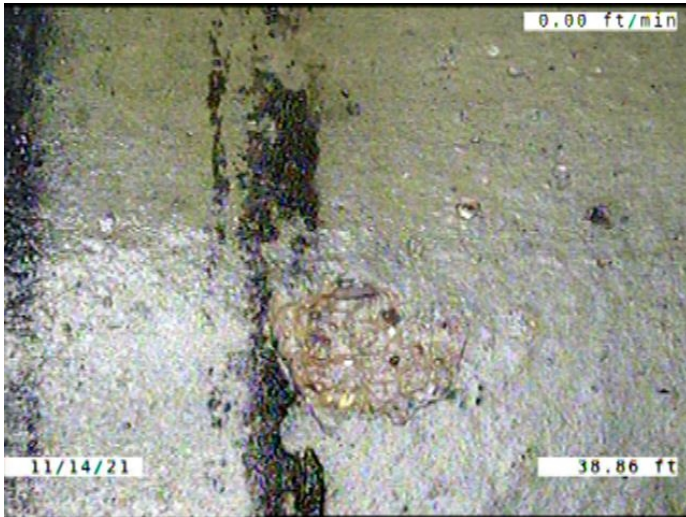
Code: **SSS**
 Description: **Surface Damage Surface Spalling**

Distance (ft): **38.9**
 Structural Grade: **2**
 O&M Grade: **0**
 Clock Start/From: **4**
 Clock To: **5**
 1st Value:
 2nd Value:
 Value Percent:
 Continuous Index:
 Within 8" of Joint: **NO**
 Remarks:

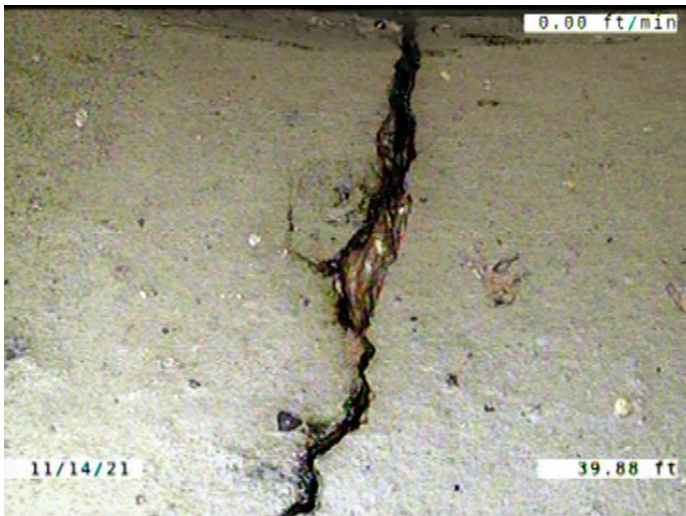
Code: **FM**
 Description: **Fracture Multiple**

Distance (ft): **39.9**
 Structural Grade: **4**
 O&M Grade: **0**
 Clock Start/From: **4**
 Clock To: **8**
 1st Value:
 2nd Value:
 Value Percent:
 Continuous Index:
 Within 8" of Joint: **YES**
 Remarks:

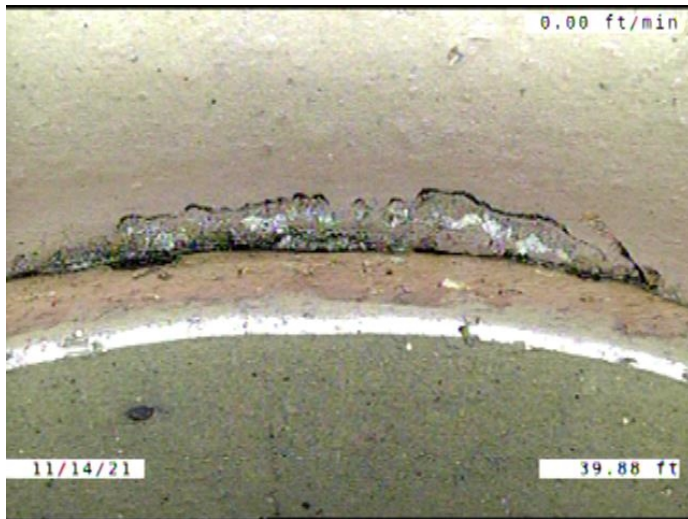
Code: **JOM**
 Description: **Joint Offset Medium**

Distance (ft): **39.9**
 Structural Grade: **3**
 O&M Grade: **0**
 Clock Start/From:
 Clock To:
 1st Value:
 2nd Value:
 Value Percent:
 Continuous Index:
 Within 8" of Joint: **NO**
 Remarks:

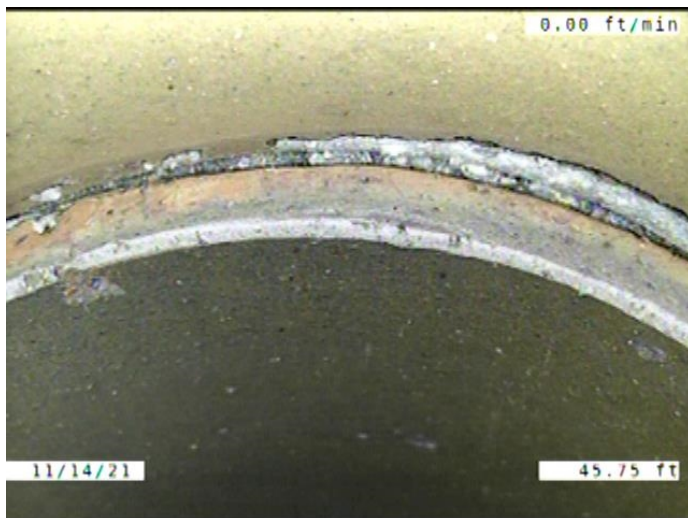
Code: **JOM**
 Description: **Joint Offset Medium**

Distance (ft): **45.8**
 Structural Grade: **3**
 O&M Grade: **0**
 Clock Start/From:
 Clock To:
 1st Value:
 2nd Value:
 Value Percent:
 Continuous Index:
 Within 8" of Joint: **NO**
 Remarks:

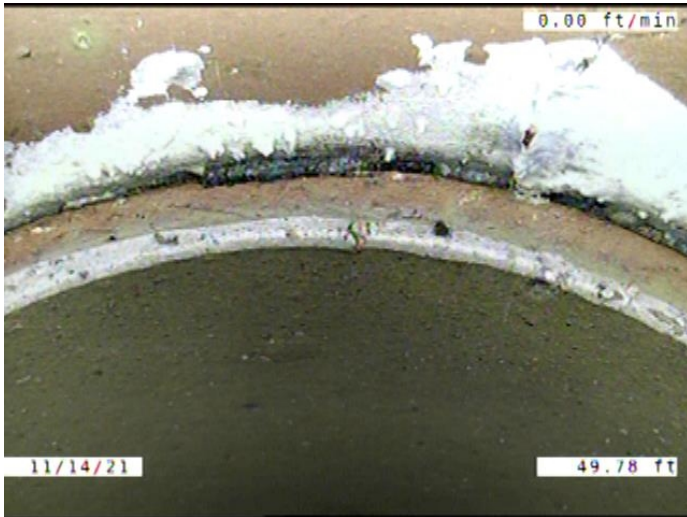
Code: **JOM**
 Description: **Joint Offset Medium**

Distance (ft): **49.8**
 Structural Grade: **3**
 O&M Grade: **0**
 Clock Start/From:
 Clock To:
 1st Value:
 2nd Value:
 Value Percent:
 Continuous Index:
 Within 8" of Joint: **NO**
 Remarks:

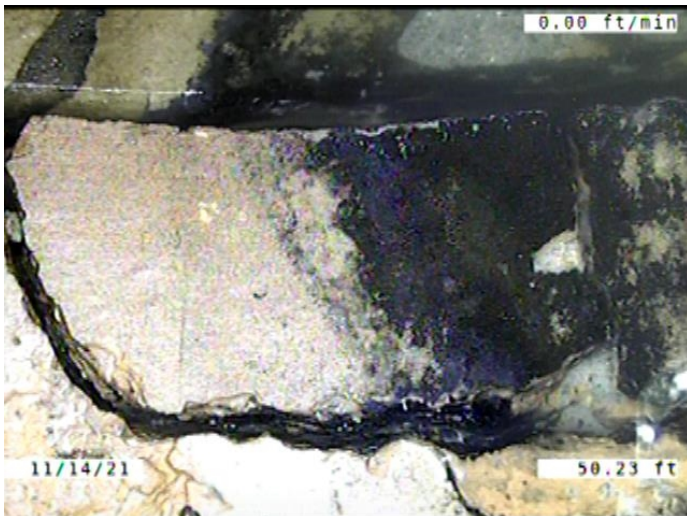
Code: **B**
 Description: **Broken**

Distance (ft): **50.2**
 Structural Grade: **4**
 O&M Grade: **0**
 Clock Start/From: **12**
 Clock To: **8**
 1st Value:
 2nd Value:
 Value Percent:
 Continuous Index:
 Within 8" of Joint: **YES**
 Remarks:

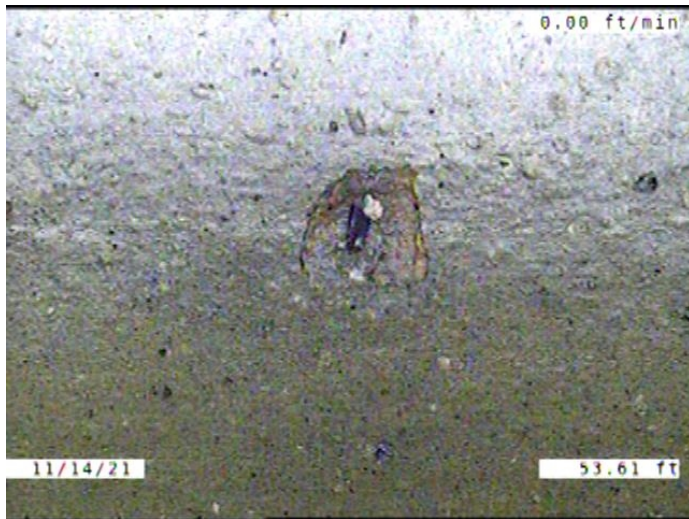
Code: **SSS**
Description: **Surface Damage Surface Spalling**

Distance (ft): **53.6**
Structural Grade: **2**
O&M Grade: **0**
Clock Start/From: **12**
Clock To:
1st Value:
2nd Value:
Value Percent:
Continuous Index:
Within 8" of Joint: **NO**
Remarks:

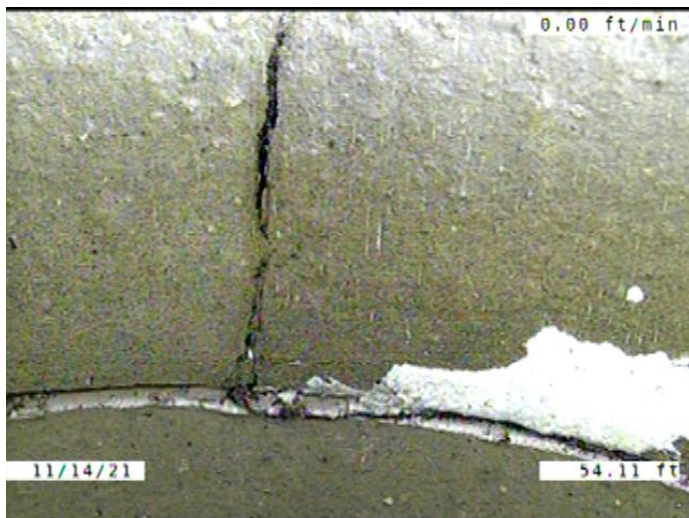
Code: **CM**
Description: **Crack Multiple**

Distance (ft): **54.1**
Structural Grade: **3**
O&M Grade: **0**
Clock Start/From: **2**
Clock To: **3**
1st Value:
2nd Value:
Value Percent:
Continuous Index:
Within 8" of Joint: **YES**
Remarks:

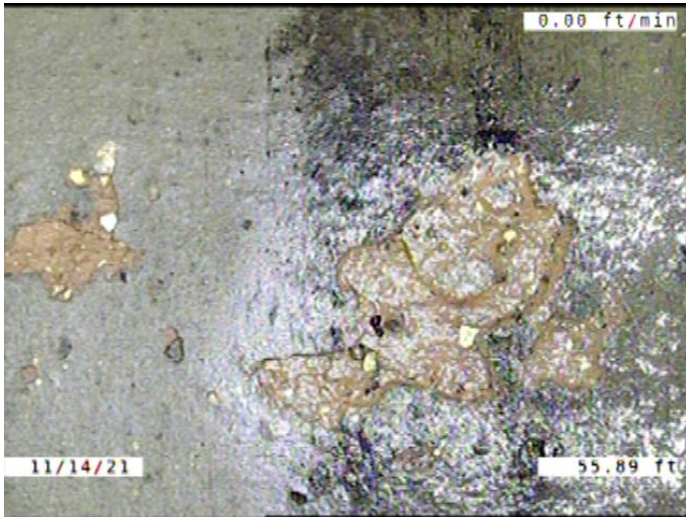
Code: **SSS**
 Description: **Surface Damage Surface Spalling**

Distance (ft): **55.9**
 Structural Grade: **2**
 O&M Grade: **0**
 Clock Start/From: **7**
 Clock To: **8**
 1st Value:
 2nd Value:
 Value Percent:
 Continuous Index:
 Within 8" of Joint: **NO**
 Remarks:

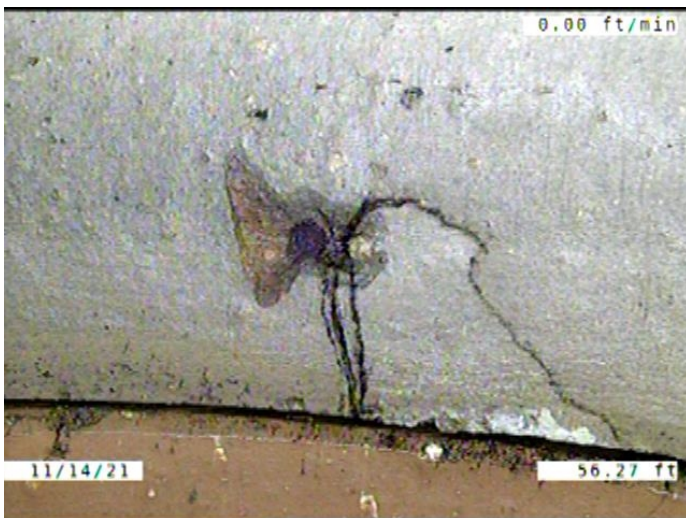
Code: **SSS**
 Description: **Surface Damage Surface Spalling**

Distance (ft): **56.3**
 Structural Grade: **2**
 O&M Grade: **0**
 Clock Start/From: **3**
 Clock To:
 1st Value:
 2nd Value:
 Value Percent:
 Continuous Index:
 Within 8" of Joint: **YES**
 Remarks:

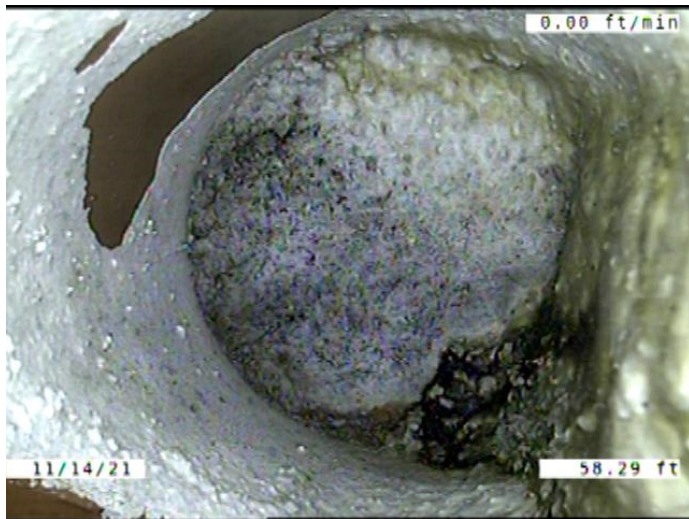
Code:	TFD
Description:	Tap Factory Defective
Distance (ft):	58.3
Structural Grade:	0
O&M Grade:	3
Clock Start/From:	2
Clock To:	
1st Value:	4.000
2nd Value:	
Value Percent:	
Continuous Index:	
Within 8" of Joint:	YES
Remarks:	CAPPED. ENCRUSTATION AROUND THE CAP

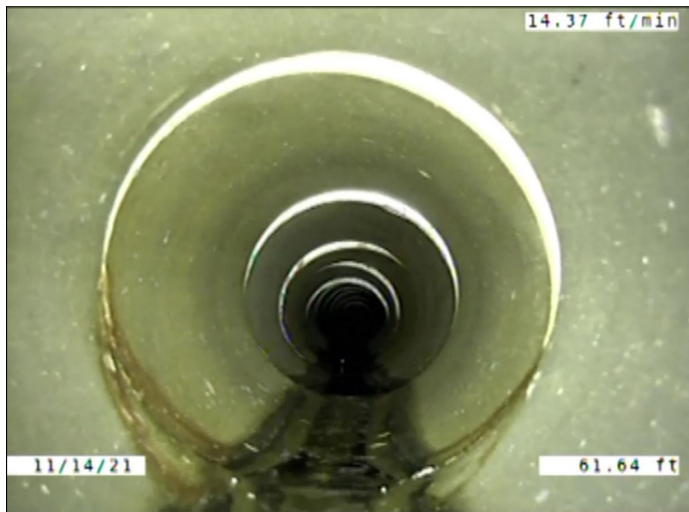
Code:	IS
Description:	Infiltration Stain
Distance (ft):	61.6
Structural Grade:	0
O&M Grade:	1
Clock Start/From:	4
Clock To:	5
1st Value:	
2nd Value:	
Value Percent:	
Continuous Index:	
Within 8" of Joint:	YES
Remarks:

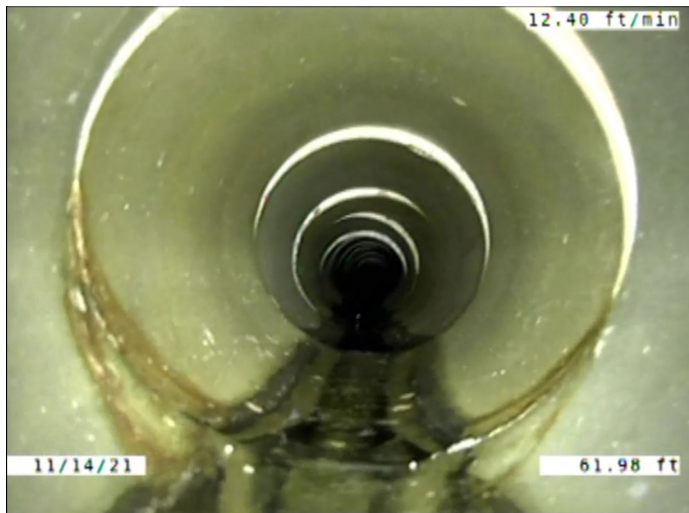
Code: **IS**
 Description: **Infiltration Stain**

Distance (ft): **61.9**
 Structural Grade: **0**
 O&M Grade: **1**
 Clock Start/From: **7**
 Clock To: **9**
 1st Value:
 2nd Value:
 Value Percent:
 Continuous Index:
 Within 8" of Joint: **YES**
 Remarks:

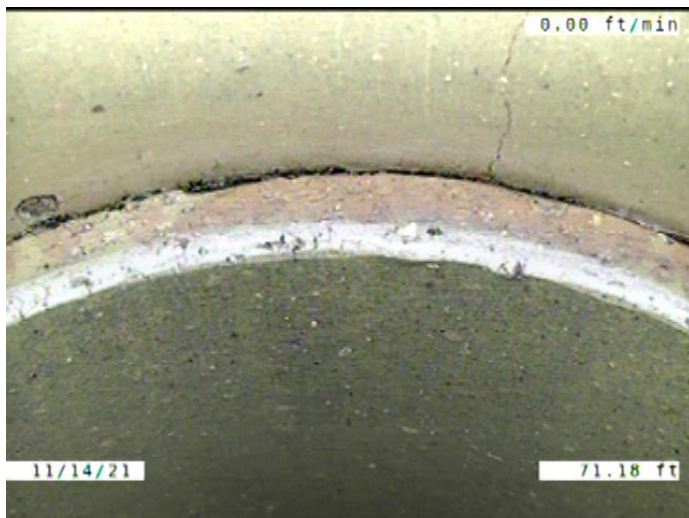
Code: **JOM**
 Description: **Joint Offset Medium**

Distance (ft): **71.2**
 Structural Grade: **3**
 O&M Grade: **0**
 Clock Start/From:
 Clock To:
 1st Value:
 2nd Value:
 Value Percent:
 Continuous Index:
 Within 8" of Joint: **NO**
 Remarks:

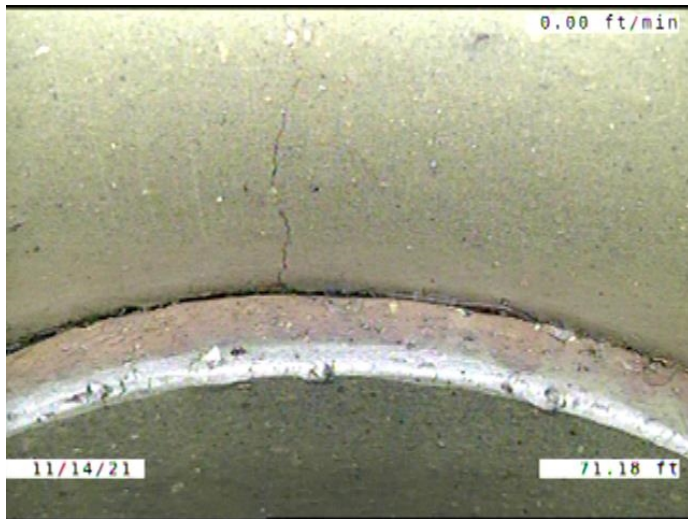
Code: **CL**
 Description: **Crack Longitudinal**

Distance (ft): **71.2**
 Structural Grade: **2**
 O&M Grade: **0**
 Clock Start/From: **1**
 Clock To:
 1st Value:
 2nd Value:
 Value Percent:
 Continuous Index:
 Within 8" of Joint: **YES**
 Remarks:

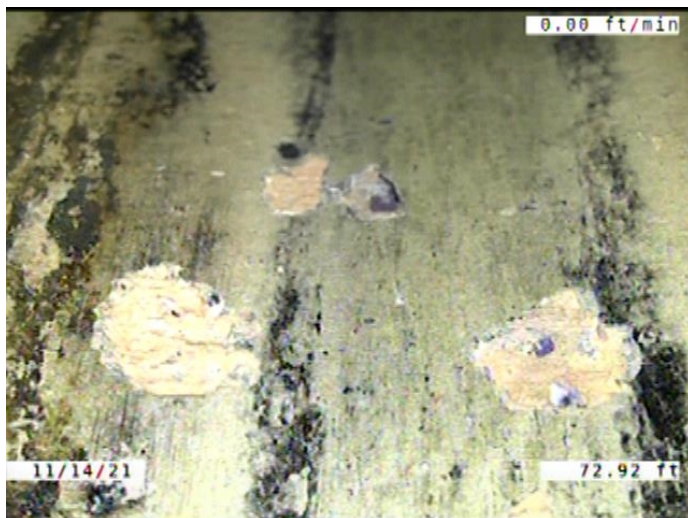
Code: **SSS**
 Description: **Surface Damage Surface Spalling**

Distance (ft): **72.9**
 Structural Grade: **2**
 O&M Grade: **0**
 Clock Start/From: **5**
 Clock To: **7**
 1st Value:
 2nd Value:
 Value Percent:
 Continuous Index:
 Within 8" of Joint: **YES**
 Remarks:

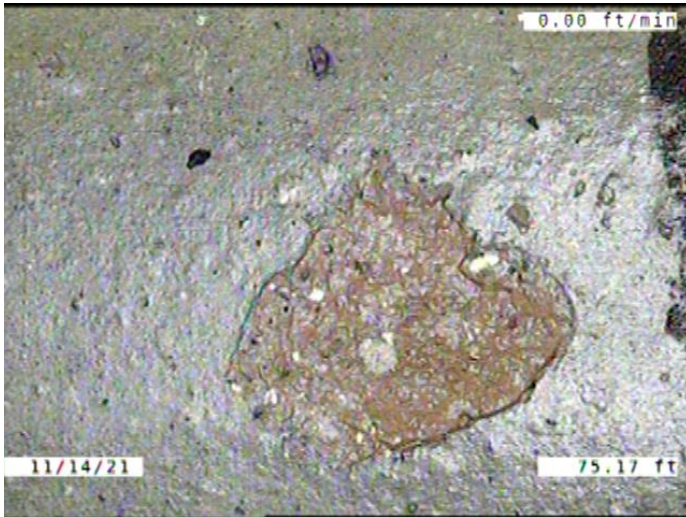
Code:	SSS
Description:	Surface Damage Surface Spalling
Distance (ft):	75.2
Structural Grade:	2
O&M Grade:	0
Clock Start/From:	8
Clock To:	
1st Value:	
2nd Value:	
Value Percent:	
Continuous Index:	
Within 8" of Joint:	YES
Remarks:

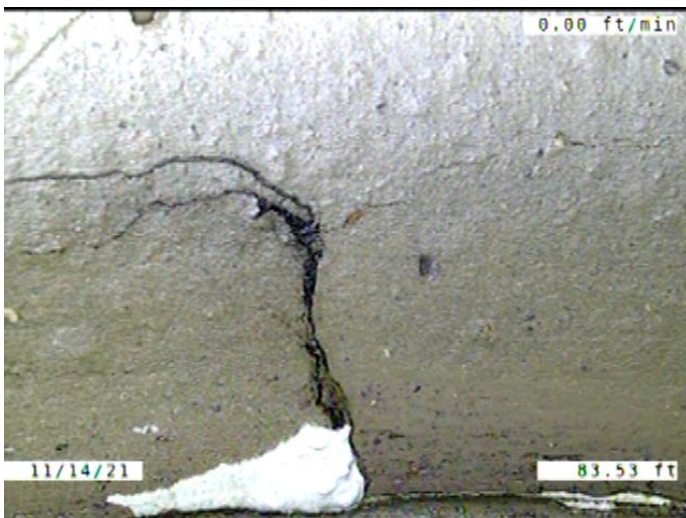
Code:	CM
Description:	Crack Multiple
Distance (ft):	83.5
Structural Grade:	3
O&M Grade:	0
Clock Start/From:	9
Clock To:	12
1st Value:	
2nd Value:	
Value Percent:	
Continuous Index:	
Within 8" of Joint:	YES
Remarks:

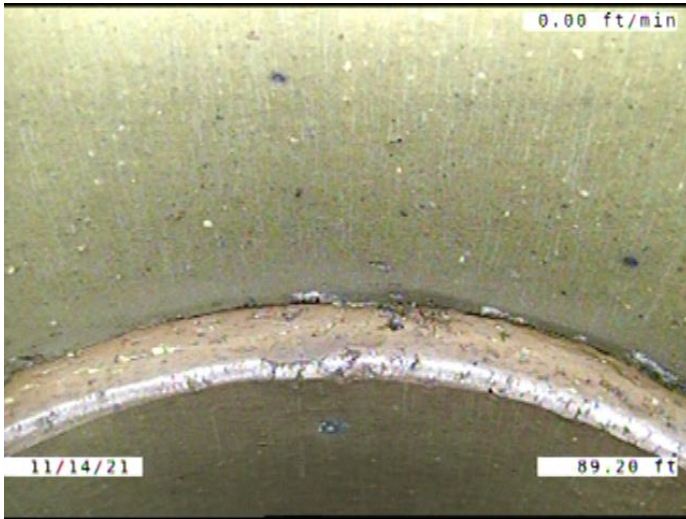
Code: **JOM**
 Description: **Joint Offset Medium**

Distance (ft): **89.2**
 Structural Grade: **3**
 O&M Grade: **0**
 Clock Start/From:
 Clock To:
 1st Value:
 2nd Value:
 Value Percent:
 Continuous Index:
 Within 8" of Joint: **NO**
 Remarks:

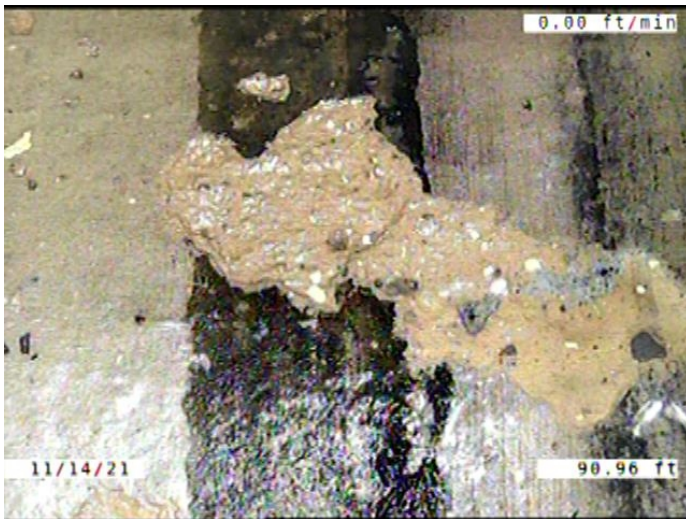
Code: **SSS**
 Description: **Surface Damage Surface Spalling**

Distance (ft): **91.0**
 Structural Grade: **2**
 O&M Grade: **0**
 Clock Start/From: **6**
 Clock To: **8**
 1st Value:
 2nd Value:
 Value Percent:
 Continuous Index:
 Within 8" of Joint: **NO**
 Remarks:

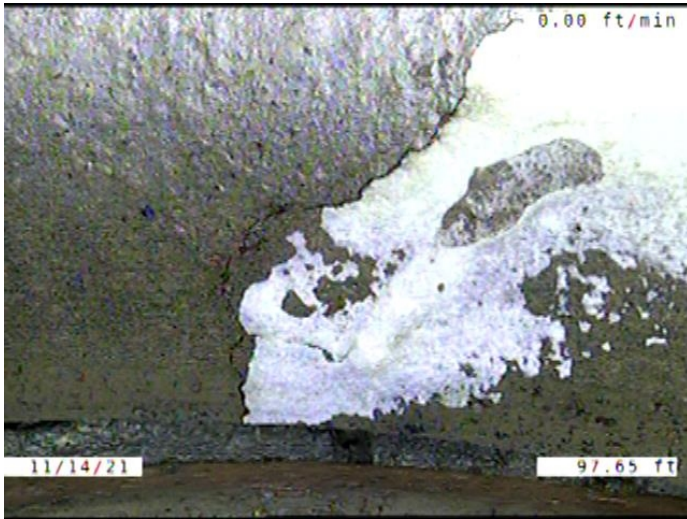
Code: **CM**
 Description: **Crack Multiple**

Distance (ft): **97.6**
 Structural Grade: **3**
 O&M Grade: **0**
 Clock Start/From: **2**
 Clock To: **3**
 1st Value:
 2nd Value:
 Value Percent:
 Continuous Index:
 Within 8" of Joint: **YES**
 Remarks:

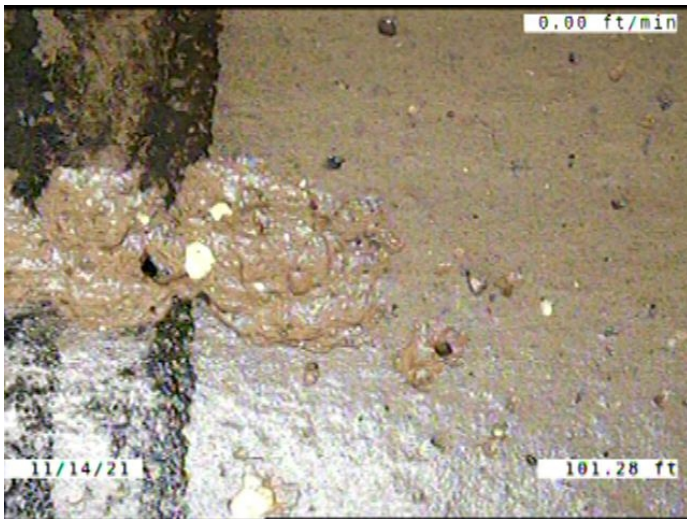
Code: **SSS**
 Description: **Surface Damage Surface Spalling**

Distance (ft): **101.3**
 Structural Grade: **2**
 O&M Grade: **0**
 Clock Start/From: **12**
 Clock To: **12**
 1st Value:
 2nd Value:
 Value Percent:
 Continuous Index: **S04**
 Within 8" of Joint: **YES**
 Remarks:

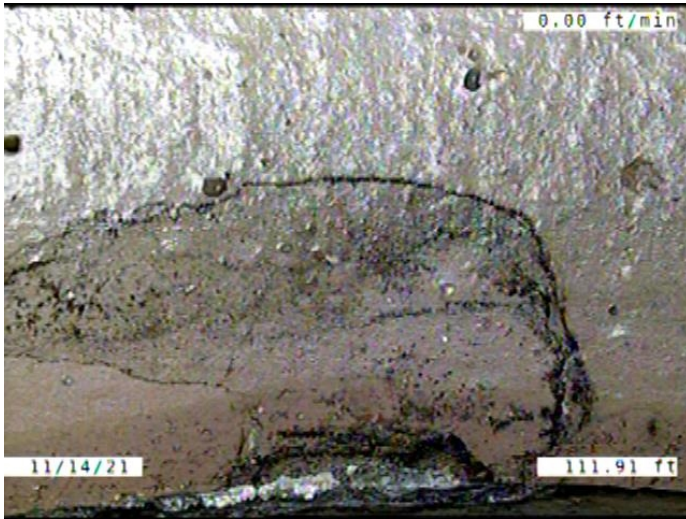
Code: **CM**
 Description: **Crack Multiple**

Distance (ft): **111.9**
 Structural Grade: **3**
 O&M Grade: **0**
 Clock Start/From: **9**
 Clock To: **10**
 1st Value:
 2nd Value:
 Value Percent:
 Continuous Index:
 Within 8" of Joint: **YES**
 Remarks:

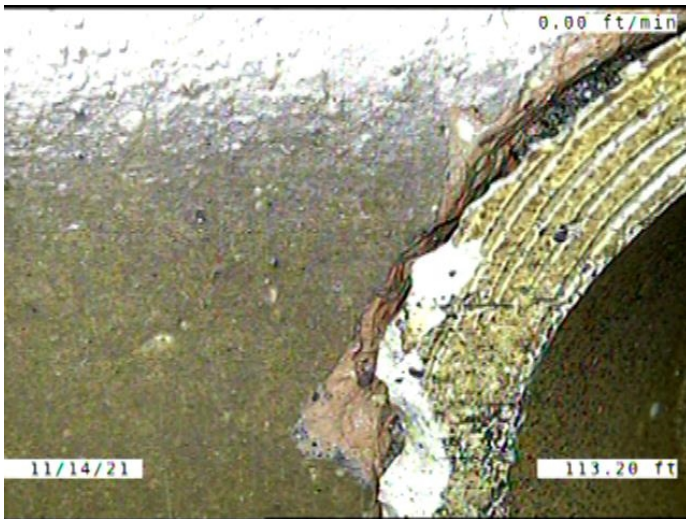
Code: **SSS**
 Description: **Surface Damage Surface Spalling**

Distance (ft): **113.2**
 Structural Grade: **2**
 O&M Grade: **0**
 Clock Start/From: **12**
 Clock To: **3**
 1st Value:
 2nd Value:
 Value Percent:
 Continuous Index:
 Within 8" of Joint: **YES**
 Remarks:

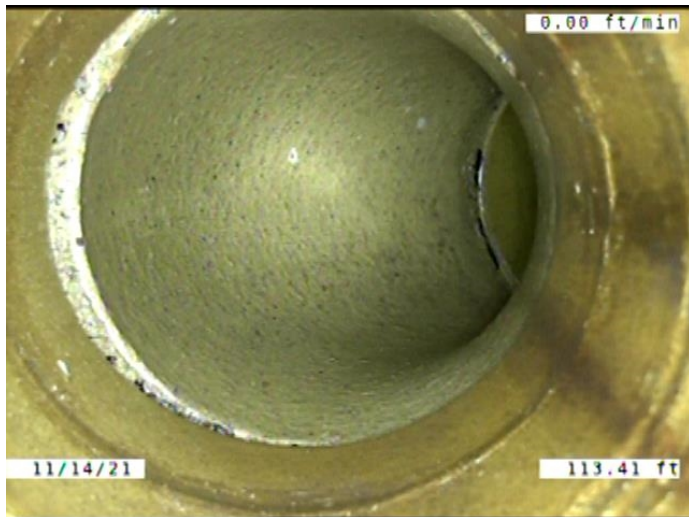
Code: **TBI**
 Description: **Tap Break-in Intruding**

Distance (ft): **113.4**
 Structural Grade: **0**
 O&M Grade: **2**
 Clock Start/From: **1**
 Clock To:
 1st Value: **6.000**
 2nd Value: **1.000**
 Value Percent:
 Continuous Index:
 Within 8" of Joint: **YES**
 Remarks:

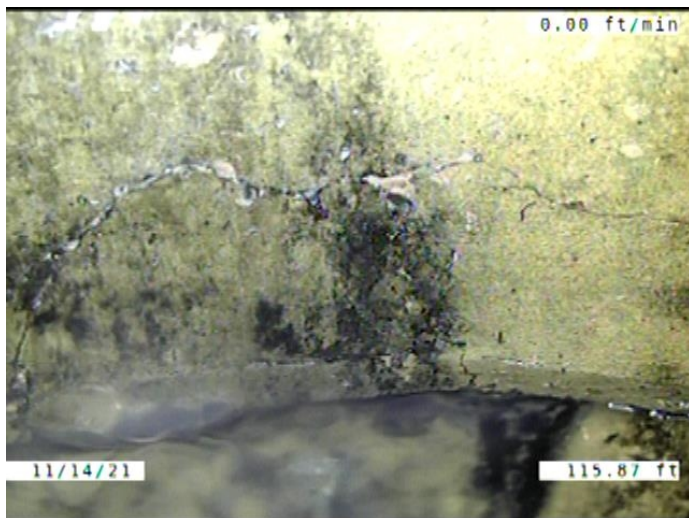
Code: **FM**
 Description: **Fracture Multiple**

Distance (ft): **115.9**
 Structural Grade: **4**
 O&M Grade: **0**
 Clock Start/From: **6**
 Clock To: **10**
 1st Value:
 2nd Value:
 Value Percent:
 Continuous Index:
 Within 8" of Joint: **YES**
 Remarks:

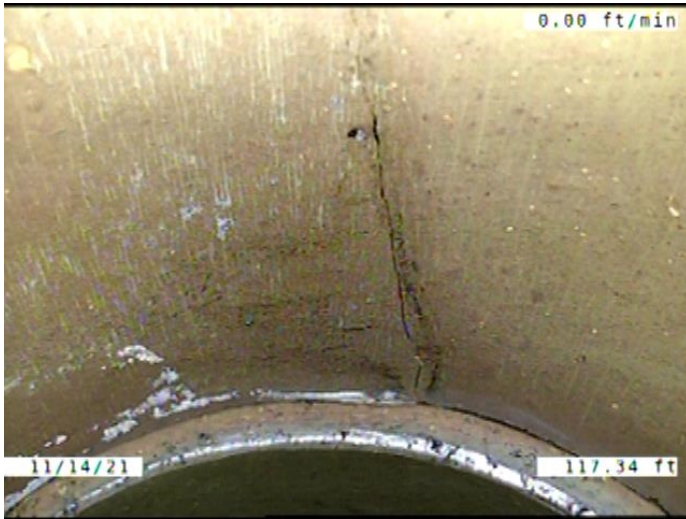
Code: **CM**
Description: **Crack Multiple**

Distance (ft): **117.3**
Structural Grade: **3**
O&M Grade: **0**
Clock Start/From: **10**
Clock To: **12**
1st Value:
2nd Value:
Value Percent:
Continuous Index:
Within 8" of Joint: **YES**
Remarks:

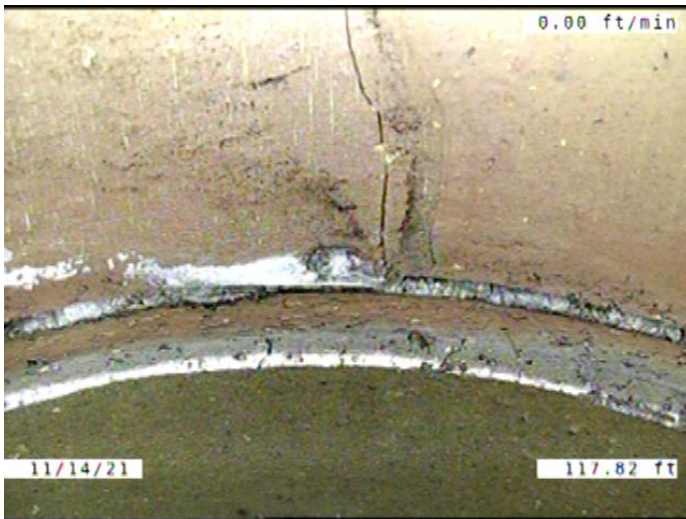
Code: **JOM**
Description: **Joint Offset Medium**

Distance (ft): **117.8**
Structural Grade: **3**
O&M Grade: **0**
Clock Start/From:
Clock To:
1st Value:
2nd Value:
Value Percent:
Continuous Index:
Within 8" of Joint: **NO**
Remarks:

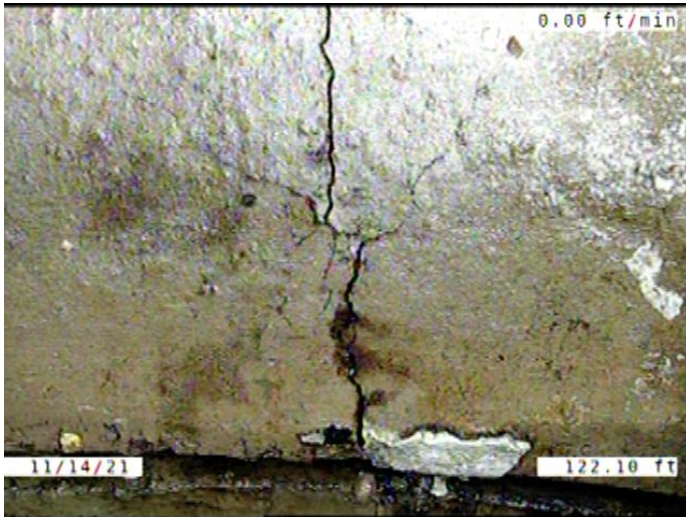
Code: **CM**
 Description: **Crack Multiple**

Distance (ft): **122.1**
 Structural Grade: **3**
 O&M Grade: **0**
 Clock Start/From: **2**
 Clock To: **5**
 1st Value:
 2nd Value:
 Value Percent:
 Continuous Index:
 Within 8" of Joint: **YES**
 Remarks:

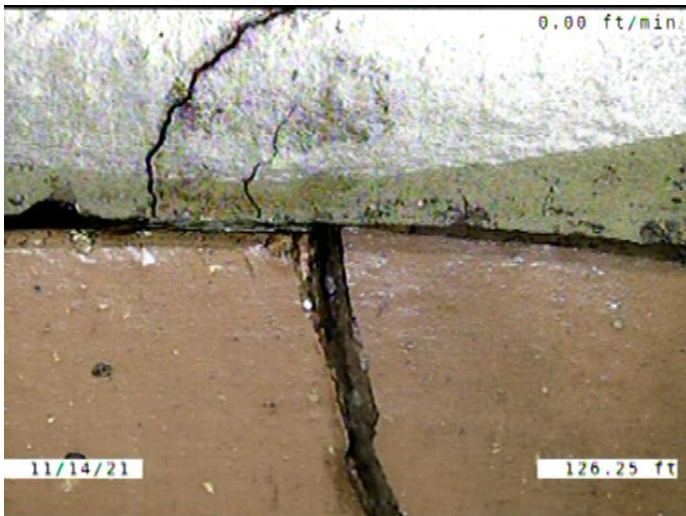
Code: **B**
 Description: **Broken**

Distance (ft): **126.2**
 Structural Grade: **4**
 O&M Grade: **0**
 Clock Start/From: **4**
 Clock To: **9**
 1st Value:
 2nd Value:
 Value Percent:
 Continuous Index:
 Within 8" of Joint: **YES**
 Remarks:

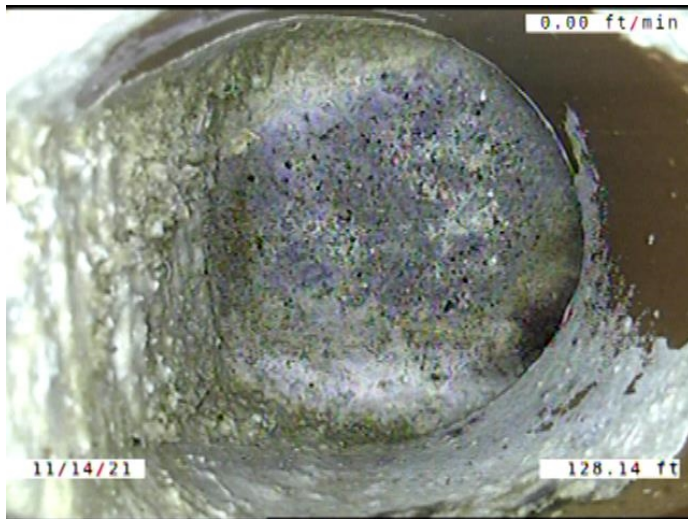
Code: **TFD**
Description: **Tap Factory Defective**

Distance (ft): **128.1**
Structural Grade: **0**
O&M Grade: **3**
Clock Start/From: **10**
Clock To:
1st Value: **4.000**
2nd Value:
Value Percent:
Continuous Index:
Within 8" of Joint: **YES**
Remarks: **CAPPED. ENCRUSTATION AROUND THE CAP.**

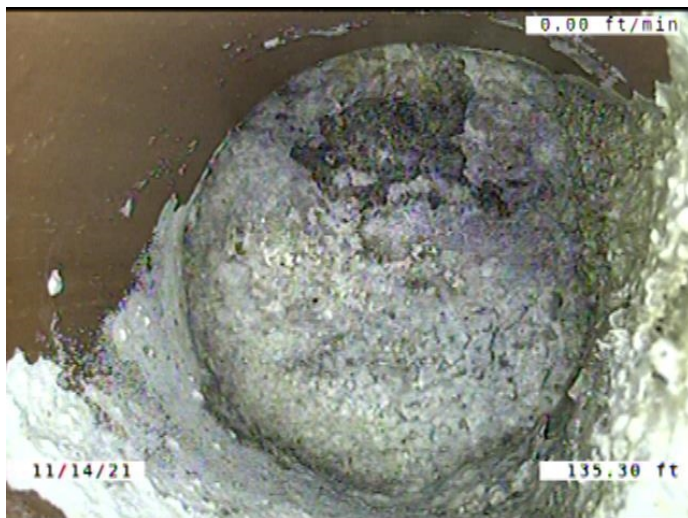
Code: **TFD**
Description: **Tap Factory Defective**

Distance (ft): **135.3**
Structural Grade: **0**
O&M Grade: **3**
Clock Start/From: **2**
Clock To:
1st Value: **4.000**
2nd Value:
Value Percent:
Continuous Index:
Within 8" of Joint: **YES**
Remarks: **CAPPED. ENCRUSTATION AROUND THE CAP.**

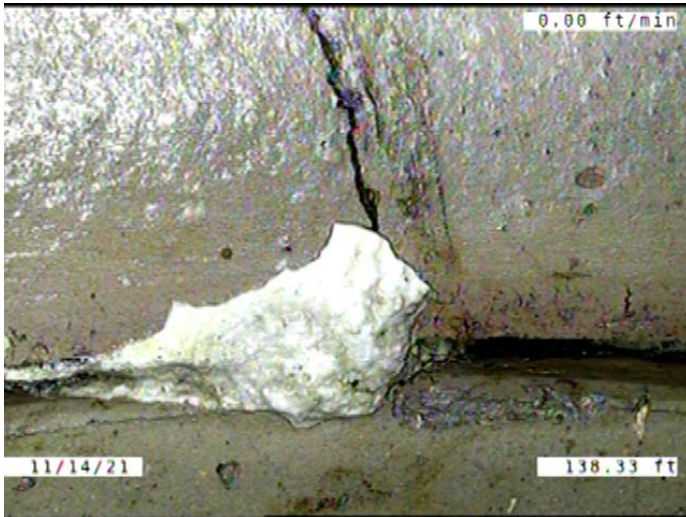
Code: **CL**
 Description: **Crack Longitudinal**

Distance (ft): **138.3**
 Structural Grade: **2**
 O&M Grade: **0**
 Clock Start/From: **9**
 Clock To:
 1st Value:
 2nd Value:
 Value Percent:
 Continuous Index:
 Within 8" of Joint: **YES**
 Remarks:

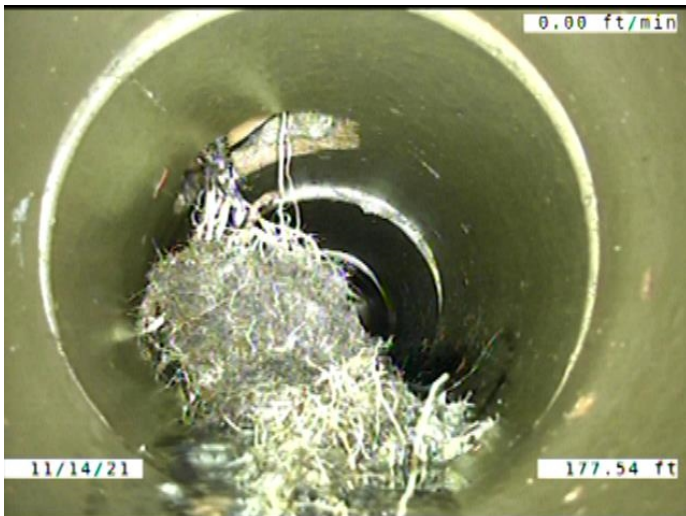
Code: **RTC**
 Description: **Roots Tap Connection**

Distance (ft): **177.5**
 Structural Grade: **0**
 O&M Grade: **2**
 Clock Start/From: **10**
 Clock To: **11**
 1st Value:
 2nd Value:
 Value Percent: **50.000**
 Continuous Index:
 Within 8" of Joint: **NO**
 Remarks:

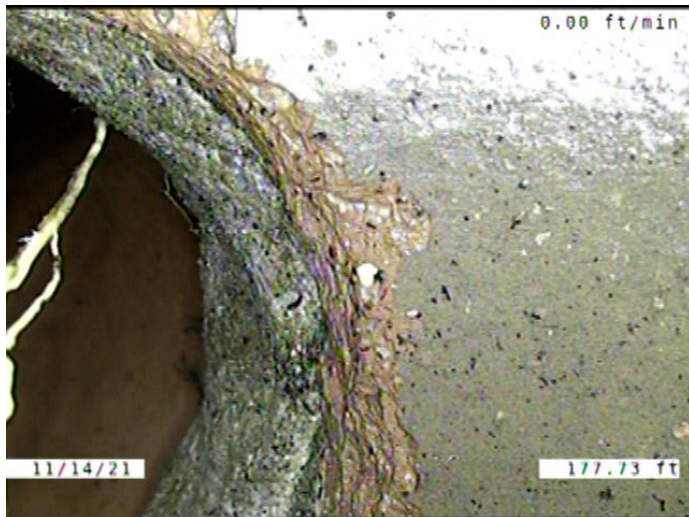
Code: **SSS**
 Description: **Surface Damage Surface Spalling**

Distance (ft): **177.7**
 Structural Grade: **2**
 O&M Grade: **0**
 Clock Start/From: **10**
 Clock To: **12**
 1st Value:
 2nd Value:
 Value Percent:
 Continuous Index:
 Within 8" of Joint: **YES**
 Remarks:

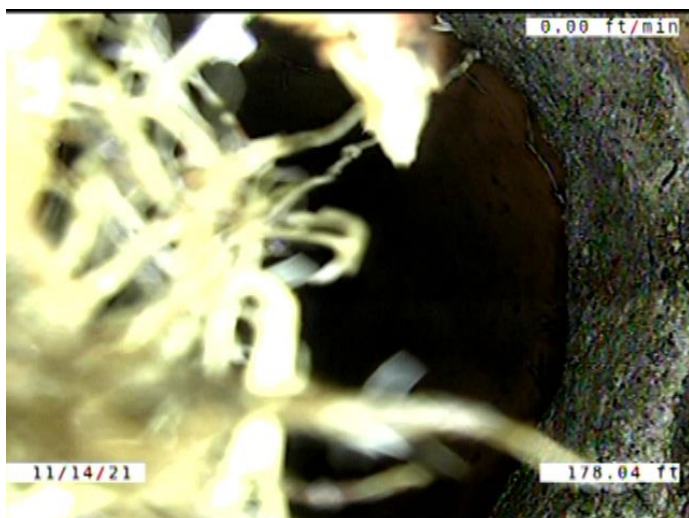
Code: **TBD**
 Description: **Tap Break-in/Hammer Defective**

Distance (ft): **178.0**
 Structural Grade: **0**
 O&M Grade: **3**
 Clock Start/From: **11**
 Clock To:
 1st Value: **4.000**
 2nd Value:
 Value Percent:
 Continuous Index:
 Within 8" of Joint: **YES**
 Remarks: **ROOTS GROWING FROM THE TAP CONNECTION**

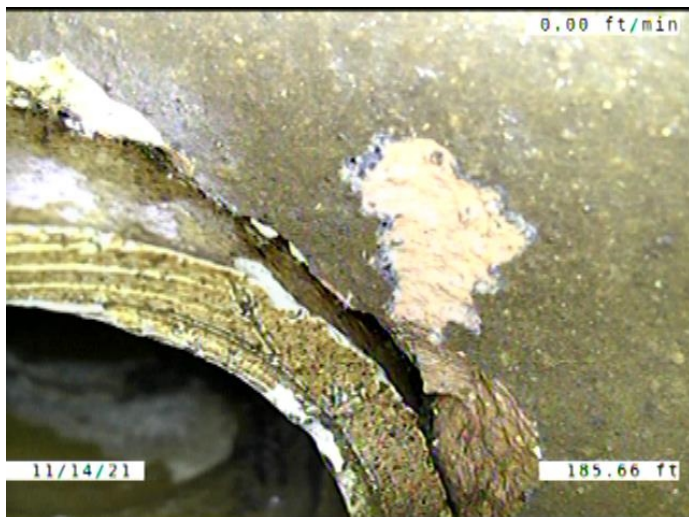
Code: **B**
 Description: **Broken**

Distance (ft): **185.7**
 Structural Grade: **4**
 O&M Grade: **0**
 Clock Start/From: **12**
 Clock To: **3**
 1st Value:
 2nd Value:
 Value Percent:
 Continuous Index:
 Within 8" of Joint: **YES**
 Remarks:

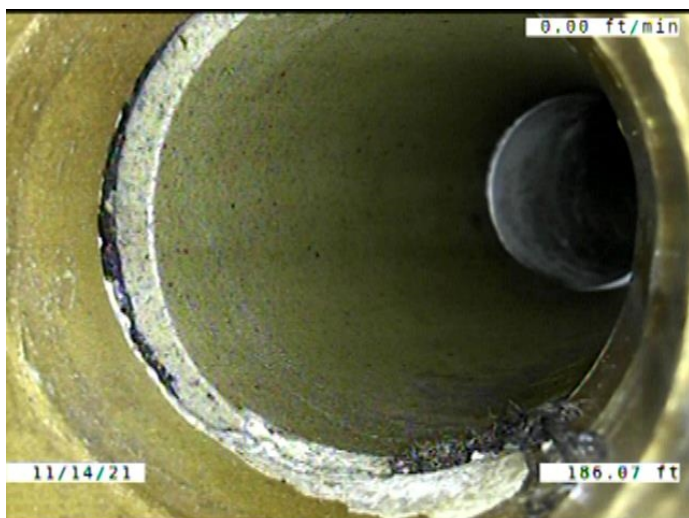
Code: **TBI**
 Description: **Tap Break-in Intruding**

Distance (ft): **186.1**
 Structural Grade: **0**
 O&M Grade: **2**
 Clock Start/From: **2**
 Clock To:
 1st Value: **6.000**
 2nd Value: **3.000**
 Value Percent:
 Continuous Index:
 Within 8" of Joint: **YES**
 Remarks: **CONSTANTLY RUNNING WATER.
 ROOTS GROWING FROM THE JOINT.**
