Profile/Photo Observation Report

Date:	11/14/2021	Weather:		Coding:	PACP 7.0
Pipe Length (ft):	273.0	Owner:	City of Hobart	Pre Clean:	Heavy Cleaning
P.O.#:	YES502259	Surveyor:	S. Bucklin	PSR:	P-604-003-002
Customer:	City of Hobart	Clean Date:	11/13/2021	Shape:	C

Street:	West Cleveland Avenue	Flow Control:	Not Controlled
City:	Hobart, IN	Year Renewed:	
Location:	Local rural streets with light traffic, t	Tape/Media #:	
Purpose:	Routine Assessment	Dia/Height:	10"
Use:	Sanitary Sewage Pipe	Material:	VCP
Drain Area:		Lining:	None
Category:	NA		
Comment:			
Location Details:		Direction of Survey:	Upstream
US MH:	M-604-003	DS MH:	M-604-002
		Total Length Surveyed (ft):	186.6

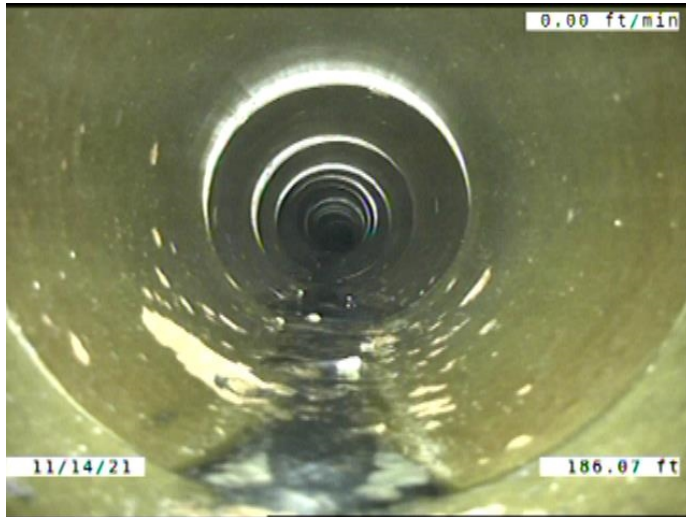
Code: **DAE**
Description: **Deposits Attached Encrustation**

Distance (ft): **186.1**
Structural Grade: **0**
O&M Grade: **2**
Clock Start/From: **9**
Clock To: **4**
1st Value:
2nd Value:
Value Percent: **5.000**
Continuous Index: **F03**
Within 8" of Joint: **YES**
Remarks:

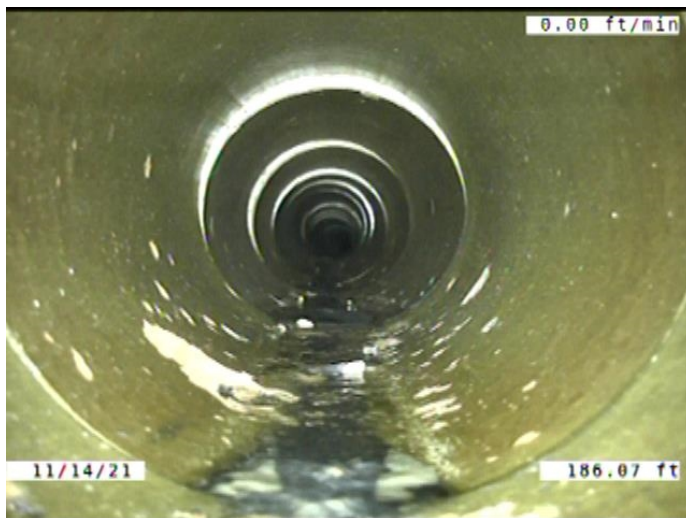
Code: **SSS**
Description: **Surface Damage Surface Spalling**

Distance (ft): **186.1**
Structural Grade: **2**
O&M Grade: **0**
Clock Start/From: **12**
Clock To: **12**
1st Value:
2nd Value:
Value Percent:
Continuous Index: **F04**
Within 8" of Joint: **YES**
Remarks:

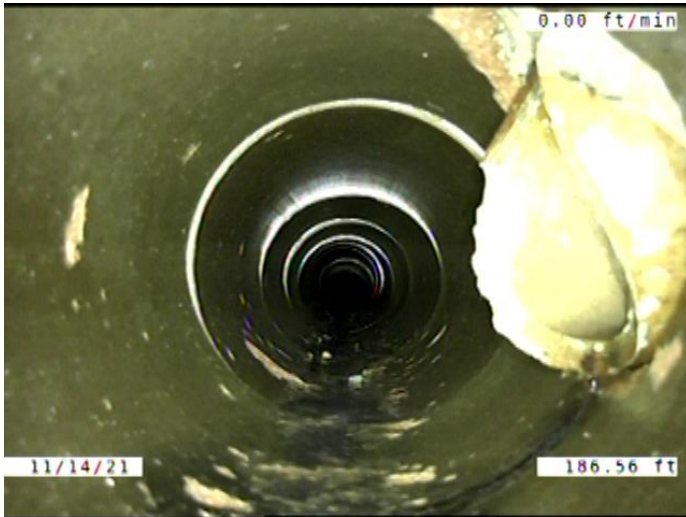
Code:	MSA
Description:	Miscellaneous Survey Abandoned
Distance (ft):	186.6
Structural Grade:	0
O&M Grade:	0
Clock Start/From:	
Clock To:	
1st Value:	
2nd Value:	
Value Percent:	
Continuous Index:	
Within 8" of Joint:	NO
Remarks:	CAMERA CANT MAKE IT PAST PROTRUDING TAP. MADE IT TO THE
