Profile/Photo Observation Report

Date:	04/23/2018	Weather:		Coding:	PACP 6.0
Pipe Length (ft):	316.8	Owner:	NA	Pre Clean:	Not Known
P.O.#:		Surveyor:	Jen Costello	PSR:	P-604-005-004
Customer:		Clean Date:	01/01/1900	Shape:	C

Street:	Willow Pl.	Flow Control:	Not Controlled
City:	Hobart, IN	Year Renewed:	
Location:	Other	Tape/Media #:	
Purpose:	Not Known	Dia/Height:	8"
Use:	Sanitary	Material:	CP
Drain Area:	NA	Lining:	
Category:	NA		
Comment:

Location Details:		Direction of Survey:	Downstream
US MH:	M-604-004	DS MH:	M-604-005
		Total Length Surveyed (ft):	5.2

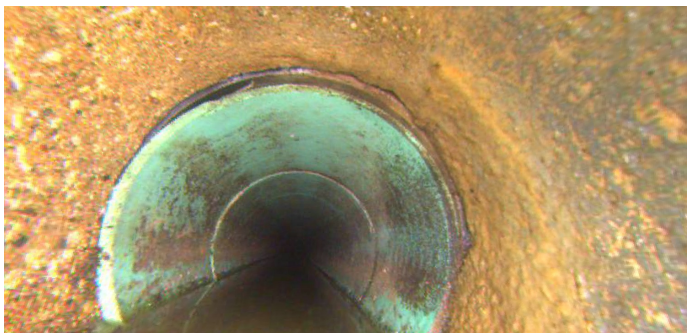
Code: **AMH**
Description: **Manhole**

Distance (ft): **.0**
Structural Grade: **0**
O&M Grade: **0**
Clock Start/From:
Clock To:
1st Value:
2nd Value:
Value Percent:
Continuous Index:
Within 8" of Joint: **NO**
Remarks: **M-604-004**

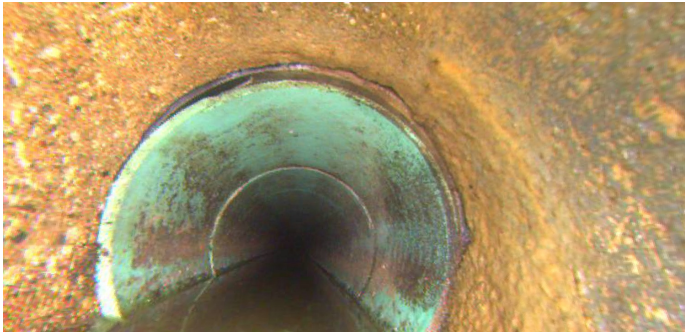
Code:	MWL
Description:	Water Level

Distance (ft):	.0
Structural Grade:	0
O&M Grade:	0
Clock Start/From:	
Clock To:	
1st Value:	
2nd Value:	
Value Percent:	10.000
Continuous Index:	
Within 8" of Joint:	NO
Remarks:

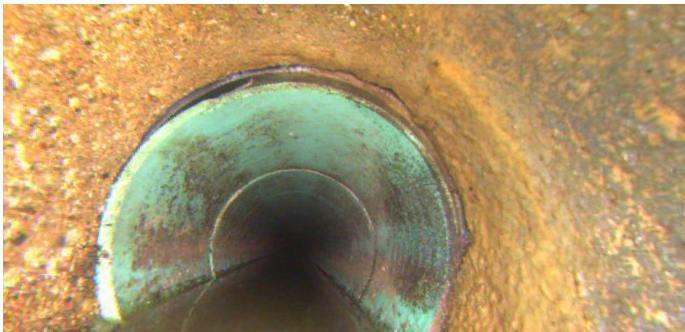
Code:	SAV
Description:	Surface Aggregate Visible

Distance (ft):	.0
Structural Grade:	3
O&M Grade:	0
Clock Start/From:	8
Clock To:	4
1st Value:	
2nd Value:	
Value Percent:	
Continuous Index:	
Within 8" of Joint:	
Remarks:

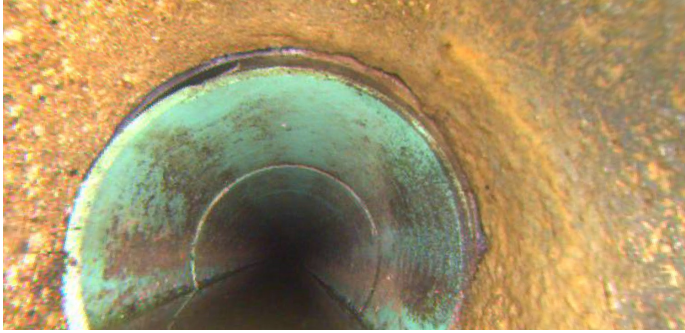
Code: **MMC**
Description: **Material Change**

Distance (ft): **.0**
Structural Grade: **0**
O&M Grade: **0**
Clock Start/From:
Clock To:
1st Value:
2nd Value:
Value Percent:
Continuous Index:
Within 8" of Joint: **NO**
Remarks: **PVC**

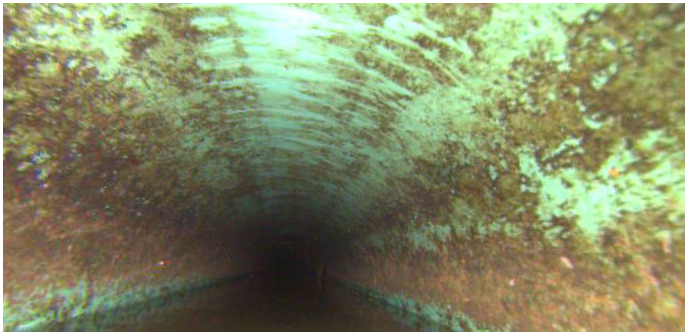
Code: **MSA**
Description: **Abandoned Survey**

Distance (ft): **5.2**
Structural Grade: **0**
O&M Grade: **0**
Clock Start/From:
Clock To:
1st Value:
2nd Value:
Value Percent:
Continuous Index:
Within 8" of Joint: **NO**
Remarks: **PVC**
