Profile/Ph	oto Observatio	n Report				RedZone	
Date:	04/23/2018	Weather:			Coding:	PACP 6.0	
Pipe Length (ft	): <b>316.8</b>	Owner:	NA		Pre Clean:	Not Known	
P.O.#:		Surveyor:	Jen Costel	lo	PSR:	P-604-005-004	
Customer:		Clean Date	e: 01/01/190	00	Shape:	С	
Street: W CLEVELAND AVE & WILLOW PL		Flow Contro	Flow Control:				
City:	Hobart, IN		Year Renew	ed:			
Location:	Other		Tape/Media	n #:			
Purpose:	Not Known		Dia/Height:		8"		
Use:	Sanitary		Material:		PVC		
Drain Area:	NA		Lining:				
Category:	NA						
Comment:							
Location Detail	ls:		Direction of	Survey:	Upstream		
US MH:	M-604-004	DS MH:	M-604-005	To	tal Length Surveyed (ft)	5 <b>.2</b>	
0&M Index:	2.00	O&M Quick	::	2100	O&M Rating:	2.00	
tructural Index:	0.00	Structural C	Quick:	0000	Structural Rating:	0.00	
Overall Index:	2.00	Overall Qui	ck:	2100	Overall Rating:	2.00

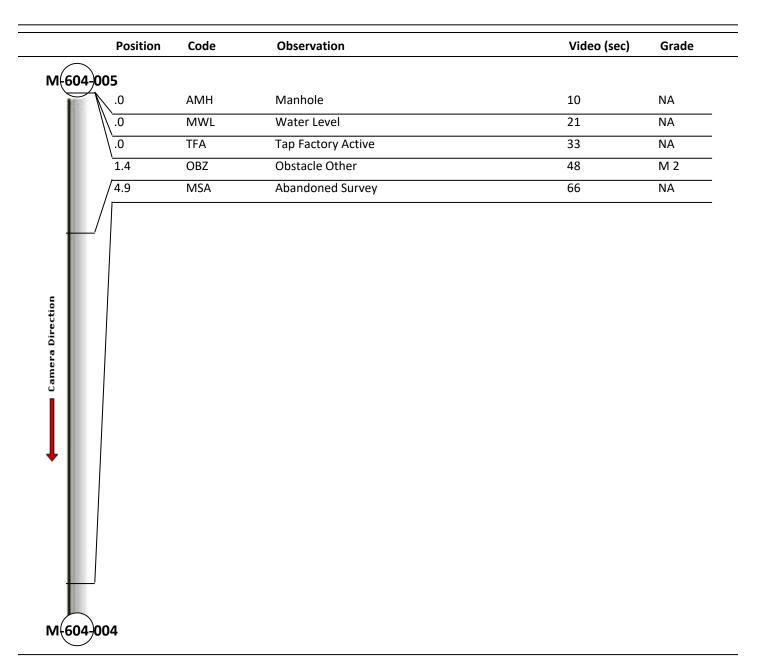
Code: Description:	AMH Manhole
Description	Manifold
Distance (ft):	.0
Structural Grade:	0
O&M Grade:	0
Clock Start/From:	
Clock To:	
1st Value:	
2nd Value:	
Value Percent:	
Continuous Index:	
Within 8" of Joint:	NO
Remarks:	M-604-005

Code: MWL Description: Water Level

Code:	TFA
Description:	<b>Tap Factory Active</b>
Distance (ft)	0
Distance (ft):	.0
Structural Grade:	0
O&M Grade:	0
Clock Start/From:	9
Clock To:	
1st Value:	4.000
2nd Value:	
Value Percent:	
Continuous Index:	
Within 8" of Joint:	
Remarks:

Code: Description:	OBZ Obstacle Other
Distance (ft):	1.4
Structural Grade:	0
O&M Grade:	2
Clock Start/From:	6
Clock To:	
1st Value:	
2nd Value:	
Value Percent:	5.000
Continuous Index:	
Within 8" of Joint:	NO

stick
