Profile/Photo Observation Report

Date:	11/12/2021	Weather:		Coding:	PACP 7.0
Pipe Length (ft):	317.0	Owner:	City of Hobart	Pre Clean:	Heavy Cleaning
P.O.#:	YES502259	Surveyor:	Steven Bucklin	PSR:	P-604-005-004
Customer:	City of Hobart, IN (Red	Clean Date:	11/12/2021	Shape:	C

Street:	Willow Place	Flow Control:	Not Controlled
City:	City of Hobart	Year Renewed:	
Location:	Local rural streets with light traffic, t	Tape/Media #:	
Purpose:	Routine Assessment	Dia/Height:	8"
Use:	Sanitary Sewage Pipe	Material:	CP
Drain Area:		Lining:	None
Category:	NA		
Comment:			
Location Details:		Direction of Survey:	Downstream
US MH:	M-604-004	DS MH:	M-604-005
		Total Length Surveyed (ft):	82.8

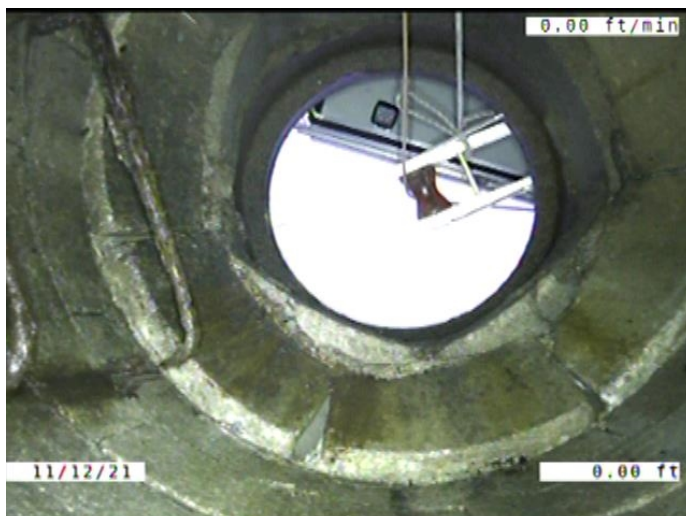
Code: **AMH**
Description: **Manhole**

Distance (ft): **.0**
Structural Grade: **0**
O&M Grade: **0**
Clock Start/From:
Clock To:
1st Value:
2nd Value:
Value Percent:
Continuous Index:
Within 8" of Joint: **NO**
Remarks: **M-604-004**

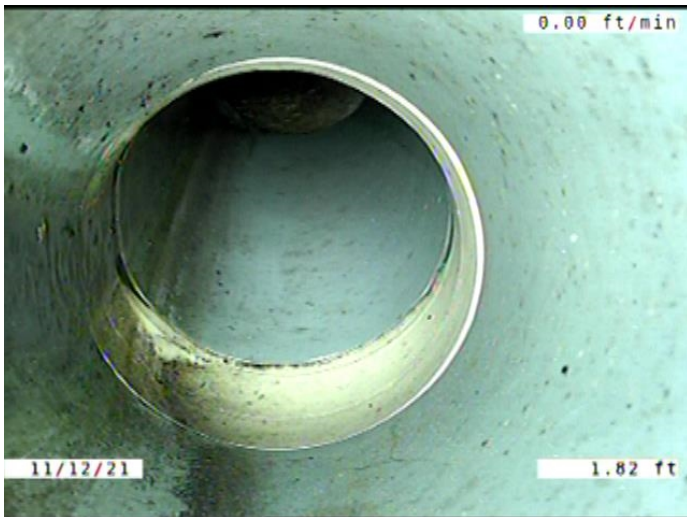
Code: **TF**
Description: **Tap Factory**

Distance (ft): **1.8**
Structural Grade: **0**
O&M Grade: **0**
Clock Start/From: **10**
Clock To:
1st Value: **4.000**
2nd Value:
Value Percent:
Continuous Index:
Within 8" of Joint: **YES**
Remarks:

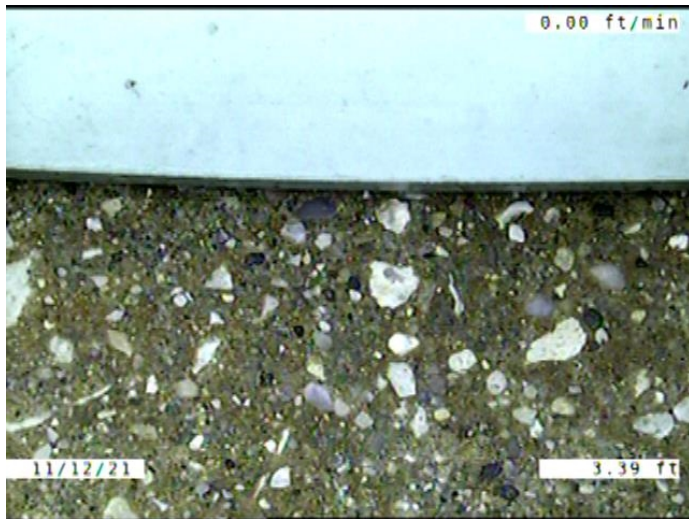
Code: **MMC**
 Description: **Miscellaneous Material Change**

Distance (ft): **3.4**
 Structural Grade: **0**
 O&M Grade: **0**
 Clock Start/From:
 Clock To:
 1st Value:
 2nd Value:
 Value Percent:
 Continuous Index:
 Within 8" of Joint: **NO**
 Remarks: **PVC TO CONCRETE**

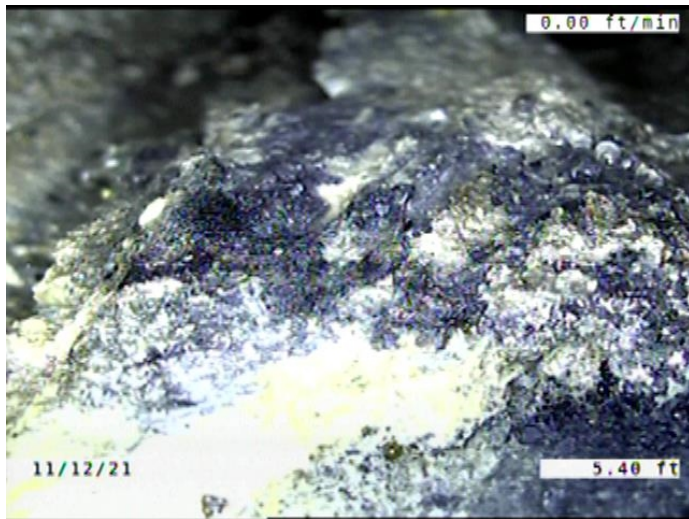
Code: **OBN**
 Description: **Obstruction Construction Debris**

Distance (ft): **5.4**
 Structural Grade: **0**
 O&M Grade: **2**
 Clock Start/From: **5**
 Clock To: **7**
 1st Value:
 2nd Value:
 Value Percent: **10.000**
 Continuous Index:
 Within 8" of Joint: **YES**
 Remarks:

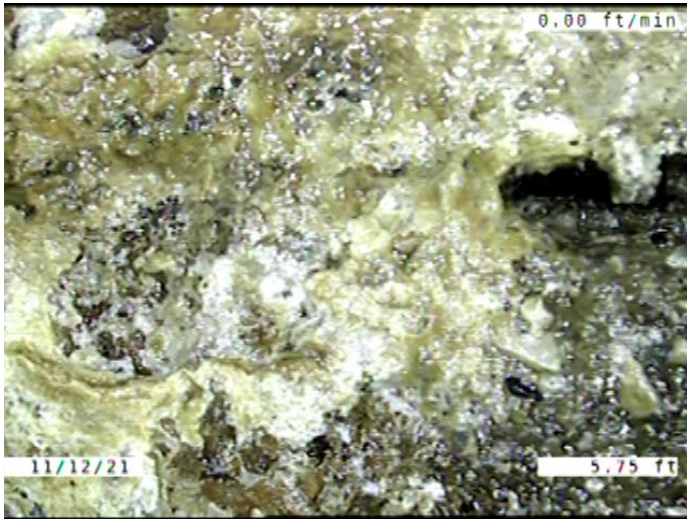
Code: **DAE**
Description: **Deposits Attached Encrustation**

Distance (ft): **5.8**
Structural Grade: **0**
O&M Grade: **2**
Clock Start/From: **8**
Clock To: **4**
1st Value:
2nd Value:
Value Percent: **5.000**
Continuous Index: **S01**
Within 8" of Joint: **YES**
Remarks:

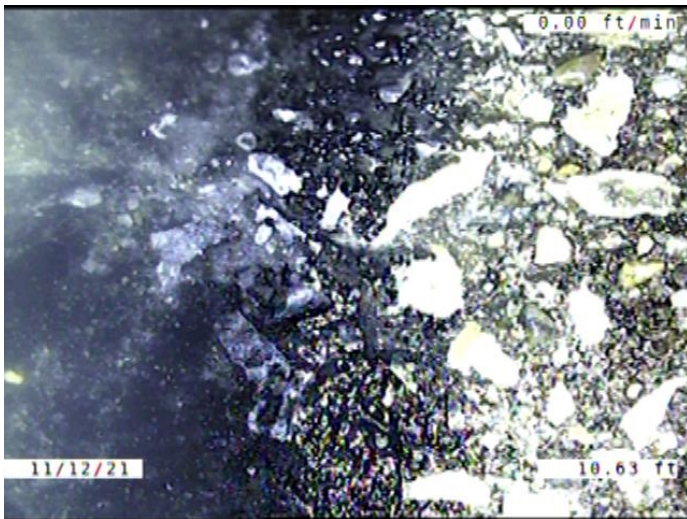
Code: **FC**
Description: **Fracture Circumferential**

Distance (ft): **10.6**
Structural Grade: **2**
O&M Grade: **0**
Clock Start/From: **3**
Clock To: **5**
1st Value:
2nd Value:
Value Percent:
Continuous Index:
Within 8" of Joint: **YES**
Remarks:

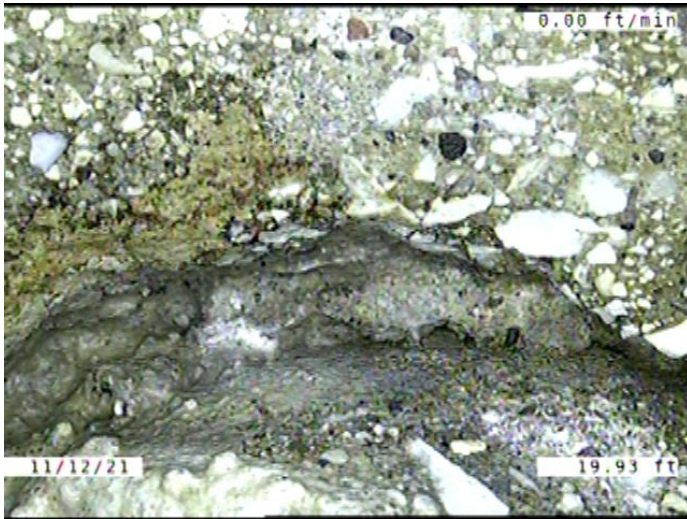
Code: **FC**
 Description: **Fracture Circumferential**

Distance (ft): **19.9**
 Structural Grade: **2**
 O&M Grade: **0**
 Clock Start/From: **4**
 Clock To: **8**
 1st Value:
 2nd Value:
 Value Percent:
 Continuous Index:
 Within 8" of Joint: **YES**
 Remarks:

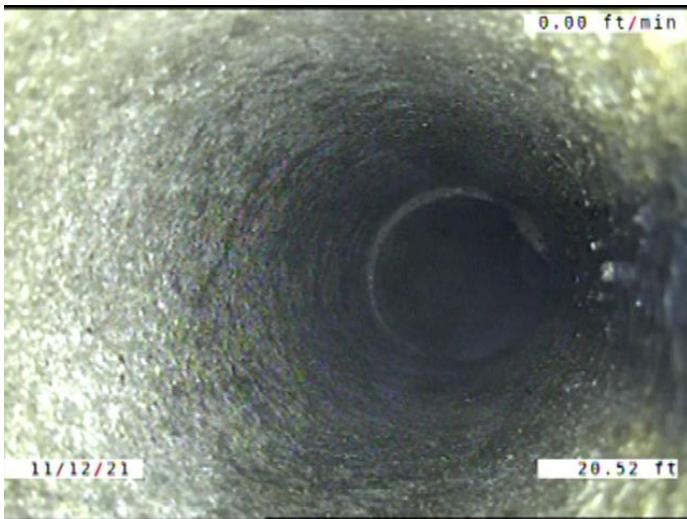
Code: **TBI**
 Description: **Tap Break-in Intruding**

Distance (ft): **20.5**
 Structural Grade: **0**
 O&M Grade: **2**
 Clock Start/From: **2**
 Clock To:
 1st Value: **4.000**
 2nd Value: **2.000**
 Value Percent:
 Continuous Index:
 Within 8" of Joint: **YES**
 Remarks:

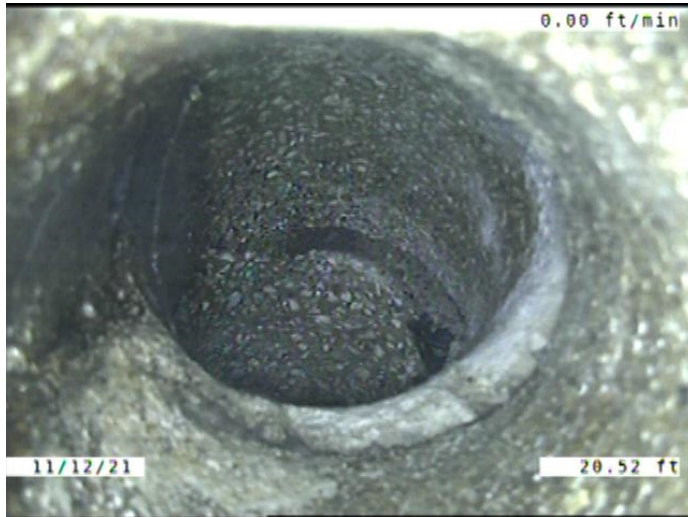
Code: **TFD**
 Description: **Tap Factory Defective**

Distance (ft): **20.5**
 Structural Grade: **0**
 O&M Grade: **3**
 Clock Start/From: **10**
 Clock To:
 1st Value: **6.000**
 2nd Value:
 Value Percent:
 Continuous Index:
 Within 8" of Joint: **YES**
 Remarks: **BROKEN. ANGLED JOINT**

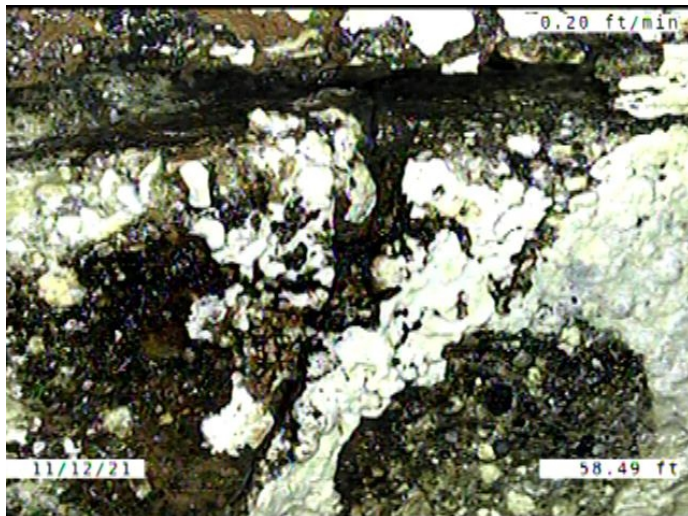
Code: **B**
 Description: **Broken**

Distance (ft): **58.5**
 Structural Grade: **4**
 O&M Grade: **0**
 Clock Start/From: **8**
 Clock To: **10**
 1st Value:
 2nd Value:
 Value Percent:
 Continuous Index:
 Within 8" of Joint: **YES**
 Remarks:

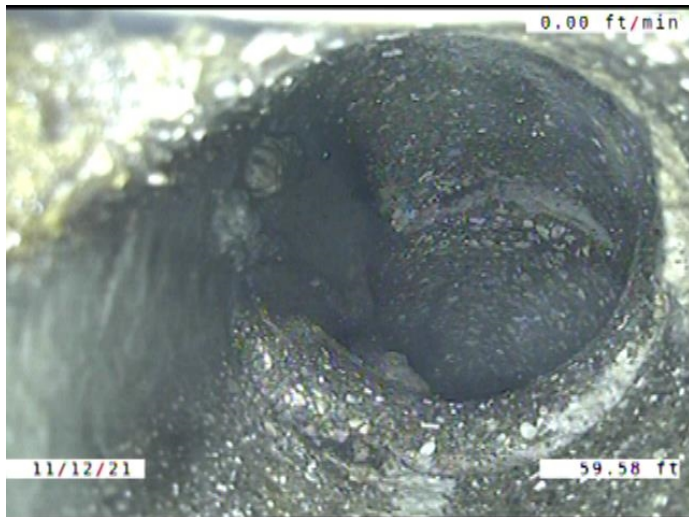
Code: **TF**
Description: **Tap Factory**

Distance (ft): **59.6**
Structural Grade: **0**
O&M Grade: **0**
Clock Start/From: **9**
Clock To:
1st Value: **6.000**
2nd Value:
Value Percent:
Continuous Index:
Within 8" of Joint: **YES**
Remarks: **CONSTANTLY RUNNING WATER.**

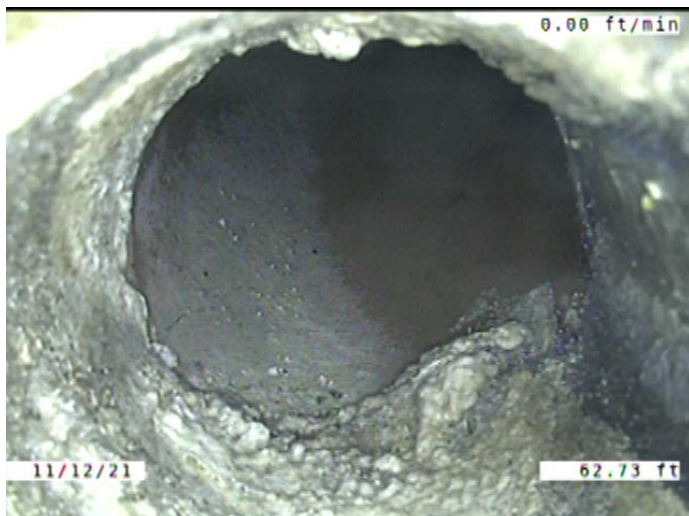
Code: **TF**
Description: **Tap Factory**

Distance (ft): **62.7**
Structural Grade: **0**
O&M Grade: **0**
Clock Start/From: **2**
Clock To:
1st Value: **6.000**
2nd Value:
Value Percent:
Continuous Index:
Within 8" of Joint: **YES**
Remarks:
