Profile/Photo Observation Report

Date:	11/12/2021	Weather:		Coding:	PACP 7.0
Pipe Length (ft):	317.0	Owner:	City of Hobart	Pre Clean:	Heavy Cleaning
P.O.#:	YES502259	Surveyor:	Steven Bucklin	PSR:	P-604-005-004
Customer:	City of Hobart, IN (Red	Clean Date:	11/12/2021	Shape:	C

Street:	Willow Place	Flow Control:	Not Controlled
City:	City of Hobart	Year Renewed:	
Location:	Local rural streets with light traffic, t	Tape/Media #:	
Purpose:	Routine Assessment	Dia/Height:	8"
Use:	Sanitary Sewage Pipe	Material:	CP
Drain Area:		Lining:	None
Category:	NA		
Comment:			
Location Details:		Direction of Survey:	Downstream
US MH:	M-604-004	DS MH:	M-604-005
		Total Length Surveyed (ft):	82.8

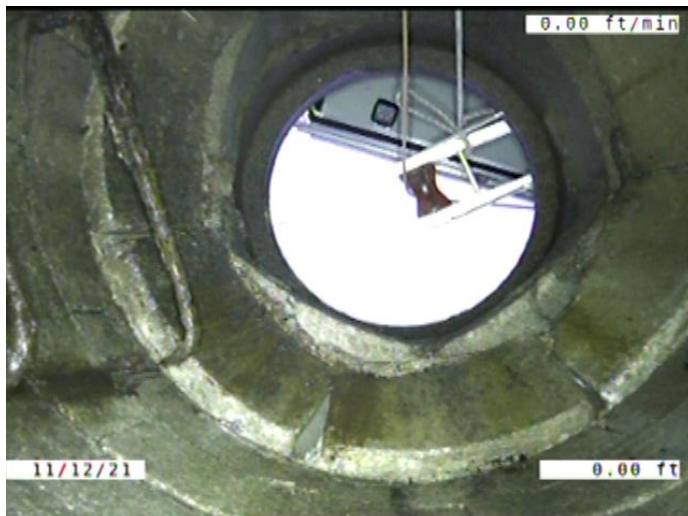
Code: **AMH**
Description: **Manhole**

Distance (ft): **.0**
Structural Grade: **0**
O&M Grade: **0**
Clock Start/From:
Clock To:
1st Value:
2nd Value:
Value Percent:
Continuous Index:
Within 8" of Joint: **NO**
Remarks: **M-604-004**

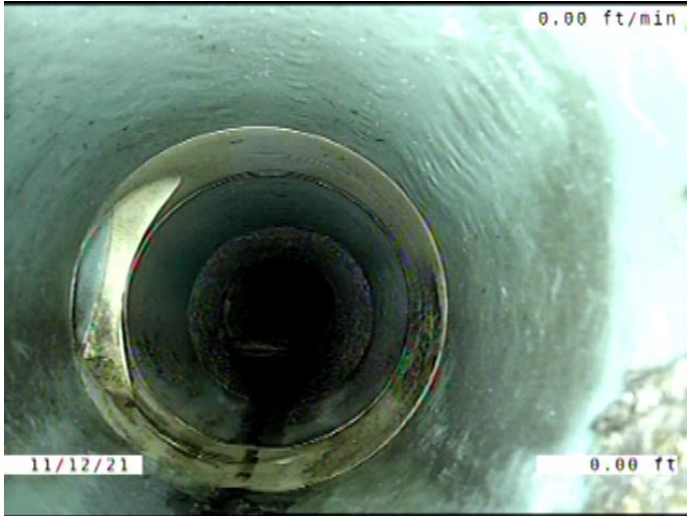
Code: **MWL**
Description: **Miscellaneous Water Level**

Distance (ft): **.0**
Structural Grade: **0**
O&M Grade: **0**
Clock Start/From:
Clock To:
1st Value:
2nd Value:
Value Percent: **5.000**
Continuous Index:
Within 8" of Joint: **NO**
Remarks:

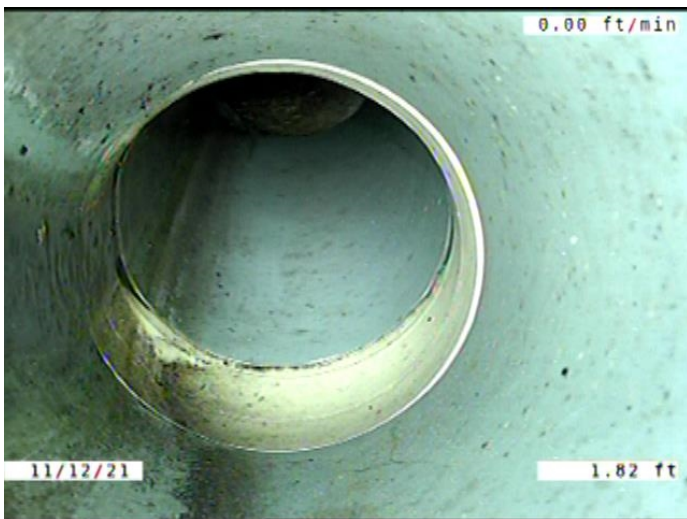
Code: **TF**
Description: **Tap Factory**

Distance (ft): **1.8**
Structural Grade: **0**
O&M Grade: **0**
Clock Start/From: **10**
Clock To:
1st Value: **4.000**
2nd Value:
Value Percent:
Continuous Index:
Within 8" of Joint: **YES**
Remarks:

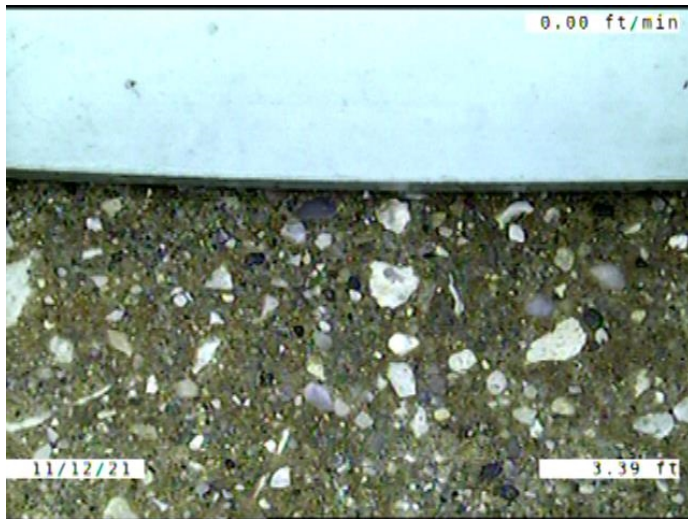
Code: **MMC**
 Description: **Miscellaneous Material Change**

Distance (ft): **3.4**
 Structural Grade: **0**
 O&M Grade: **0**
 Clock Start/From:
 Clock To:
 1st Value:
 2nd Value:
 Value Percent:
 Continuous Index:
 Within 8" of Joint: **NO**
 Remarks: **PVC TO CONCRETE**

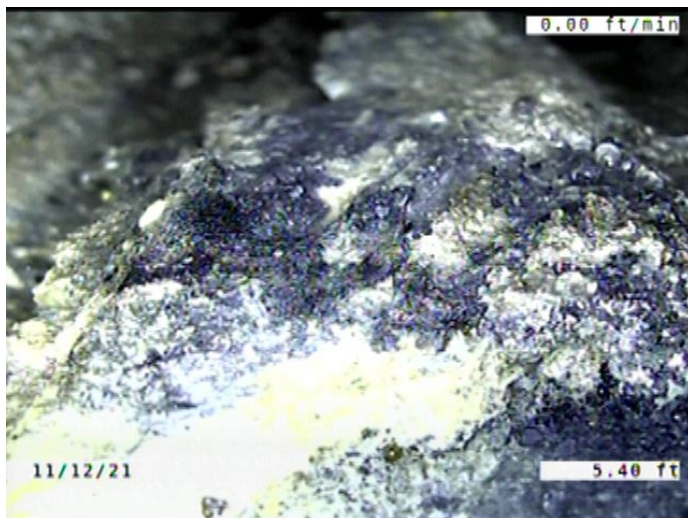
Code: **OBN**
 Description: **Obstruction Construction Debris**

Distance (ft): **5.4**
 Structural Grade: **0**
 O&M Grade: **2**
 Clock Start/From: **5**
 Clock To: **7**
 1st Value:
 2nd Value:
 Value Percent: **10.000**
 Continuous Index:
 Within 8" of Joint: **YES**
 Remarks:

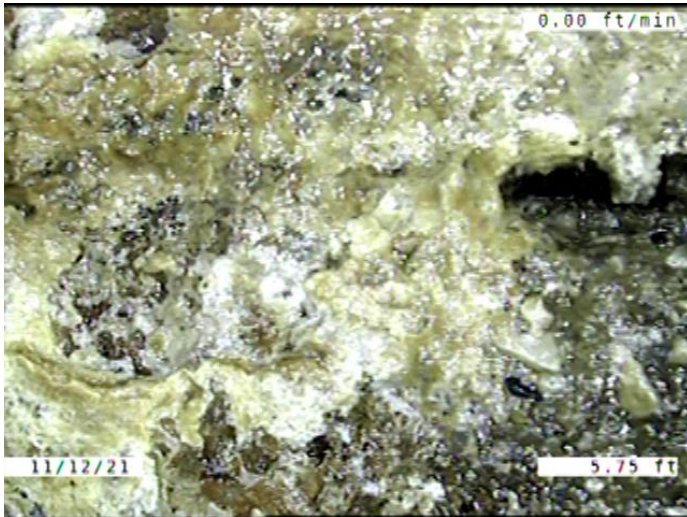
Code: **DAE**
 Description: **Deposits Attached Encrustation**

Distance (ft): **5.8**
 Structural Grade: **0**
 O&M Grade: **2**
 Clock Start/From: **8**
 Clock To: **4**
 1st Value:
 2nd Value:
 Value Percent: **5.000**
 Continuous Index: **S01**
 Within 8" of Joint: **YES**
 Remarks:

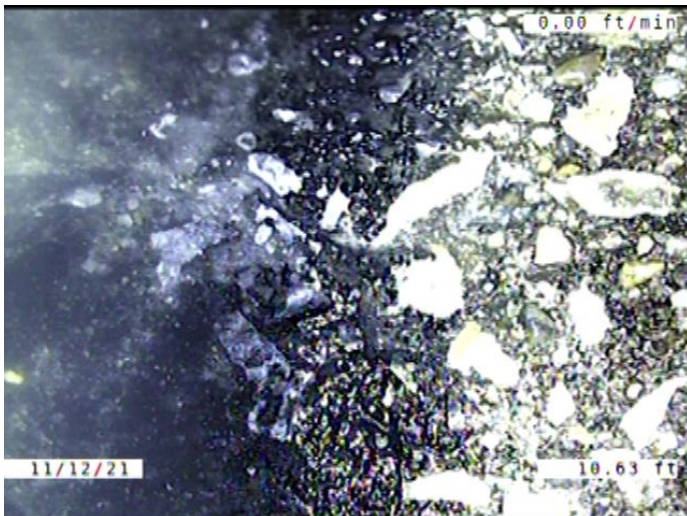
Code: **FC**
 Description: **Fracture Circumferential**

Distance (ft): **10.6**
 Structural Grade: **2**
 O&M Grade: **0**
 Clock Start/From: **3**
 Clock To: **5**
 1st Value:
 2nd Value:
 Value Percent:
 Continuous Index:
 Within 8" of Joint: **YES**
 Remarks:

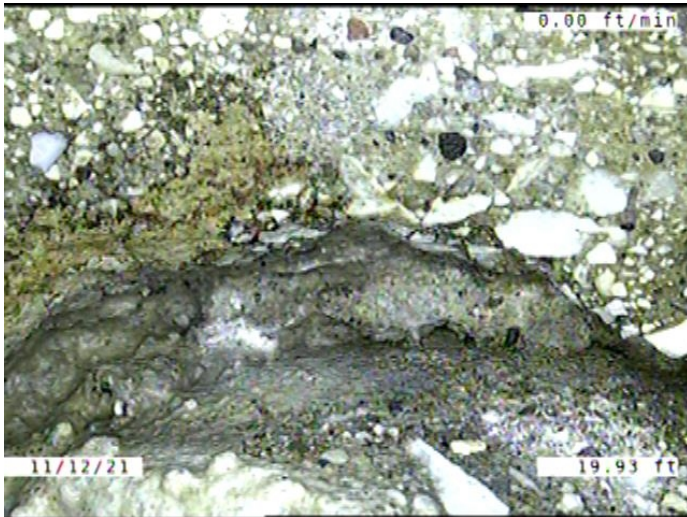
Code: **FC**
 Description: **Fracture Circumferential**

Distance (ft): **19.9**
 Structural Grade: **2**
 O&M Grade: **0**
 Clock Start/From: **4**
 Clock To: **8**
 1st Value:
 2nd Value:
 Value Percent:
 Continuous Index:
 Within 8" of Joint: **YES**
 Remarks:

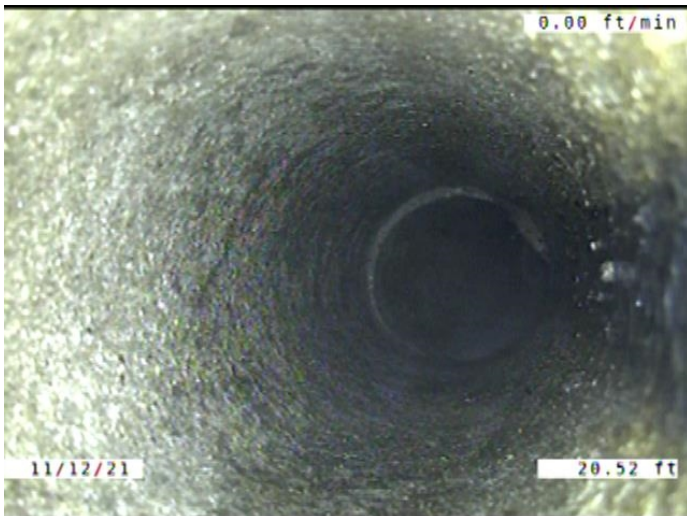
Code: **TBI**
 Description: **Tap Break-in Intruding**

Distance (ft): **20.5**
 Structural Grade: **0**
 O&M Grade: **2**
 Clock Start/From: **2**
 Clock To:
 1st Value: **4.000**
 2nd Value: **2.000**
 Value Percent:
 Continuous Index:
 Within 8" of Joint: **YES**
 Remarks:

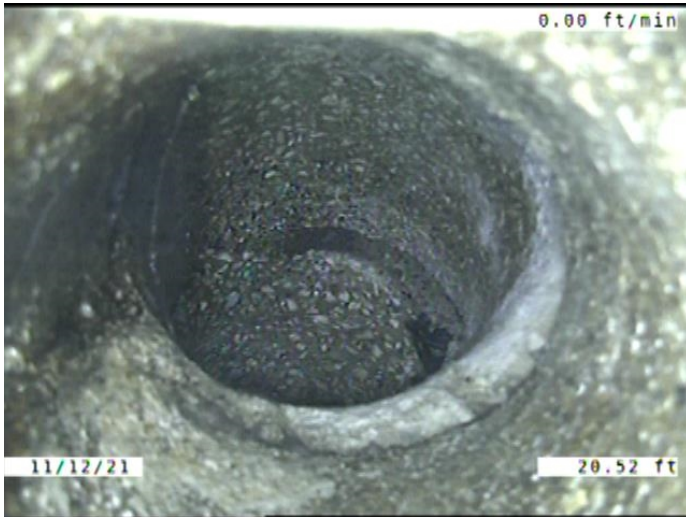
Code: **TFD**
 Description: **Tap Factory Defective**

Distance (ft): **20.5**
 Structural Grade: **0**
 O&M Grade: **3**
 Clock Start/From: **10**
 Clock To:
 1st Value: **6.000**
 2nd Value:
 Value Percent:
 Continuous Index:
 Within 8" of Joint: **YES**
 Remarks: **BROKEN. ANGLED JOINT**

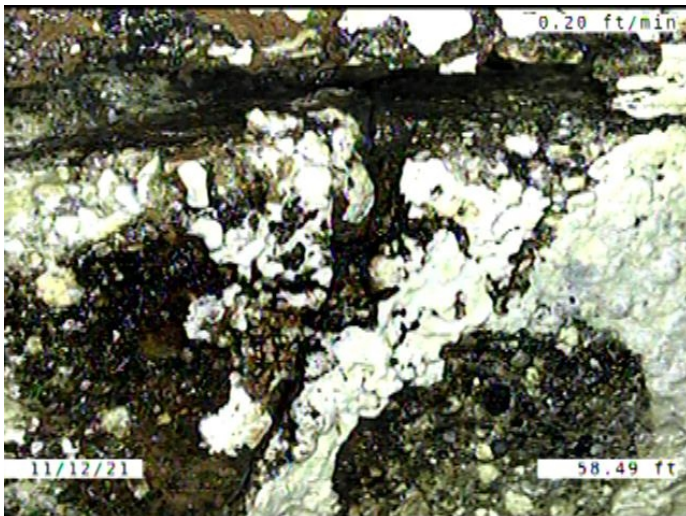
Code: **B**
 Description: **Broken**

Distance (ft): **58.5**
 Structural Grade: **4**
 O&M Grade: **0**
 Clock Start/From: **8**
 Clock To: **10**
 1st Value:
 2nd Value:
 Value Percent:
 Continuous Index:
 Within 8" of Joint: **YES**
 Remarks:

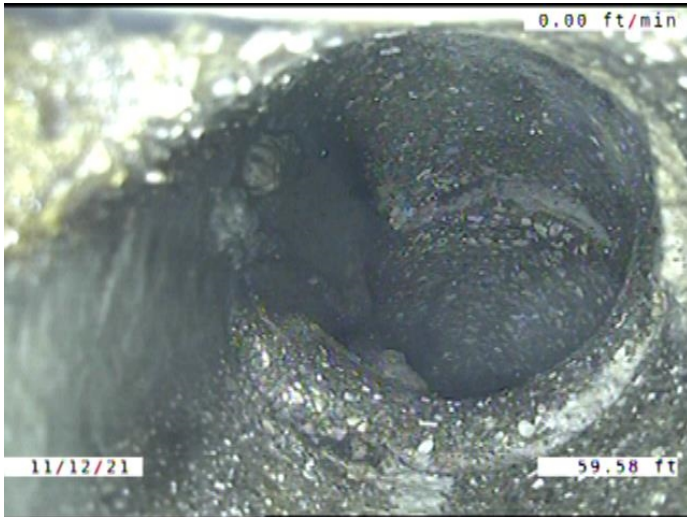
Code: **TF**
Description: **Tap Factory**

Distance (ft): **59.6**
Structural Grade: **0**
O&M Grade: **0**
Clock Start/From: **9**
Clock To:
1st Value: **6.000**
2nd Value:
Value Percent:
Continuous Index:
Within 8" of Joint: **YES**
Remarks: **CONSTANTLY RUNNING WATER.**

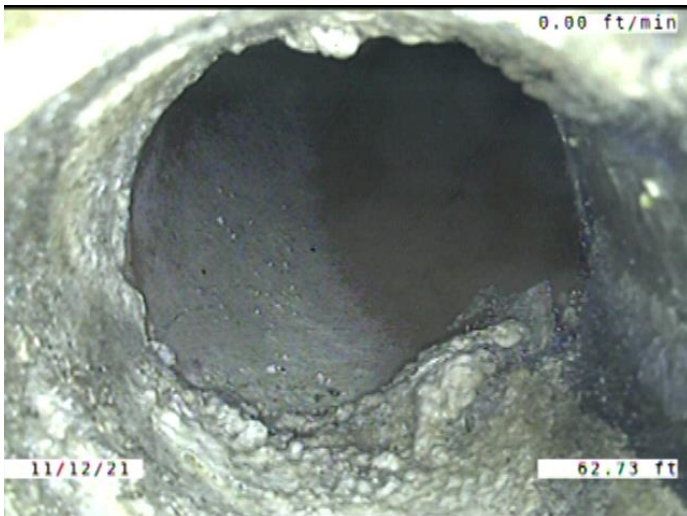
Code: **TF**
Description: **Tap Factory**

Distance (ft): **62.7**
Structural Grade: **0**
O&M Grade: **0**
Clock Start/From: **2**
Clock To:
1st Value: **6.000**
2nd Value:
Value Percent:
Continuous Index:
Within 8" of Joint: **YES**
Remarks:

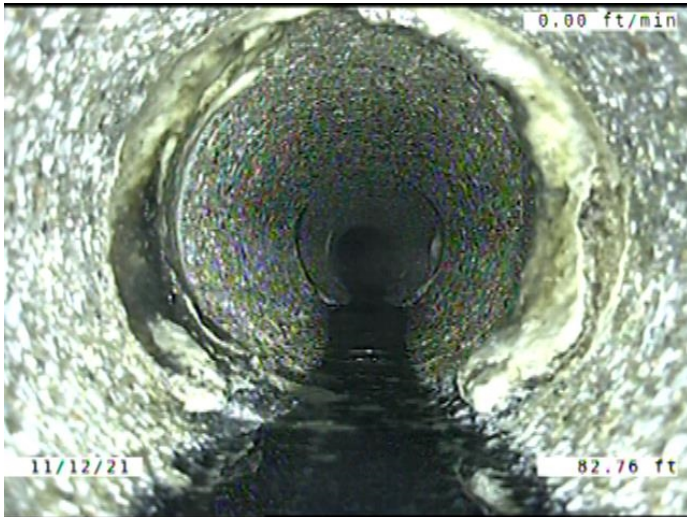
Code: **DAE**
 Description: **Deposits Attached Encrustation**

Distance (ft): **82.8**
 Structural Grade: **0**
 O&M Grade: **2**
 Clock Start/From: **8**
 Clock To: **4**
 1st Value:
 2nd Value:
 Value Percent: **5.000**
 Continuous Index: **F01**
 Within 8" of Joint: **YES**
 Remarks:

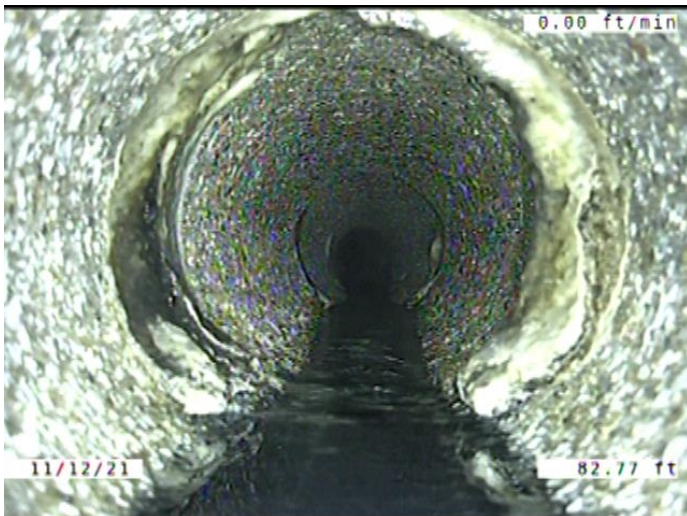
Code: **MSA**
 Description: **Miscellaneous Survey Abandoned**

Distance (ft): **82.8**
 Structural Grade: **0**
 O&M Grade: **0**
 Clock Start/From:
 Clock To:
 1st Value:
 2nd Value:
 Value Percent:
 Continuous Index:
 Within 8" of Joint: **NO**
 Remarks: **CAMERA CANT MAKE IT PAST ENCRUSTATION**
