Profile/Photo Observation Report

Date:	11/12/2021	Weather:		Coding:	PACP 7.0
Pipe Length (ft):	317.0	Owner:	City of Hobart	Pre Clean:	Heavy Cleaning
P.O.#:	YES502259	Surveyor:	Steven Bucklin	PSR:	P-604-005-004
Customer:	City of Hobart, IN (Red	Clean Date:	11/12/2021	Shape:	C

Street:	Willow Place	Flow Control:	Not Controlled
City:	City of Hobart	Year Renewed:	
Location:	Local rural streets with light traffic, t	Tape/Media #:	
Purpose:	Routine Assessment	Dia/Height:	8"
Use:	Sanitary Sewage Pipe	Material:	CP
Drain Area:		Lining:	None
Category:	NA		
Comment:			
Location Details:		Direction of Survey:	Upstream
US MH:	M-604-004	DS MH:	M-604-005
		Total Length Surveyed (ft):	231.7

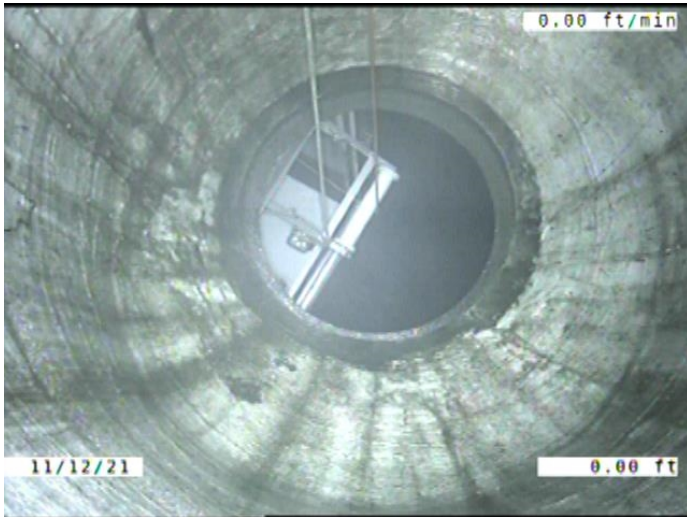
Code: **AMH**
Description: **Manhole**

Distance (ft): **.0**
Structural Grade: **0**
O&M Grade: **0**
Clock Start/From:
Clock To:
1st Value:
2nd Value:
Value Percent:
Continuous Index:
Within 8" of Joint: **NO**
Remarks: **M-604-005**

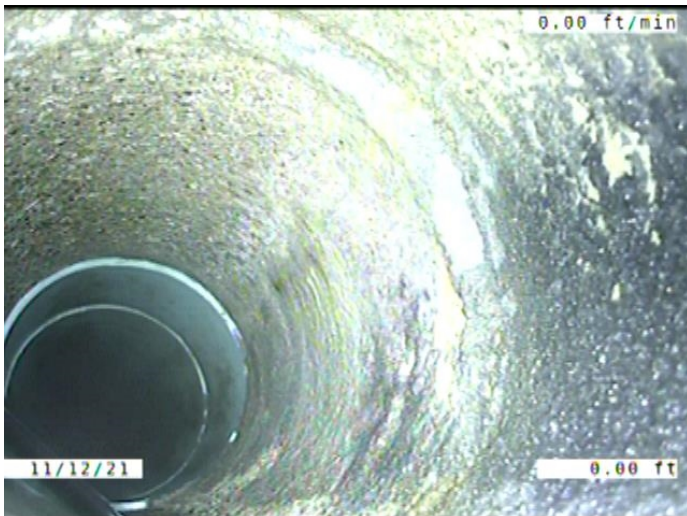
Code: **MWL**
Description: **Miscellaneous Water Level**

Distance (ft): **.0**
Structural Grade: **0**
O&M Grade: **0**
Clock Start/From:
Clock To:
1st Value:
2nd Value:
Value Percent: **5.000**
Continuous Index:
Within 8" of Joint: **NO**
Remarks:

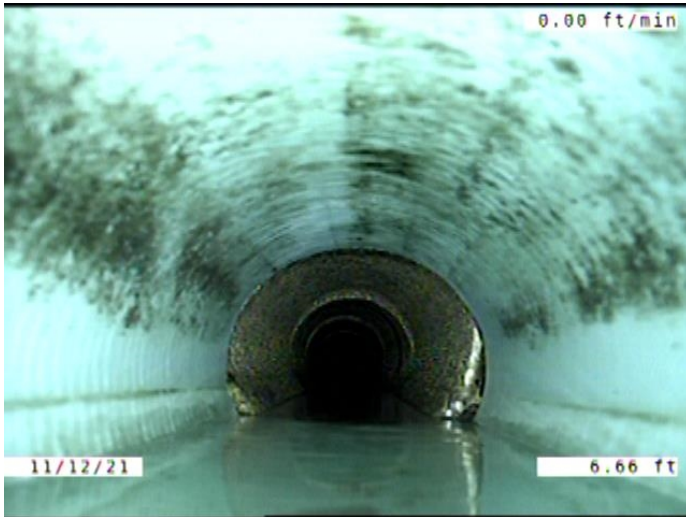
Code:	MWLS
Description:	Miscellaneous Water Level Sag
Distance (ft):	6.7
Structural Grade:	2
O&M Grade:	0
Clock Start/From:	
Clock To:	
1st Value:	
2nd Value:	
Value Percent:	10.000
Continuous Index:	
Within 8" of Joint:	NO
Remarks:

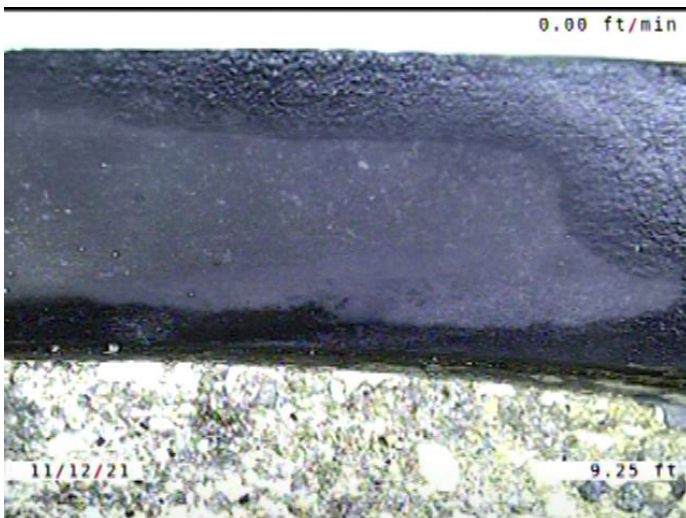
Code:	MMC
Description:	Miscellaneous Material Change
Distance (ft):	9.2
Structural Grade:	0
O&M Grade:	0
Clock Start/From:	
Clock To:	
1st Value:	
2nd Value:	
Value Percent:	
Continuous Index:	
Within 8" of Joint:	NO
Remarks:	PVC TO CONCRETE

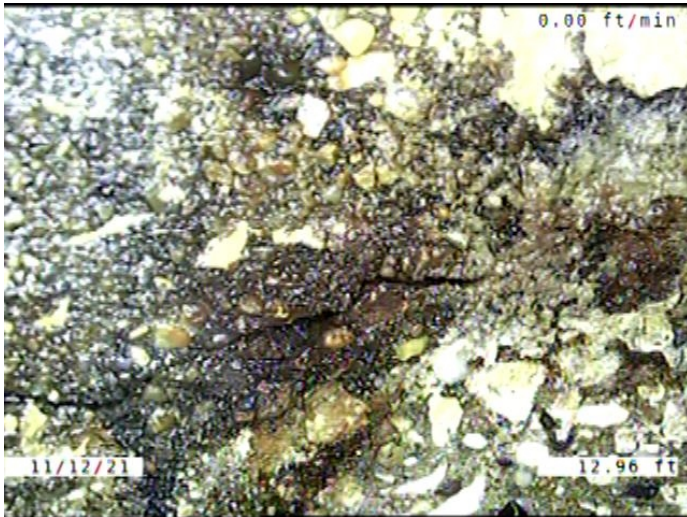
Code: **FC**
 Description: **Fracture Circumferential**

Distance (ft): **13.0**
 Structural Grade: **2**
 O&M Grade: **0**
 Clock Start/From: **3**
 Clock To: **9**
 1st Value:
 2nd Value:
 Value Percent:
 Continuous Index:
 Within 8" of Joint: **NO**
 Remarks:

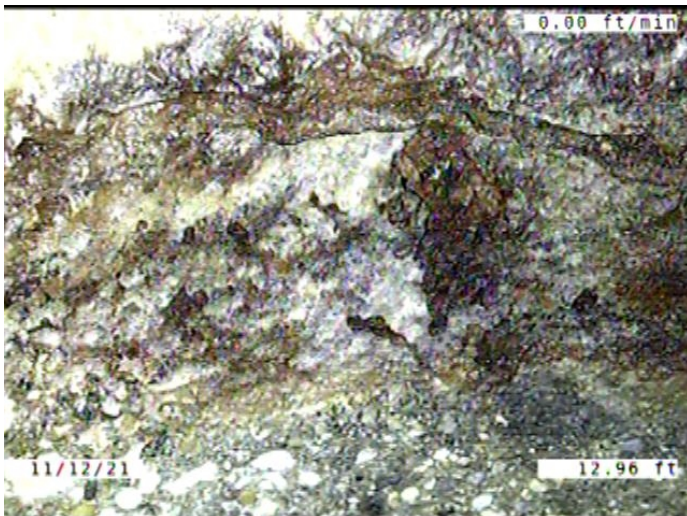
Code: **DAE**
 Description: **Deposits Attached Encrustation**

Distance (ft): **13.0**
 Structural Grade: **0**
 O&M Grade: **2**
 Clock Start/From: **9**
 Clock To: **3**
 1st Value:
 2nd Value:
 Value Percent: **5.000**
 Continuous Index:
 Within 8" of Joint: **NO**
 Remarks:

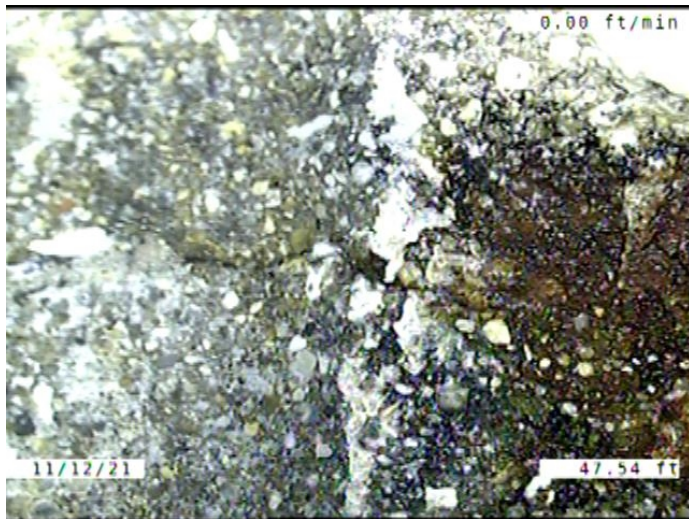
Code: **CM**
Description: **Crack Multiple**

Distance (ft): **47.5**
Structural Grade: **3**
O&M Grade: **0**
Clock Start/From: **4**
Clock To: **9**
1st Value:
2nd Value:
Value Percent:
Continuous Index:
Within 8" of Joint: **NO**
Remarks:

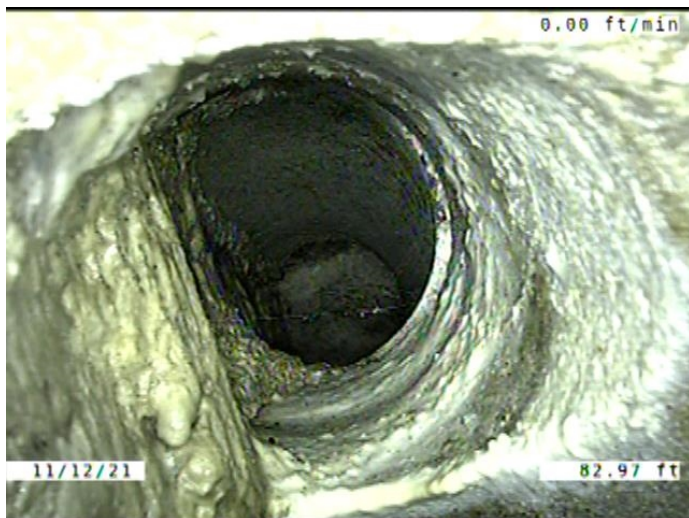
Code: **TF**
Description: **Tap Factory**

Distance (ft): **83.0**
Structural Grade: **0**
O&M Grade: **0**
Clock Start/From: **10**
Clock To:
1st Value: **6.000**
2nd Value:
Value Percent:
Continuous Index:
Within 8" of Joint: **YES**
Remarks: **ENCRUSTATION IN THE TAP**

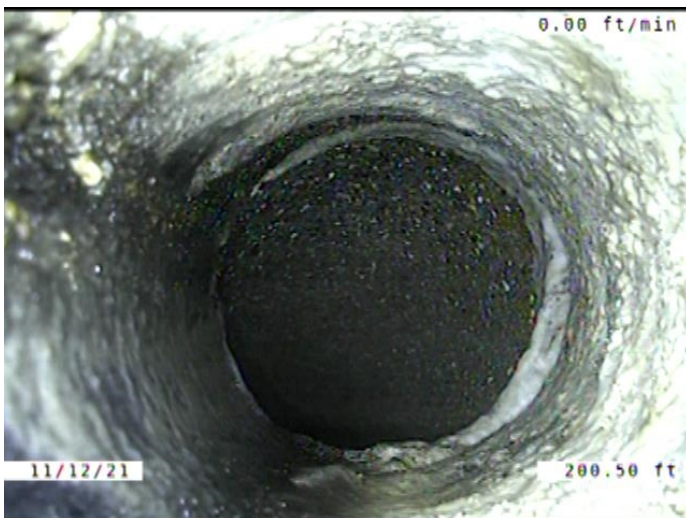
Code: **TF**
Description: **Tap Factory**

Distance (ft): **200.5**
Structural Grade: **0**
O&M Grade: **0**
Clock Start/From: **10**
Clock To:
1st Value: **4.000**
2nd Value:
Value Percent:
Continuous Index:
Within 8" of Joint: **YES**
Remarks: **ENCUSTATION ALL AROUND THE TAP.**

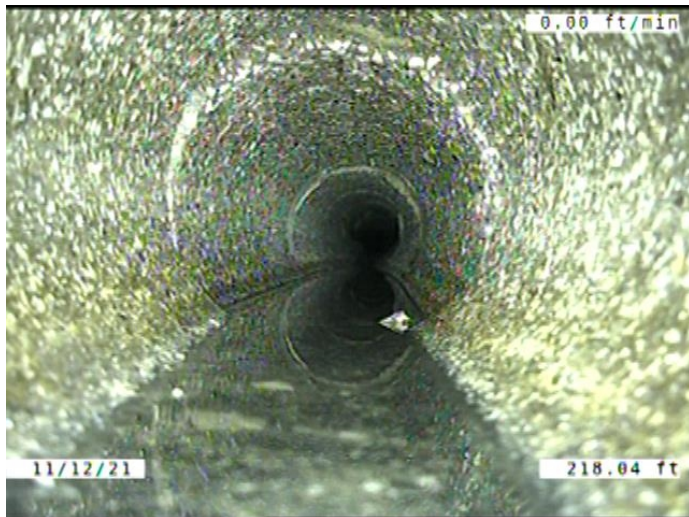
Code: **MWLS**
Description: **Miscellaneous Water Level Sag**

Distance (ft): **218.0**
Structural Grade: **2**
O&M Grade: **0**
Clock Start/From:
Clock To:
1st Value:
2nd Value:
Value Percent: **5.000**
Continuous Index: **S05**
Within 8" of Joint: **NO**
Remarks:

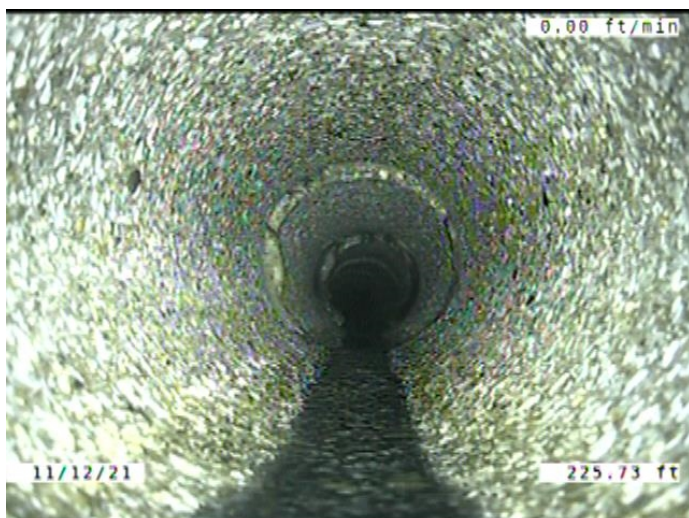
Code: **MWLS**
Description: **Miscellaneous Water Level Sag**

Distance (ft): **225.7**
Structural Grade: **2**
O&M Grade: **0**
Clock Start/From:
Clock To:
1st Value:
2nd Value:
Value Percent: **5.000**
Continuous Index: **F05**
Within 8" of Joint: **NO**
Remarks:

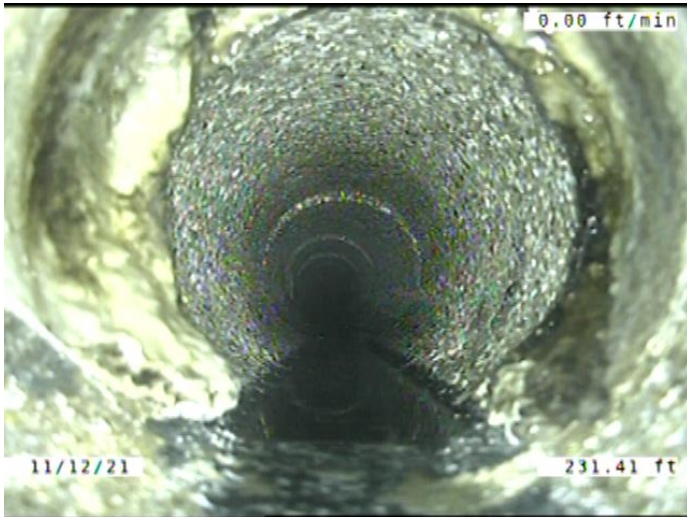
Code: **DAE**
Description: **Deposits Attached Encrustation**

Distance (ft): **231.4**
Structural Grade: **0**
O&M Grade: **2**
Clock Start/From: **8**
Clock To: **4**
1st Value:
2nd Value:
Value Percent: **5.000**
Continuous Index: **F01**
Within 8" of Joint: **YES**
Remarks:

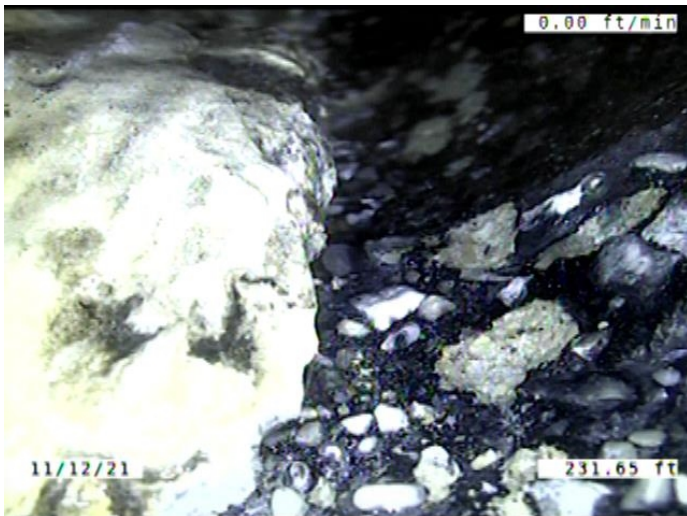
Code: **IDJ**
Description: **Infiltration Dripper Joint**

Distance (ft): **231.7**
Structural Grade: **0**
O&M Grade: **3**
Clock Start/From: **7**
Clock To: **8**
1st Value:
2nd Value:
Value Percent:
Continuous Index:
Within 8" of Joint: **YES**
Remarks:

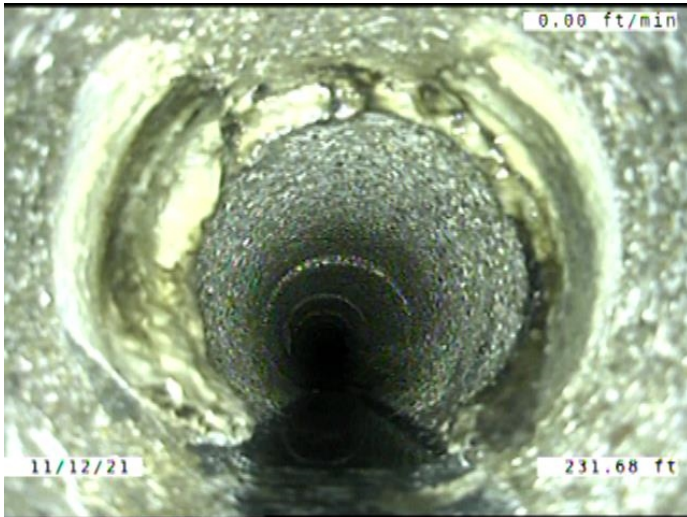
Code:	MSA
Description:	Miscellaneous Survey Abandoned
Distance (ft):	231.7
Structural Grade:	0
O&M Grade:	0
Clock Start/From:	
Clock To:	
1st Value:	
2nd Value:	
Value Percent:	
Continuous Index:	
Within 8" of Joint:	NO
Remarks:	MADE IT TO THE POINT OF OVERLAP. REVERSAL COMPLETE.
