Profile/Photo Observation Report

Date:	11/12/2021	Weather:		Coding:	PACP 7.0
Pipe Length (ft):	317.0	Owner:	City of Hobart	Pre Clean:	Heavy Cleaning
P.O.#:	YES502259	Surveyor:	Steven Bucklin	PSR:	P-604-005-004
Customer:	City of Hobart, IN (Red	Clean Date:	11/12/2021	Shape:	C

Street:	Willow Place	Flow Control:	Not Controlled
City:	City of Hobart	Year Renewed:	
Location:	Local rural streets with light traffic, t	Tape/Media #:	
Purpose:	Routine Assessment	Dia/Height:	8"
Use:	Sanitary Sewage Pipe	Material:	CP
Drain Area:		Lining:	None
Category:	NA		
Comment:			
Location Details:		Direction of Survey:	Upstream
US MH:	M-604-004	DS MH:	M-604-005
		Total Length Surveyed (ft):	231.7

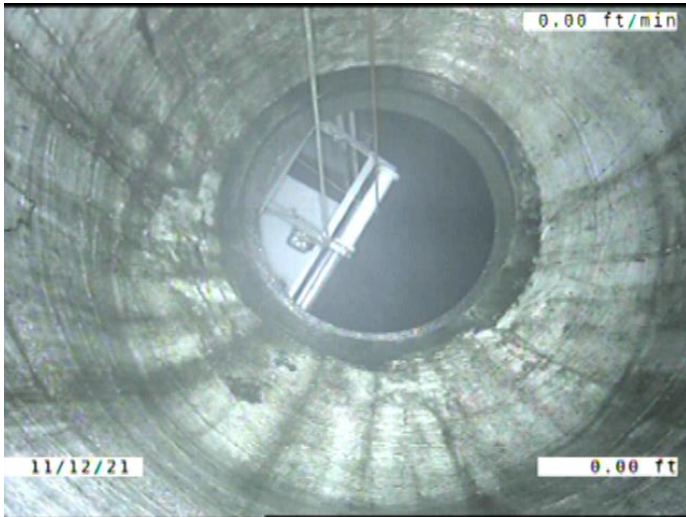
Code: **AMH**
 Description: **Manhole**

Distance (ft): **.0**
 Structural Grade: **0**
 O&M Grade: **0**
 Clock Start/From:
 Clock To:
 1st Value:
 2nd Value:
 Value Percent:
 Continuous Index:
 Within 8" of Joint: **NO**
 Remarks: **M-604-005**

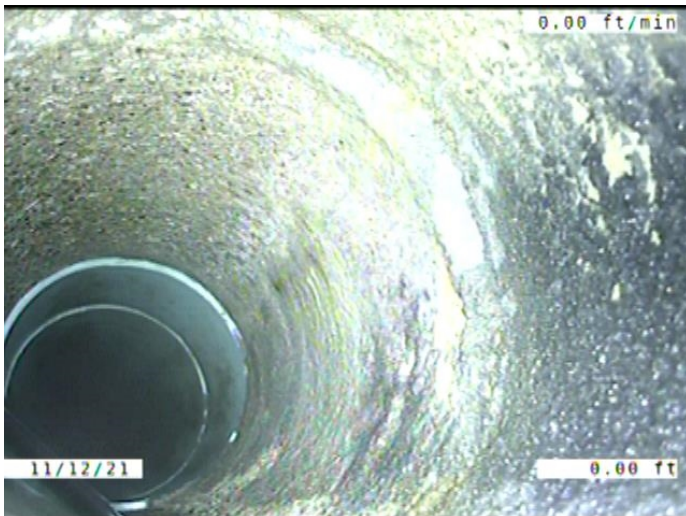
Code: **MWL**
 Description: **Miscellaneous Water Level**

Distance (ft): **.0**
 Structural Grade: **0**
 O&M Grade: **0**
 Clock Start/From:
 Clock To:
 1st Value:
 2nd Value:
 Value Percent: **5.000**
 Continuous Index:
 Within 8" of Joint: **NO**
 Remarks:

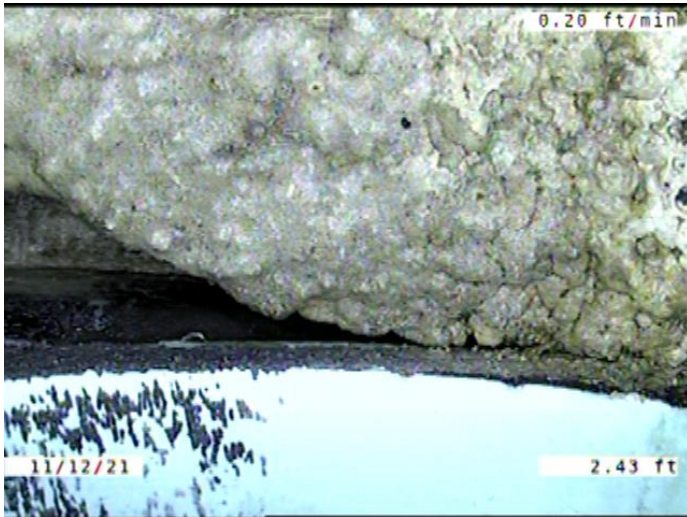
Code: **DAE**
 Description: **Deposits Attached Encrustation**

Distance (ft): **2.4**
 Structural Grade: **0**
 O&M Grade: **2**
 Clock Start/From: **8**
 Clock To: **4**
 1st Value:
 2nd Value:
 Value Percent: **5.000**
 Continuous Index:
 Within 8" of Joint: **YES**
 Remarks:

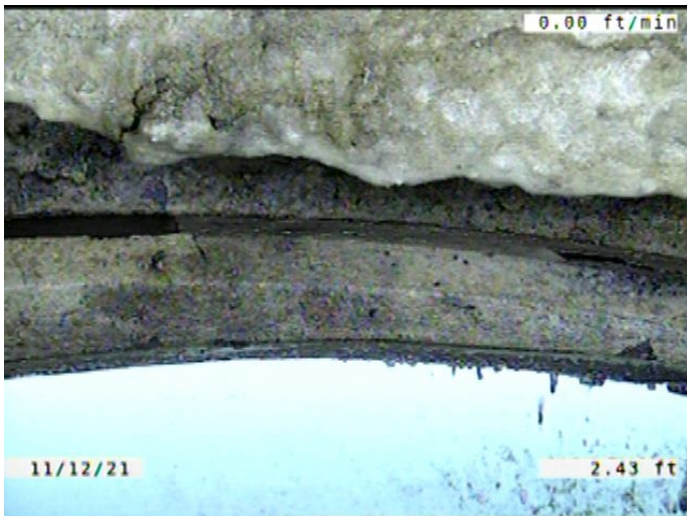
Code: **MMC**
 Description: **Miscellaneous Material Change**

Distance (ft): **2.4**
 Structural Grade: **0**
 O&M Grade: **0**
 Clock Start/From:
 Clock To:
 1st Value:
 2nd Value:
 Value Percent:
 Continuous Index:
 Within 8" of Joint: **NO**
 Remarks: **CONCRETE TO PVC**

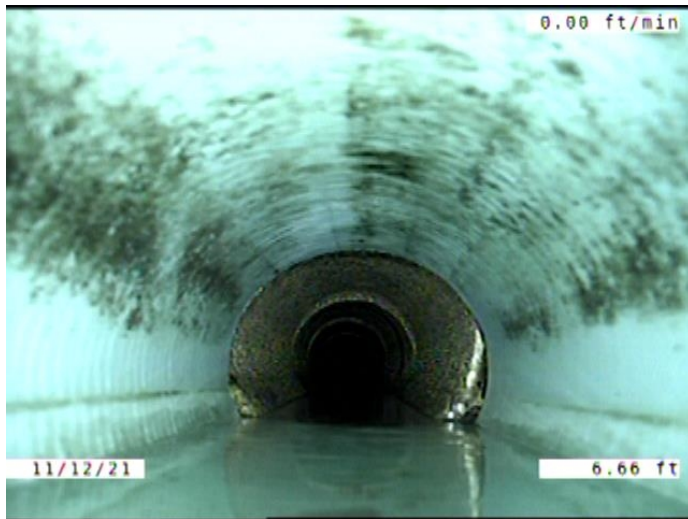
Code: **MWLS**
 Description: **Miscellaneous Water Level Sag**

Distance (ft): **6.7**
 Structural Grade: **2**
 O&M Grade: **0**
 Clock Start/From:
 Clock To:
 1st Value:
 2nd Value:
 Value Percent: **10.000**
 Continuous Index:
 Within 8" of Joint: **NO**
 Remarks:

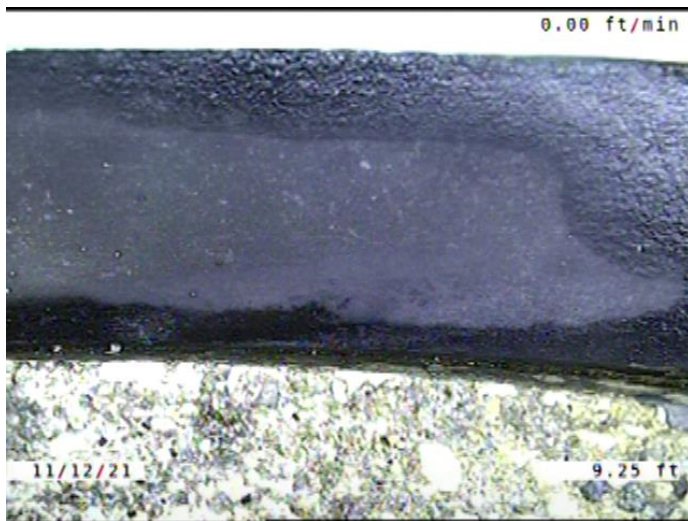
Code: **MMC**
 Description: **Miscellaneous Material Change**

Distance (ft): **9.2**
 Structural Grade: **0**
 O&M Grade: **0**
 Clock Start/From:
 Clock To:
 1st Value:
 2nd Value:
 Value Percent:
 Continuous Index:
 Within 8" of Joint: **NO**
 Remarks: **PVC TO CONCRETE**

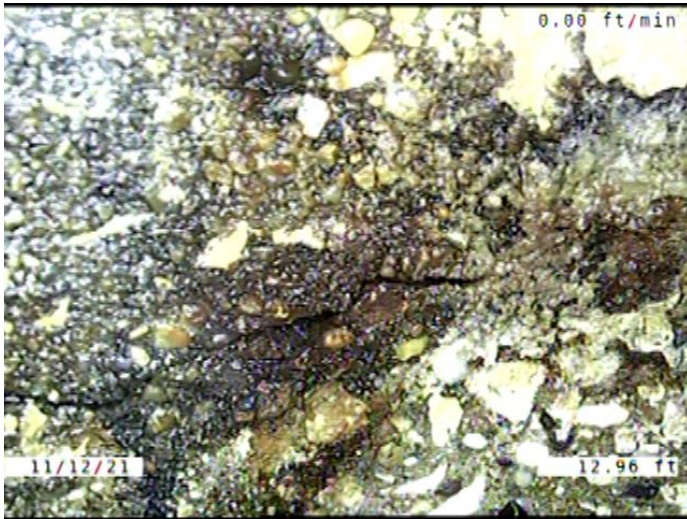
Code: **FC**
Description: **Fracture Circumferential**

Distance (ft): **13.0**
Structural Grade: **2**
O&M Grade: **0**
Clock Start/From: **3**
Clock To: **9**
1st Value:
2nd Value:
Value Percent:
Continuous Index:
Within 8" of Joint: **NO**
Remarks:

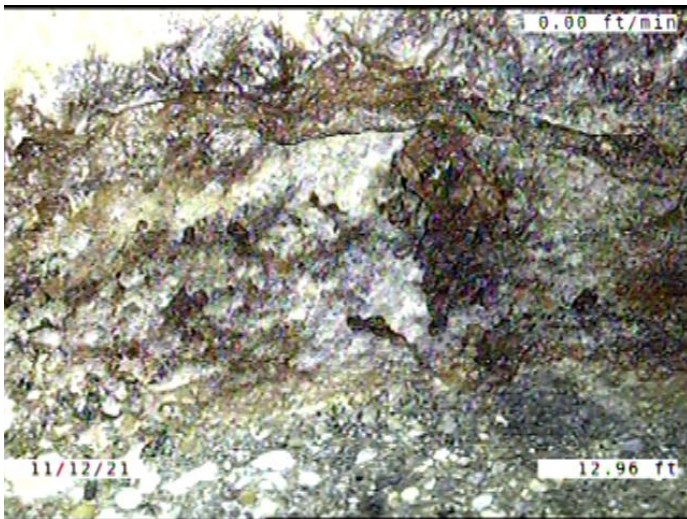
Code: **DAE**
Description: **Deposits Attached Encrustation**

Distance (ft): **13.0**
Structural Grade: **0**
O&M Grade: **2**
Clock Start/From: **9**
Clock To: **3**
1st Value:
2nd Value:
Value Percent: **5.000**
Continuous Index:
Within 8" of Joint: **NO**
Remarks:

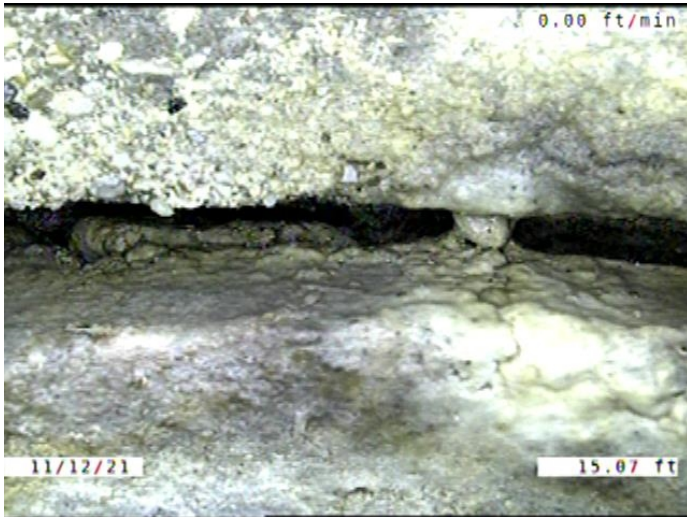
Code: **DAE**
 Description: **Deposits Attached Encrustation**

Distance (ft): **15.1**
 Structural Grade: **0**
 O&M Grade: **2**
 Clock Start/From: **8**
 Clock To: **4**
 1st Value:
 2nd Value:
 Value Percent: **5.000**
 Continuous Index: **S01**
 Within 8" of Joint: **YES**
 Remarks:

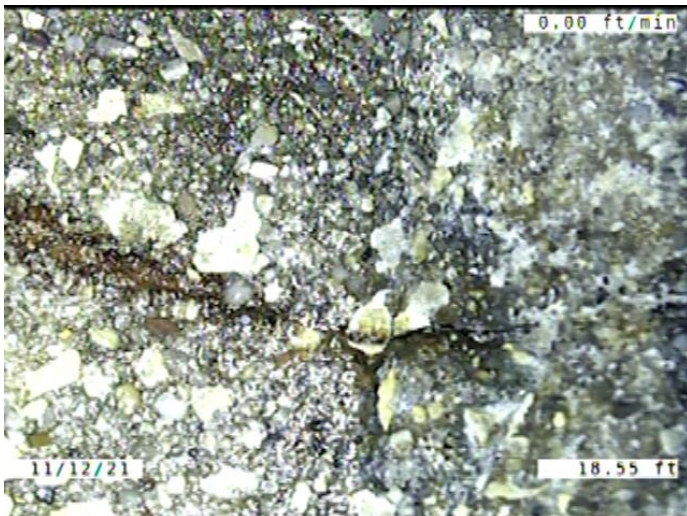
Code: **FM**
 Description: **Fracture Multiple**

Distance (ft): **18.5**
 Structural Grade: **4**
 O&M Grade: **0**
 Clock Start/From: **4**
 Clock To: **9**
 1st Value:
 2nd Value:
 Value Percent:
 Continuous Index:
 Within 8" of Joint: **NO**
 Remarks:

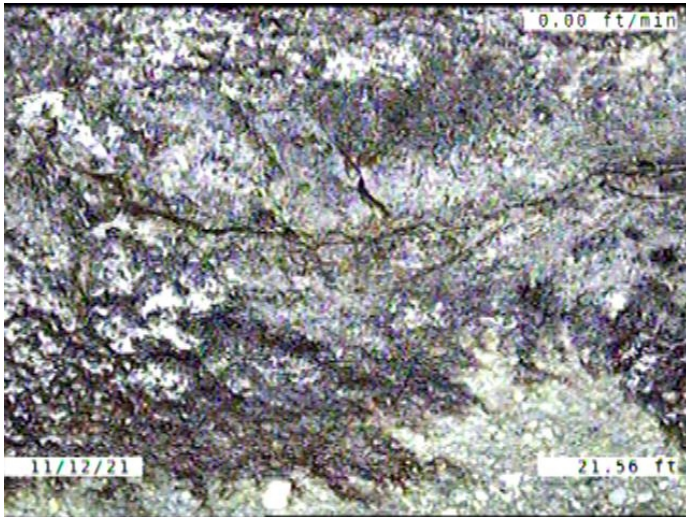
Code: **FM**
 Description: **Fracture Multiple**

Distance (ft): **21.6**
 Structural Grade: **4**
 O&M Grade: **0**
 Clock Start/From: **10**
 Clock To: **3**
 1st Value:
 2nd Value:
 Value Percent:
 Continuous Index:
 Within 8" of Joint: **NO**
 Remarks:

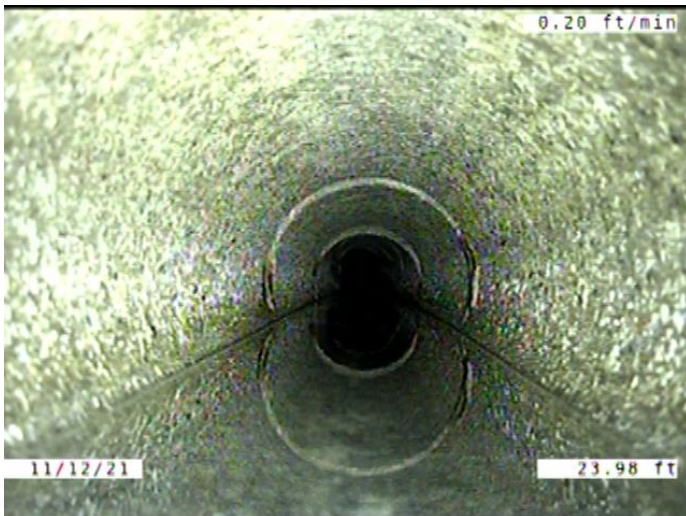
Code: **MWLS**
 Description: **Miscellaneous Water Level Sag**

Distance (ft): **24.0**
 Structural Grade: **2**
 O&M Grade: **0**
 Clock Start/From:
 Clock To:
 1st Value:
 2nd Value:
 Value Percent: **10.000**
 Continuous Index: **S02**
 Within 8" of Joint: **NO**
 Remarks:

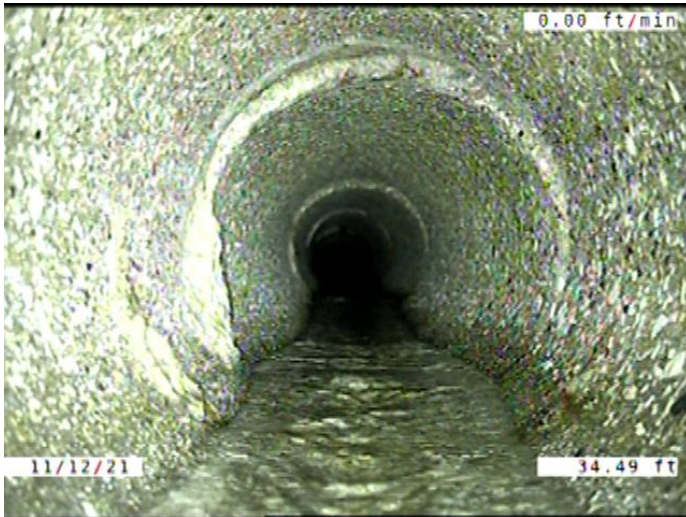
Code: **MWLS**
 Description: **Miscellaneous Water Level Sag**

Distance (ft): **34.5**
 Structural Grade: **2**
 O&M Grade: **0**
 Clock Start/From:
 Clock To:
 1st Value:
 2nd Value:
 Value Percent: **10.000**
 Continuous Index: **F02**
 Within 8" of Joint: **NO**
 Remarks:

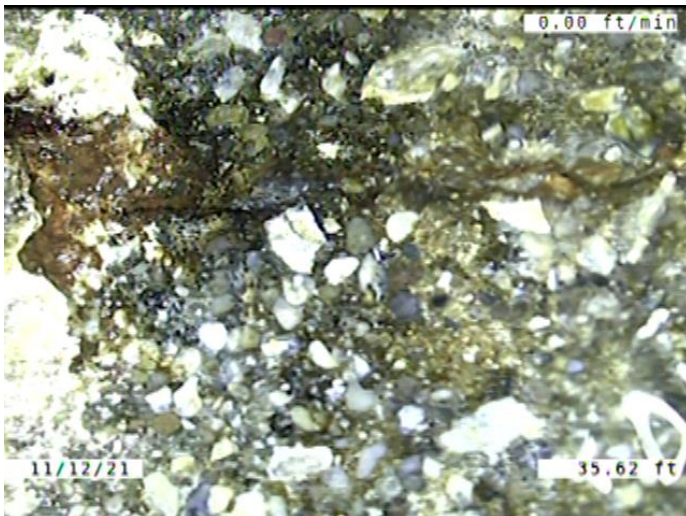
Code: **FM**
 Description: **Fracture Multiple**

Distance (ft): **35.6**
 Structural Grade: **4**
 O&M Grade: **0**
 Clock Start/From: **4**
 Clock To: **8**
 1st Value:
 2nd Value:
 Value Percent:
 Continuous Index:
 Within 8" of Joint: **NO**
 Remarks:

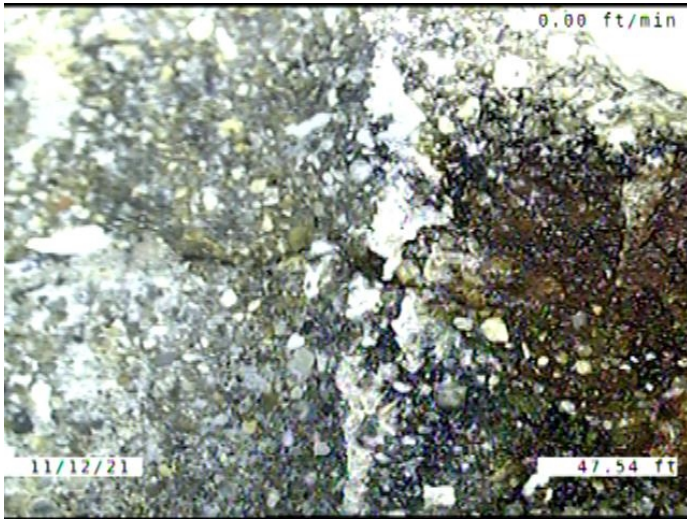
Code: **CM**
Description: **Crack Multiple**

Distance (ft): **47.5**
Structural Grade: **3**
O&M Grade: **0**
Clock Start/From: **4**
Clock To: **9**
1st Value:
2nd Value:
Value Percent:
Continuous Index:
Within 8" of Joint: **NO**
Remarks:

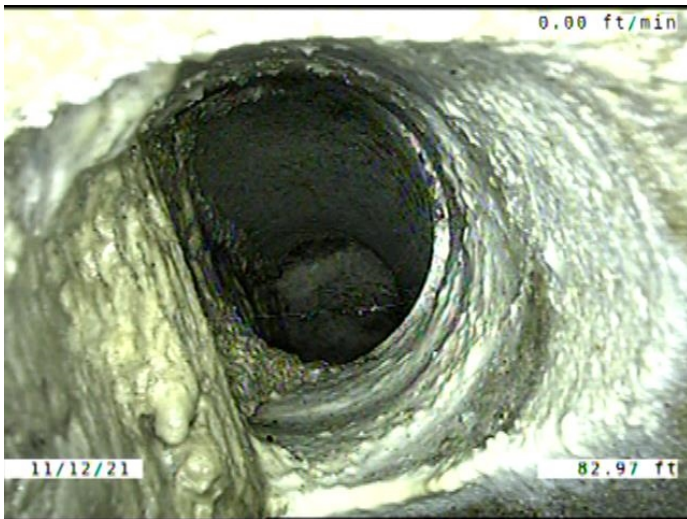
Code: **TF**
Description: **Tap Factory**

Distance (ft): **83.0**
Structural Grade: **0**
O&M Grade: **0**
Clock Start/From: **10**
Clock To:
1st Value: **6.000**
2nd Value:
Value Percent:
Continuous Index:
Within 8" of Joint: **YES**
Remarks: **ENCRUSTATION IN THE TAP**

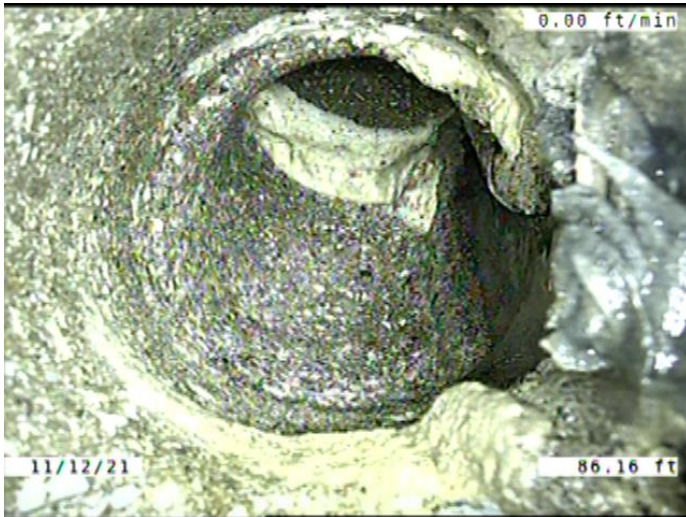
Code: **TF**
Description: **Tap Factory**

Distance (ft): **86.2**
Structural Grade: **0**
O&M Grade: **0**
Clock Start/From: **2**
Clock To:
1st Value: **6.000**
2nd Value:
Value Percent:
Continuous Index:
Within 8" of Joint: **YES**
Remarks: **ENCRUSTATION AT THE JOINTS.**

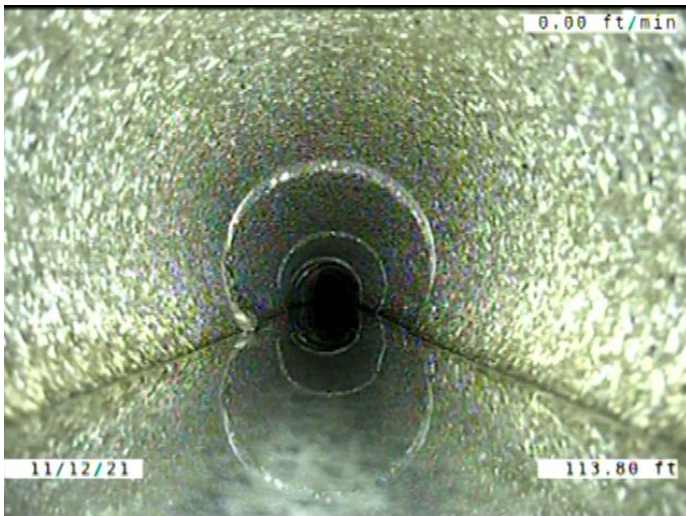
Code: **MWLS**
Description: **Miscellaneous Water Level Sag**

Distance (ft): **113.8**
Structural Grade: **2**
O&M Grade: **0**
Clock Start/From:
Clock To:
1st Value:
2nd Value:
Value Percent: **10.000**
Continuous Index: **S03**
Within 8" of Joint: **NO**
Remarks:

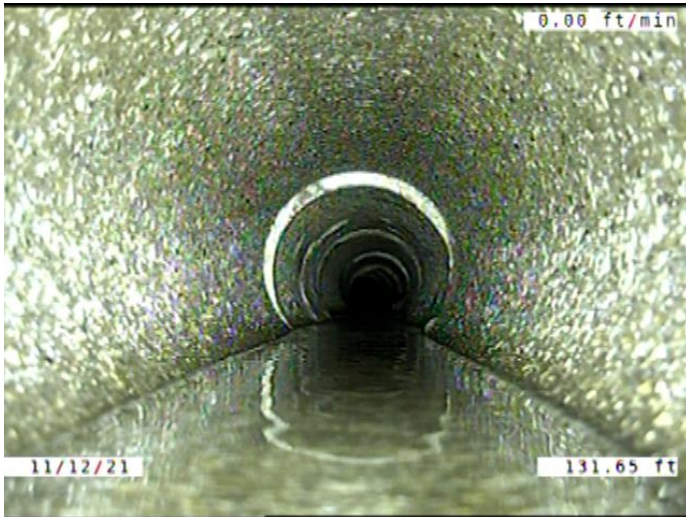
Code: **MWLS**
 Description: **Miscellaneous Water Level Sag**

Distance (ft): **131.6**
 Structural Grade: **2**
 O&M Grade: **0**
 Clock Start/From:
 Clock To:
 1st Value:
 2nd Value:
 Value Percent: **10.000**
 Continuous Index: **F03**
 Within 8" of Joint: **NO**
 Remarks:

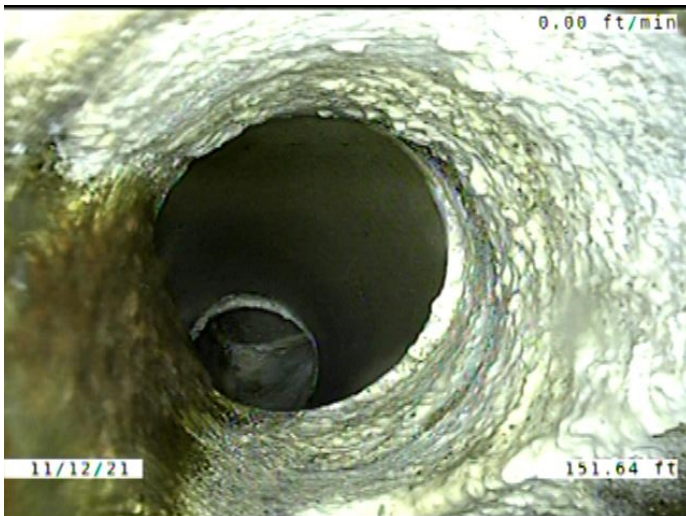
Code: **TFD**
 Description: **Tap Factory Defective**

Distance (ft): **151.6**
 Structural Grade: **0**
 O&M Grade: **3**
 Clock Start/From: **10**
 Clock To:
 1st Value: **6.000**
 2nd Value:
 Value Percent:
 Continuous Index:
 Within 8" of Joint: **YES**
 Remarks: **LARGE AMOUNT OF WATER FLOW
 CONSTANTLY. ENCRUSTATION ALL A**

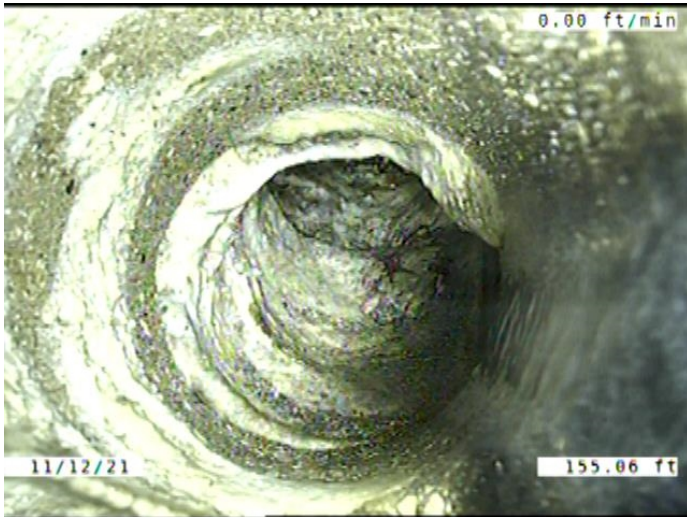
Code:	TF
Description:	Tap Factory
Distance (ft):	155.1
Structural Grade:	0
O&M Grade:	0
Clock Start/From:	2
Clock To:	
1st Value:	6.000
2nd Value:	
Value Percent:	
Continuous Index:	
Within 8" of Joint:	YES
Remarks:	ENCUSTATION ALL AROUND THE TAP.

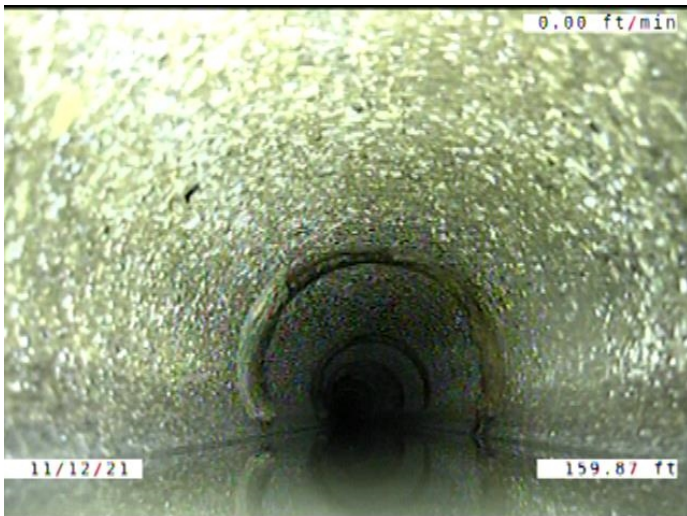
Code:	MWLS
Description:	Miscellaneous Water Level Sag
Distance (ft):	159.9
Structural Grade:	2
O&M Grade:	0
Clock Start/From:	
Clock To:	
1st Value:	
2nd Value:	
Value Percent:	10.000
Continuous Index:	S04
Within 8" of Joint:	NO
Remarks:

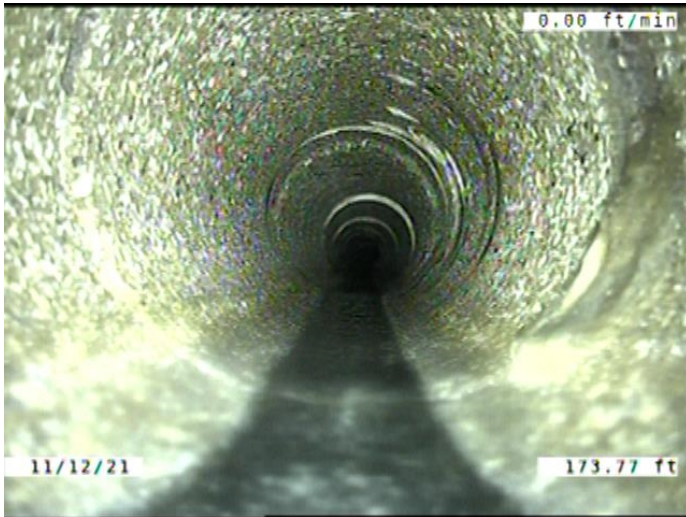
Code: **MWLS**
 Description: **Miscellaneous Water Level Sag**

Distance (ft): **173.8**
 Structural Grade: **2**
 O&M Grade: **0**
 Clock Start/From:
 Clock To:
 1st Value:
 2nd Value:
 Value Percent: **10.000**
 Continuous Index: **F04**
 Within 8" of Joint: **NO**
 Remarks:

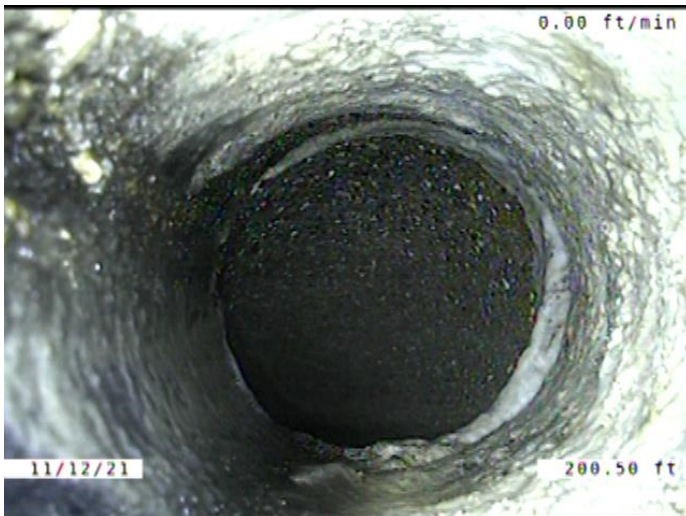
Code: **TF**
 Description: **Tap Factory**

Distance (ft): **200.5**
 Structural Grade: **0**
 O&M Grade: **0**
 Clock Start/From: **10**
 Clock To:
 1st Value: **4.000**
 2nd Value:
 Value Percent:
 Continuous Index:
 Within 8" of Joint: **YES**
 Remarks: **ENCUSTATION ALL AROUND THE TAP.**

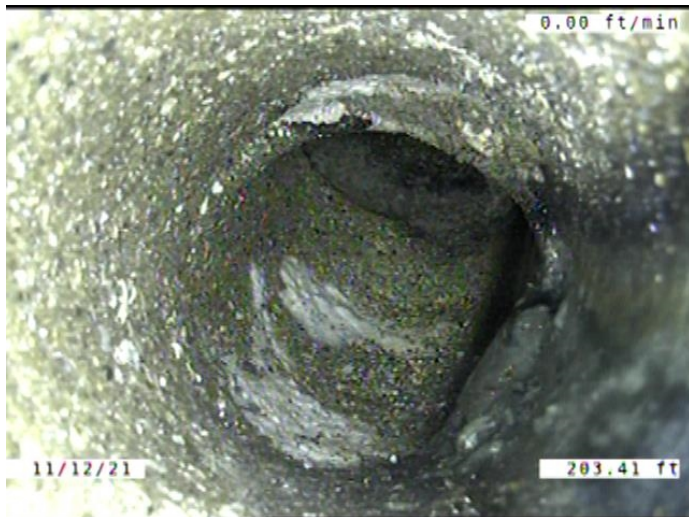
Code: **TF**
Description: **Tap Factory**

Distance (ft): **203.4**
Structural Grade: **0**
O&M Grade: **0**
Clock Start/From: **2**
Clock To:
1st Value: **4.000**
2nd Value:
Value Percent:
Continuous Index:
Within 8" of Joint: **YES**
Remarks: **CONSTANTLY RUNNING WATER.**

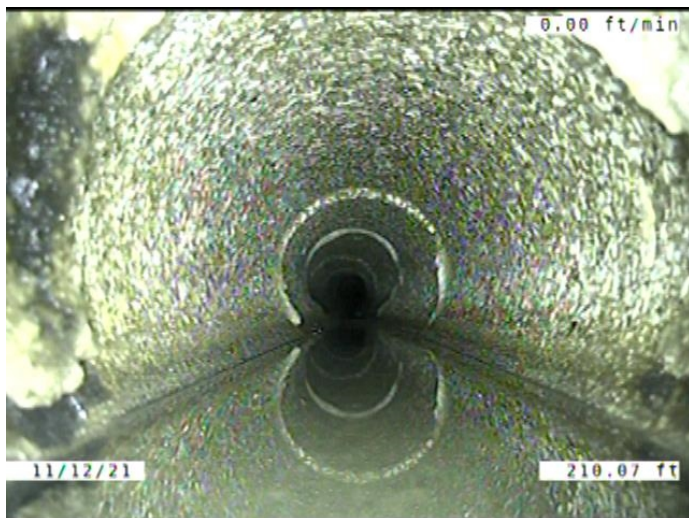
Code: **MWLS**
Description: **Miscellaneous Water Level Sag**

Distance (ft): **210.1**
Structural Grade: **2**
O&M Grade: **0**
Clock Start/From:
Clock To:
1st Value:
2nd Value:
Value Percent: **5.000**
Continuous Index:
Within 8" of Joint: **NO**
Remarks:

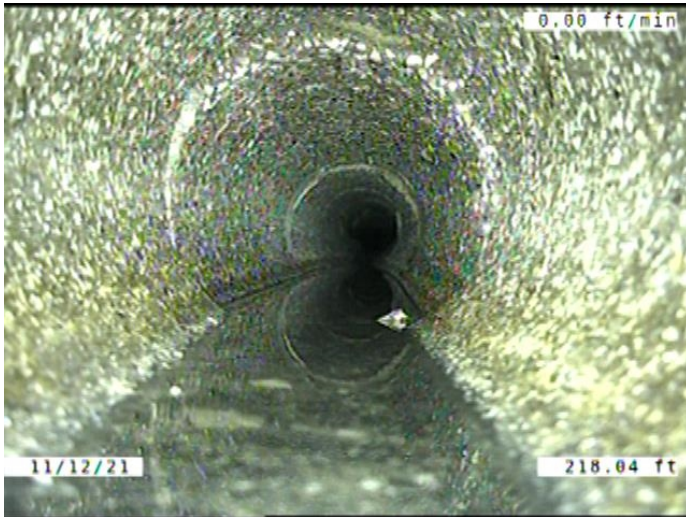
Code: **MWLS**
Description: **Miscellaneous Water Level Sag**

Distance (ft): **218.0**
Structural Grade: **2**
O&M Grade: **0**
Clock Start/From:
Clock To:
1st Value:
2nd Value:
Value Percent: **5.000**
Continuous Index: **S05**
Within 8" of Joint: **NO**
Remarks:

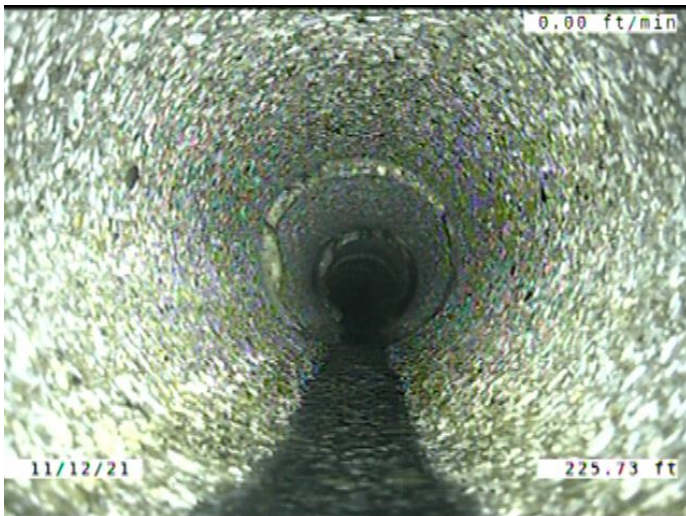
Code: **MWLS**
Description: **Miscellaneous Water Level Sag**

Distance (ft): **225.7**
Structural Grade: **2**
O&M Grade: **0**
Clock Start/From:
Clock To:
1st Value:
2nd Value:
Value Percent: **5.000**
Continuous Index: **F05**
Within 8" of Joint: **NO**
Remarks:

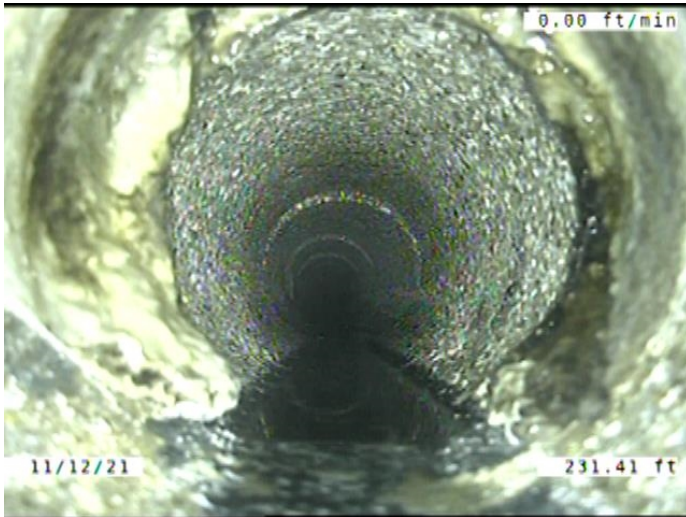
Code: **DAE**
Description: **Deposits Attached Encrustation**

Distance (ft): **231.4**
Structural Grade: **0**
O&M Grade: **2**
Clock Start/From: **8**
Clock To: **4**
1st Value:
2nd Value:
Value Percent: **5.000**
Continuous Index: **F01**
Within 8" of Joint: **YES**
Remarks:

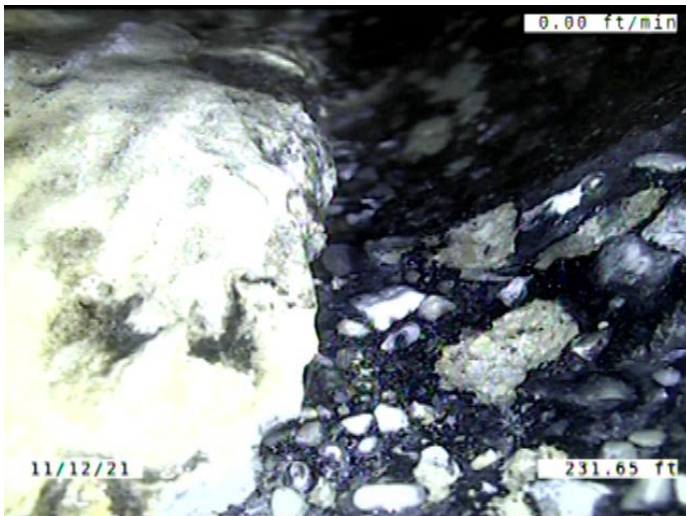
Code: **IDJ**
Description: **Infiltration Dripper Joint**

Distance (ft): **231.7**
Structural Grade: **0**
O&M Grade: **3**
Clock Start/From: **7**
Clock To: **8**
1st Value:
2nd Value:
Value Percent:
Continuous Index:
Within 8" of Joint: **YES**
Remarks:

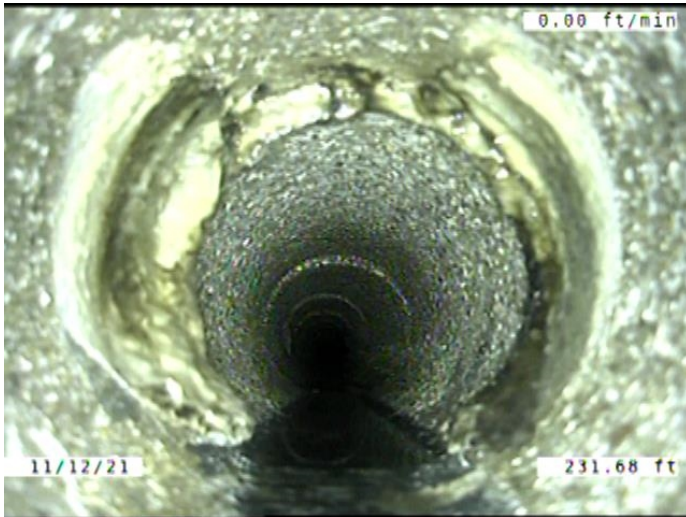
Code:	MSA
Description:	Miscellaneous Survey Abandoned
Distance (ft):	231.7
Structural Grade:	0
O&M Grade:	0
Clock Start/From:	
Clock To:	
1st Value:	
2nd Value:	
Value Percent:	
Continuous Index:	
Within 8" of Joint:	NO
Remarks:	MADE IT TO THE POINT OF OVERLAP. REVERSAL COMPLETE.
