Profile/Photo Observation Report

Date:	04/23/2018	Weather:		Coding:	PACP 6.0
Pipe Length (ft):	297.6	Owner:	NA	Pre Clean:	Not Known
P.O.#:		Surveyor:	Jen Costello	PSR:	P-604-007-006
Customer:		Clean Date:	01/01/1900	Shape:	C

Street:	BEVERLY BLVD	Flow Control:	Not Controlled
City:	Hobart, IN	Year Renewed:	
Location:	Other	Tape/Media #:	
Purpose:	Not Known	Dia/Height:	10"
Use:	Sanitary	Material:	VCP
Drain Area:	NA	Lining:	
Category:	NA		
Comment:

Location Details:		Direction of Survey:	Upstream
US MH:	M-604-006	DS MH:	M-604-007
		Total Length Surveyed (ft):	89.8

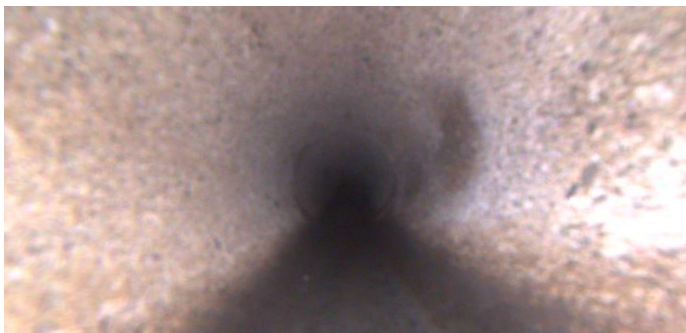
Code: **AMH**
Description: **Manhole**

Distance (ft): **.0**
Structural Grade: **0**
O&M Grade: **0**
Clock Start/From:
Clock To:
1st Value:
2nd Value:
Value Percent:
Continuous Index:
Within 8" of Joint: **NO**
Remarks: **M-604-007**

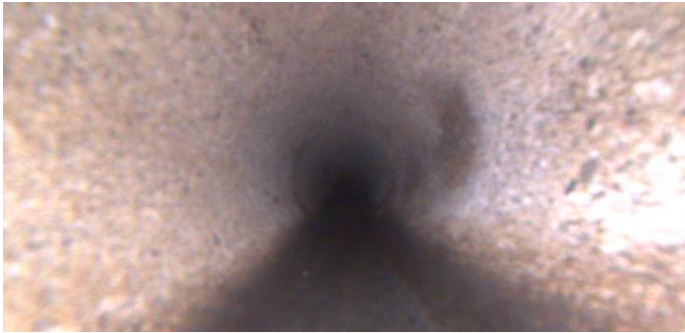
Code:	MWL
Description:	Water Level

Distance (ft):	.0
Structural Grade:	0
O&M Grade:	0
Clock Start/From:	
Clock To:	
1st Value:	
2nd Value:	
Value Percent:	5.000
Continuous Index:	
Within 8" of Joint:	NO
Remarks:

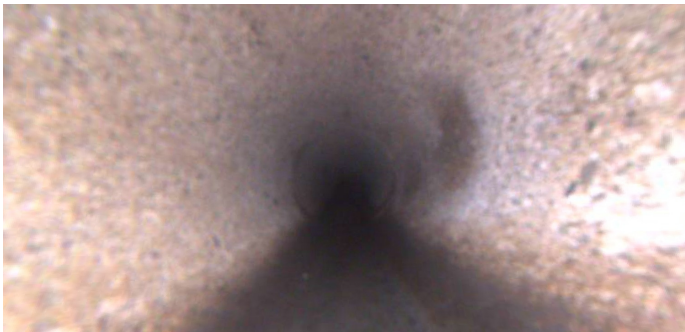
Code:	SAP
Description:	Surface Aggregate Projecting

Distance (ft):	.0
Structural Grade:	3
O&M Grade:	0
Clock Start/From:	7
Clock To:	5
1st Value:	
2nd Value:	
Value Percent:	
Continuous Index:	S01
Within 8" of Joint:	
Remarks:

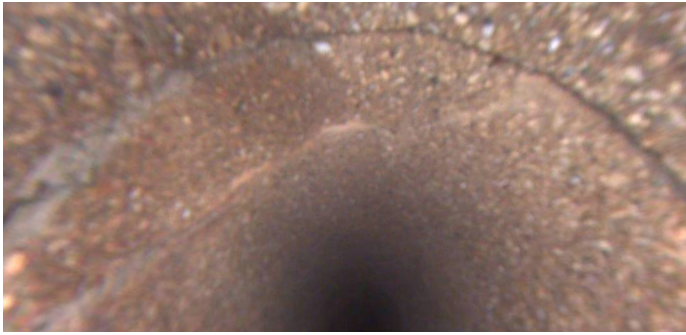
Code: **FM**
Description: **Fracture Multiple**

Distance (ft): **39.1**
Structural Grade: **4**
O&M Grade: **0**
Clock Start/From: **8**
Clock To: **12**
1st Value:
2nd Value:
Value Percent:
Continuous Index:
Within 8" of Joint: **YES**
Remarks:

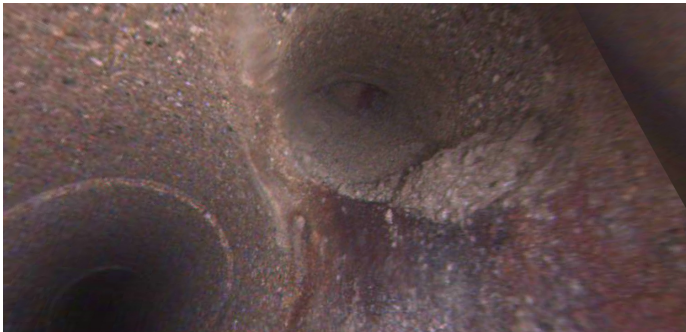
Code: **TFC**
Description: **Tap Factory Capped**

Distance (ft): **43.9**
Structural Grade: **0**
O&M Grade: **0**
Clock Start/From: **10**
Clock To:
1st Value: **4.000**
2nd Value:
Value Percent:
Continuous Index:
Within 8" of Joint:
Remarks:

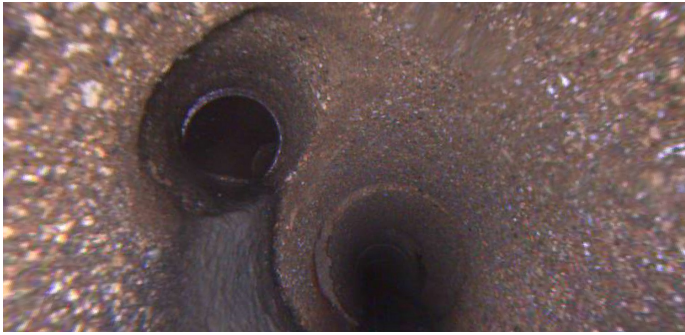
Code: **TFA**
Description: **Tap Factory Active**

Distance (ft): **47.4**
Structural Grade: **0**
O&M Grade: **0**
Clock Start/From: **2**
Clock To:
1st Value: **4.000**
2nd Value:
Value Percent:
Continuous Index:
Within 8" of Joint:
Remarks:

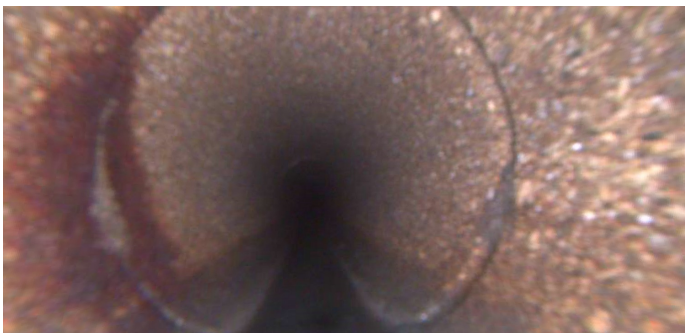
Code: **IS**
Description: **Infil Stain**

Distance (ft): **51.0**
Structural Grade: **0**
O&M Grade: **0**
Clock Start/From: **8**
Clock To: **11**
1st Value:
2nd Value:
Value Percent:
Continuous Index:
Within 8" of Joint: **YES**
Remarks:

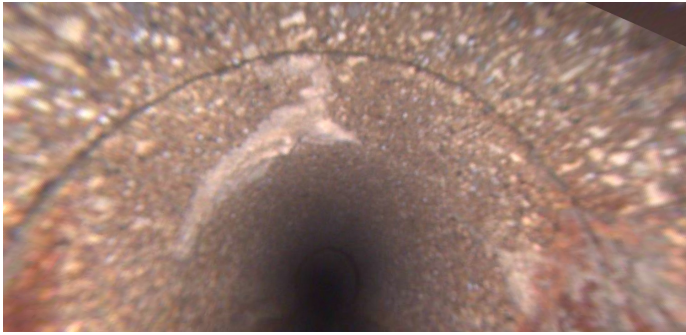
Code: **FL**
Description: **Fracture Longitudinal**

Distance (ft): **54.2**
Structural Grade: **3**
O&M Grade: **0**
Clock Start/From: **12**
Clock To:
1st Value:
2nd Value:
Value Percent:
Continuous Index:
Within 8" of Joint: **YES**
Remarks:

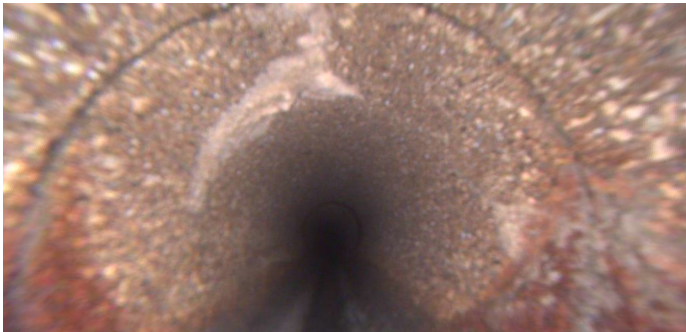
Code: **IS**
Description: **Infil Stain**

Distance (ft): **54.2**
Structural Grade: **0**
O&M Grade: **0**
Clock Start/From: **8**
Clock To: **4**
1st Value:
2nd Value:
Value Percent:
Continuous Index: **S02**
Within 8" of Joint: **YES**
Remarks:

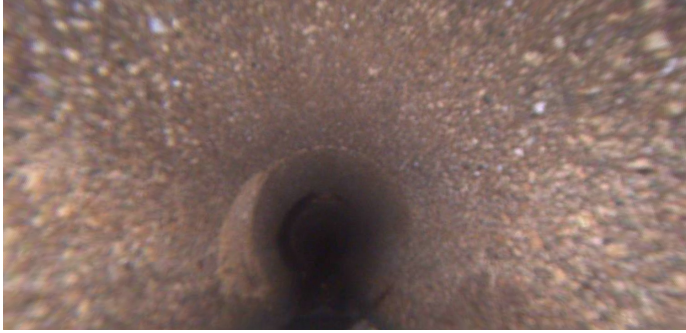
Code: **SAP**
Description: **Surface Aggregate Projecting**

Distance (ft): **89.8**
Structural Grade: **3**
O&M Grade: **0**
Clock Start/From: **7**
Clock To: **5**
1st Value:
2nd Value:
Value Percent:
Continuous Index: **F01**
Within 8" of Joint:
Remarks:

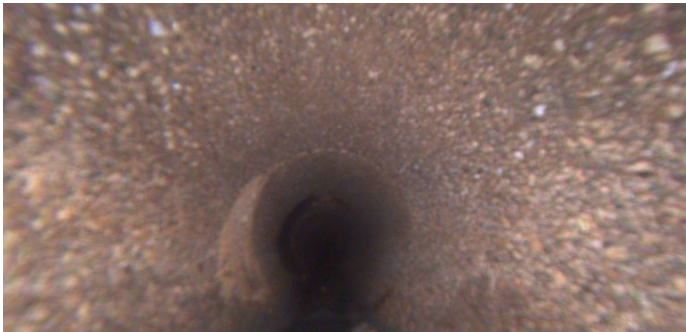
Code: **IS**
Description: **Infil Stain**

Distance (ft): **89.8**
Structural Grade: **0**
O&M Grade: **0**
Clock Start/From: **8**
Clock To: **4**
1st Value:
2nd Value:
Value Percent:
Continuous Index: **F02**
Within 8" of Joint: **YES**
Remarks:

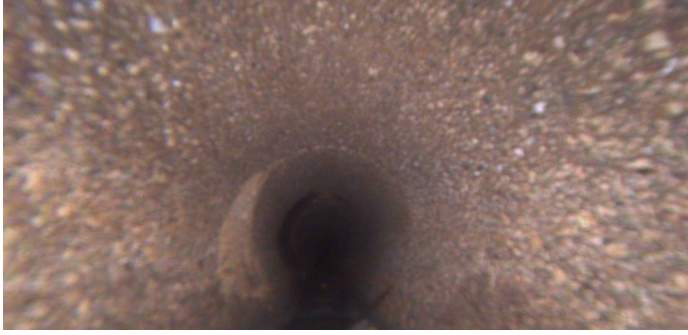
Code:	MSA
Description:	Abandoned Survey
Distance (ft):	89.8
Structural Grade:	0
O&M Grade:	0
Clock Start/From:	
Clock To:	
1st Value:	
2nd Value:	
Value Percent:	
Continuous Index:	
Within 8" of Joint:	NO
Remarks:	debris
