Profile/Photo Observation Report

Street:	Beverly Blvd.	Flow Control:	Not Controlled
City:	Hobart, IN	Year Renewed:	
Location:	Other	Tape/Media #:	
Purpose:	Not Known	Dia/Height:	10"
Use:	Sanitary	Material:	VCP
Drain Area:	NA	Lining:	
Category:	NA		
Comment:

Location Details:		Direction of Survey:	Upstream
US MH:	M-604-006	DS MH:	M-604-007
		Total Length Surveyed (ft):	89.8

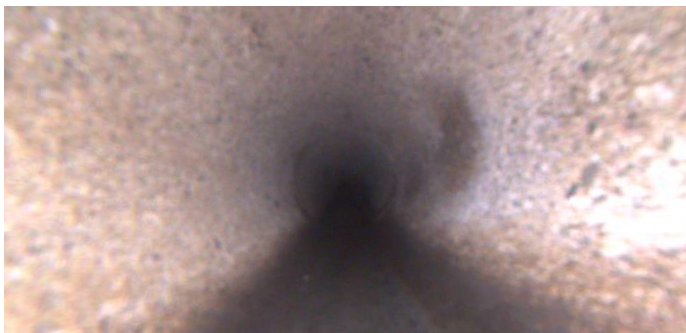
Code: **AMH**
Description: **Manhole**

Distance (ft): **.0**
Structural Grade: **0**
O&M Grade: **0**
Clock Start/From:
Clock To:
1st Value:
2nd Value:
Value Percent:
Continuous Index:
Within 8" of Joint: **NO**
Remarks: **M-604-007**

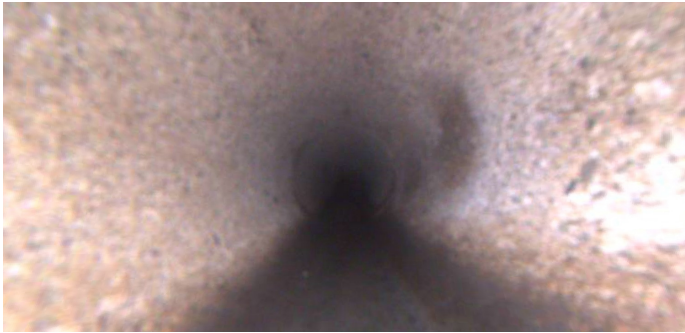
Code:	MWL
Description:	Water Level

Distance (ft):	.0
Structural Grade:	0
O&M Grade:	0
Clock Start/From:	
Clock To:	
1st Value:	
2nd Value:	
Value Percent:	5.000
Continuous Index:	
Within 8" of Joint:	NO
Remarks:

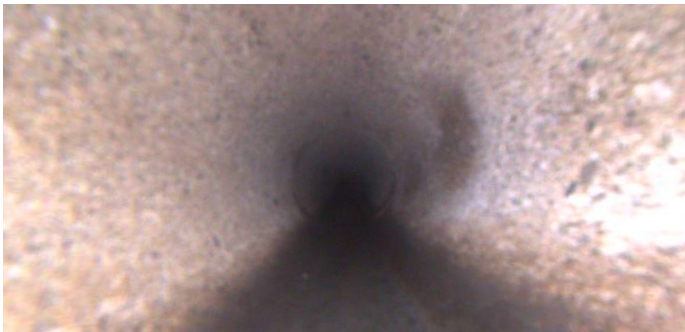
Code:	SAP
Description:	Surface Aggregate Projecting

Distance (ft):	.0
Structural Grade:	3
O&M Grade:	0
Clock Start/From:	7
Clock To:	5
1st Value:	
2nd Value:	
Value Percent:	
Continuous Index:	S01
Within 8" of Joint:	
Remarks:

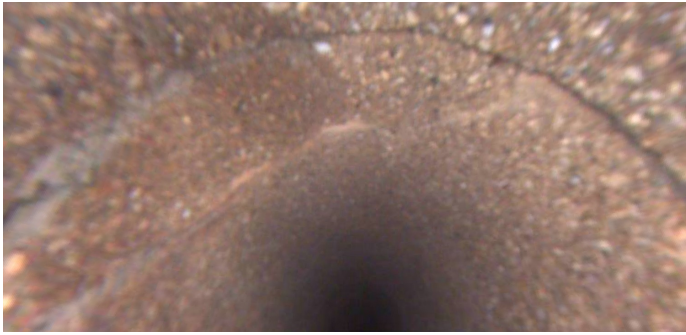
Code: **FM**
Description: **Fracture Multiple**

Distance (ft): **39.1**
Structural Grade: **4**
O&M Grade: **0**
Clock Start/From: **8**
Clock To: **12**
1st Value:
2nd Value:
Value Percent:
Continuous Index:
Within 8" of Joint: **YES**
Remarks:

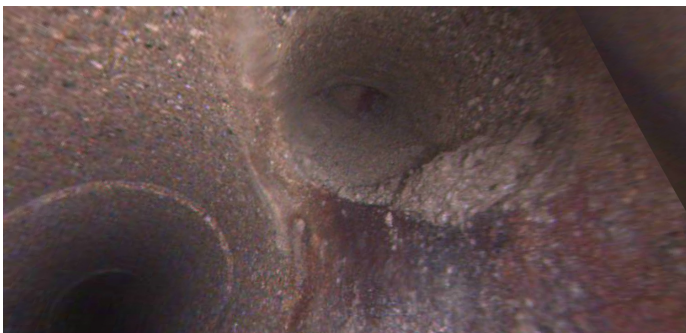
Code: **TFC**
Description: **Tap Factory Capped**

Distance (ft): **43.9**
Structural Grade: **0**
O&M Grade: **0**
Clock Start/From: **10**
Clock To:
1st Value: **4.000**
2nd Value:
Value Percent:
Continuous Index:
Within 8" of Joint:
Remarks:

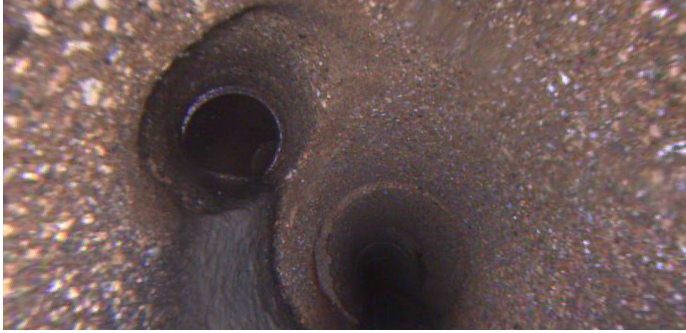
Code: **TFA**
Description: **Tap Factory Active**

Distance (ft): **47.4**
Structural Grade: **0**
O&M Grade: **0**
Clock Start/From: **2**
Clock To:
1st Value: **4.000**
2nd Value:
Value Percent:
Continuous Index:
Within 8" of Joint:
Remarks:

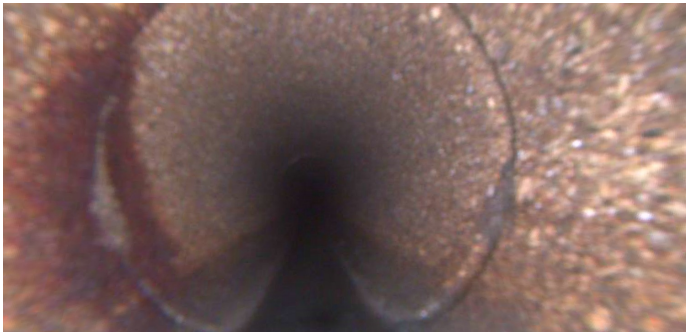
Code: **IS**
Description: **Infil Stain**

Distance (ft): **51.0**
Structural Grade: **0**
O&M Grade: **0**
Clock Start/From: **8**
Clock To: **11**
1st Value:
2nd Value:
Value Percent:
Continuous Index:
Within 8" of Joint: **YES**
Remarks:

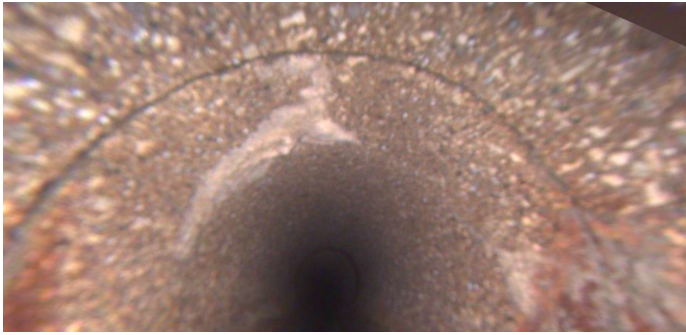
Code: **FL**
Description: **Fracture Longitudinal**

Distance (ft): **54.2**
Structural Grade: **3**
O&M Grade: **0**
Clock Start/From: **12**
Clock To:
1st Value:
2nd Value:
Value Percent:
Continuous Index:
Within 8" of Joint: **YES**
Remarks:

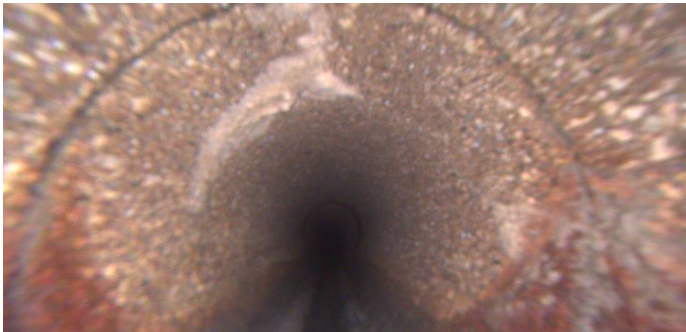
Code: **IS**
Description: **Infil Stain**

Distance (ft): **54.2**
Structural Grade: **0**
O&M Grade: **0**
Clock Start/From: **8**
Clock To: **4**
1st Value:
2nd Value:
Value Percent:
Continuous Index: **S02**
Within 8" of Joint: **YES**
Remarks:

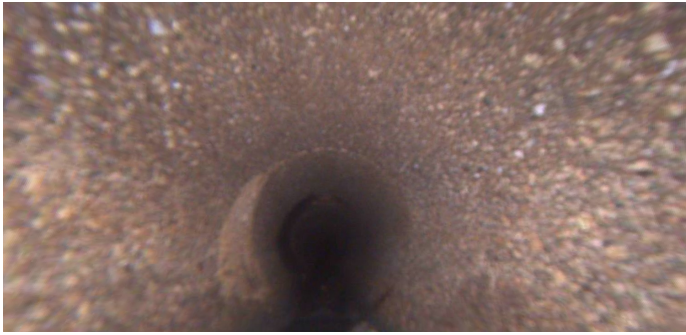
Code: **SAP**
Description: **Surface Aggregate Projecting**

Distance (ft): **89.8**
Structural Grade: **3**
O&M Grade: **0**
Clock Start/From: **7**
Clock To: **5**
1st Value:
2nd Value:
Value Percent:
Continuous Index: **F01**
Within 8" of Joint:
Remarks:

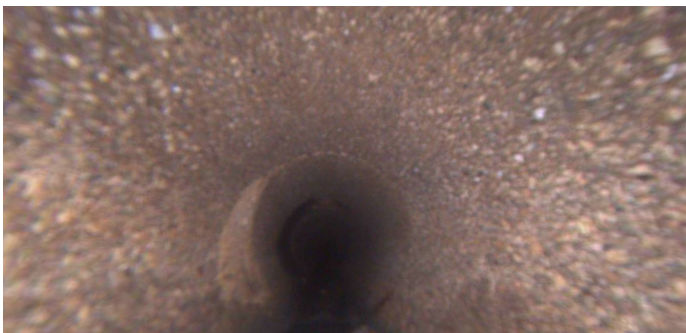
Code: **IS**
Description: **Infil Stain**

Distance (ft): **89.8**
Structural Grade: **0**
O&M Grade: **0**
Clock Start/From: **8**
Clock To: **4**
1st Value:
2nd Value:
Value Percent:
Continuous Index: **F02**
Within 8" of Joint: **YES**
Remarks:

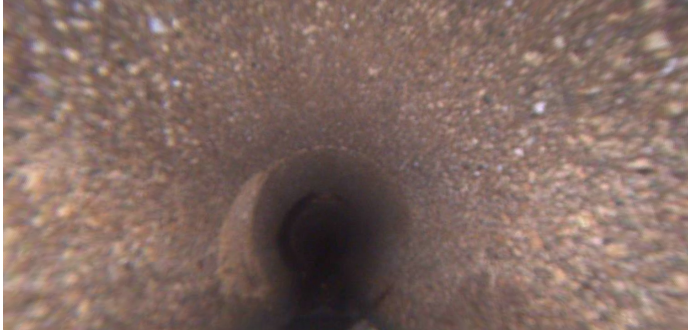
Code:	MSA
Description:	Abandoned Survey
Distance (ft):	89.8
Structural Grade:	0
O&M Grade:	0
Clock Start/From:	
Clock To:	
1st Value:	
2nd Value:	
Value Percent:	
Continuous Index:	
Within 8" of Joint:	NO
Remarks:	debris
