Profile/Photo Observation Report

Street:	BEVERLY BLVD	Flow Control:	Not Controlled
City:	Hobart, IN	Year Renewed:	
Location:	Other	Tape/Media #:	
Purpose:	Not Known	Dia/Height:	10"
Use:	Sanitary	Material:	CP
Drain Area:	NA	Lining:	
Category:	NA		
Comment:

Location Details:		Direction of Survey:	Downstream
US MH:	M-604-006	DS MH:	M-604-007
		Total Length Surveyed (ft):	3.5

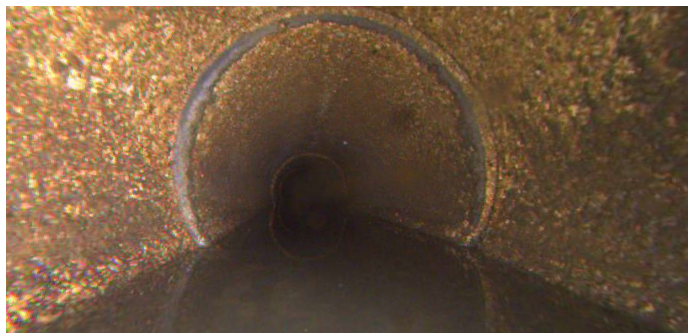
Code: **AMH**
 Description: **Manhole**

Distance (ft): **.0**
 Structural Grade: **0**
 O&M Grade: **0**
 Clock Start/From:
 Clock To:
 1st Value:
 2nd Value:
 Value Percent:
 Continuous Index:
 Within 8" of Joint: **NO**
 Remarks: **M-604-006**

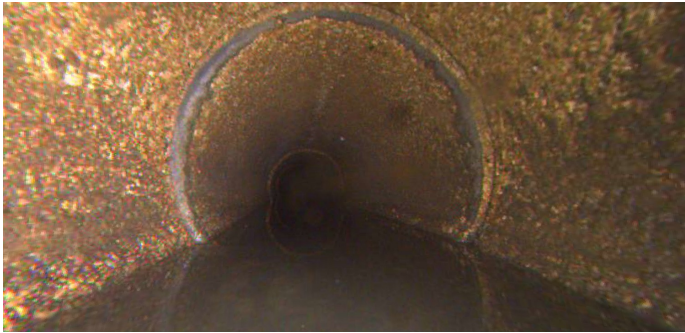
Code:	MWL
Description:	Water Level

Distance (ft):	.0
Structural Grade:	0
O&M Grade:	0
Clock Start/From:	
Clock To:	
1st Value:	
2nd Value:	
Value Percent:	40.000
Continuous Index:	
Within 8" of Joint:	NO
Remarks:

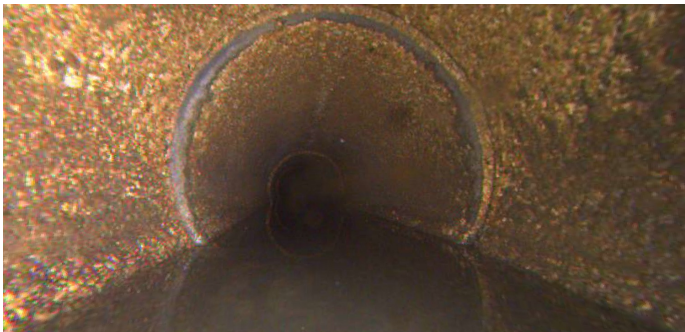
Code:	SAP
Description:	Surface Aggregate Projecting

Distance (ft):	.0
Structural Grade:	3
O&M Grade:	0
Clock Start/From:	8
Clock To:	4
1st Value:	
2nd Value:	
Value Percent:	
Continuous Index:	
Within 8" of Joint:	
Remarks:

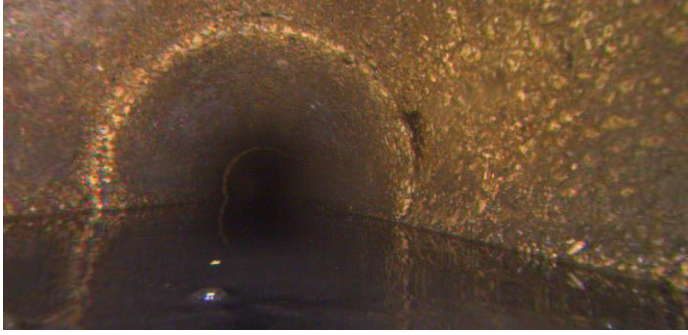
Code:	MSA
Description:	Abandoned Survey
Distance (ft):	3.5
Structural Grade:	0
O&M Grade:	0
Clock Start/From:	
Clock To:	
1st Value:	
2nd Value:	
Value Percent:	
Continuous Index:	
Within 8" of Joint:	NO
Remarks:	debris under water
