## Profile/Photo Observation Report

Street:	<b>Beverly Blvd.</b>	Flow Control:	<b>Not Controlled</b>
City:	<b>Hobart, IN</b>	Year Renewed:	
Location:	<b>Other</b>	Tape/Media #:	
Purpose:	<b>Not Known</b>	Dia/Height:	<b>10"</b>
Use:	<b>Sanitary</b>	Material:	<b>CP</b>
Drain Area:	<b>NA</b>	Lining:	
Category:	<b>NA</b>		
Comment:

Location Details:		Direction of Survey:	<b>Downstream</b>
US MH:	<b>M-604-006</b>	DS MH:	<b>M-604-007</b>
		Total Length Surveyed (ft):	<b>3.5</b>

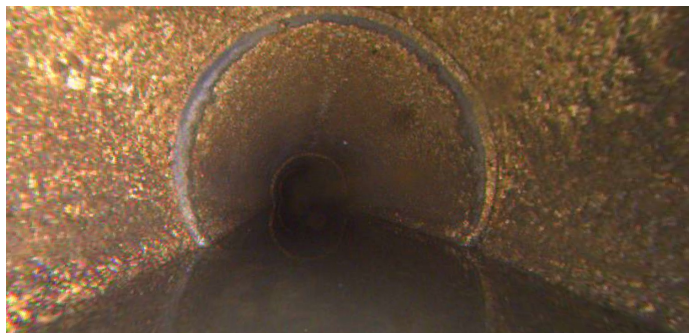
Code: **AMH**  
Description: **Manhole**

Distance (ft): **.0**  
Structural Grade: **0**  
O&M Grade: **0**  
Clock Start/From:  
Clock To:  
1st Value:  
2nd Value:  
Value Percent:  
Continuous Index:  
Within 8" of Joint: **NO**  
Remarks: **M-604-006**

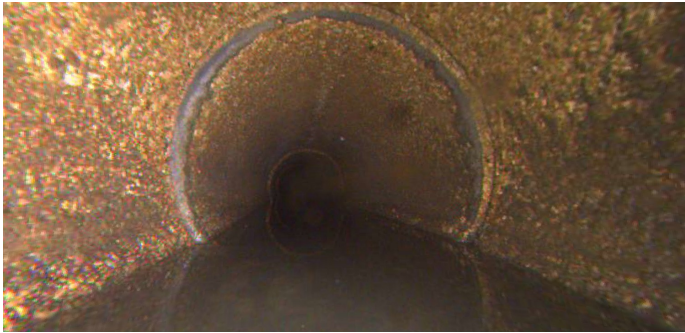
Code:	<b>MWL</b>
Description:	<b>Water Level</b>

Distance (ft):	<b>.0</b>
Structural Grade:	<b>0</b>
O&M Grade:	<b>0</b>
Clock Start/From:	
Clock To:	
1st Value:	
2nd Value:	
Value Percent:	<b>40.000</b>
Continuous Index:	
Within 8" of Joint:	<b>NO</b>
Remarks:

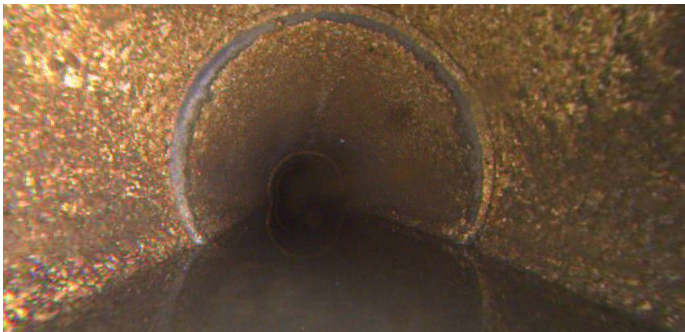
Code:	<b>SAP</b>
Description:	<b>Surface Aggregate Projecting</b>

Distance (ft):	<b>.0</b>
Structural Grade:	<b>3</b>
O&M Grade:	<b>0</b>
Clock Start/From:	<b>8</b>
Clock To:	<b>4</b>
1st Value:	
2nd Value:	
Value Percent:	
Continuous Index:	
Within 8" of Joint:	
Remarks:

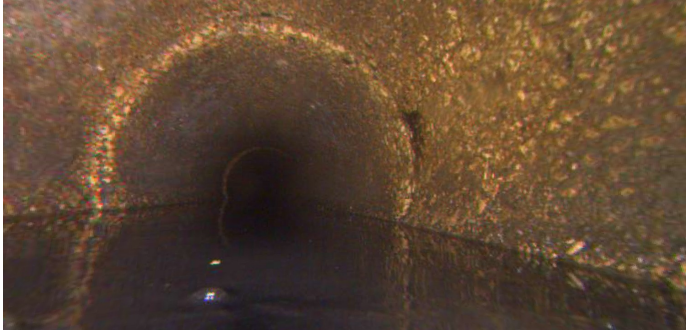
Code:	<b>MSA</b>
Description:	<b>Abandoned Survey</b>
Distance (ft):	<b>3.5</b>
Structural Grade:	<b>0</b>
O&M Grade:	<b>0</b>
Clock Start/From:	
Clock To:	
1st Value:	
2nd Value:	
Value Percent:	
Continuous Index:	
Within 8" of Joint:	<b>NO</b>
Remarks:	<b>debris under water</b>
