## Profile/Photo Observation Report

Street:	<b>W CLEVELAND AVE &amp; BEVERLY BLVD</b>	Flow Control:	<b>Not Controlled</b>
City:	<b>Hobart, IN</b>	Year Renewed:	
Location:	<b>Other</b>	Tape/Media #:	
Purpose:	<b>Not Known</b>	Dia/Height:	<b>12"</b>
Use:	<b>Sanitary</b>	Material:	<b>CP</b>
Drain Area:	<b>NA</b>	Lining:	
Category:	<b>NA</b>		
Comment:

Location Details:		Direction of Survey:	<b>Downstream</b>
US MH:	<b>M-604-006</b>	DS MH:	<b>M-605-067</b>
		Total Length Surveyed (ft):	<b>47.3</b>

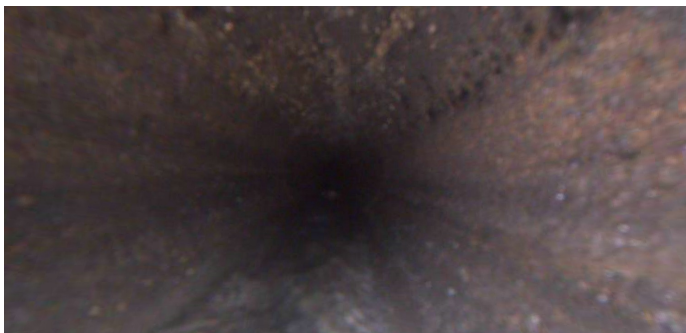
Code: **AMH**  
Description: **Manhole**

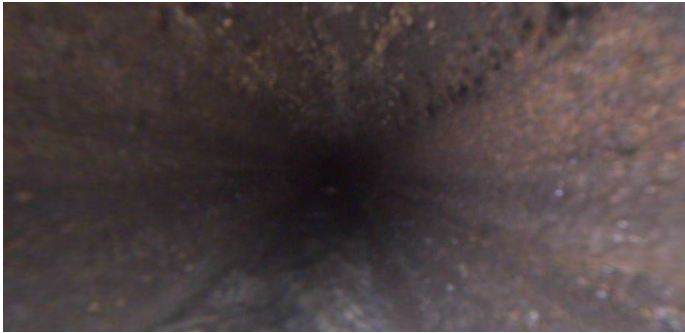
Code:	<b>MWL</b>
Description:	<b>Water Level</b>

Distance (ft):	<b>.0</b>
Structural Grade:	<b>0</b>
O&M Grade:	<b>0</b>
Clock Start/From:	
Clock To:	
1st Value:	
2nd Value:	
Value Percent:	<b>5.000</b>
Continuous Index:	
Within 8" of Joint:	<b>NO</b>
Remarks:

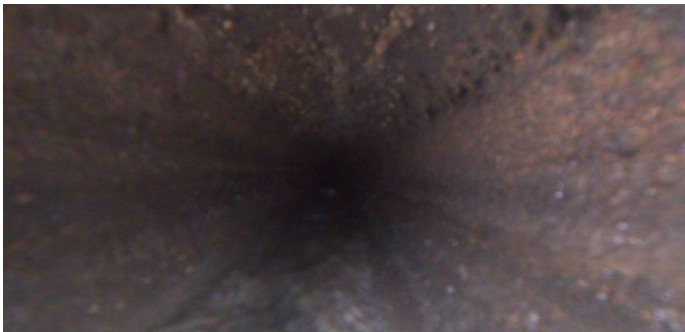
Code:	<b>SAP</b>
Description:	<b>Surface Aggregate Projecting</b>

Distance (ft):	<b>.0</b>
Structural Grade:	<b>3</b>
O&M Grade:	<b>0</b>
Clock Start/From:	<b>7</b>
Clock To:	<b>5</b>
1st Value:	
2nd Value:	
Value Percent:	
Continuous Index:	<b>S01</b>
Within 8" of Joint:	
Remarks:

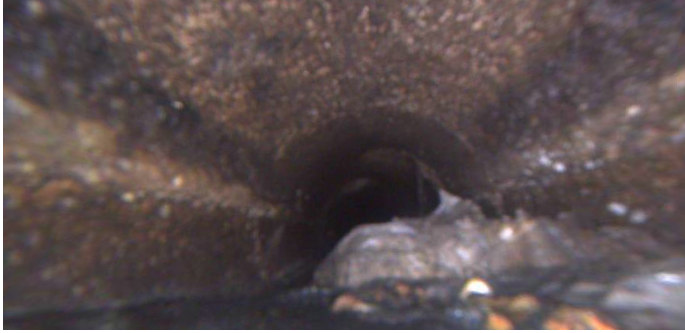
Code: **OBZ**  
Description: **Obstacle Other**

Distance (ft): **45.6**  
Structural Grade: **0**  
O&M Grade: **3**  
Clock Start/From: **3**  
Clock To: **6**  
1st Value:  
2nd Value:  
Value Percent: **20.000**  
Continuous Index:  
Within 8" of Joint: **NO**  
Remarks: **MISC**

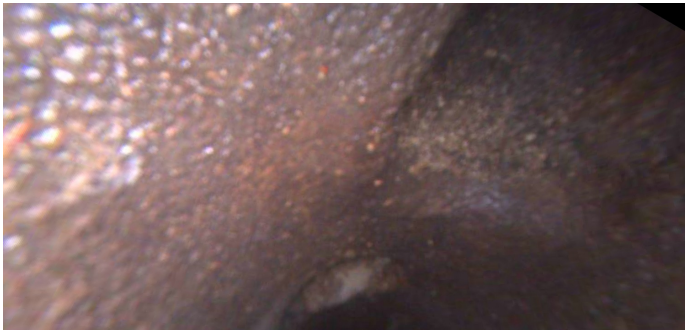
Code: **TFD**  
Description: **Tap Factory Defective**

Distance (ft): **47.3**  
Structural Grade: **0**  
O&M Grade: **2**  
Clock Start/From: **12**  
Clock To:  
1st Value: **4.000**  
2nd Value:  
Value Percent:  
Continuous Index:  
Within 8" of Joint:  
Remarks: **ROOTS**

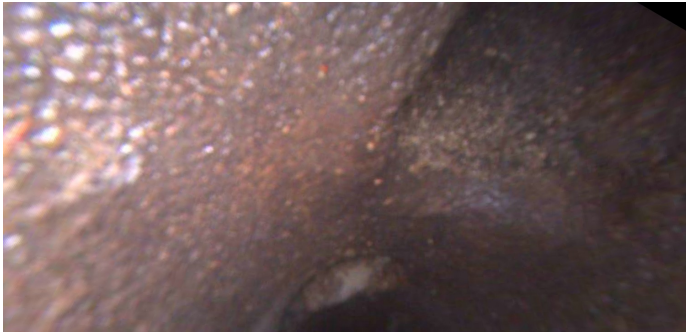
Code: **RFL**  
Description: **Roots Fine Lateral**

Distance (ft): **47.3**  
Structural Grade: **0**  
O&M Grade: **1**  
Clock Start/From: **1**  
Clock To:  
1st Value:  
2nd Value:  
Value Percent:  
Continuous Index:  
Within 8" of Joint: **NO**  
Remarks:

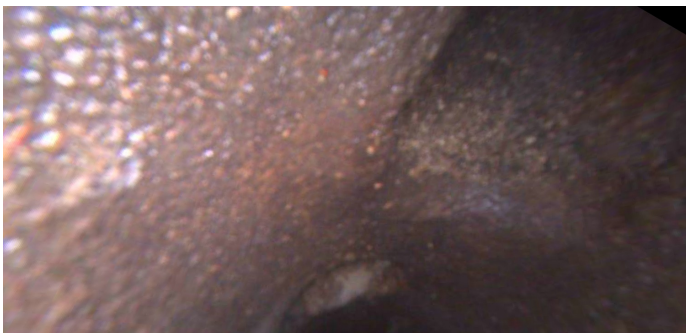
Code: **MSA**  
Description: **Abandoned Survey**

Distance (ft): **47.3**  
Structural Grade: **0**  
O&M Grade: **0**  
Clock Start/From:  
Clock To:  
1st Value:  
2nd Value:  
Value Percent:  
Continuous Index:  
Within 8" of Joint: **NO**  
Remarks: **OBZ**

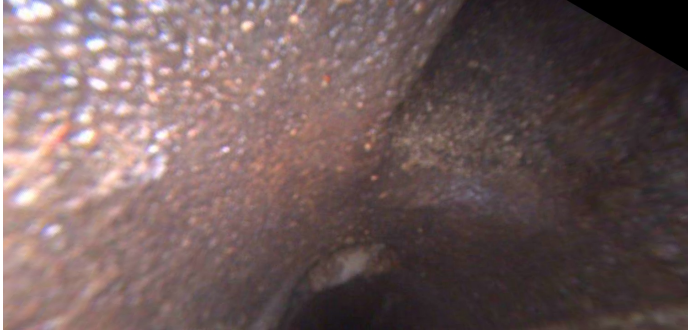
Code:	<b>SAP</b>
Description:	<b>Surface Aggregate Projecting</b>
Distance (ft):	<b>47.3</b>
Structural Grade:	<b>3</b>
O&M Grade:	<b>0</b>
Clock Start/From:	<b>7</b>
Clock To:	<b>5</b>
1st Value:	
2nd Value:	
Value Percent:	
Continuous Index:	<b>F01</b>
Within 8" of Joint:	
Remarks:
