RedZone  
ROBOTICS

Street:	Beverly Boulevard		Flow Control:	Not Controlled	
City:	City of Hobart		Year Renewed:		
Location:	Local rural streets with light traffic, t		Tape/Media #:		
Purpose:	Routine Assessment		Dia/Height:	12"	
Use:	Sanitary Sewage Pipe		Material:	CP	
Drain Area:			Lining:	None	
Category:	NA				
Comment:					
Location Details:			Direction of Survey:	Downstream	
US MH:	M-604-006	DS MH:	M-605-067	Total Length Surveyed (ft):	238.5

O&M Index:	<b>2.06</b>	O&M Quick:	<b>4133</b>	O&M Rating:	<b>33.00</b>
Structural Index:	<b>2.75</b>	Structural Quick:	<b>4731</b>	Structural Rating:	<b>55.00</b>
Overall Index:	<b>2.44</b>	Overall Quick:	<b>4834</b>	Overall Rating:	<b>88.00</b>

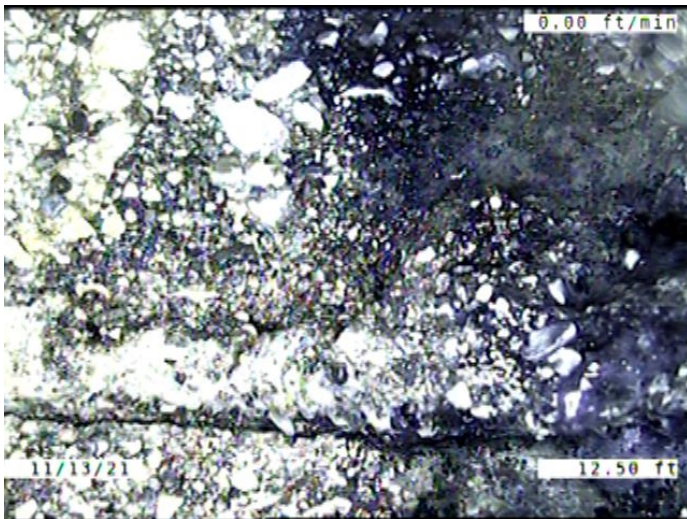
Code: **ISGT**  
 Description: **Intruding Sealing Material Grout**

Distance (ft): **12.5**  
 Structural Grade: **0**  
 O&M Grade: **2**  
 Clock Start/From: **5**  
 Clock To: **8**  
 1st Value:  
 2nd Value:  
 Value Percent: **5.000**  
 Continuous Index:  
 Within 8" of Joint: **NO**  
 Remarks:

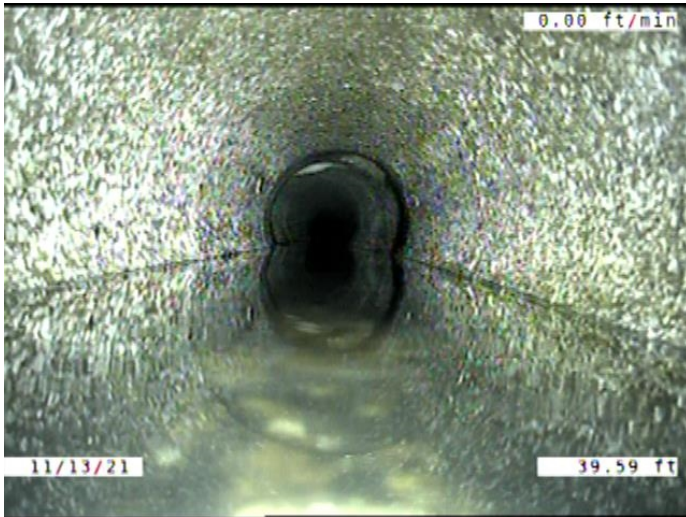
Code: **MWLS**  
 Description: **Miscellaneous Water Level Sag**

Distance (ft): **39.6**  
 Structural Grade: **2**  
 O&M Grade: **0**  
 Clock Start/From:  
 Clock To:  
 1st Value:  
 2nd Value:  
 Value Percent: **15.000**  
 Continuous Index: **S01**  
 Within 8" of Joint: **NO**  
 Remarks:

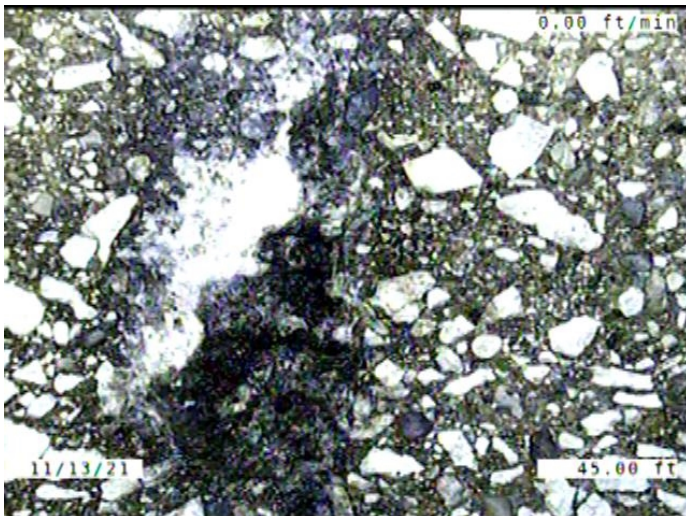
Code: **DAE**  
 Description: **Deposits Attached Encrustation**

Distance (ft): **45.0**  
 Structural Grade: **0**  
 O&M Grade: **2**  
 Clock Start/From: **10**  
 Clock To:  
 1st Value:  
 2nd Value:  
 Value Percent: **5.000**  
 Continuous Index:  
 Within 8" of Joint: **NO**  
 Remarks:

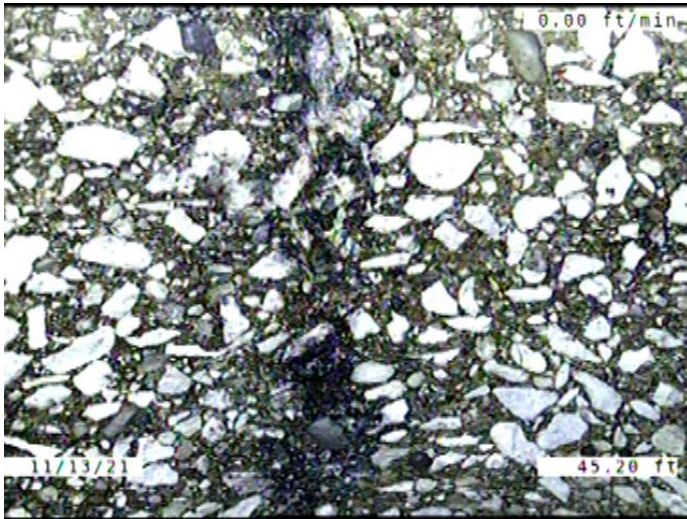
Code: **CL**  
Description: **Crack Longitudinal**

Distance (ft): **45.2**  
Structural Grade: **2**  
O&M Grade: **0**  
Clock Start/From: **10**  
Clock To:  
1st Value:  
2nd Value:  
Value Percent:  
Continuous Index:  
Within 8" of Joint: **NO**  
Remarks:

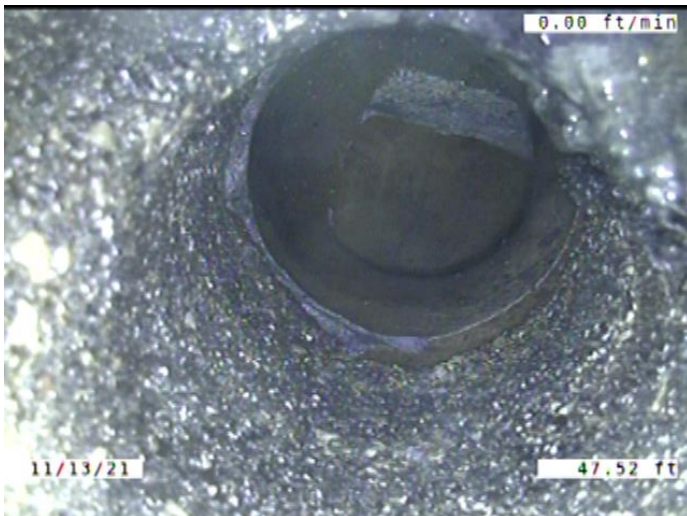
Code: **TF**  
Description: **Tap Factory**

Distance (ft): **47.5**  
Structural Grade: **0**  
O&M Grade: **0**  
Clock Start/From: **1**  
Clock To:  
1st Value: **6.000**  
2nd Value:  
Value Percent:  
Continuous Index:  
Within 8" of Joint: **YES**  
Remarks: **CONSTANTLY RUNNING WATER.**

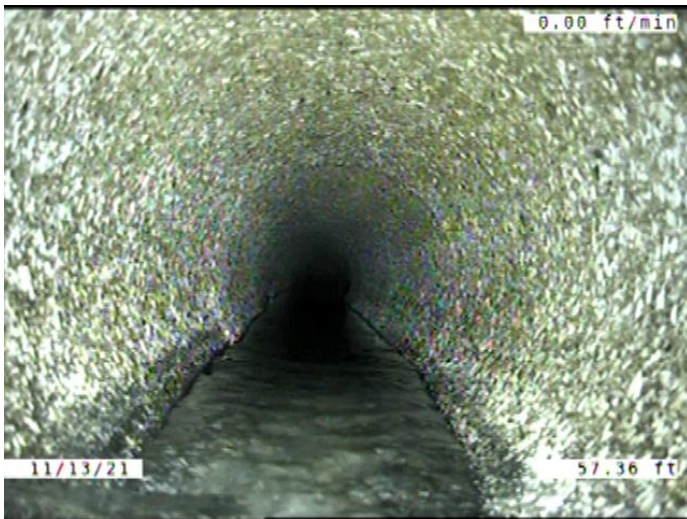
Code: **MWLS**  
Description: **Miscellaneous Water Level Sag**

Distance (ft): **57.4**  
Structural Grade: **2**  
O&M Grade: **0**  
Clock Start/From:  
Clock To:  
1st Value:  
2nd Value:  
Value Percent: **15.000**  
Continuous Index: **F01**  
Within 8" of Joint: **NO**  
Remarks:

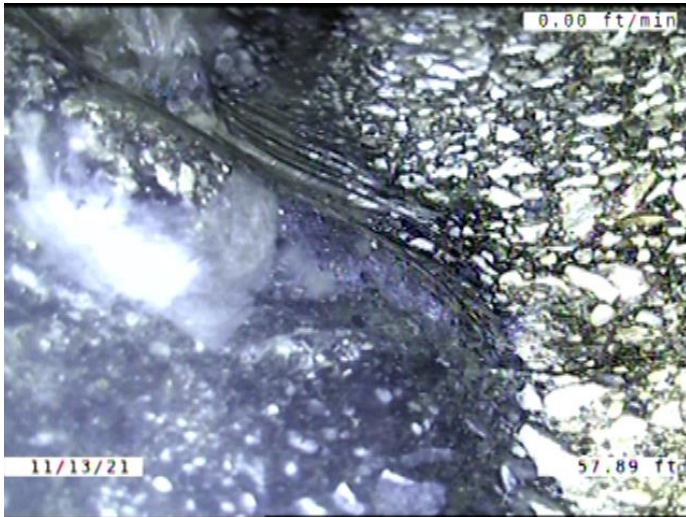
Code:	<b>ISGT</b>
Description:	<b>Intruding Sealing Material Grout</b>
Distance (ft):	<b>57.9</b>
Structural Grade:	<b>0</b>
O&M Grade:	<b>2</b>
Clock Start/From:	<b>5</b>
Clock To:	<b>7</b>
1st Value:	
2nd Value:	
Value Percent:	<b>10.000</b>
Continuous Index:	
Within 8" of Joint:	<b>NO</b>
Remarks:

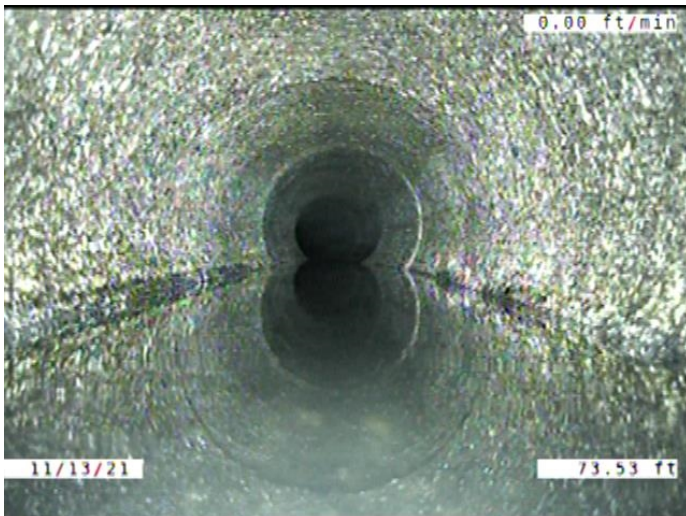
Code:	<b>MWLS</b>
Description:	<b>Miscellaneous Water Level Sag</b>
Distance (ft):	<b>73.5</b>
Structural Grade:	<b>2</b>
O&M Grade:	<b>0</b>
Clock Start/From:	
Clock To:	
1st Value:	
2nd Value:	
Value Percent:	<b>10.000</b>
Continuous Index:	<b>S02</b>
Within 8" of Joint:	<b>NO</b>
Remarks:

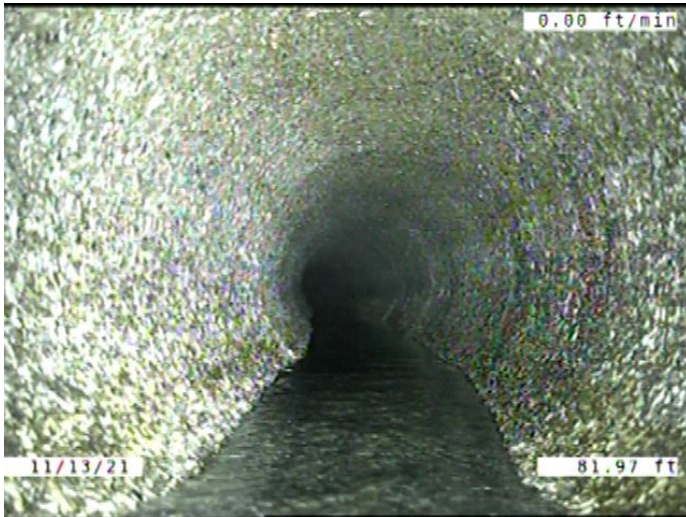
Code: **MWLS**  
Description: **Miscellaneous Water Level Sag**

Distance (ft): **82.0**  
Structural Grade: **2**  
O&M Grade: **0**  
Clock Start/From:  
Clock To:  
1st Value:  
2nd Value:  
Value Percent: **10.000**  
Continuous Index: **F02**  
Within 8" of Joint: **NO**  
Remarks:

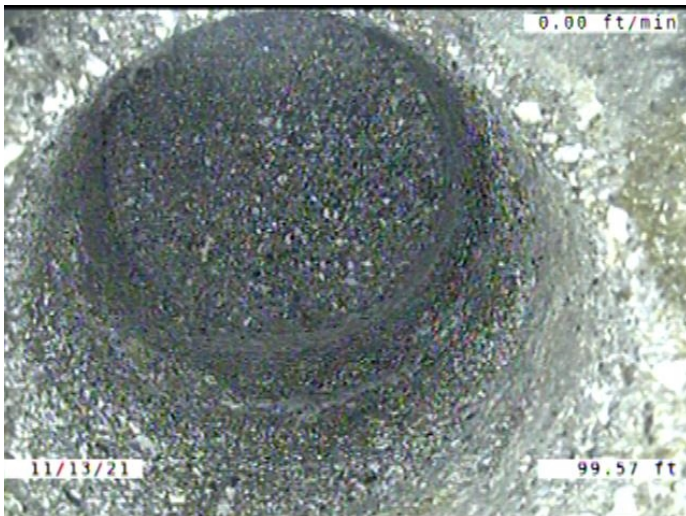
Code: **TFC**  
Description: **Tap Factory Capped**

Distance (ft): **99.6**  
Structural Grade: **0**  
O&M Grade: **0**  
Clock Start/From: **11**  
Clock To:  
1st Value: **6.000**  
2nd Value:  
Value Percent:  
Continuous Index:  
Within 8" of Joint: **YES**  
Remarks: **TAP CRACKED**

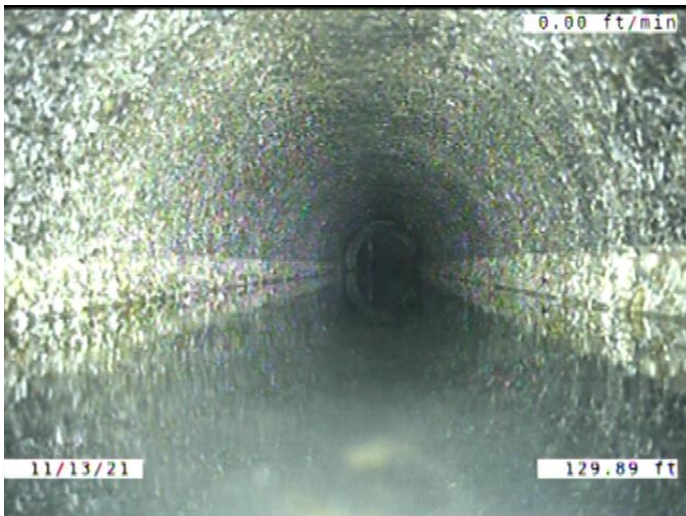
Code: **MWLS**  
Description: **Miscellaneous Water Level Sag**

Distance (ft): **129.9**  
Structural Grade: **2**  
O&M Grade: **0**  
Clock Start/From:  
Clock To:  
1st Value:  
2nd Value:  
Value Percent: **15.000**  
Continuous Index: **S03**  
Within 8" of Joint: **NO**  
Remarks:

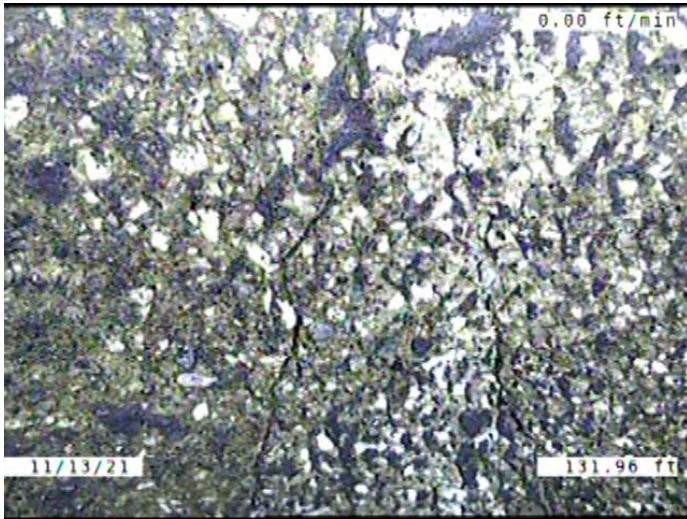
Code: **FM**  
Description: **Fracture Multiple**

Distance (ft): **132.0**  
Structural Grade: **4**  
O&M Grade: **0**  
Clock Start/From: **10**  
Clock To: **3**  
1st Value:  
2nd Value:  
Value Percent:  
Continuous Index: **S04**  
Within 8" of Joint: **YES**  
Remarks:

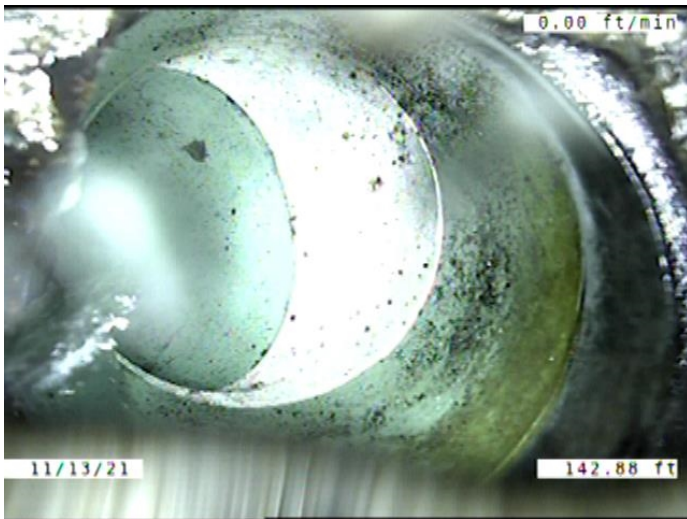
Code: **TBA**  
Description: **Tap Break-in Activity**

Distance (ft): **142.9**  
Structural Grade: **0**  
O&M Grade: **0**  
Clock Start/From: **12**  
Clock To:  
1st Value: **4.000**  
2nd Value:  
Value Percent:  
Continuous Index:  
Within 8" of Joint: **NO**  
Remarks: **CONSTANTLY RUNNING WATER.**

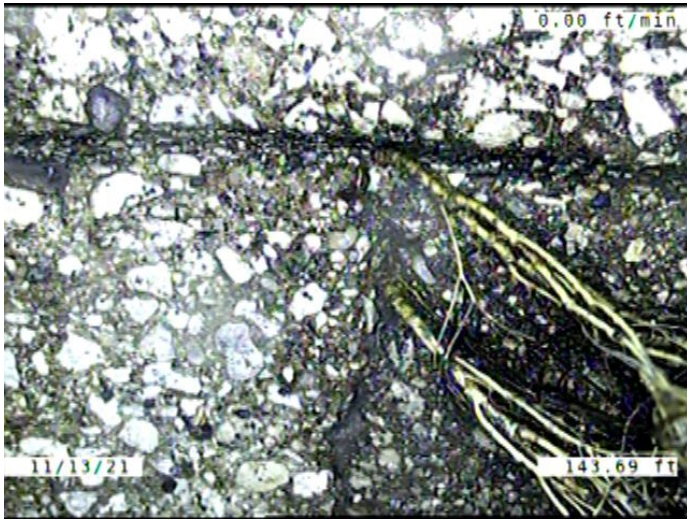
Code: **RFJ**  
 Description: **Roots Fine Joint**

Distance (ft): **143.7**  
 Structural Grade: **0**  
 O&M Grade: **1**  
 Clock Start/From: **1**  
 Clock To: **2**  
 1st Value:  
 2nd Value:  
 Value Percent:  
 Continuous Index:  
 Within 8" of Joint: **YES**  
 Remarks:

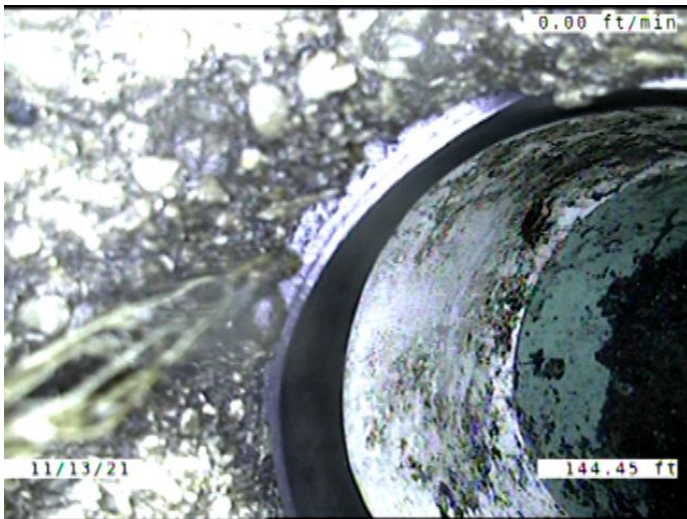
Code: **RFC**  
 Description: **Roots Fine Connection**

Distance (ft): **144.4**  
 Structural Grade: **0**  
 O&M Grade: **1**  
 Clock Start/From: **11**  
 Clock To: **12**  
 1st Value:  
 2nd Value:  
 Value Percent:  
 Continuous Index:  
 Within 8" of Joint: **NO**  
 Remarks:

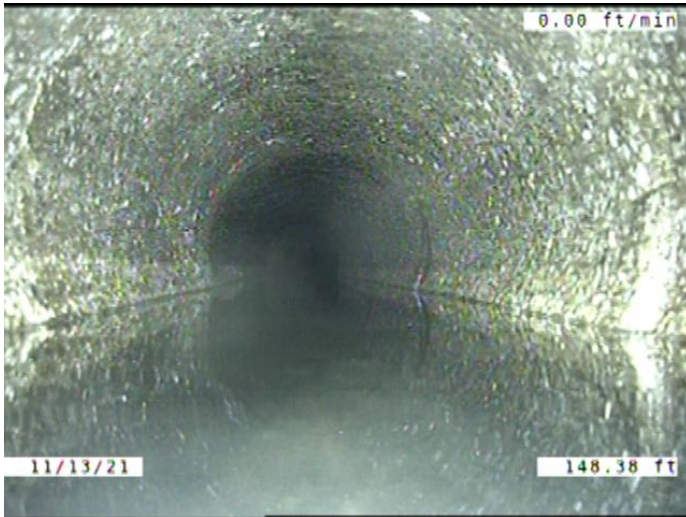
Code: **MWLS**  
 Description: **Miscellaneous Water Level Sag**

Distance (ft): **148.4**  
 Structural Grade: **2**  
 O&M Grade: **0**  
 Clock Start/From:  
 Clock To:  
 1st Value:  
 2nd Value:  
 Value Percent: **15.000**  
 Continuous Index: **F03**  
 Within 8" of Joint: **NO**  
 Remarks:

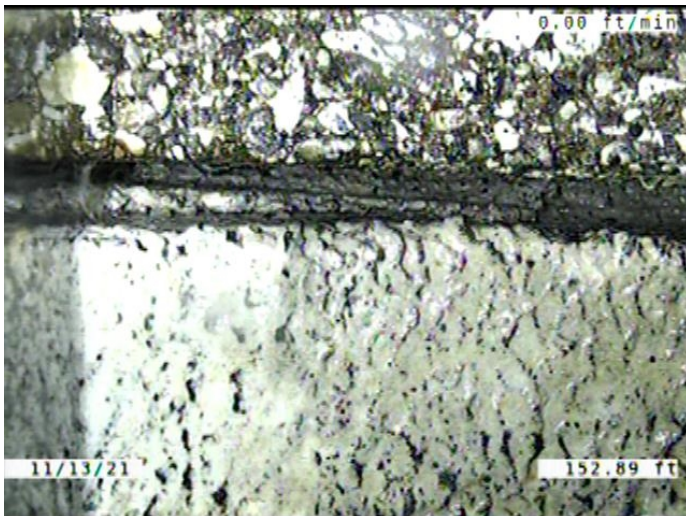
Code: **DAE**  
 Description: **Deposits Attached Encrustation**

Distance (ft): **152.9**  
 Structural Grade: **0**  
 O&M Grade: **2**  
 Clock Start/From: **9**  
 Clock To: **3**  
 1st Value:  
 2nd Value:  
 Value Percent: **5.000**  
 Continuous Index:  
 Within 8" of Joint: **YES**  
 Remarks:

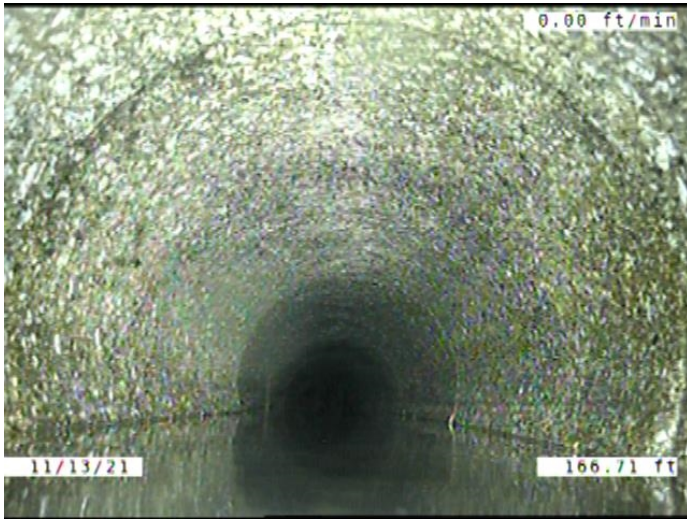
166.7	FM(F04)	Fracture Multiple	1402	S 4
177.0	MWLS	Miscellaneous Water Level Sag	1456	S 2
183.3	RFJ	Roots Fine Joint	1841	M 1
183.8	MCU	Miscellaneous Camera Underwater	1546	M 4

Code: **FM**  
Description: **Fracture Multiple**

Distance (ft): **166.7**  
Structural Grade: **4**  
O&M Grade: **0**  
Clock Start/From: **10**  
Clock To: **3**  
1st Value:  
2nd Value:  
Value Percent:  
Continuous Index: **F04**  
Within 8" of Joint: **YES**  
Remarks:

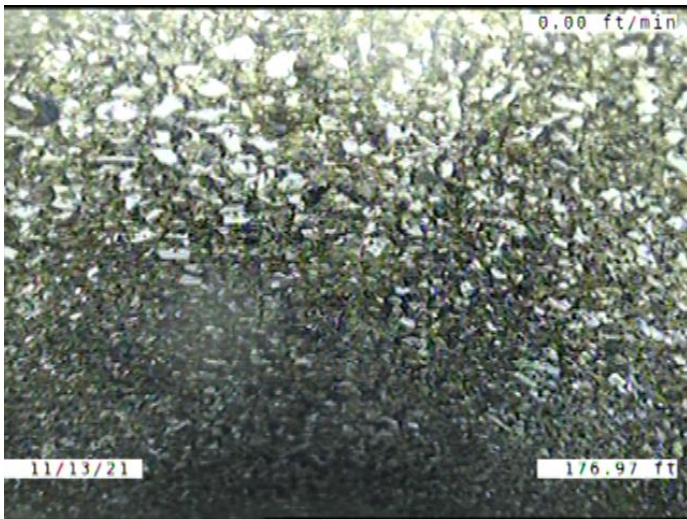
Code: **MWLS**  
Description: **Miscellaneous Water Level Sag**

Distance (ft): **177.0**  
Structural Grade: **2**  
O&M Grade: **0**  
Clock Start/From:  
Clock To:  
1st Value:  
2nd Value:  
Value Percent: **15.000**  
Continuous Index:  
Within 8" of Joint: **NO**  
Remarks:

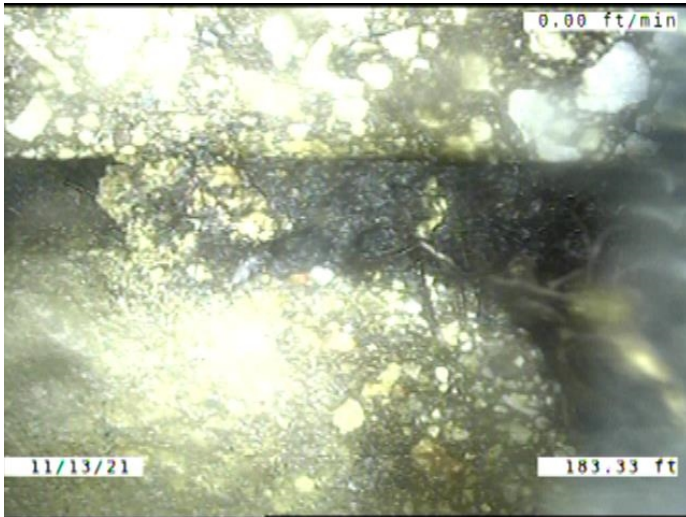
Code: **RFJ**  
Description: **Roots Fine Joint**

Distance (ft): **183.3**  
Structural Grade: **0**  
O&M Grade: **1**  
Clock Start/From: **9**  
Clock To: **3**  
1st Value:  
2nd Value:  
Value Percent:  
Continuous Index:  
Within 8" of Joint: **YES**  
Remarks:

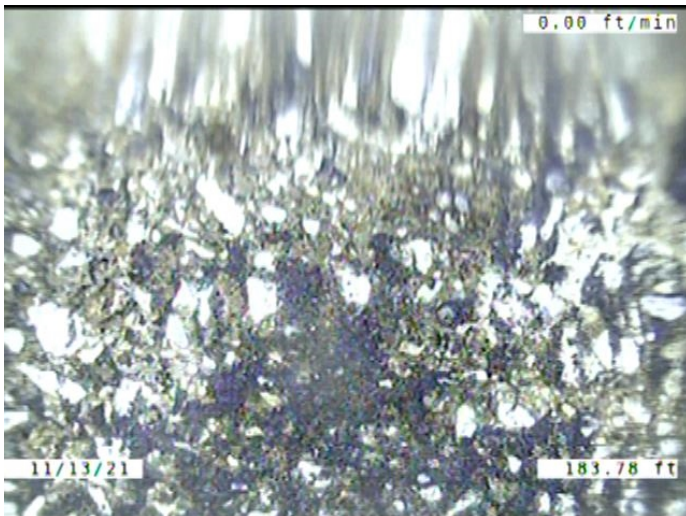
Code: **MCU**  
Description: **Miscellaneous Camera Underwater**

Distance (ft): **183.8**  
Structural Grade: **0**  
O&M Grade: **4**  
Clock Start/From:  
Clock To:  
1st Value:  
2nd Value:  
Value Percent:  
Continuous Index:  
Within 8" of Joint: **NO**  
Remarks: **Out at 186.7**

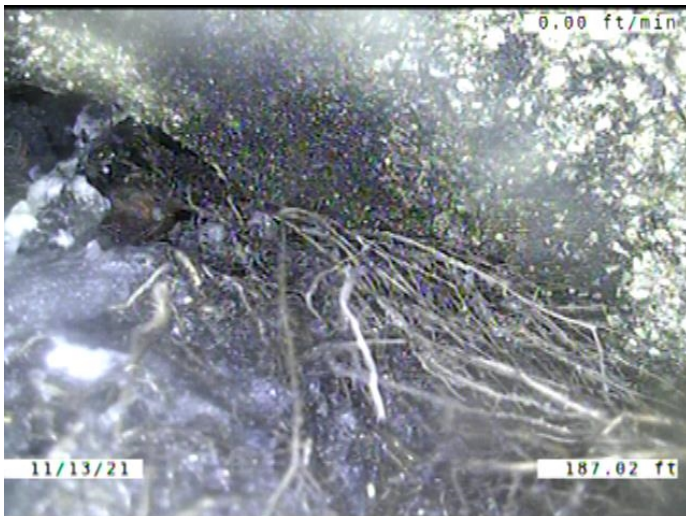
Code: **RML**  
 Description: **Roots Medium Lateral**

Distance (ft): **187.0**  
 Structural Grade: **0**  
 O&M Grade: **3**  
 Clock Start/From: **10**  
 Clock To: **3**  
 1st Value:  
 2nd Value:  
 Value Percent: **40.000**  
 Continuous Index:  
 Within 8" of Joint: **NO**  
 Remarks:

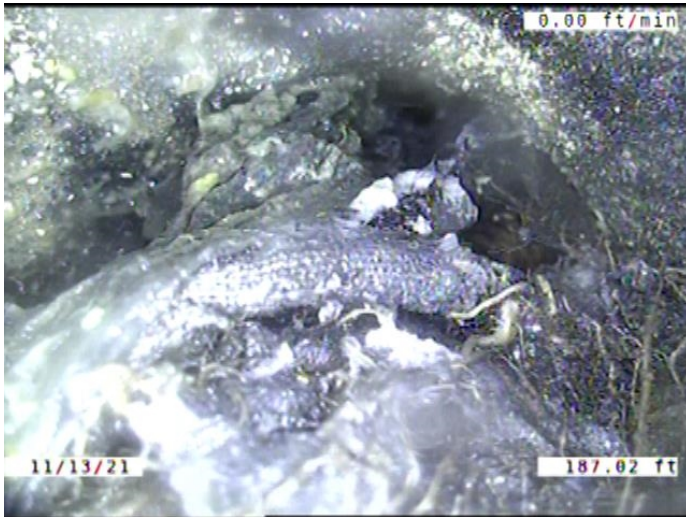
Code: **TFD**  
 Description: **Tap Factory Defective**

Distance (ft): **187.8**  
 Structural Grade: **0**  
 O&M Grade: **3**  
 Clock Start/From: **11**  
 Clock To:  
 1st Value: **6.000**  
 2nd Value:  
 Value Percent:  
 Continuous Index:  
 Within 8" of Joint: **YES**  
 Remarks: **ROOTS GROWING OUT OF THE TAP INTO THE MAIN.**

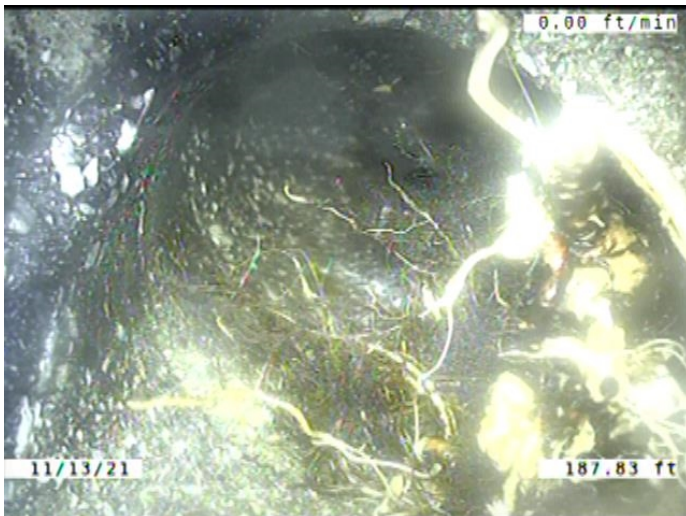
Code: **MGP**  
 Description: **Miscellaneous General Photograph**

Distance (ft): **187.8**  
 Structural Grade: **0**  
 O&M Grade: **0**  
 Clock Start/From: **11**  
 Clock To:  
 1st Value:  
 2nd Value:  
 Value Percent:  
 Continuous Index:  
 Within 8" of Joint: **NO**  
 Remarks: **TAP AFTER ROOT CUTTING**

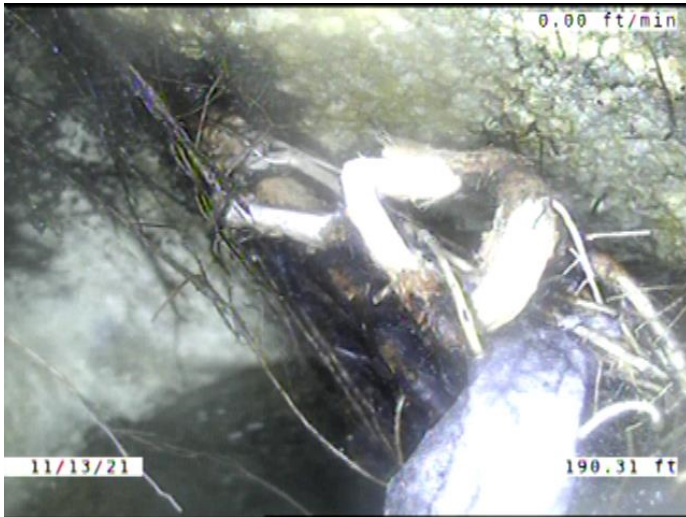
Code: **RTL**  
 Description: **Roots Tap Lateral**

Distance (ft): **190.3**  
 Structural Grade: **0**  
 O&M Grade: **2**  
 Clock Start/From: **2**  
 Clock To: **7**  
 1st Value:  
 2nd Value:  
 Value Percent: **40.000**  
 Continuous Index:  
 Within 8" of Joint: **NO**  
 Remarks:

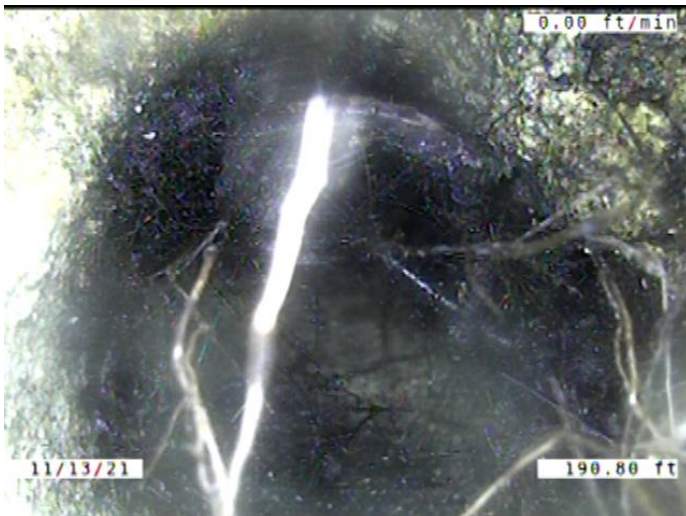
Code: **TFD**  
 Description: **Tap Factory Defective**

Distance (ft): **190.8**  
 Structural Grade: **0**  
 O&M Grade: **3**  
 Clock Start/From: **1**  
 Clock To:  
 1st Value: **6.000**  
 2nd Value:  
 Value Percent:  
 Continuous Index:  
 Within 8" of Joint: **YES**  
 Remarks: **ROOTS GROWING OUT OF THE TAP INTO THE MAIN.**

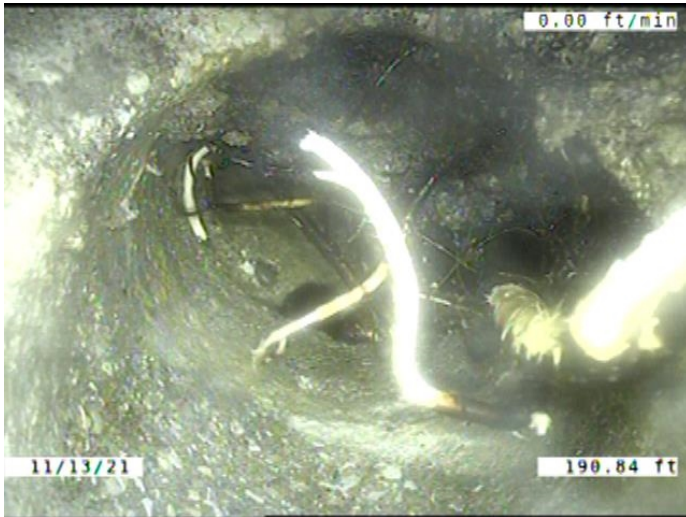
Code: **MGP**  
 Description: **Miscellaneous General Photograph**

Distance (ft): **190.8**  
 Structural Grade: **0**  
 O&M Grade: **0**  
 Clock Start/From: **1**  
 Clock To:  
 1st Value:  
 2nd Value:  
 Value Percent:  
 Continuous Index:  
 Within 8" of Joint: **NO**  
 Remarks: **TAP AFTER ROOT CUTTING**

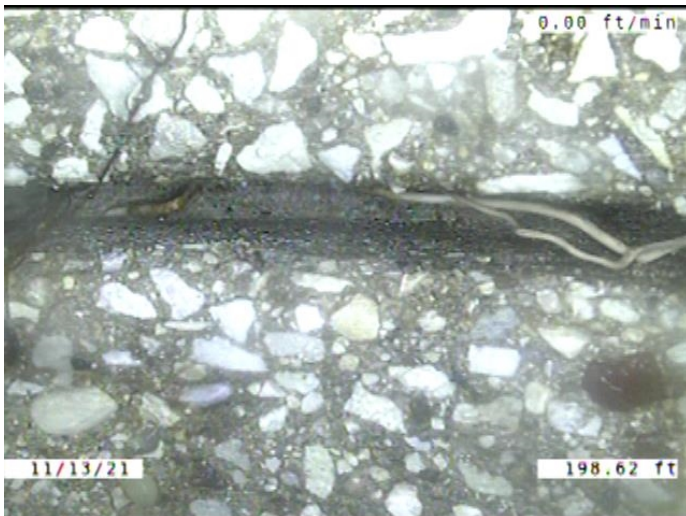
Code: **RFJ**  
 Description: **Roots Fine Joint**

Distance (ft): **198.6**  
 Structural Grade: **0**  
 O&M Grade: **1**  
 Clock Start/From: **1**  
 Clock To: **3**  
 1st Value:  
 2nd Value:  
 Value Percent:  
 Continuous Index:  
 Within 8" of Joint: **YES**  
 Remarks:

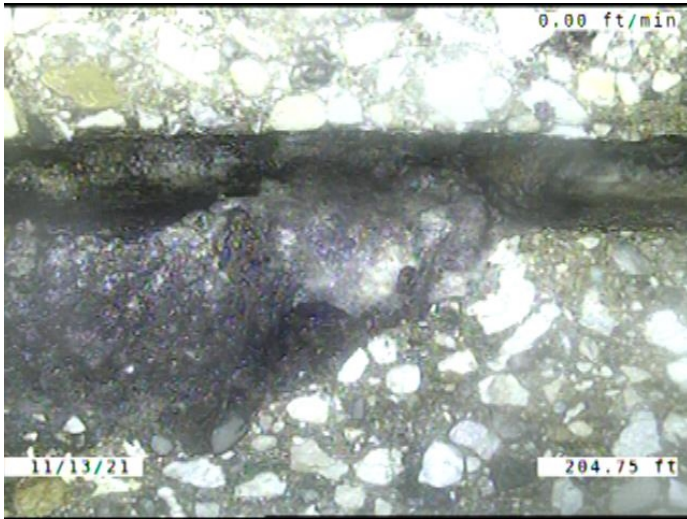
Code: **DAE**  
Description: **Deposits Attached Encrustation**

Distance (ft): **204.8**  
Structural Grade: **0**  
O&M Grade: **2**  
Clock Start/From: **9**  
Clock To: **10**  
1st Value:  
2nd Value:  
Value Percent: **5.000**  
Continuous Index:  
Within 8" of Joint: **YES**  
Remarks:

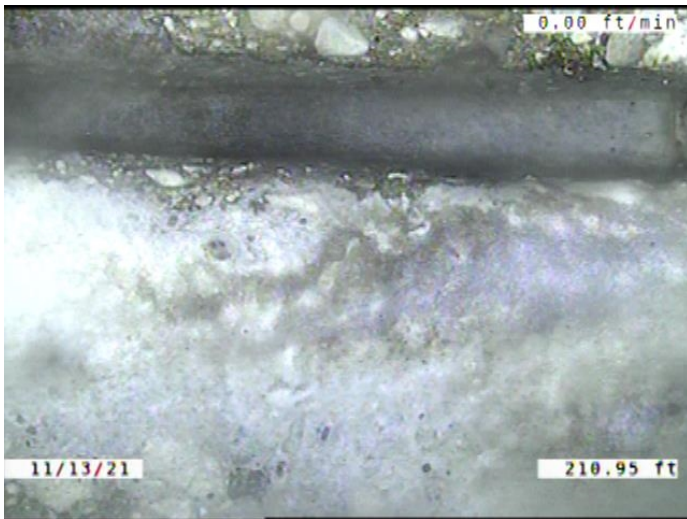
Code: **DAE**  
Description: **Deposits Attached Encrustation**

Distance (ft): **210.9**  
Structural Grade: **0**  
O&M Grade: **2**  
Clock Start/From: **10**  
Clock To: **12**  
1st Value:  
2nd Value:  
Value Percent: **5.000**  
Continuous Index:  
Within 8" of Joint: **YES**  
Remarks:

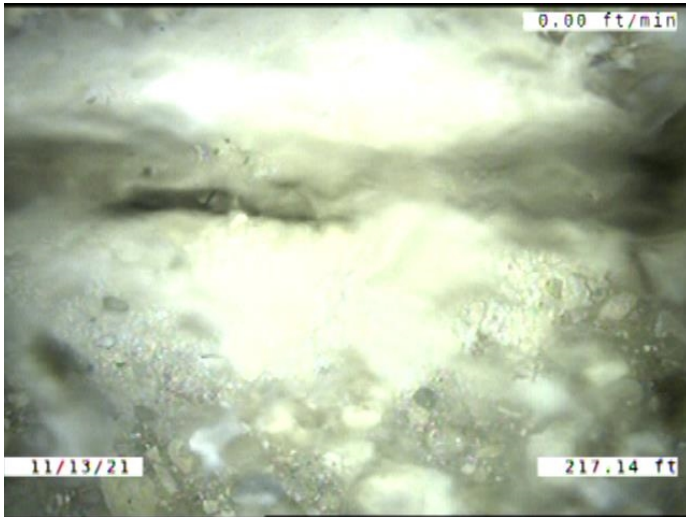
Code: **DAE**  
Description: **Deposits Attached Encrustation**

Distance (ft): **217.1**  
Structural Grade: **0**  
O&M Grade: **2**  
Clock Start/From: **9**  
Clock To: **2**  
1st Value:  
2nd Value:  
Value Percent: **5.000**  
Continuous Index:  
Within 8" of Joint: **YES**  
Remarks:

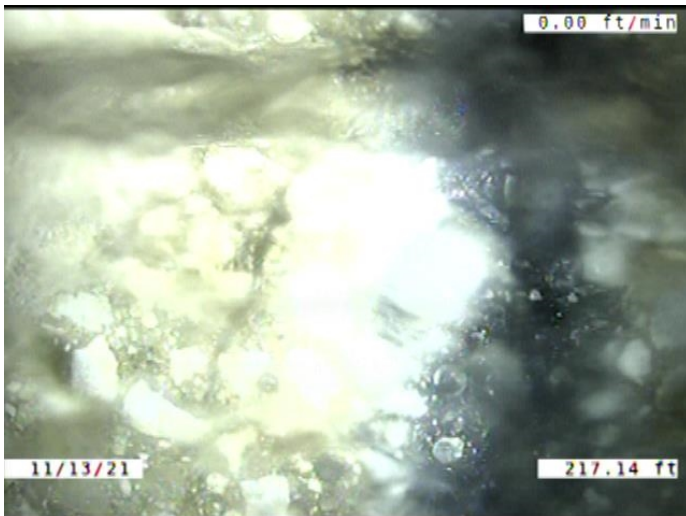
Code: **FL**  
Description: **Fracture Longitudinal**

Distance (ft): **217.1**  
Structural Grade: **3**  
O&M Grade: **0**  
Clock Start/From: **3**  
Clock To:  
1st Value:  
2nd Value:  
Value Percent:  
Continuous Index:  
Within 8" of Joint: **YES**  
Remarks:
