Profile/Photo Observation Report

Date: **11/13/2021** Weather: _____ Coding: **PACP 7.0**
 Pipe Length (ft): **238.5** Owner: **City of Hobart** Pre Clean: **Heavy Cleaning**
 P.O.#: **YES502259** Surveyor: **Steven Bucklin** PSR: **P-604-006-067**
 Customer: **City of Hobart, IN (Red** Clean Date: **11/13/2021** Shape: **C**

Street: **Beverly Boulevard** Flow Control: **Not Controlled**
 City: **City of Hobart** Year Renewed: _____
 Location: **Local rural streets with light traffic, t** Tape/Media #: _____
 Purpose: **Routine Assessment** Dia/Height: **12"**
 Use: **Sanitary Sewage Pipe** Material: **CP**
 Drain Area: _____ Lining: **None**
 Category: **NA**
 Comment: _____
 Location Details: _____ Direction of Survey: **Downstream**
 US MH: **M-604-006** DS MH: **M-605-067** Total Length Surveyed (ft): **238.5**

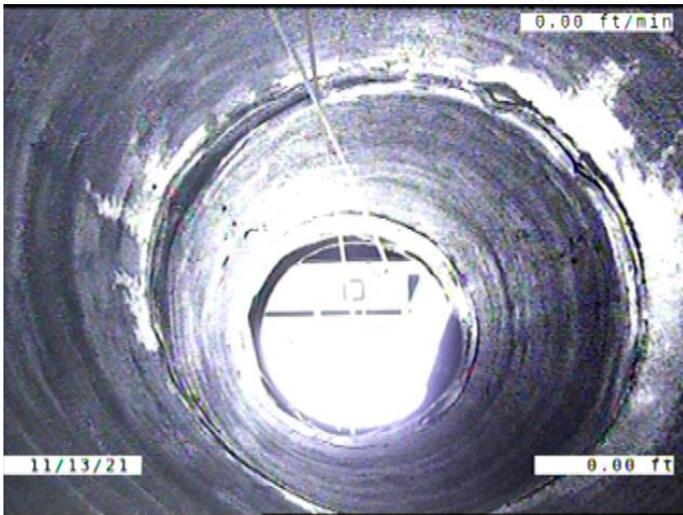
Code: **AMH**
Description: **Manhole**

Distance (ft): **.0**
Structural Grade: **0**
O&M Grade: **0**
Clock Start/From:
Clock To:
1st Value:
2nd Value:
Value Percent:
Continuous Index:
Within 8" of Joint: **NO**
Remarks: **M-604-006**

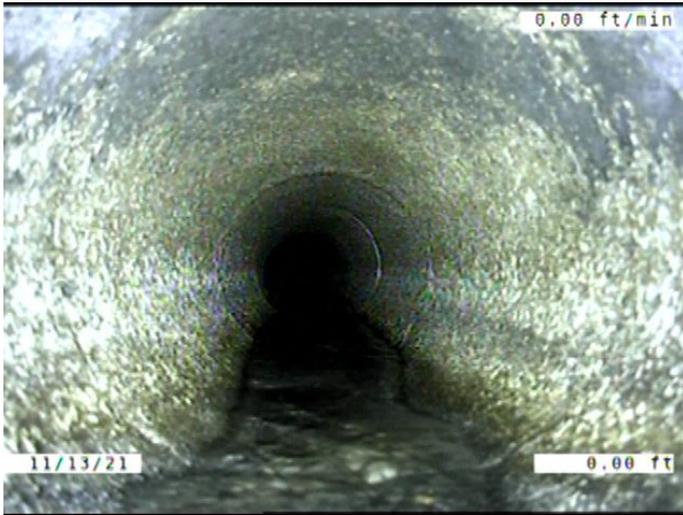
Code: **MWL**
 Description: **Miscellaneous Water Level**

Distance (ft): **.0**
 Structural Grade: **0**
 O&M Grade: **0**
 Clock Start/From:
 Clock To:
 1st Value:
 2nd Value:
 Value Percent: **5.000**
 Continuous Index:
 Within 8" of Joint: **NO**
 Remarks:

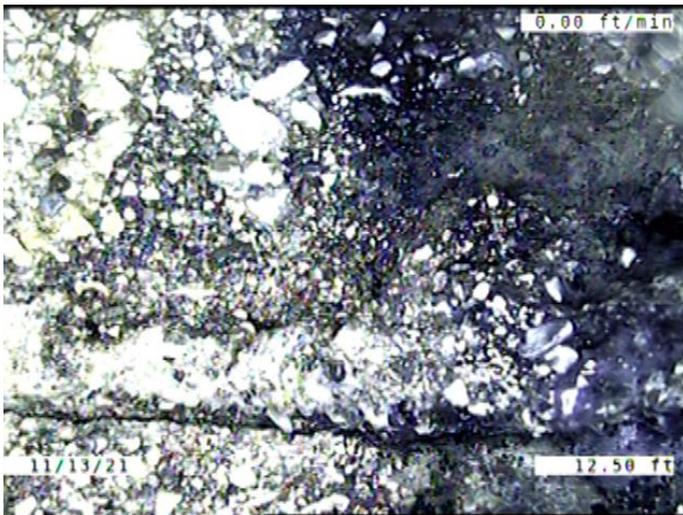
Code: **ISGT**
 Description: **Intruding Sealing Material Grout**

Distance (ft): **12.5**
 Structural Grade: **0**
 O&M Grade: **2**
 Clock Start/From: **5**
 Clock To: **8**
 1st Value:
 2nd Value:
 Value Percent: **5.000**
 Continuous Index:
 Within 8" of Joint: **NO**
 Remarks:

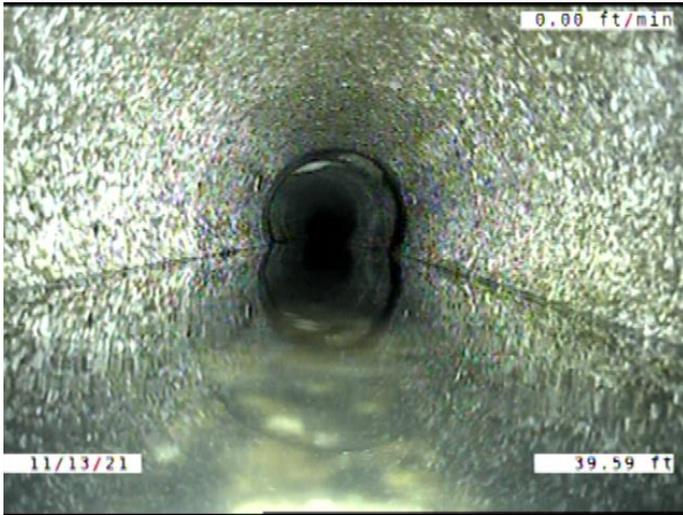
Code: **MWLS**
 Description: **Miscellaneous Water Level Sag**

Distance (ft): **39.6**
 Structural Grade: **2**
 O&M Grade: **0**
 Clock Start/From:
 Clock To:
 1st Value:
 2nd Value:
 Value Percent: **15.000**
 Continuous Index: **S01**
 Within 8" of Joint: **NO**
 Remarks:

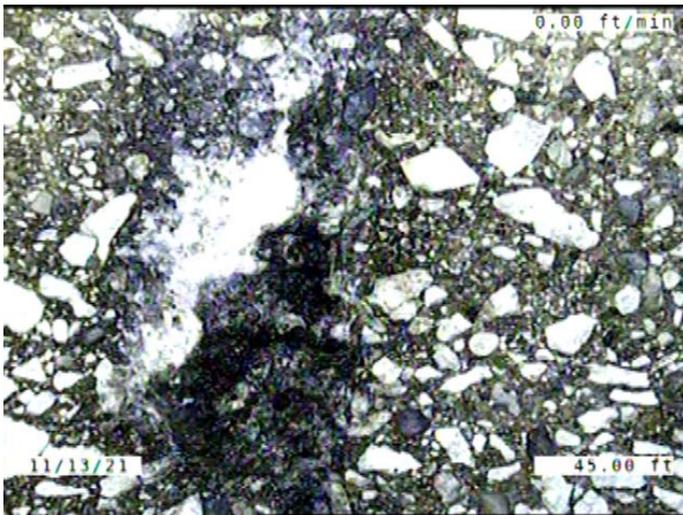
Code: **DAE**
 Description: **Deposits Attached Encrustation**

Distance (ft): **45.0**
 Structural Grade: **0**
 O&M Grade: **2**
 Clock Start/From: **10**
 Clock To:
 1st Value:
 2nd Value:
 Value Percent: **5.000**
 Continuous Index:
 Within 8" of Joint: **NO**
 Remarks:

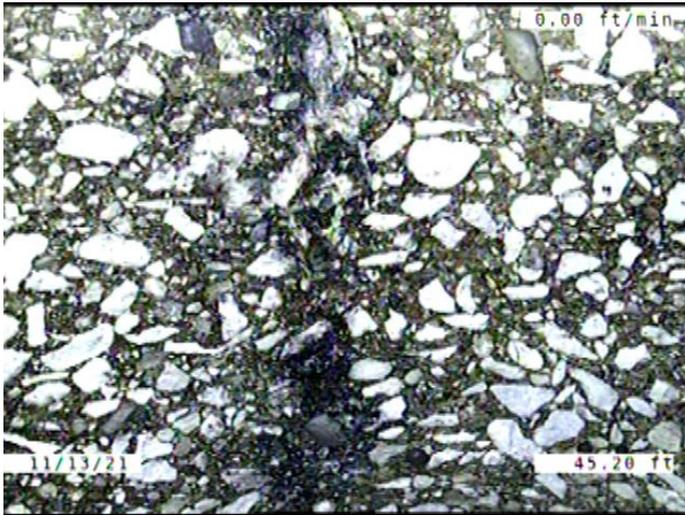
Code: **CL**
Description: **Crack Longitudinal**

Distance (ft): **45.2**
Structural Grade: **2**
O&M Grade: **0**
Clock Start/From: **10**
Clock To:
1st Value:
2nd Value:
Value Percent:
Continuous Index:
Within 8" of Joint: **NO**
Remarks:

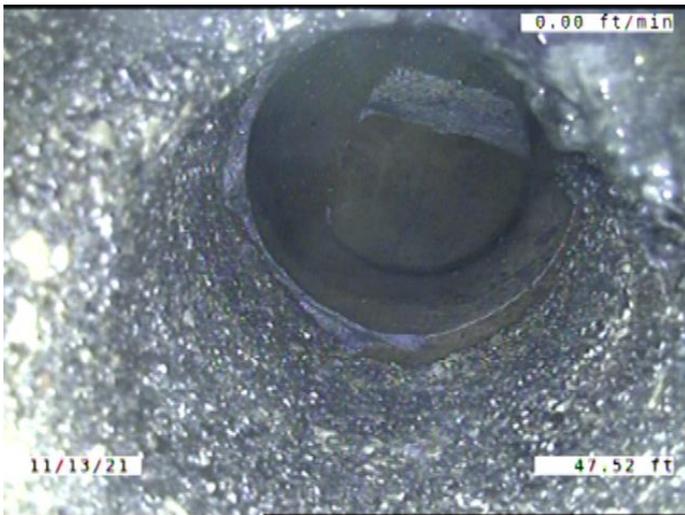
Code: **TF**
Description: **Tap Factory**

Distance (ft): **47.5**
Structural Grade: **0**
O&M Grade: **0**
Clock Start/From: **1**
Clock To:
1st Value: **6.000**
2nd Value:
Value Percent:
Continuous Index:
Within 8" of Joint: **YES**
Remarks: **CONSTANTLY RUNNING WATER.**

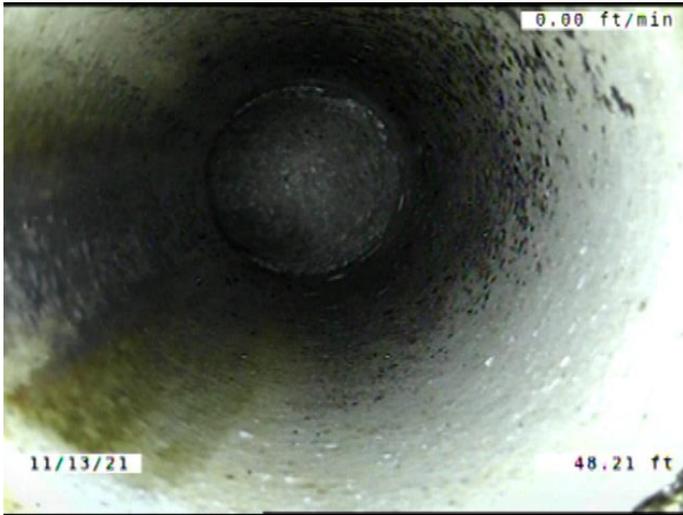
Code: **TB**
Description: **Tap Break-in/Hammer**

Distance (ft): **48.2**
Structural Grade: **0**
O&M Grade: **0**
Clock Start/From: **11**
Clock To:
1st Value: **6.000**
2nd Value:
Value Percent:
Continuous Index:
Within 8" of Joint: **YES**
Remarks:

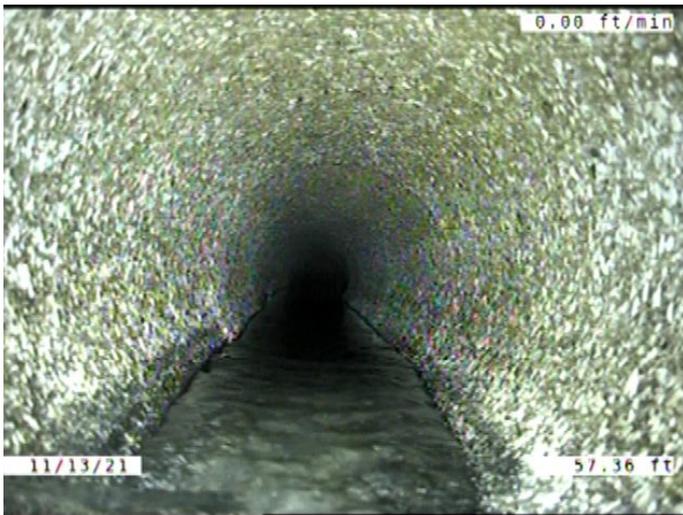
Code: **MWLS**
Description: **Miscellaneous Water Level Sag**

Distance (ft): **57.4**
Structural Grade: **2**
O&M Grade: **0**
Clock Start/From:
Clock To:
1st Value:
2nd Value:
Value Percent: **15.000**
Continuous Index: **F01**
Within 8" of Joint: **NO**
Remarks:

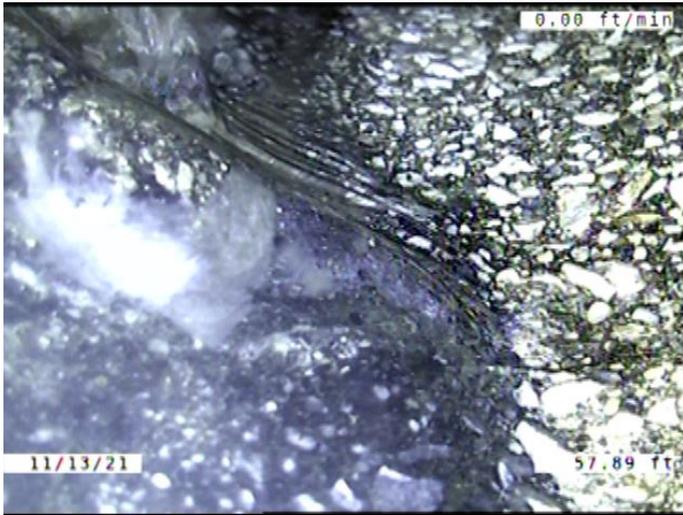
Code: **ISGT**
Description: **Intruding Sealing Material Grout**

Distance (ft): **57.9**
Structural Grade: **0**
O&M Grade: **2**
Clock Start/From: **5**
Clock To: **7**
1st Value:
2nd Value:
Value Percent: **10.000**
Continuous Index:
Within 8" of Joint: **NO**
Remarks:

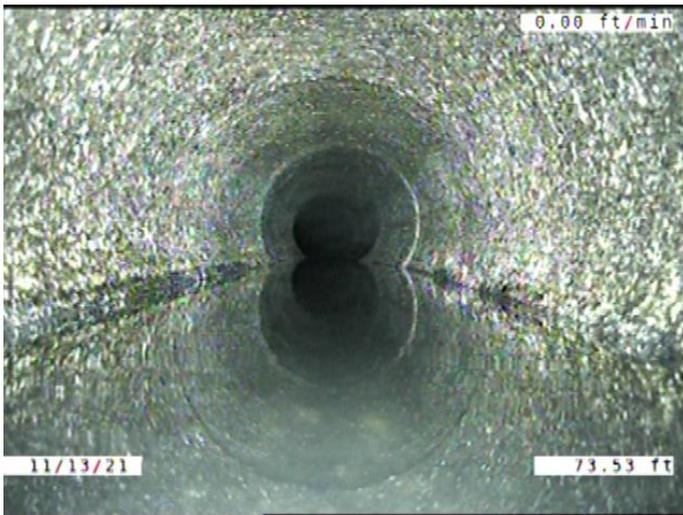
Code: **MWLS**
Description: **Miscellaneous Water Level Sag**

Distance (ft): **73.5**
Structural Grade: **2**
O&M Grade: **0**
Clock Start/From:
Clock To:
1st Value:
2nd Value:
Value Percent: **10.000**
Continuous Index: **S02**
Within 8" of Joint: **NO**
Remarks:

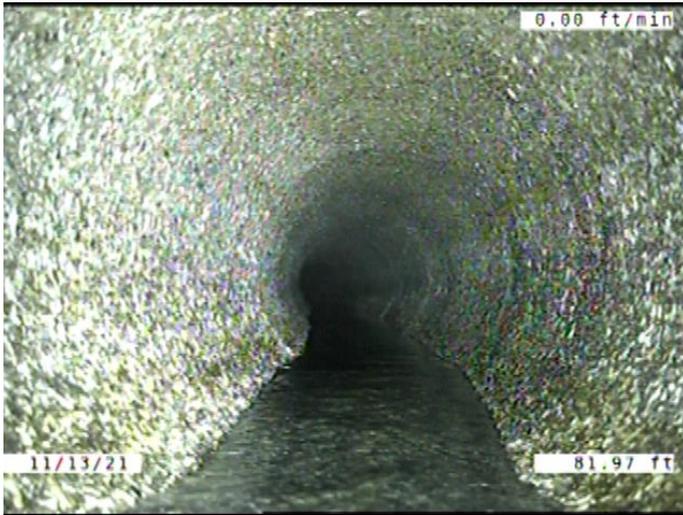
Code: **MWLS**
 Description: **Miscellaneous Water Level Sag**

Distance (ft): **82.0**
 Structural Grade: **2**
 O&M Grade: **0**
 Clock Start/From:
 Clock To:
 1st Value:
 2nd Value:
 Value Percent: **10.000**
 Continuous Index: **F02**
 Within 8" of Joint: **NO**
 Remarks:

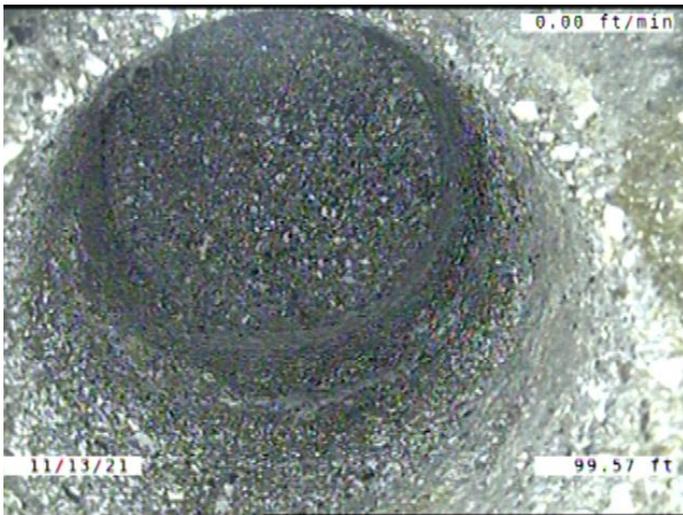
Code: **TFC**
 Description: **Tap Factory Capped**

Distance (ft): **99.6**
 Structural Grade: **0**
 O&M Grade: **0**
 Clock Start/From: **11**
 Clock To:
 1st Value: **6.000**
 2nd Value:
 Value Percent:
 Continuous Index:
 Within 8" of Joint: **YES**
 Remarks: **TAP CRACKED**

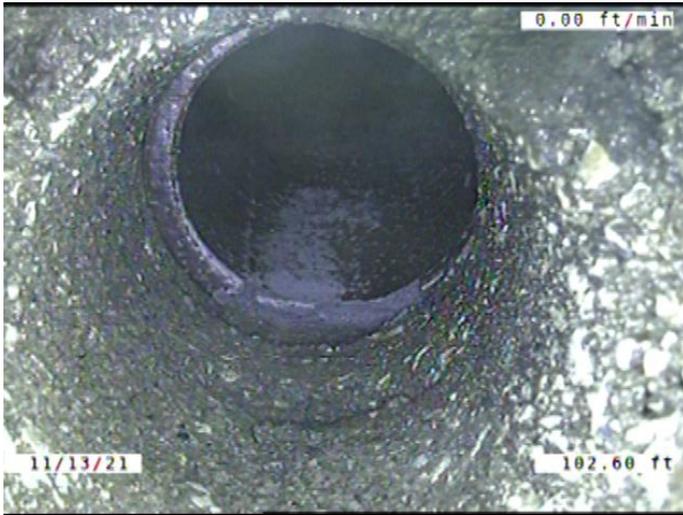
Code: **TF**
Description: **Tap Factory**

Distance (ft): **102.6**
Structural Grade: **0**
O&M Grade: **0**
Clock Start/From: **1**
Clock To:
1st Value: **6.000**
2nd Value:
Value Percent:
Continuous Index:
Within 8" of Joint: **YES**
Remarks:

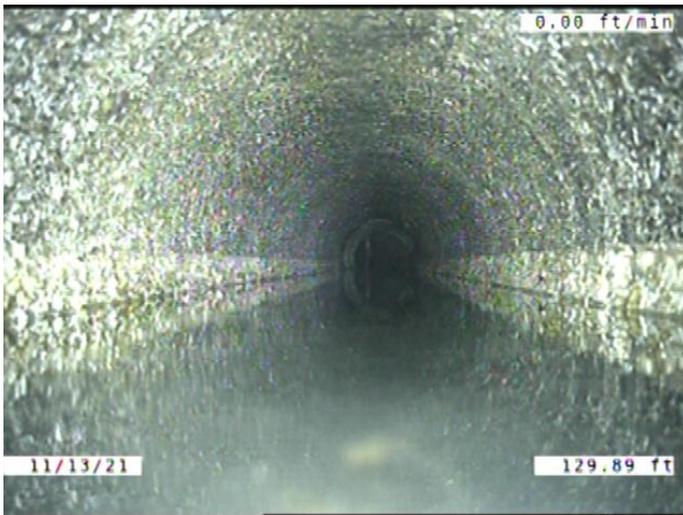
Code: **MWLS**
Description: **Miscellaneous Water Level Sag**

Distance (ft): **129.9**
Structural Grade: **2**
O&M Grade: **0**
Clock Start/From:
Clock To:
1st Value:
2nd Value:
Value Percent: **15.000**
Continuous Index: **S03**
Within 8" of Joint: **NO**
Remarks:

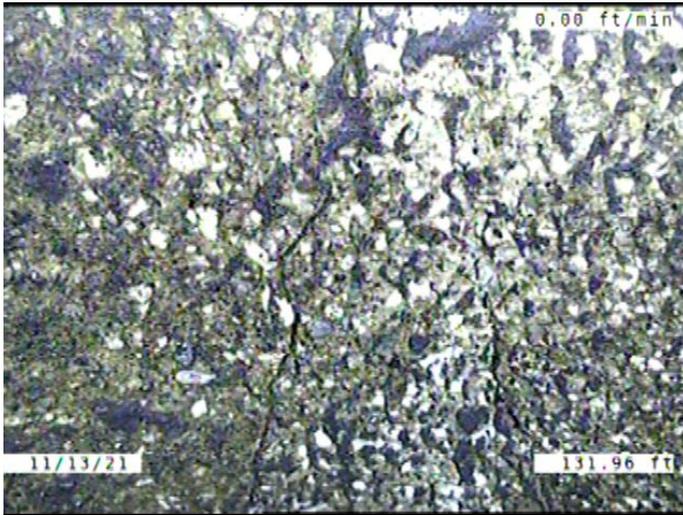
Code: **FM**
Description: **Fracture Multiple**

Distance (ft): **132.0**
Structural Grade: **4**
O&M Grade: **0**
Clock Start/From: **10**
Clock To: **3**
1st Value:
2nd Value:
Value Percent:
Continuous Index: **S04**
Within 8" of Joint: **YES**
Remarks:

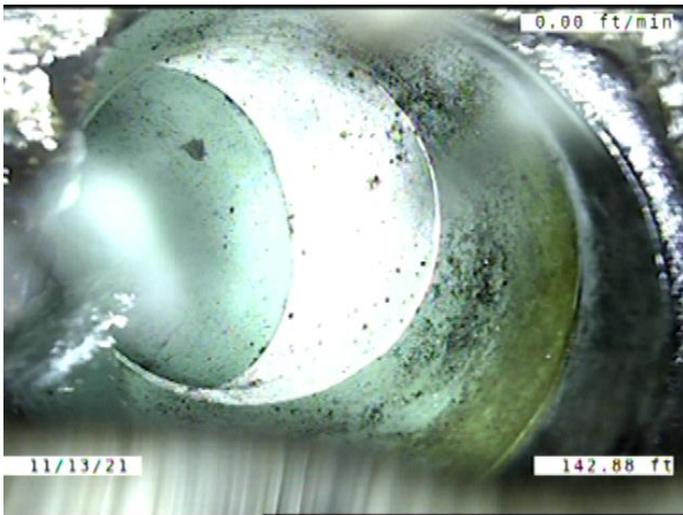
Code: **TBA**
Description: **Tap Break-in Activity**

Distance (ft): **142.9**
Structural Grade: **0**
O&M Grade: **0**
Clock Start/From: **12**
Clock To:
1st Value: **4.000**
2nd Value:
Value Percent:
Continuous Index:
Within 8" of Joint: **NO**
Remarks: **CONSTANTLY RUNNING WATER.**

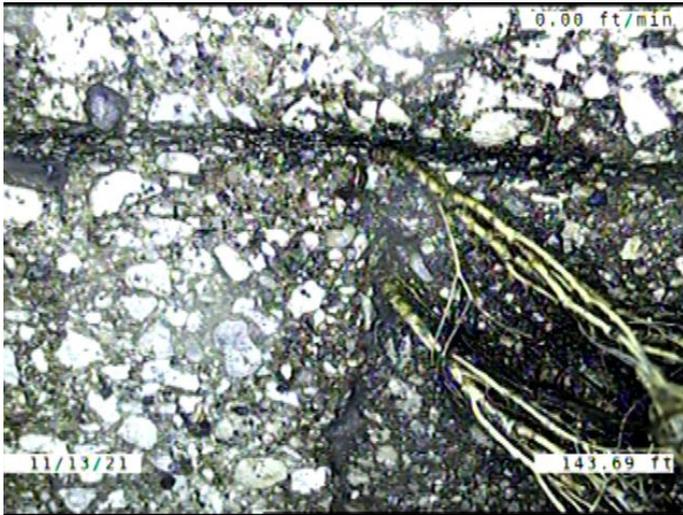
Code: **RFJ**
 Description: **Roots Fine Joint**

Distance (ft): **143.7**
 Structural Grade: **0**
 O&M Grade: **1**
 Clock Start/From: **1**
 Clock To: **2**
 1st Value:
 2nd Value:
 Value Percent:
 Continuous Index:
 Within 8" of Joint: **YES**
 Remarks:

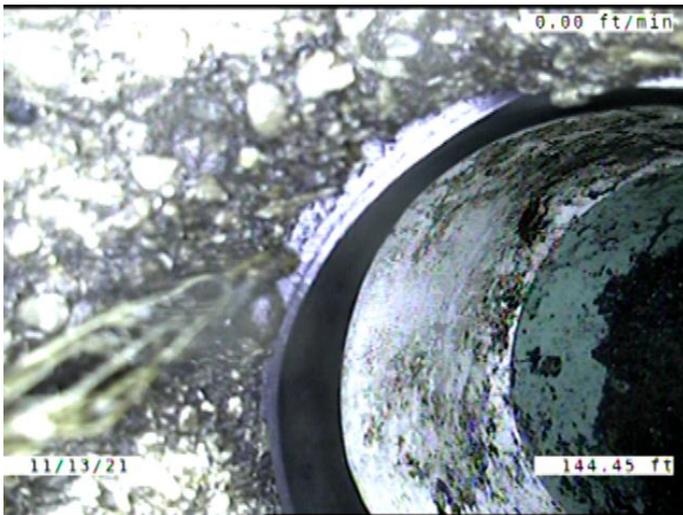
Code: **RFC**
 Description: **Roots Fine Connection**

Distance (ft): **144.4**
 Structural Grade: **0**
 O&M Grade: **1**
 Clock Start/From: **11**
 Clock To: **12**
 1st Value:
 2nd Value:
 Value Percent:
 Continuous Index:
 Within 8" of Joint: **NO**
 Remarks:

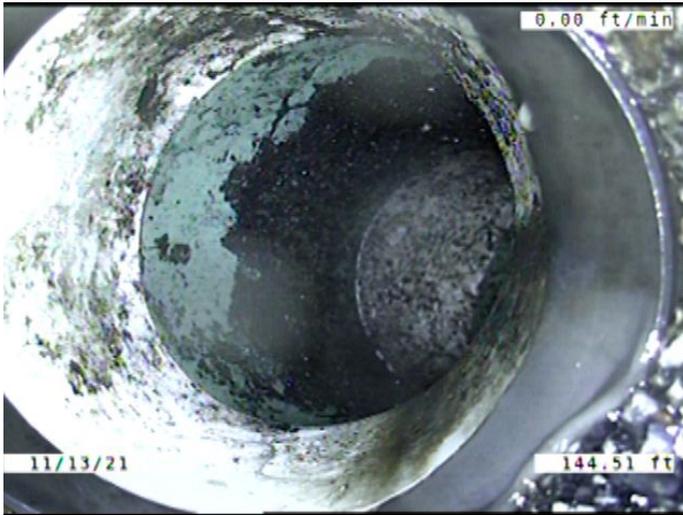
Code: **TB**
 Description: **Tap Break-in/Hammer**

Distance (ft): **144.5**
 Structural Grade: **0**
 O&M Grade: **0**
 Clock Start/From: **12**
 Clock To:
 1st Value: **4.000**
 2nd Value:
 Value Percent:
 Continuous Index:
 Within 8" of Joint: **NO**
 Remarks:

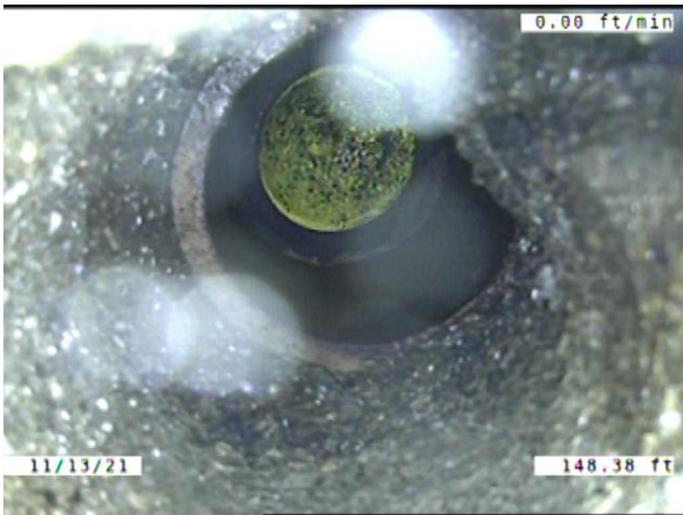
Code: **TFC**
 Description: **Tap Factory Capped**

Distance (ft): **148.4**
 Structural Grade: **0**
 O&M Grade: **0**
 Clock Start/From: **1**
 Clock To:
 1st Value: **6.000**
 2nd Value:
 Value Percent:
 Continuous Index:
 Within 8" of Joint: **YES**
 Remarks:

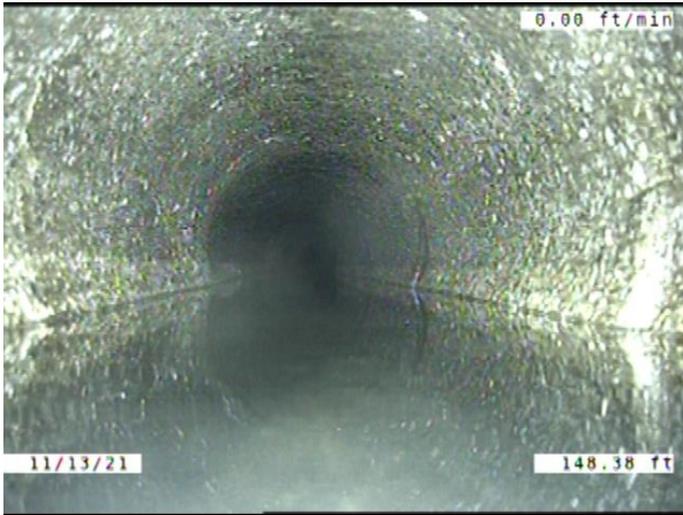
Code: **MWLS**
Description: **Miscellaneous Water Level Sag**

Distance (ft): **148.4**
Structural Grade: **2**
O&M Grade: **0**
Clock Start/From:
Clock To:
1st Value:
2nd Value:
Value Percent: **15.000**
Continuous Index: **F03**
Within 8" of Joint: **NO**
Remarks:

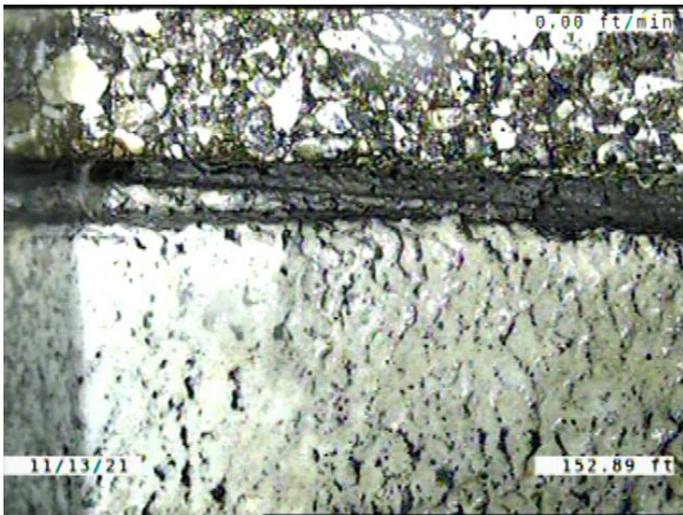
Code: **DAE**
Description: **Deposits Attached Encrustation**

Distance (ft): **152.9**
Structural Grade: **0**
O&M Grade: **2**
Clock Start/From: **9**
Clock To: **3**
1st Value:
2nd Value:
Value Percent: **5.000**
Continuous Index:
Within 8" of Joint: **YES**
Remarks:

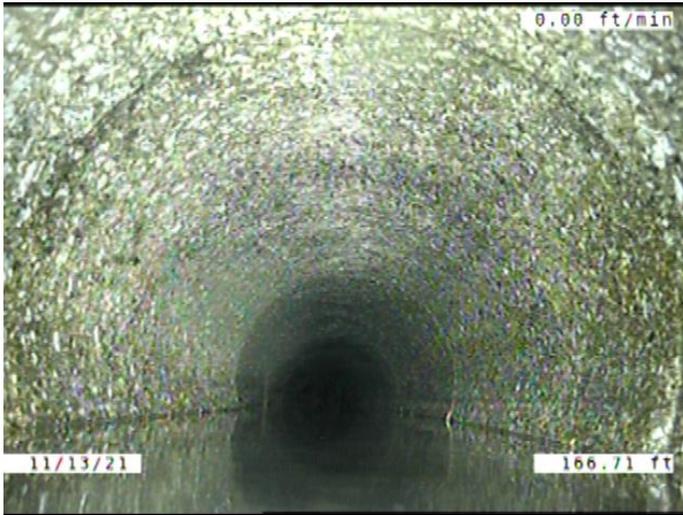
Code: **FM**
 Description: **Fracture Multiple**

Distance (ft): **166.7**
 Structural Grade: **4**
 O&M Grade: **0**
 Clock Start/From: **10**
 Clock To: **3**
 1st Value:
 2nd Value:
 Value Percent:
 Continuous Index: **F04**
 Within 8" of Joint: **YES**
 Remarks:

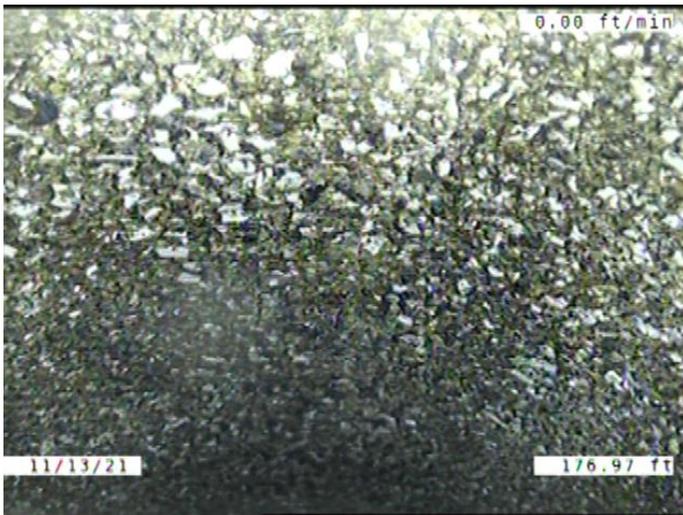
Code: **MWLS**
 Description: **Miscellaneous Water Level Sag**

Distance (ft): **177.0**
 Structural Grade: **2**
 O&M Grade: **0**
 Clock Start/From:
 Clock To:
 1st Value:
 2nd Value:
 Value Percent: **15.000**
 Continuous Index:
 Within 8" of Joint: **NO**
 Remarks:

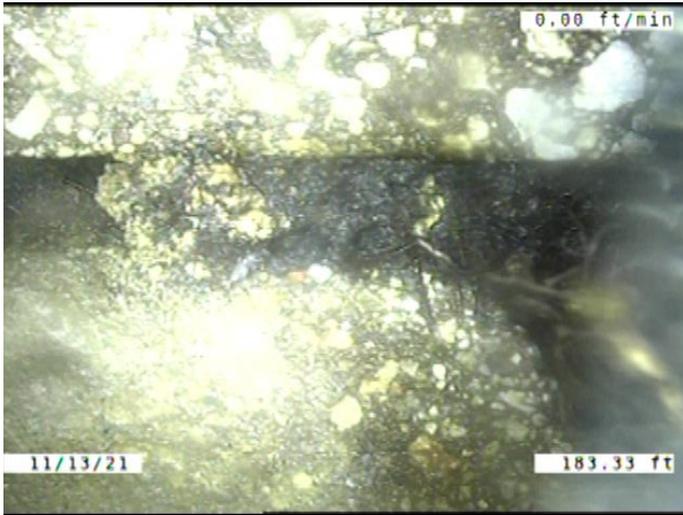
Code: **RFJ**
Description: **Roots Fine Joint**

Distance (ft): **183.3**
Structural Grade: **0**
O&M Grade: **1**
Clock Start/From: **9**
Clock To: **3**
1st Value:
2nd Value:
Value Percent:
Continuous Index:
Within 8" of Joint: **YES**
Remarks:

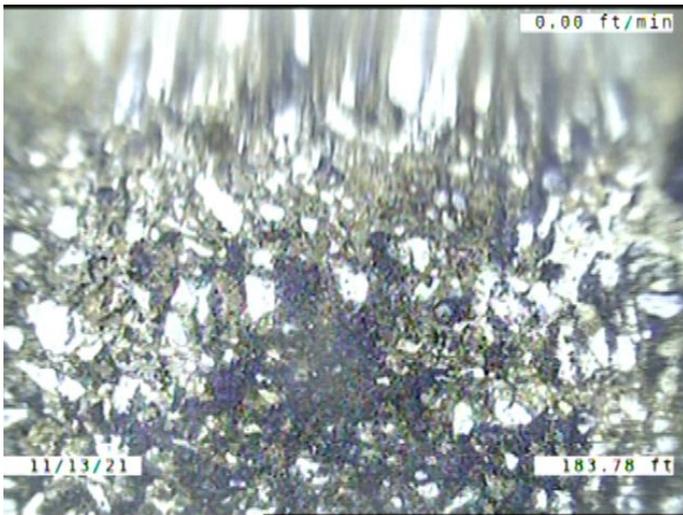
Code: **MCU**
Description: **Miscellaneous Camera Underwater**

Distance (ft): **183.8**
Structural Grade: **0**
O&M Grade: **4**
Clock Start/From:
Clock To:
1st Value:
2nd Value:
Value Percent:
Continuous Index:
Within 8" of Joint: **NO**
Remarks: **Out at 186.7**

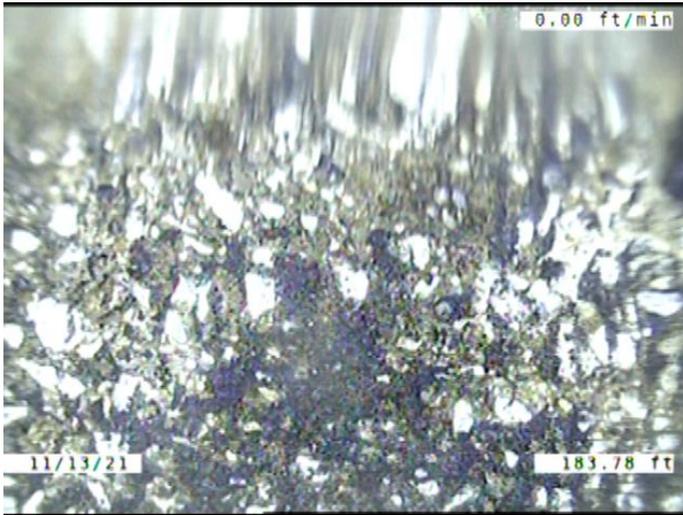
Code: **MWL**
 Description: **Miscellaneous Water Level**

Distance (ft): **183.8**
 Structural Grade: **0**
 O&M Grade: **0**
 Clock Start/From:
 Clock To:
 1st Value:
 2nd Value:
 Value Percent: **35.000**
 Continuous Index:
 Within 8" of Joint: **NO**
 Remarks:

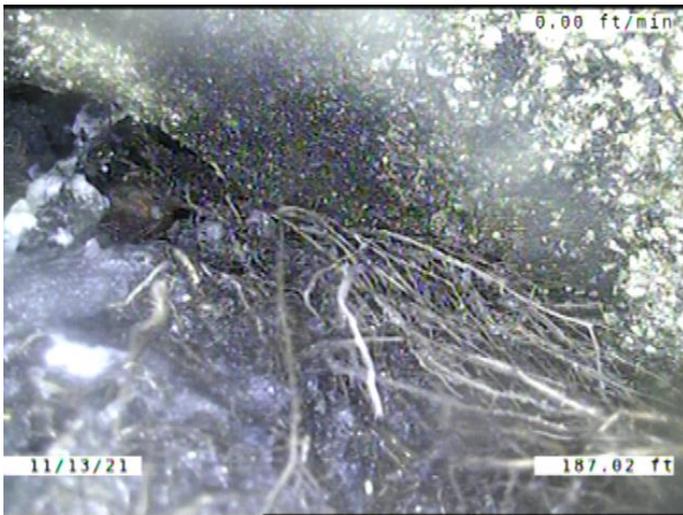
Code: **RML**
 Description: **Roots Medium Lateral**

Distance (ft): **187.0**
 Structural Grade: **0**
 O&M Grade: **3**
 Clock Start/From: **10**
 Clock To: **3**
 1st Value:
 2nd Value:
 Value Percent: **40.000**
 Continuous Index:
 Within 8" of Joint: **NO**
 Remarks:

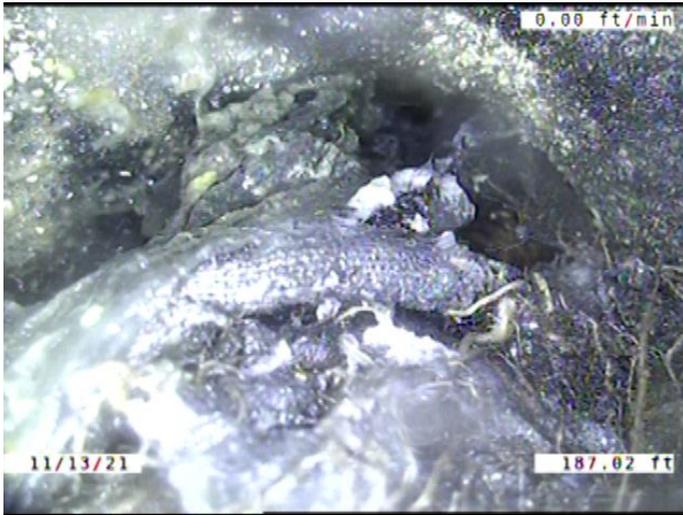
Code: **TFD**
Description: **Tap Factory Defective**

Distance (ft): **187.8**
Structural Grade: **0**
O&M Grade: **3**
Clock Start/From: **11**
Clock To:
1st Value: **6.000**

2nd Value:
Value Percent:
Continuous Index:
Within 8" of Joint: **YES**
Remarks: **ROOTS GROWING OUT OF THE TAP INTO THE MAIN.**

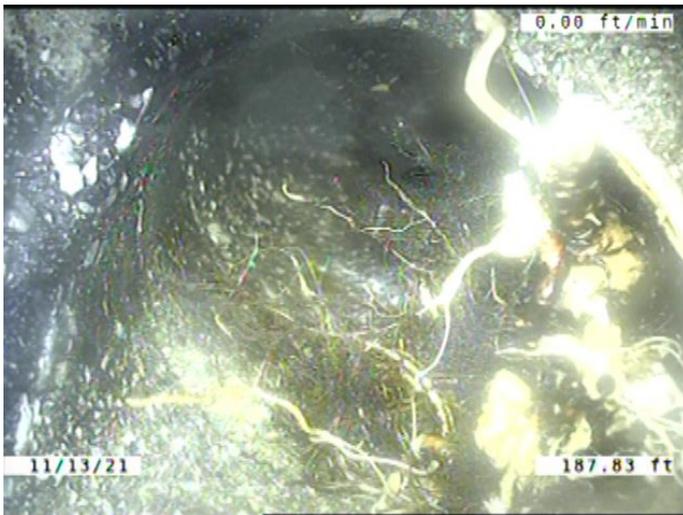
Code: **MGP**
Description: **Miscellaneous General Photograph**

Distance (ft): **187.8**
Structural Grade: **0**
O&M Grade: **0**
Clock Start/From: **11**
Clock To:

1st Value:
2nd Value:
Value Percent:
Continuous Index:
Within 8" of Joint: **NO**
Remarks: **TAP AFTER ROOT CUTTING**

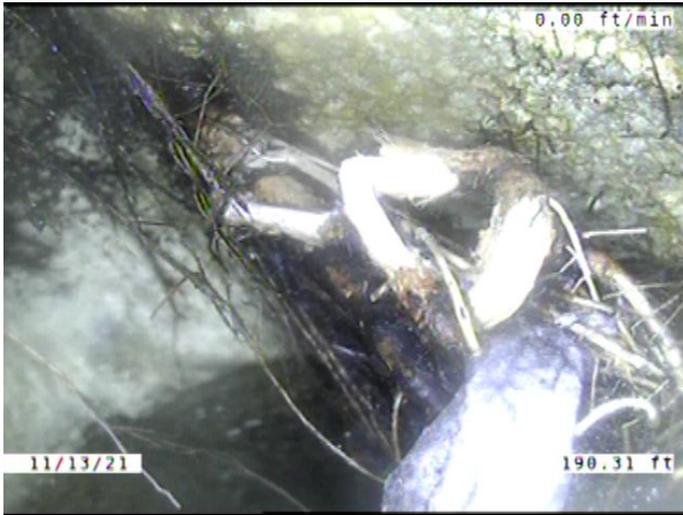
Code: **RTL**
 Description: **Roots Tap Lateral**

Distance (ft): **190.3**
 Structural Grade: **0**
 O&M Grade: **2**
 Clock Start/From: **2**
 Clock To: **7**
 1st Value:
 2nd Value:
 Value Percent: **40.000**
 Continuous Index:
 Within 8" of Joint: **NO**
 Remarks:

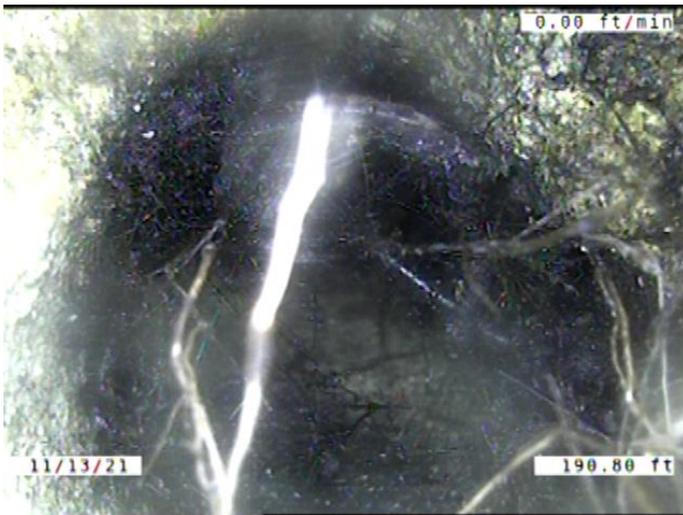
Code: **TFD**
 Description: **Tap Factory Defective**

Distance (ft): **190.8**
 Structural Grade: **0**
 O&M Grade: **3**
 Clock Start/From: **1**
 Clock To:
 1st Value: **6.000**
 2nd Value:
 Value Percent:
 Continuous Index:
 Within 8" of Joint: **YES**
 Remarks: **ROOTS GROWING OUT OF THE TAP INTO THE MAIN.**

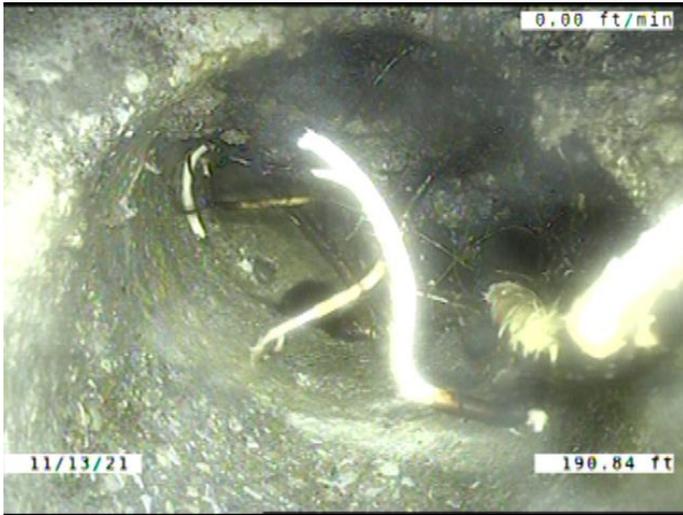
Code: **MGP**
 Description: **Miscellaneous General Photograph**

Distance (ft): **190.8**
 Structural Grade: **0**
 O&M Grade: **0**
 Clock Start/From: **1**
 Clock To:
 1st Value:
 2nd Value:
 Value Percent:
 Continuous Index:
 Within 8" of Joint: **NO**
 Remarks: **TAP AFTER ROOT CUTTING**

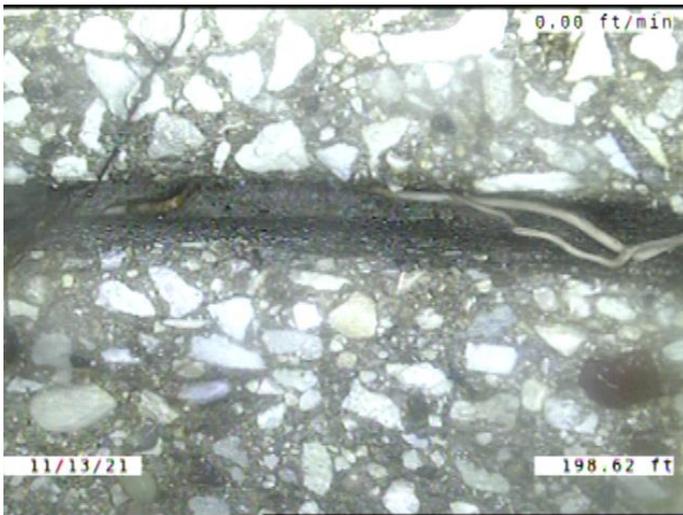
Code: **RFJ**
 Description: **Roots Fine Joint**

Distance (ft): **198.6**
 Structural Grade: **0**
 O&M Grade: **1**
 Clock Start/From: **1**
 Clock To: **3**
 1st Value:
 2nd Value:
 Value Percent:
 Continuous Index:
 Within 8" of Joint: **YES**
 Remarks:

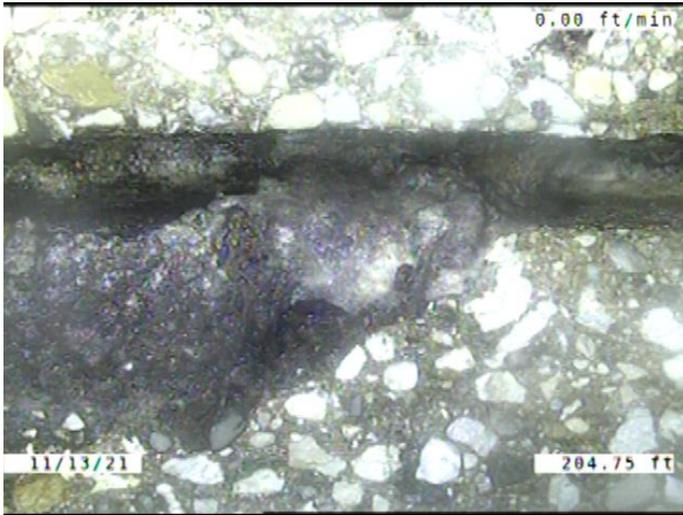
Code: **DAE**
Description: **Deposits Attached Encrustation**

Distance (ft): **204.8**
Structural Grade: **0**
O&M Grade: **2**
Clock Start/From: **9**
Clock To: **10**
1st Value:
2nd Value:
Value Percent: **5.000**
Continuous Index:
Within 8" of Joint: **YES**
Remarks:

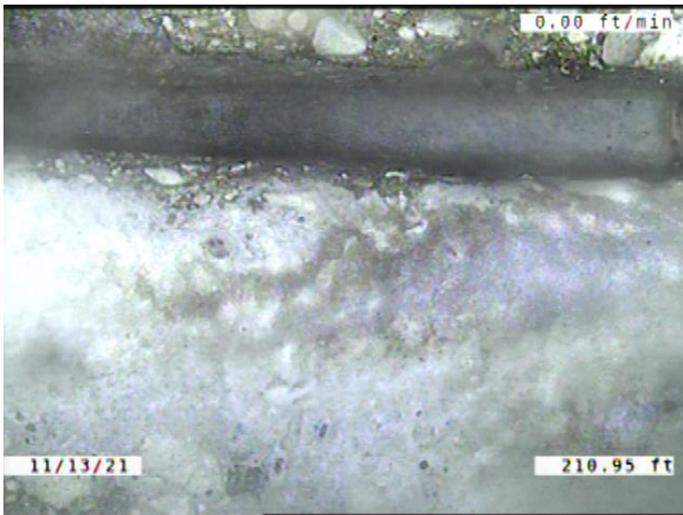
Code: **DAE**
Description: **Deposits Attached Encrustation**

Distance (ft): **210.9**
Structural Grade: **0**
O&M Grade: **2**
Clock Start/From: **10**
Clock To: **12**
1st Value:
2nd Value:
Value Percent: **5.000**
Continuous Index:
Within 8" of Joint: **YES**
Remarks:

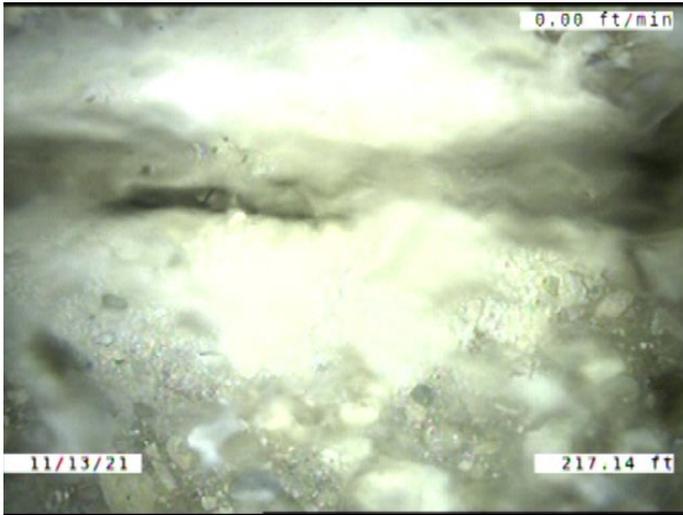
Code: **DAE**
Description: **Deposits Attached Encrustation**

Distance (ft): **217.1**
Structural Grade: **0**
O&M Grade: **2**
Clock Start/From: **9**
Clock To: **2**
1st Value:
2nd Value:
Value Percent: **5.000**
Continuous Index:
Within 8" of Joint: **YES**
Remarks:

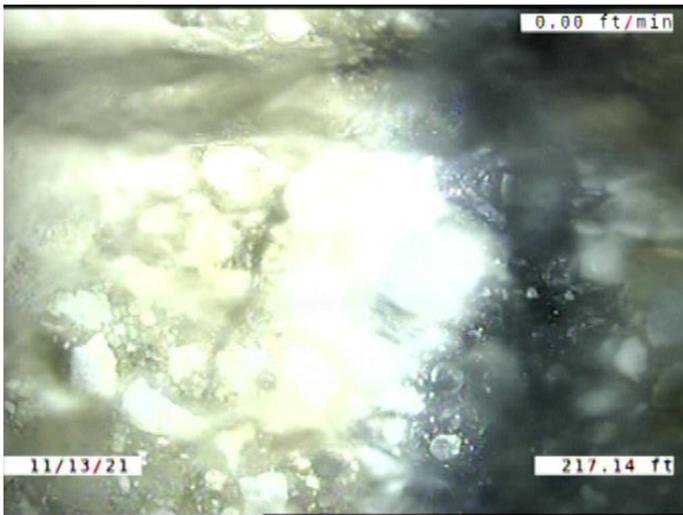
Code: **FL**
Description: **Fracture Longitudinal**

Distance (ft): **217.1**
Structural Grade: **3**
O&M Grade: **0**
Clock Start/From: **3**
Clock To:
1st Value:
2nd Value:
Value Percent:
Continuous Index:
Within 8" of Joint: **YES**
Remarks:

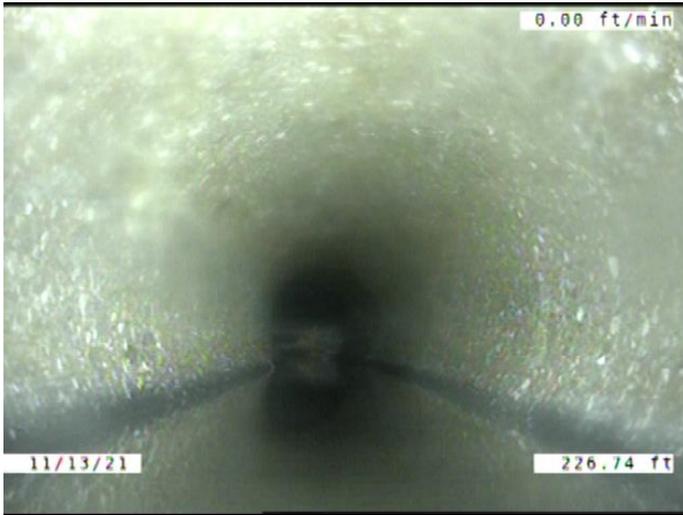
Code: **MWL**
 Description: **Miscellaneous Water Level**

Distance (ft): **226.7**
 Structural Grade: **0**
 O&M Grade: **0**
 Clock Start/From:
 Clock To:
 1st Value:
 2nd Value:
 Value Percent: **5.000**
 Continuous Index:
 Within 8" of Joint: **NO**
 Remarks:

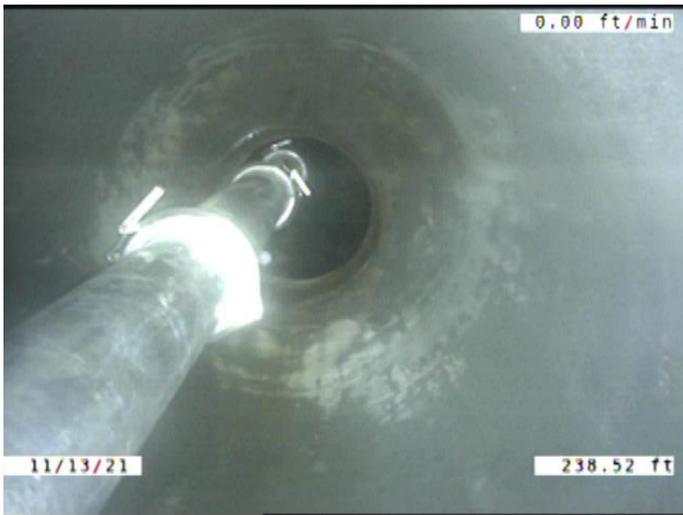
Code: **AMH**
 Description: **Manhole**

Distance (ft): **238.5**
 Structural Grade: **0**
 O&M Grade: **0**
 Clock Start/From:
 Clock To:
 1st Value:
 2nd Value:
 Value Percent:
 Continuous Index:
 Within 8" of Joint: **NO**
 Remarks: **M-605-067**
