## Profile/Photo Observation Report

Street:	<b>BEVERLY BLVD</b>	Flow Control:	<b>Not Controlled</b>
City:	<b>Hobart, IN</b>	Year Renewed:	
Location:	<b>Other</b>	Tape/Media #:	
Purpose:	<b>Not Known</b>	Dia/Height:	<b>10"</b>
Use:	<b>Sanitary</b>	Material:	<b>CP</b>
Drain Area:	<b>NA</b>	Lining:	
Category:	<b>NA</b>		
Comment:

Location Details:		Direction of Survey:	<b>Downstream</b>
US MH:	<b>M-604-007</b>	DS MH:	<b>M-604-008</b>
		Total Length Surveyed (ft):	<b>38.0</b>

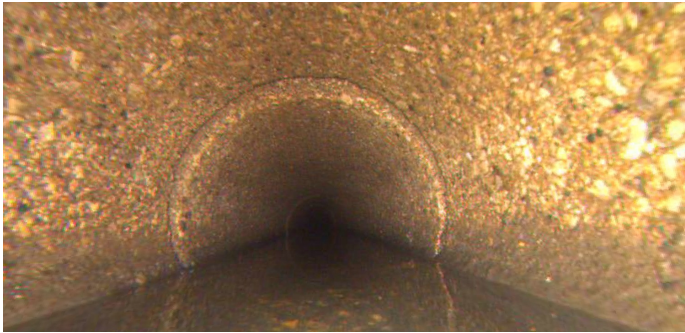
Code:	<b>MWL</b>
Description:	<b>Water Level</b>

Distance (ft):	<b>.0</b>
Structural Grade:	<b>0</b>
O&M Grade:	<b>0</b>
Clock Start/From:	
Clock To:	
1st Value:	
2nd Value:	
Value Percent:	<b>30.000</b>
Continuous Index:	
Within 8" of Joint:	<b>NO</b>
Remarks:

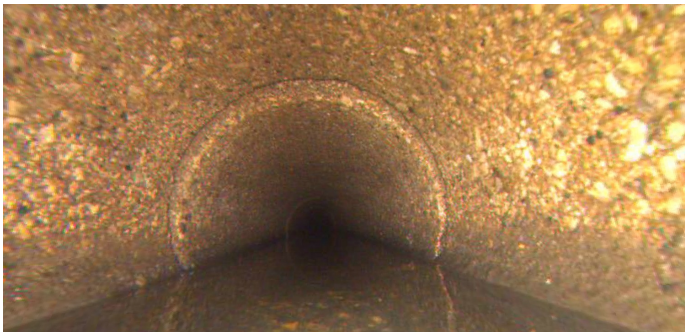
Code:	<b>SAP</b>
Description:	<b>Surface Aggregate Projecting</b>

Distance (ft):	<b>.0</b>
Structural Grade:	<b>3</b>
O&M Grade:	<b>0</b>
Clock Start/From:	<b>8</b>
Clock To:	<b>4</b>
1st Value:	
2nd Value:	
Value Percent:	
Continuous Index:	<b>S01</b>
Within 8" of Joint:	
Remarks:

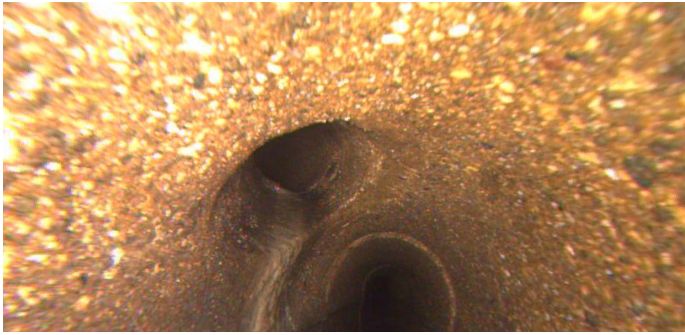
Code: **TF**  
Description: **Tap Factory**

Distance (ft): **11.8**  
Structural Grade: **0**  
O&M Grade: **0**  
Clock Start/From: **10**  
Clock To:  
1st Value: **4.000**  
2nd Value:  
Value Percent:  
Continuous Index:  
Within 8" of Joint:  
Remarks:

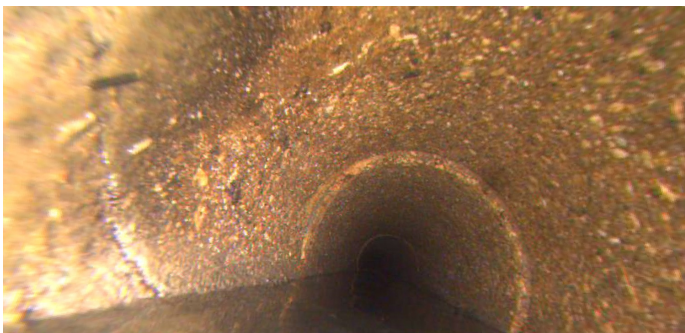
Code: **FC**  
Description: **Fracture Circumferential**

Distance (ft): **12.7**  
Structural Grade: **2**  
O&M Grade: **0**  
Clock Start/From: **8**  
Clock To: **10**  
1st Value:  
2nd Value:  
Value Percent:  
Continuous Index:  
Within 8" of Joint:  
Remarks:

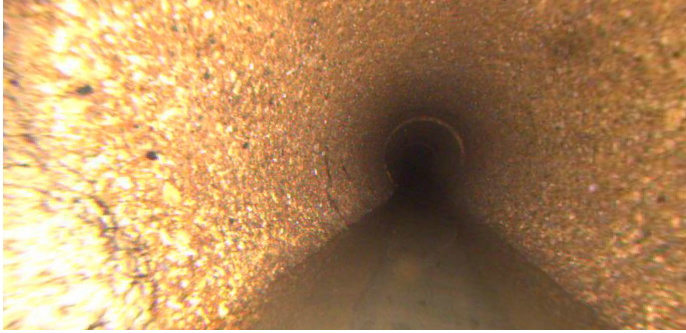
Code: **DAGS**  
Description: **Deposits Attached Grease**

Distance (ft): **25.7**  
Structural Grade: **0**  
O&M Grade: **2**  
Clock Start/From: **8**  
Clock To: **9**  
1st Value:  
2nd Value:  
Value Percent: **5.000**  
Continuous Index:  
Within 8" of Joint: **YES**  
Remarks:

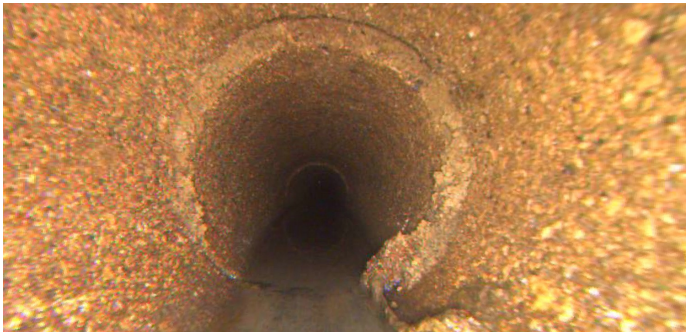
Code: **DAGS**  
Description: **Deposits Attached Grease**

Distance (ft): **37.0**  
Structural Grade: **0**  
O&M Grade: **2**  
Clock Start/From: **8**  
Clock To: **4**  
1st Value:  
2nd Value:  
Value Percent: **5.000**  
Continuous Index:  
Within 8" of Joint: **YES**  
Remarks:

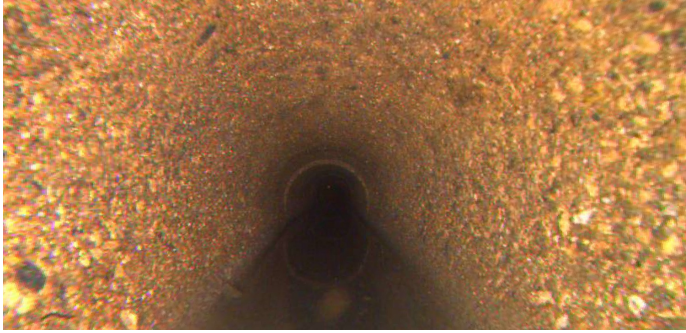
Code: **MSA**  
Description: **Abandoned Survey**

Distance (ft): **38.0**  
Structural Grade: **0**  
O&M Grade: **0**  
Clock Start/From:  
Clock To:  
1st Value:  
2nd Value:  
Value Percent:  
Continuous Index:  
Within 8" of Joint: **NO**  
Remarks: **dags**

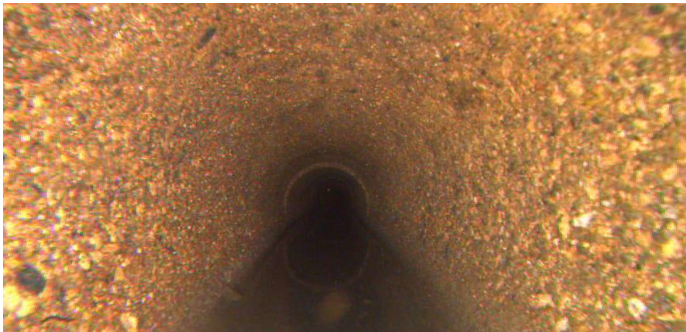
Code: **SAP**  
Description: **Surface Aggregate Projecting**

Distance (ft): **38.0**  
Structural Grade: **3**  
O&M Grade: **0**  
Clock Start/From: **8**  
Clock To: **4**  
1st Value:  
2nd Value:  
Value Percent:  
Continuous Index: **F01**  
Within 8" of Joint:  
Remarks:
