Profile/Photo Observation Report

| Street: | Beverly Blvd. | Flow Control: | Not Controlled |
| City: | Hobart, IN | Year Renewed: | |

| US MH: | M-604-007 | DS MH: | M-604-008 |

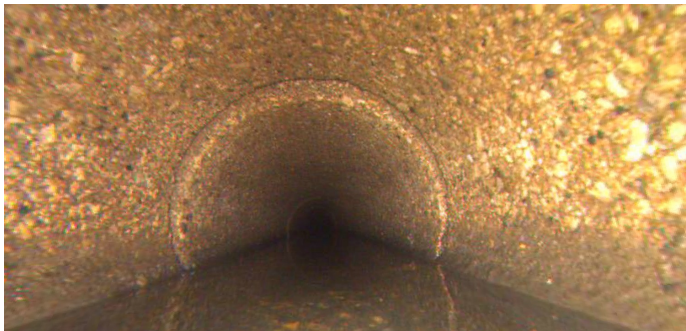
Code: **AMH**
Description: **Manhole**

Distance (ft): **.0**
Structural Grade: **0**
O&M Grade: **0**
Clock Start/From:
Clock To:
1st Value:
2nd Value:
Value Percent:
Continuous Index:
Within 8" of Joint: **NO**
Remarks: **M-604-007**

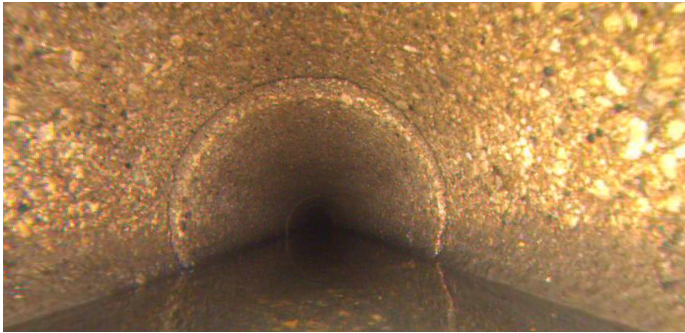
| Code: | MWL |
| Description: | Water Level |

| Value Percent: | 30.000 |

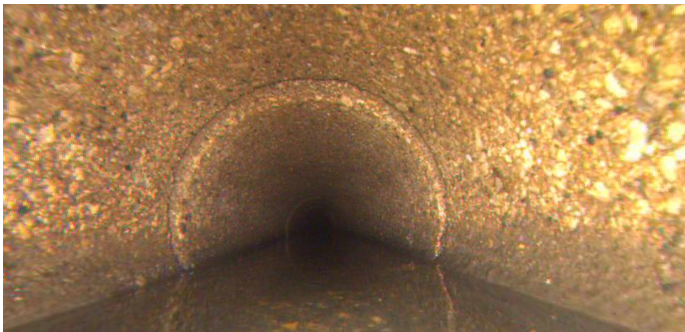
| Code: | SAP |
| Description: | Surface Aggregate Projecting |

| Structural Grade: | 3 |
| Clock Start/From: | 8 |
| Clock To: | 4 |

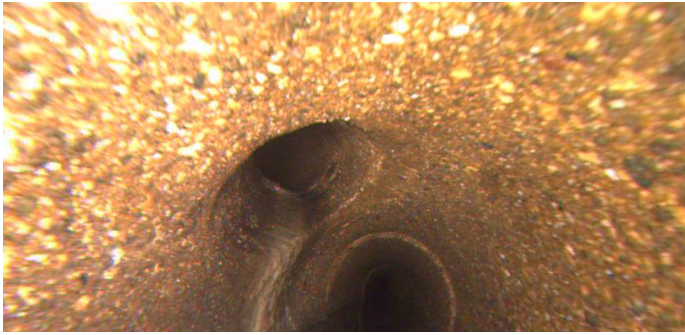
Code: **TF**
Description: **Tap Factory**

Distance (ft): **11.8**
Structural Grade: **0**
O&M Grade: **0**
Clock Start/From: **10**
Clock To:
1st Value: **4.000**
2nd Value:
Value Percent:
Continuous Index:
Within 8" of Joint:
Remarks:

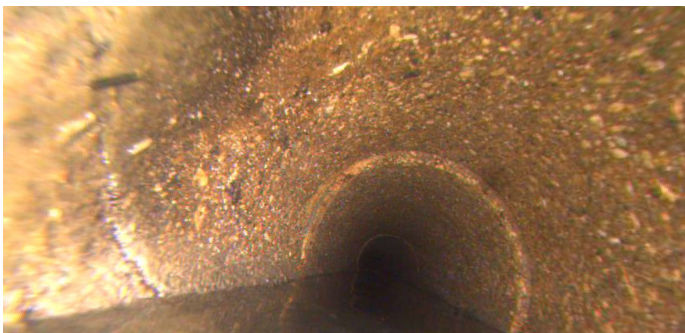
| | Position | Code | Observation | Video (sec) | Grade |
|--|---|---|---|---|---|
| | 12.7 | FC | Fracture Circumferential | 82 | S 2 |

Code: **FC**
Description: **Fracture Circumferential**

Distance (ft): **12.7**
Structural Grade: **2**
O&M Grade: **0**
Clock Start/From: **8**
Clock To: **10**
1st Value:
2nd Value:
Value Percent:
Continuous Index:
Within 8" of Joint:
Remarks:

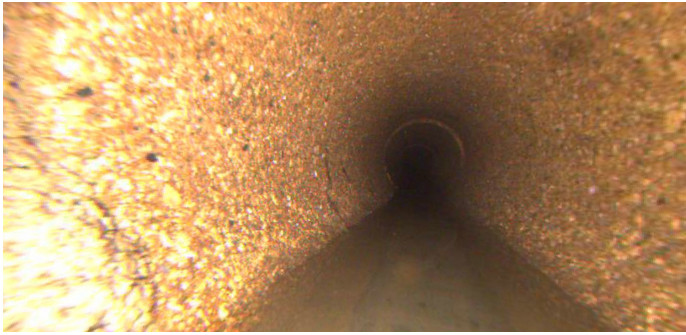
| | Position | Code | Observation | Video (sec) | Grade |
|--|---|---|---|---|---|
| | 25.7 | DAGS | Deposits Attached Grease | 119 | M 2 |

Code: **DAGS**
Description: **Deposits Attached Grease**

Distance (ft): **25.7**
Structural Grade: **0**
O&M Grade: **2**
Clock Start/From: **8**
Clock To: **9**
1st Value:
2nd Value:
Value Percent: **5.000**
Continuous Index:
Within 8" of Joint: **YES**
Remarks:

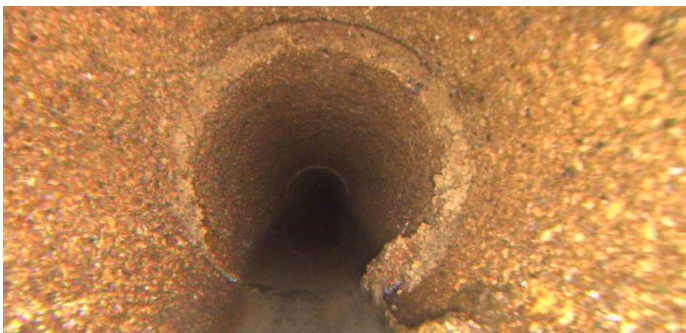
| | Position | Code | Observation | Video (sec) | Grade |
|--|---|---|---|---|---|
| | 37.0 | DAGS | Deposits Attached Grease | 153 | M 2 |

Code: **DAGS**
Description: **Deposits Attached Grease**

Distance (ft): **37.0**
Structural Grade: **0**
O&M Grade: **2**
Clock Start/From: **8**
Clock To: **4**
1st Value:
2nd Value:
Value Percent: **5.000**
Continuous Index:
Within 8" of Joint: **YES**
Remarks:

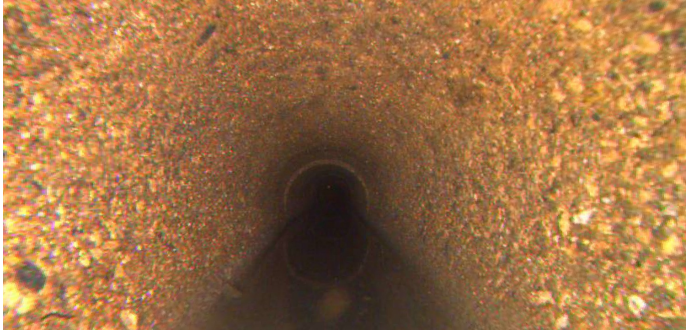
Code: **MSA**
Description: **Abandoned Survey**

Distance (ft): **38.0**
Structural Grade: **0**
O&M Grade: **0**
Clock Start/From:
Clock To:
1st Value:
2nd Value:
Value Percent:
Continuous Index:
Within 8" of Joint: **NO**
Remarks: **dags**

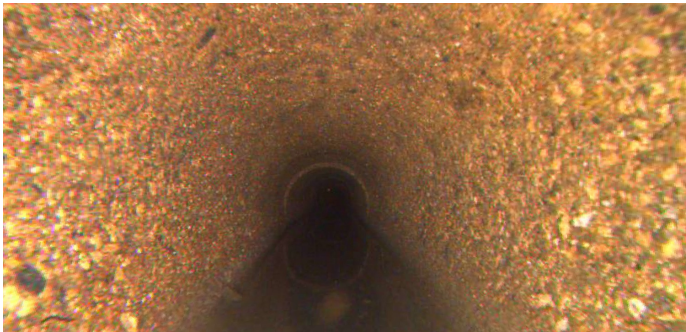
| | Position | Code | Observation | Video (sec) | Grade |
|--|---|---|---|---|---|
| | 38.0 | SAP(F01) | Surface Aggregate Projecting | 178 | S 3 |

Code: **SAP**
Description: **Surface Aggregate Projecting**

Distance (ft): **38.0**
Structural Grade: **3**
O&M Grade: **0**
Clock Start/From: **8**
Clock To: **4**
1st Value:
2nd Value:
Value Percent:
Continuous Index: **F01**
Within 8" of Joint:
Remarks:
