Profile/Photo Observation Report

Street:	BEVERLY BLVD	Flow Control:	Not Controlled
City:	Hobart, IN	Year Renewed:	
Location:	Other	Tape/Media #:	
Purpose:	Not Known	Dia/Height:	10"
Use:	Sanitary	Material:	VCP
Drain Area:	NA	Lining:	
Category:	NA		
Comment:

Location Details:		Direction of Survey:	Upstream
US MH:	M-604-007	DS MH:	M-604-008
		Total Length Surveyed (ft):	129.4

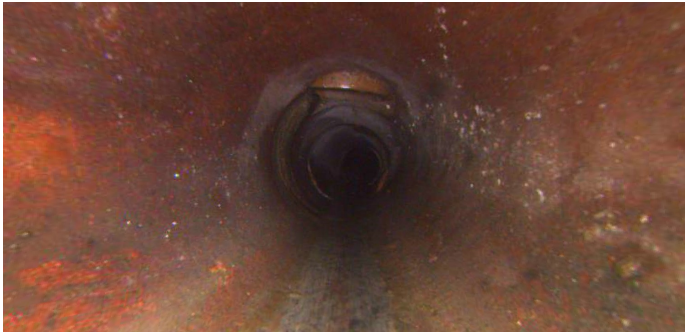
Code: **AMH**
Description: **Manhole**

Distance (ft): **.0**
Structural Grade: **0**
O&M Grade: **0**
Clock Start/From:
Clock To:
1st Value:
2nd Value:
Value Percent:
Continuous Index:
Within 8" of Joint: **NO**
Remarks: **M-604-008**

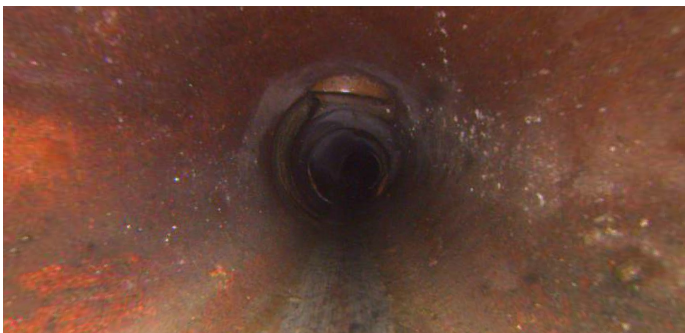
Code: **MWL**
Description: **Water Level**

Distance (ft): **.0**
Structural Grade: **0**
O&M Grade: **0**
Clock Start/From:
Clock To:
1st Value:
2nd Value:
Value Percent: **5.000**
Continuous Index:
Within 8" of Joint: **NO**
Remarks:

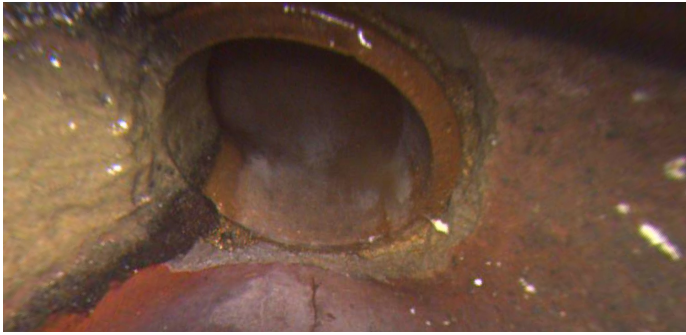
Code: **TBI**
Description: **Tap Break-in Intruding**

Distance (ft): **2.5**
Structural Grade: **0**
O&M Grade: **2**
Clock Start/From: **12**
Clock To:
1st Value: **4.000**
2nd Value: **1.000**
Value Percent:
Continuous Index:
Within 8" of Joint:
Remarks:

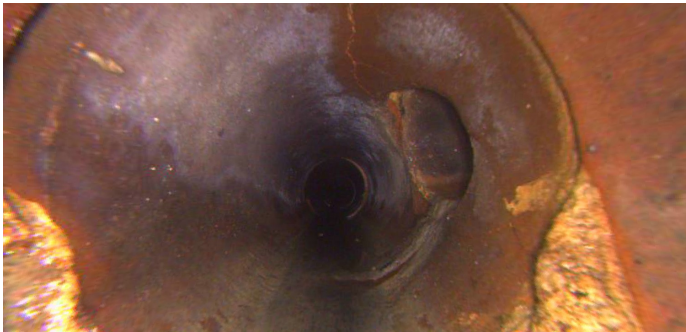
Code: **DAE**
Description: **Deposits Attached Encrustation**

Distance (ft): **3.6**
Structural Grade: **0**
O&M Grade: **2**
Clock Start/From: **8**
Clock To: **4**
1st Value:
2nd Value:
Value Percent: **5.000**
Continuous Index:
Within 8" of Joint: **YES**
Remarks:

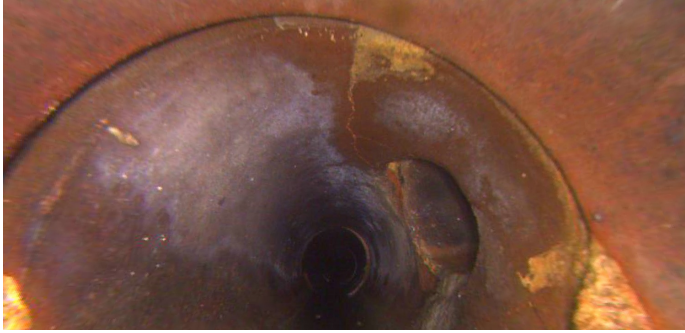
Code: **FS**
Description: **Fracture Spiral**

Distance (ft): **3.6**
Structural Grade: **3**
O&M Grade: **0**
Clock Start/From: **12**
Clock To: **1**
1st Value:
2nd Value:
Value Percent:
Continuous Index:
Within 8" of Joint: **YES**
Remarks:

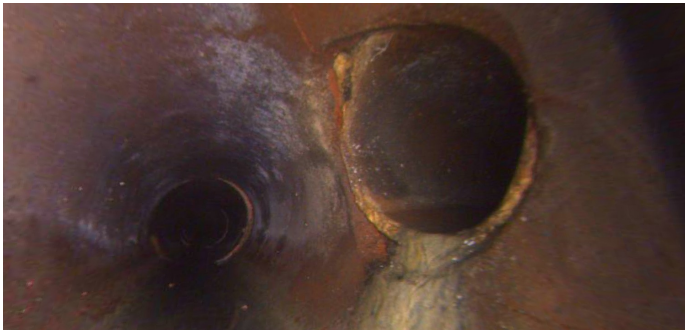
Code: **TBI**
Description: **Tap Break-in Intruding**

Distance (ft): **4.2**
Structural Grade: **0**
O&M Grade: **2**
Clock Start/From: **3**
Clock To:
1st Value: **4.000**
2nd Value: **1.000**
Value Percent:
Continuous Index:
Within 8" of Joint:
Remarks:

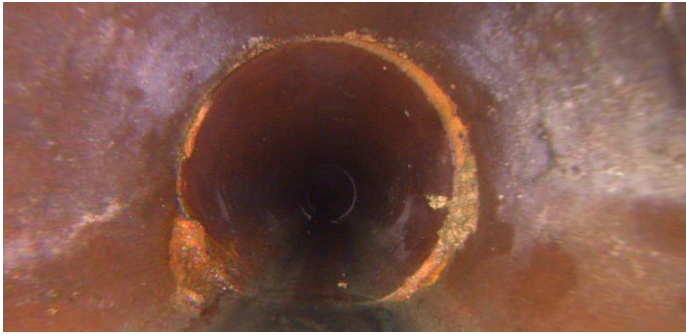
Code: **DAE**
Description: **Deposits Attached Encrustation**

Distance (ft): **6.2**
Structural Grade: **0**
O&M Grade: **2**
Clock Start/From: **8**
Clock To: **4**
1st Value:
2nd Value:
Value Percent: **5.000**
Continuous Index:
Within 8" of Joint: **YES**
Remarks:

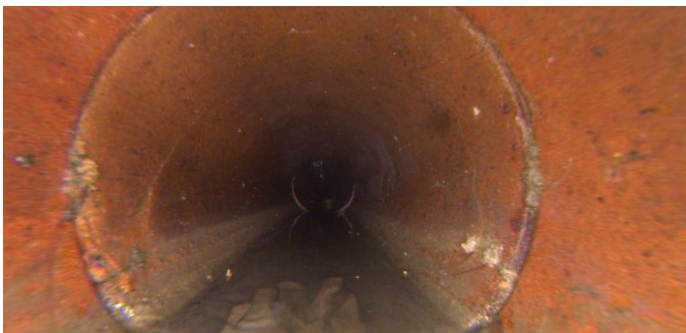
Code: **FC**
Description: **Fracture Circumferential**

Distance (ft): **21.5**
Structural Grade: **2**
O&M Grade: **0**
Clock Start/From: **8**
Clock To: **4**
1st Value:
2nd Value:
Value Percent:
Continuous Index:
Within 8" of Joint: **YES**
Remarks:

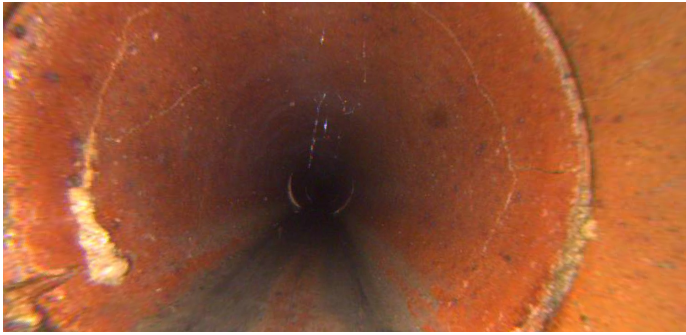
Code: **FC**
Description: **Fracture Circumferential**

Distance (ft): **30.6**
Structural Grade: **2**
O&M Grade: **0**
Clock Start/From: **8**
Clock To: **4**
1st Value:
2nd Value:
Value Percent:
Continuous Index:
Within 8" of Joint: **YES**
Remarks:

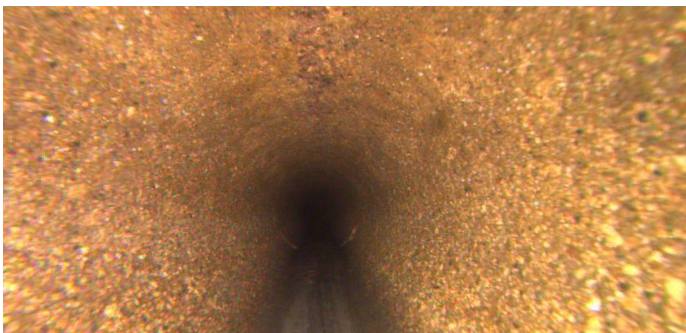
Code: **MMC**
Description: **Material Change**

Distance (ft): **40.3**
Structural Grade: **0**
O&M Grade: **0**
Clock Start/From:
Clock To:
1st Value:
2nd Value:
Value Percent:
Continuous Index:
Within 8" of Joint: **NO**
Remarks: **cp**

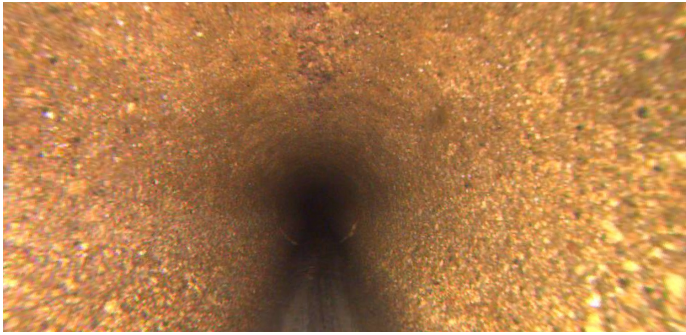
Code: **SAP**
Description: **Surface Aggregate Projecting**

Distance (ft): **40.3**
Structural Grade: **3**
O&M Grade: **0**
Clock Start/From: **7**
Clock To: **5**
1st Value:
2nd Value:
Value Percent:
Continuous Index: **S01**
Within 8" of Joint:
Remarks:

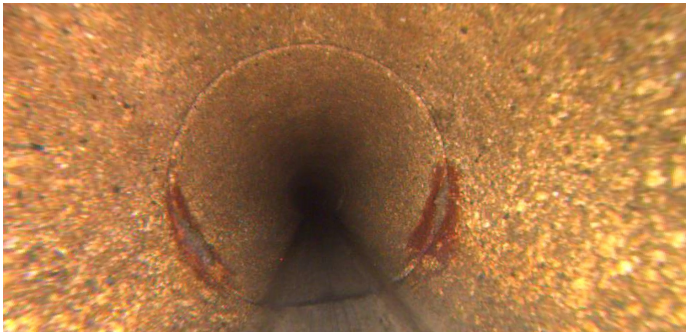
Code: **IS**
Description: **Infil Stain**

Distance (ft): **45.0**
Structural Grade: **0**
O&M Grade: **0**
Clock Start/From: **8**
Clock To: **4**
1st Value:
2nd Value:
Value Percent:
Continuous Index: **S02**
Within 8" of Joint: **YES**
Remarks:

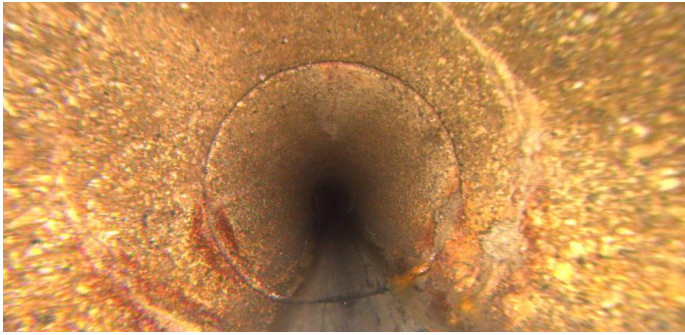
Code: **FC**
Description: **Fracture Circumferential**

Distance (ft): **48.1**
Structural Grade: **2**
O&M Grade: **0**
Clock Start/From: **7**
Clock To: **5**
1st Value:
2nd Value:
Value Percent:
Continuous Index:
Within 8" of Joint:
Remarks:

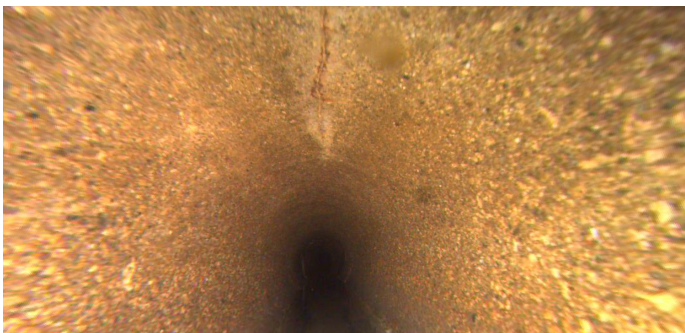
Code: **FL**
Description: **Fracture Longitudinal**

Distance (ft): **48.8**
Structural Grade: **3**
O&M Grade: **0**
Clock Start/From: **12**
Clock To:
1st Value:
2nd Value:
Value Percent:
Continuous Index:
Within 8" of Joint: **YES**
Remarks:

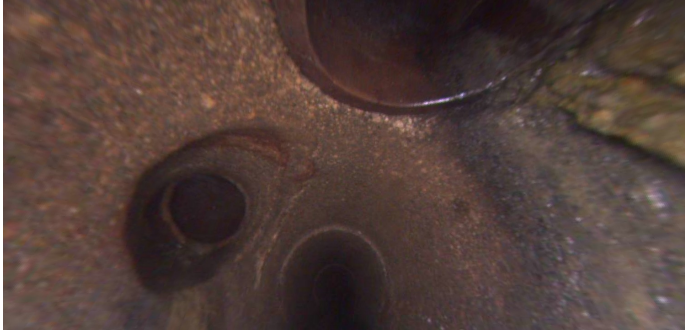
Code: **TF**
Description: **Tap Factory**

Distance (ft): **53.6**
Structural Grade: **0**
O&M Grade: **0**
Clock Start/From: **2**
Clock To:
1st Value: **4.000**
2nd Value:
Value Percent:
Continuous Index:
Within 8" of Joint:
Remarks:

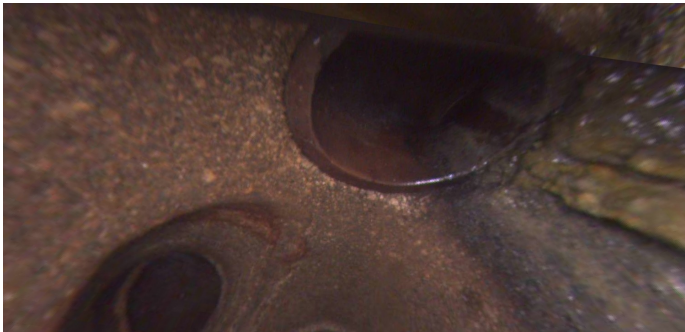
Code: **TB**
Description: **Tap Break-in**

Distance (ft): **53.6**
Structural Grade: **0**
O&M Grade: **0**
Clock Start/From: **12**
Clock To:
1st Value: **4.000**
2nd Value:
Value Percent:
Continuous Index:
Within 8" of Joint:
Remarks:

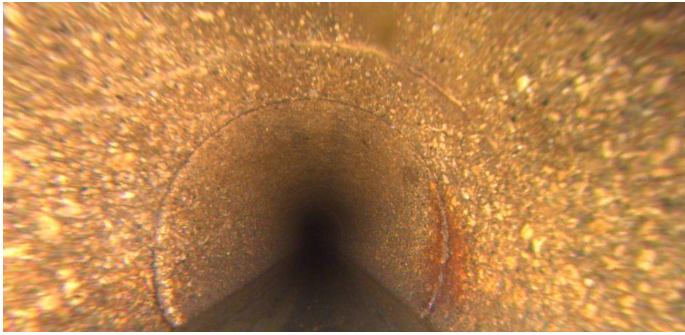
Code: **FC**
Description: **Fracture Circumferential**

Distance (ft): **57.2**
Structural Grade: **2**
O&M Grade: **0**
Clock Start/From: **10**
Clock To: **2**
1st Value:
2nd Value:
Value Percent:
Continuous Index:
Within 8" of Joint:
Remarks:

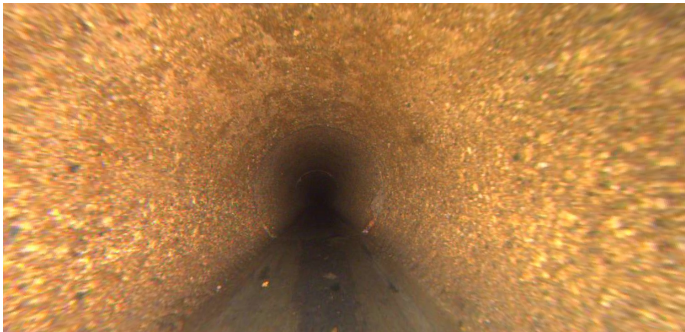
Code: **IS**
Description: **Infil Stain**

Distance (ft): **71.5**
Structural Grade: **0**
O&M Grade: **0**
Clock Start/From: **8**
Clock To: **4**
1st Value:
2nd Value:
Value Percent:
Continuous Index: **F02**
Within 8" of Joint: **YES**
Remarks:

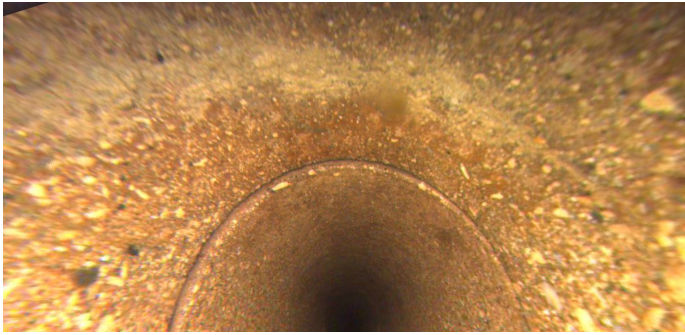
Code: **FC**
Description: **Fracture Circumferential**

Distance (ft): **75.3**
Structural Grade: **2**
O&M Grade: **0**
Clock Start/From: **10**
Clock To: **2**
1st Value:
2nd Value:
Value Percent:
Continuous Index:
Within 8" of Joint:
Remarks:

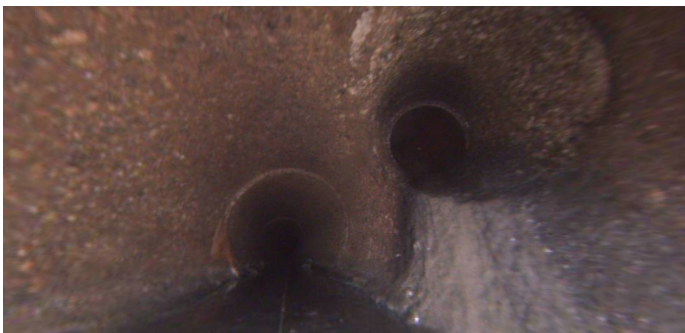
Code: **TFA**
Description: **Tap Factory Active**

Distance (ft): **125.4**
Structural Grade: **0**
O&M Grade: **0**
Clock Start/From: **10**
Clock To:
1st Value: **4.000**
2nd Value:
Value Percent:
Continuous Index:
Within 8" of Joint:
Remarks:

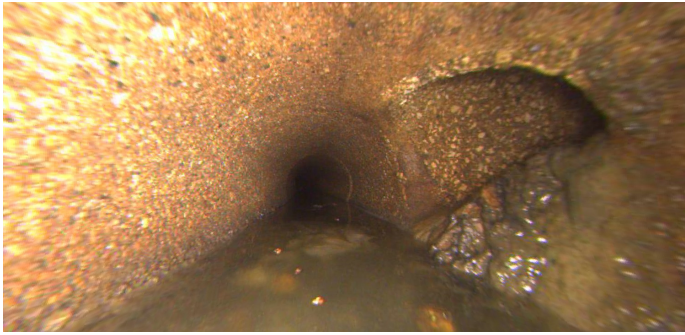
Code: **TFD**
Description: **Tap Factory Defective**

Distance (ft): **127.4**
Structural Grade: **0**
O&M Grade: **2**
Clock Start/From: **2**
Clock To:
1st Value: **4.000**
2nd Value:
Value Percent:
Continuous Index:
Within 8" of Joint:
Remarks: **dae**

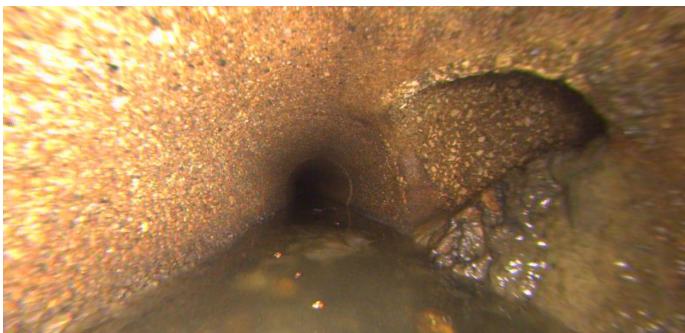
Code: **DAE**
Description: **Deposits Attached Encrustation**

Distance (ft): **127.4**
Structural Grade: **0**
O&M Grade: **2**
Clock Start/From: **3**
Clock To: **4**
1st Value:
2nd Value:
Value Percent: **5.000**
Continuous Index:
Within 8" of Joint: **NO**
Remarks:

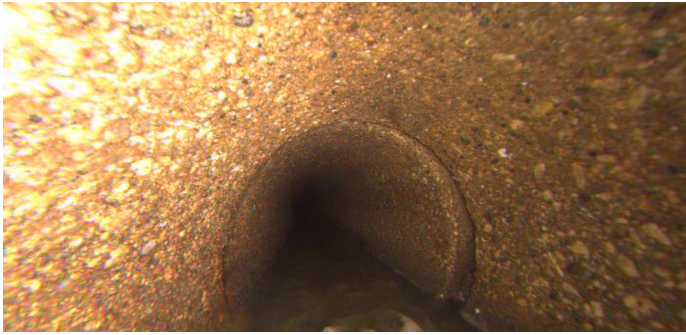
Code: **SAP**
Description: **Surface Aggregate Projecting**

Distance (ft): **129.4**
Structural Grade: **3**
O&M Grade: **0**
Clock Start/From: **7**
Clock To: **5**
1st Value:
2nd Value:
Value Percent:
Continuous Index: **F01**
Within 8" of Joint:
Remarks:

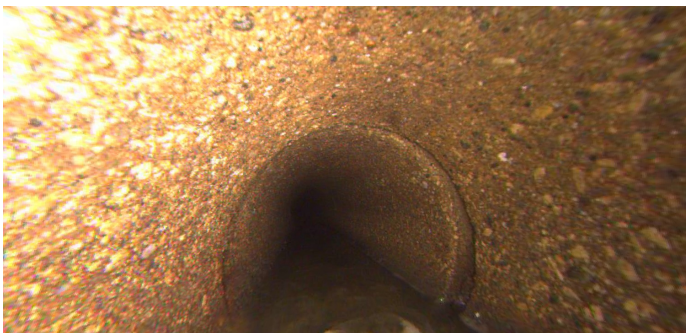
Code: **MSA**
Description: **Abandoned Survey**

Distance (ft): **129.4**
Structural Grade: **0**
O&M Grade: **0**
Clock Start/From:
Clock To:
1st Value:
2nd Value:
Value Percent:
Continuous Index:
Within 8" of Joint: **NO**
Remarks: **debris under water**
