## Profile/Photo Observation Report

Street:	<b>Beverly Blvd.</b>	Flow Control:	<b>Not Controlled</b>
City:	<b>Hobart, IN</b>	Year Renewed:	
Location:	<b>Other</b>	Tape/Media #:	
Purpose:	<b>Not Known</b>	Dia/Height:	<b>10"</b>
Use:	<b>Sanitary</b>	Material:	<b>VCP</b>
Drain Area:	<b>NA</b>	Lining:	
Category:	<b>NA</b>		
Comment:

Location Details:		Direction of Survey:	<b>Upstream</b>
US MH:	<b>M-604-007</b>	DS MH:	<b>M-604-008</b>
		Total Length Surveyed (ft):	<b>129.4</b>

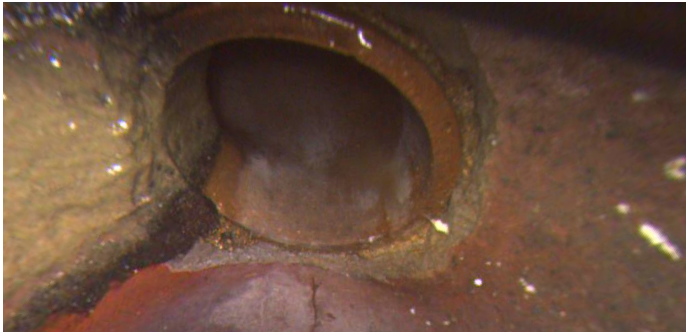
Code: **TBI**  
Description: **Tap Break-in Intruding**

Distance (ft): **2.5**  
Structural Grade: **0**  
O&M Grade: **2**  
Clock Start/From: **12**  
Clock To:  
1st Value: **4.000**  
2nd Value: **1.000**  
Value Percent:  
Continuous Index:  
Within 8" of Joint:  
Remarks:

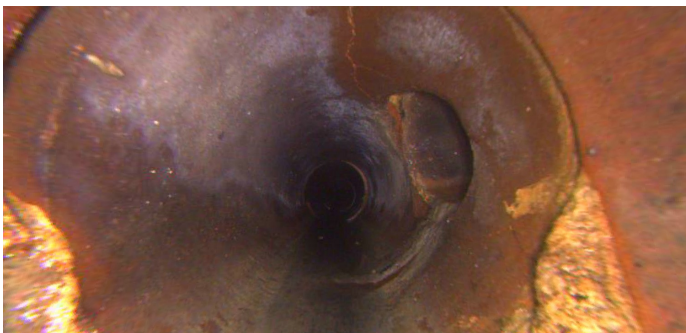
Code: **DAE**  
Description: **Deposits Attached Encrustation**

Distance (ft): **3.6**  
Structural Grade: **0**  
O&M Grade: **2**  
Clock Start/From: **8**  
Clock To: **4**  
1st Value:  
2nd Value:  
Value Percent: **5.000**  
Continuous Index:  
Within 8" of Joint: **YES**  
Remarks:

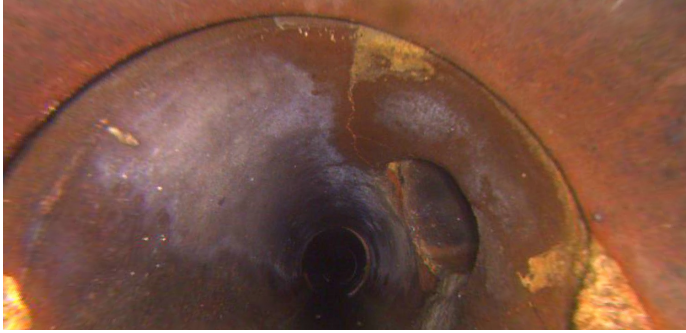
Code: **FS**  
Description: **Fracture Spiral**

Distance (ft): **3.6**  
Structural Grade: **3**  
O&M Grade: **0**  
Clock Start/From: **12**  
Clock To: **1**  
1st Value:  
2nd Value:  
Value Percent:  
Continuous Index:  
Within 8" of Joint: **YES**  
Remarks:

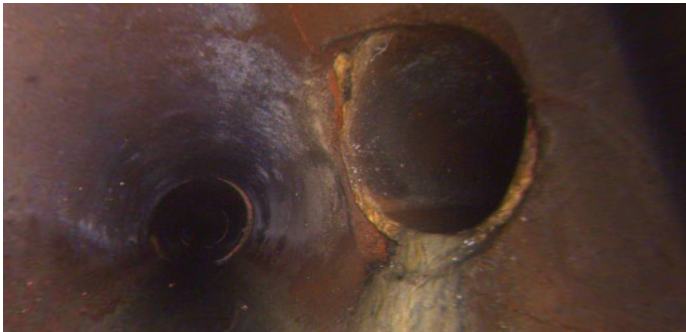
Code: **TBI**  
Description: **Tap Break-in Intruding**

Distance (ft): **4.2**  
Structural Grade: **0**  
O&M Grade: **2**  
Clock Start/From: **3**  
Clock To:  
1st Value: **4.000**  
2nd Value: **1.000**  
Value Percent:  
Continuous Index:  
Within 8" of Joint:  
Remarks:

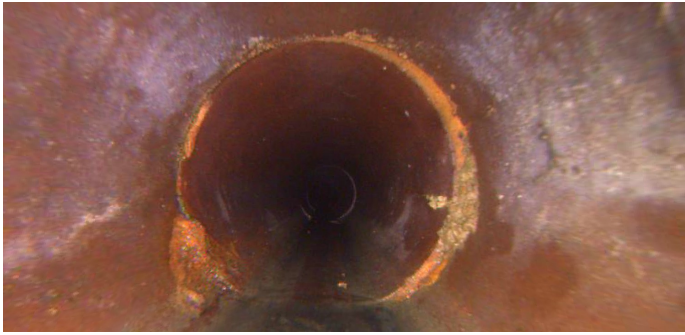
Code: **DAE**  
Description: **Deposits Attached Encrustation**

Distance (ft): **6.2**  
Structural Grade: **0**  
O&M Grade: **2**  
Clock Start/From: **8**  
Clock To: **4**  
1st Value:  
2nd Value:  
Value Percent: **5.000**  
Continuous Index:  
Within 8" of Joint: **YES**  
Remarks:

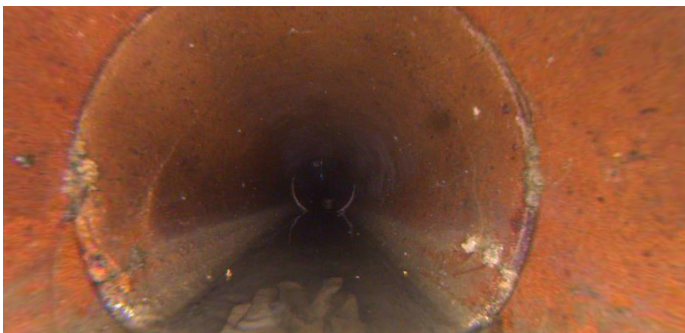
Code: **FC**  
Description: **Fracture Circumferential**

Distance (ft): **21.5**  
Structural Grade: **2**  
O&M Grade: **0**  
Clock Start/From: **8**  
Clock To: **4**  
1st Value:  
2nd Value:  
Value Percent:  
Continuous Index:  
Within 8" of Joint: **YES**  
Remarks:

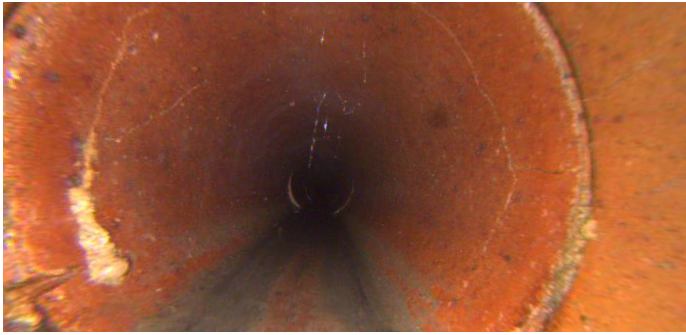
Code: **FC**  
Description: **Fracture Circumferential**

Distance (ft): **30.6**  
Structural Grade: **2**  
O&M Grade: **0**  
Clock Start/From: **8**  
Clock To: **4**  
1st Value:  
2nd Value:  
Value Percent:  
Continuous Index:  
Within 8" of Joint: **YES**  
Remarks:

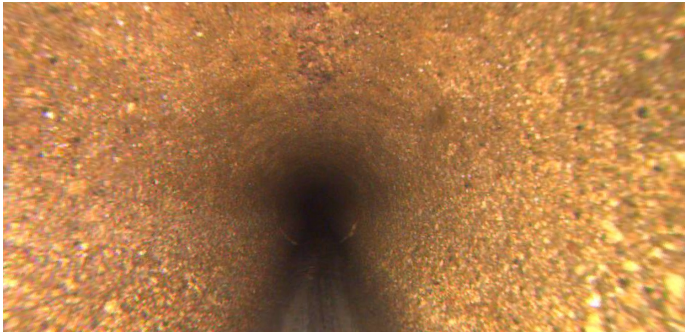
Code: **SAP**  
Description: **Surface Aggregate Projecting**

Distance (ft): **40.3**  
Structural Grade: **3**  
O&M Grade: **0**  
Clock Start/From: **7**  
Clock To: **5**  
1st Value:  
2nd Value:  
Value Percent:  
Continuous Index: **S01**  
Within 8" of Joint:  
Remarks:

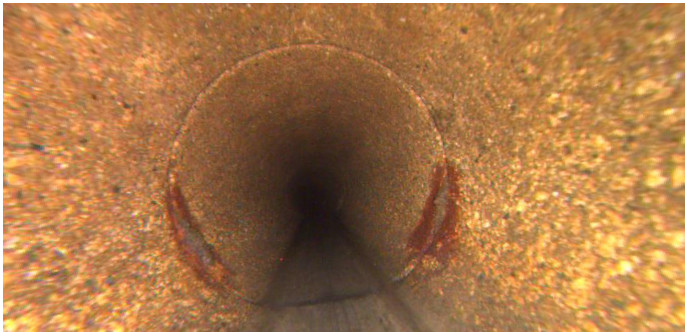
Code: **IS**  
Description: **Infil Stain**

Distance (ft): **45.0**  
Structural Grade: **0**  
O&M Grade: **0**  
Clock Start/From: **8**  
Clock To: **4**  
1st Value:  
2nd Value:  
Value Percent:  
Continuous Index: **S02**  
Within 8" of Joint: **YES**  
Remarks:

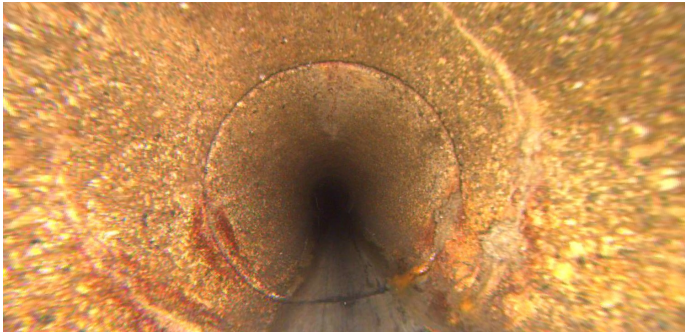
Code: **FC**  
Description: **Fracture Circumferential**

Distance (ft): **48.1**  
Structural Grade: **2**  
O&M Grade: **0**  
Clock Start/From: **7**  
Clock To: **5**  
1st Value:  
2nd Value:  
Value Percent:  
Continuous Index:  
Within 8" of Joint:  
Remarks:

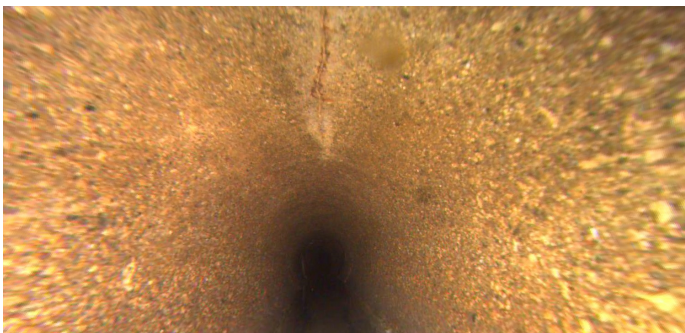
Code: **FL**  
Description: **Fracture Longitudinal**

Distance (ft): **48.8**  
Structural Grade: **3**  
O&M Grade: **0**  
Clock Start/From: **12**  
Clock To:  
1st Value:  
2nd Value:  
Value Percent:  
Continuous Index:  
Within 8" of Joint: **YES**  
Remarks:

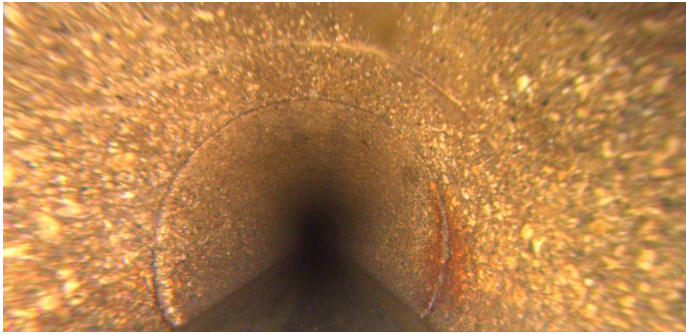
Code: **FC**  
Description: **Fracture Circumferential**

Distance (ft): **57.2**  
Structural Grade: **2**  
O&M Grade: **0**  
Clock Start/From: **10**  
Clock To: **2**  
1st Value:  
2nd Value:  
Value Percent:  
Continuous Index:  
Within 8" of Joint:  
Remarks:

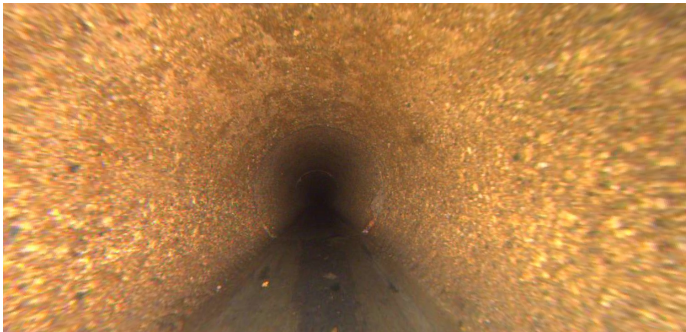
Code: **IS**  
Description: **Infil Stain**

Distance (ft): **71.5**  
Structural Grade: **0**  
O&M Grade: **0**  
Clock Start/From: **8**  
Clock To: **4**  
1st Value:  
2nd Value:  
Value Percent:  
Continuous Index: **F02**  
Within 8" of Joint: **YES**  
Remarks:

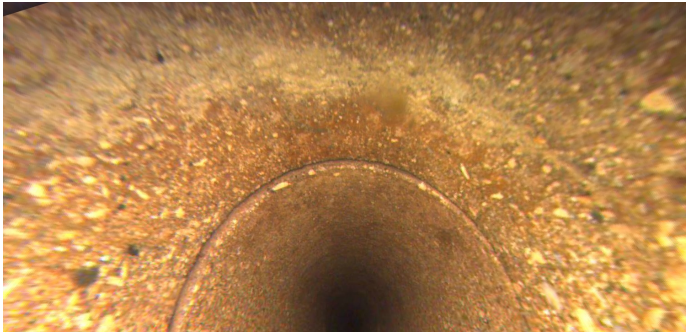
Code: **FC**  
Description: **Fracture Circumferential**

Distance (ft): **75.3**  
Structural Grade: **2**  
O&M Grade: **0**  
Clock Start/From: **10**  
Clock To: **2**  
1st Value:  
2nd Value:  
Value Percent:  
Continuous Index:  
Within 8" of Joint:  
Remarks:

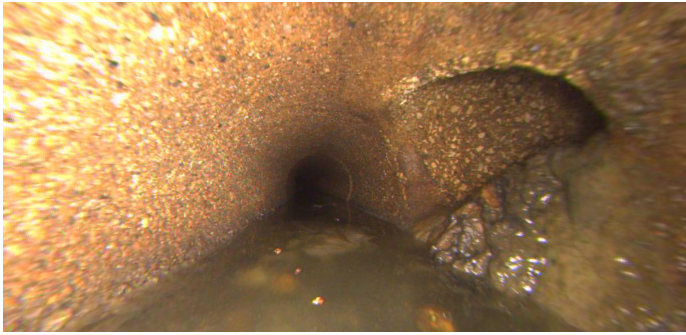
Code: **TFD**  
Description: **Tap Factory Defective**

Distance (ft): **127.4**  
Structural Grade: **0**  
O&M Grade: **2**  
Clock Start/From: **2**  
Clock To:  
1st Value: **4.000**  
2nd Value:  
Value Percent:  
Continuous Index:  
Within 8" of Joint:  
Remarks: **dae**

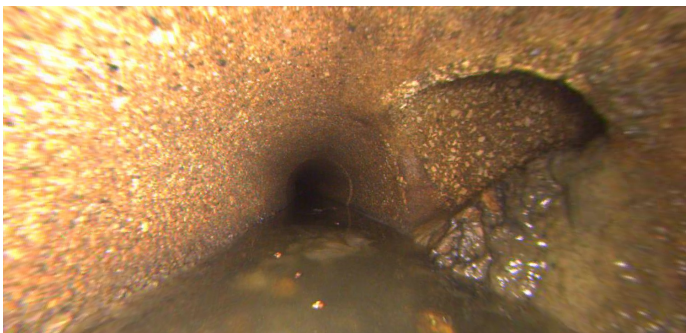
Code: **DAE**  
Description: **Deposits Attached Encrustation**

Distance (ft): **127.4**  
Structural Grade: **0**  
O&M Grade: **2**  
Clock Start/From: **3**  
Clock To: **4**  
1st Value:  
2nd Value:  
Value Percent: **5.000**  
Continuous Index:  
Within 8" of Joint: **NO**  
Remarks:

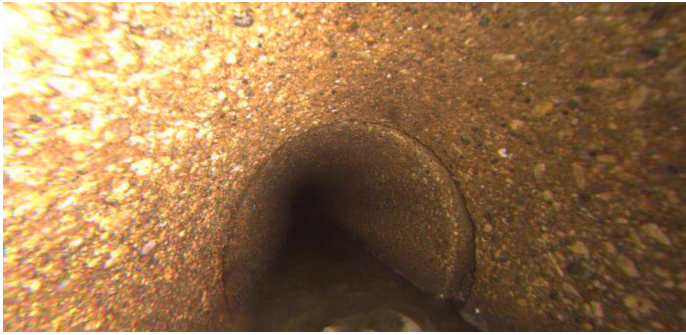
Code: **SAP**  
Description: **Surface Aggregate Projecting**

Distance (ft): **129.4**  
Structural Grade: **3**  
O&M Grade: **0**  
Clock Start/From: **7**  
Clock To: **5**  
1st Value:  
2nd Value:  
Value Percent:  
Continuous Index: **F01**  
Within 8" of Joint:  
Remarks:

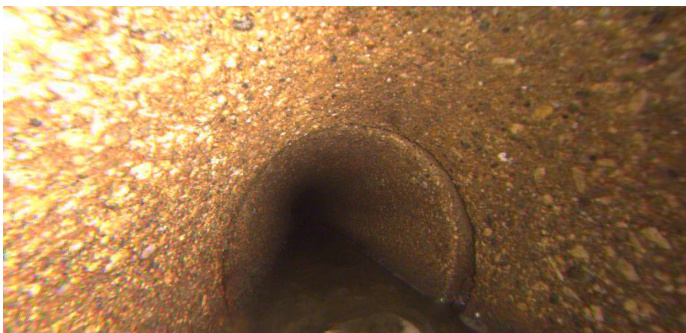
Code: **MSA**  
Description: **Abandoned Survey**

Distance (ft): **129.4**  
Structural Grade: **0**  
O&M Grade: **0**  
Clock Start/From:  
Clock To:  
1st Value:  
2nd Value:  
Value Percent:  
Continuous Index:  
Within 8" of Joint: **NO**  
Remarks: **debris under water**
