RedZone
ROBOTICS

Street:	Beverly Boulevard		Flow Control:	Not Controlled	
City:	City of Hobart		Year Renewed:		
Location:	Local rural streets with light traffic, t		Tape/Media #:		
Purpose:	Routine Assessment		Dia/Height:	10"	
Use:	Sanitary Sewage Pipe		Material:	CP	
Drain Area:			Lining:	None	
Category:	NA				
Comment:					
Location Details:			Direction of Survey:	Downstream	
US MH:	M-604-007	DS MH:	M-604-008	Total Length Surveyed (ft):	282.3

Tuesday, April 25, 2023

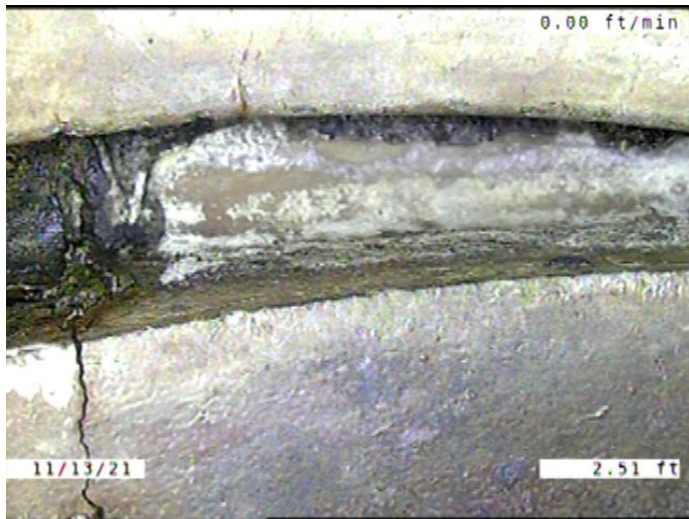
Code: **JAM**
 Description: **Joint Angular Medium**

Distance (ft): **2.5**
 Structural Grade: **3**
 O&M Grade: **0**
 Clock Start/From:
 Clock To:
 1st Value:
 2nd Value:
 Value Percent:
 Continuous Index:
 Within 8" of Joint: **NO**
 Remarks:

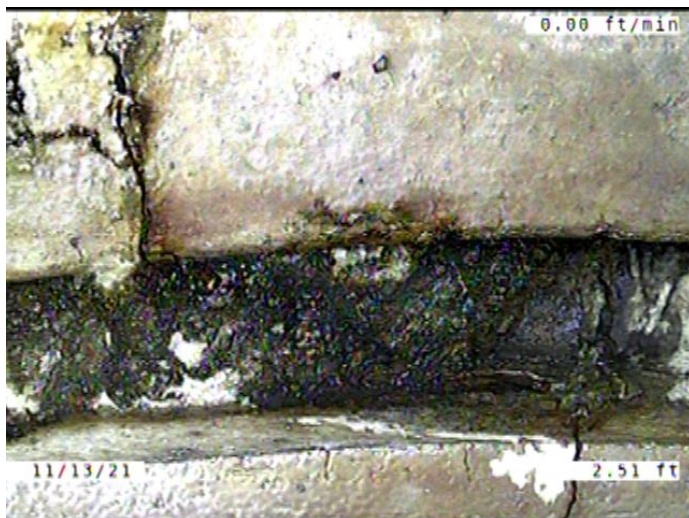
Code: **CM**
 Description: **Crack Multiple**

Distance (ft): **2.5**
 Structural Grade: **3**
 O&M Grade: **0**
 Clock Start/From: **8**
 Clock To: **10**
 1st Value:
 2nd Value:
 Value Percent:
 Continuous Index:
 Within 8" of Joint: **YES**
 Remarks:

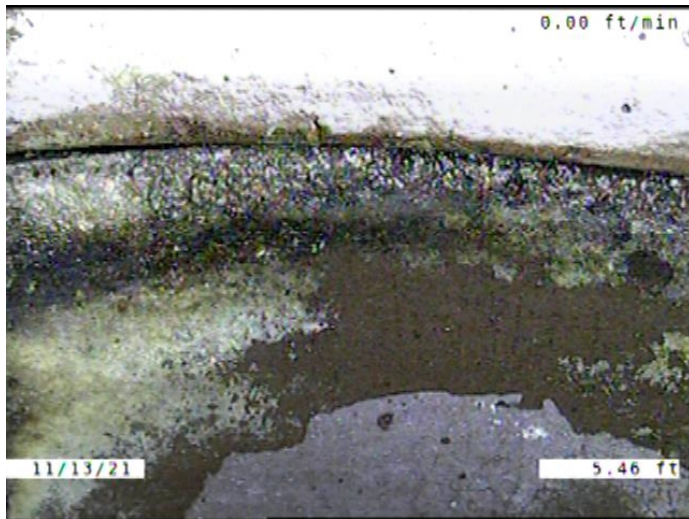
Code: **DAE**
 Description: **Deposits Attached Encrustation**

Distance (ft): **5.5**
 Structural Grade: **0**
 O&M Grade: **2**
 Clock Start/From: **11**
 Clock To: **5**
 1st Value:
 2nd Value:
 Value Percent: **5.000**
 Continuous Index:
 Within 8" of Joint: **YES**
 Remarks:

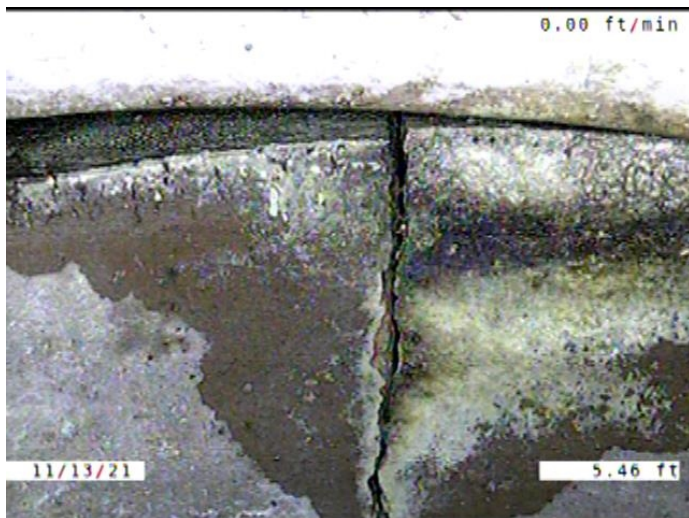
Code: **B**
 Description: **Broken**

Distance (ft): **5.5**
 Structural Grade: **4**
 O&M Grade: **0**
 Clock Start/From: **10**
 Clock To: **4**
 1st Value:
 2nd Value:
 Value Percent:
 Continuous Index:
 Within 8" of Joint: **YES**
 Remarks:

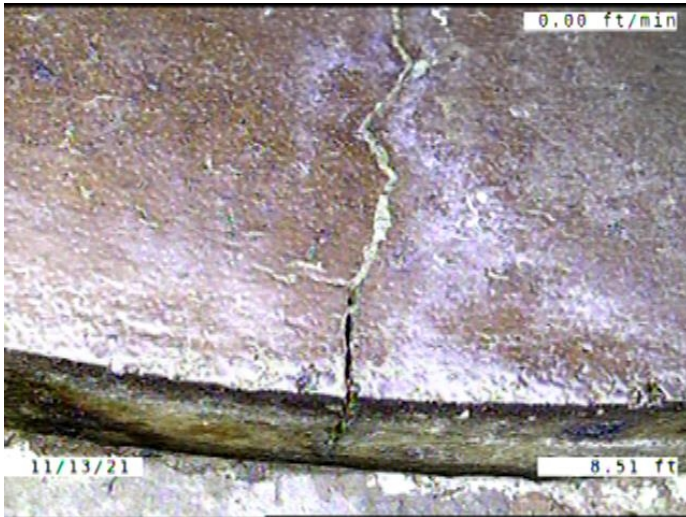
Code: **CM**
 Description: **Crack Multiple**

Distance (ft): **8.5**
 Structural Grade: **3**
 O&M Grade: **0**
 Clock Start/From: **3**
 Clock To: **4**
 1st Value:
 2nd Value:
 Value Percent:
 Continuous Index:
 Within 8" of Joint: **YES**
 Remarks:

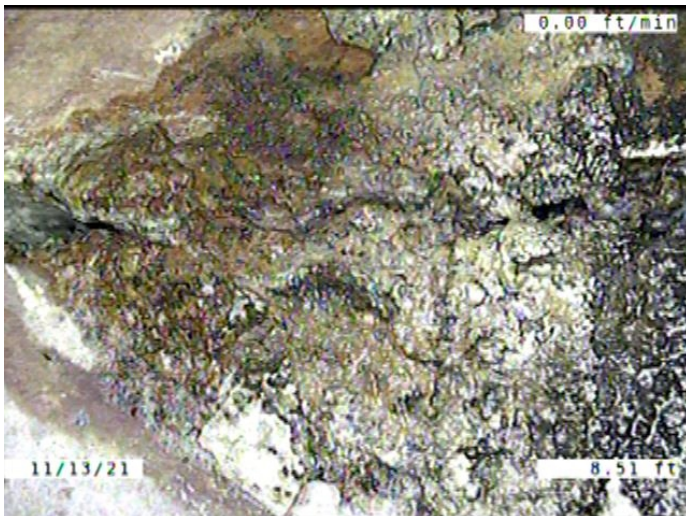
Code: **DAE**
 Description: **Deposits Attached Encrustation**

Distance (ft): **8.5**
 Structural Grade: **0**
 O&M Grade: **2**
 Clock Start/From: **7**
 Clock To: **5**
 1st Value:
 2nd Value:
 Value Percent: **5.000**
 Continuous Index: **S01**
 Within 8" of Joint: **YES**
 Remarks:

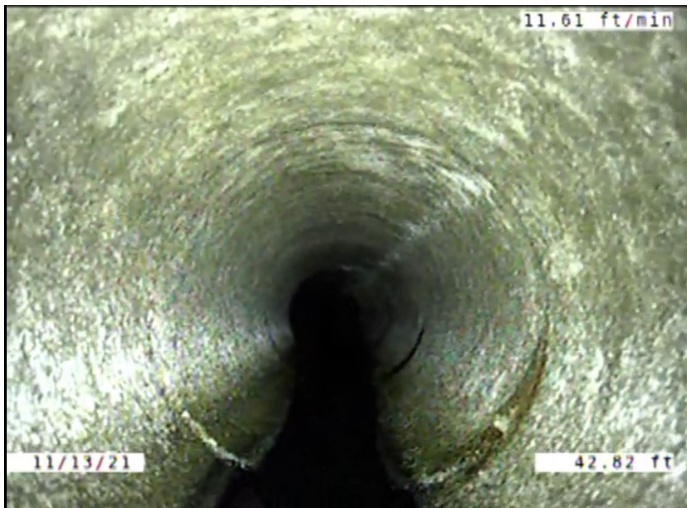
Code: **ISJ**
 Description: **Infiltration Stain Joint**

Distance (ft): **42.8**
 Structural Grade: **0**
 O&M Grade: **1**
 Clock Start/From: **3**
 Clock To: **5**
 1st Value:
 2nd Value:
 Value Percent:
 Continuous Index: **S09**
 Within 8" of Joint: **YES**
 Remarks:

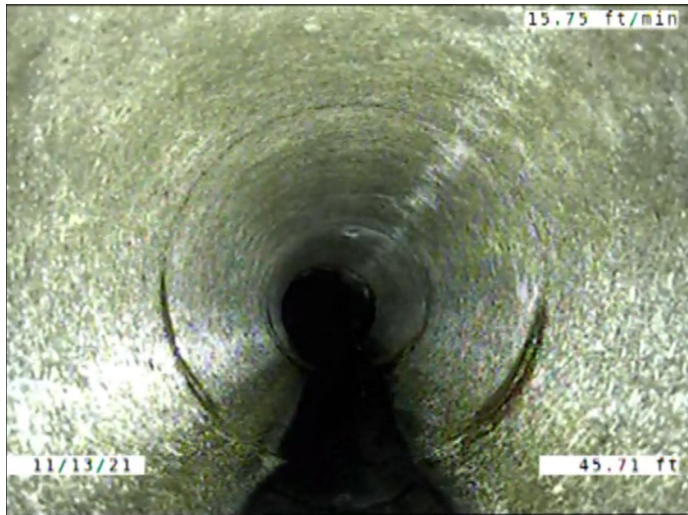
Code: **ISJ**
Description: **Infiltration Stain Joint**

Distance (ft): **45.7**
Structural Grade: **0**
O&M Grade: **1**
Clock Start/From: **7**
Clock To: **9**
1st Value:
2nd Value:
Value Percent:
Continuous Index: **S10**
Within 8" of Joint: **YES**
Remarks:

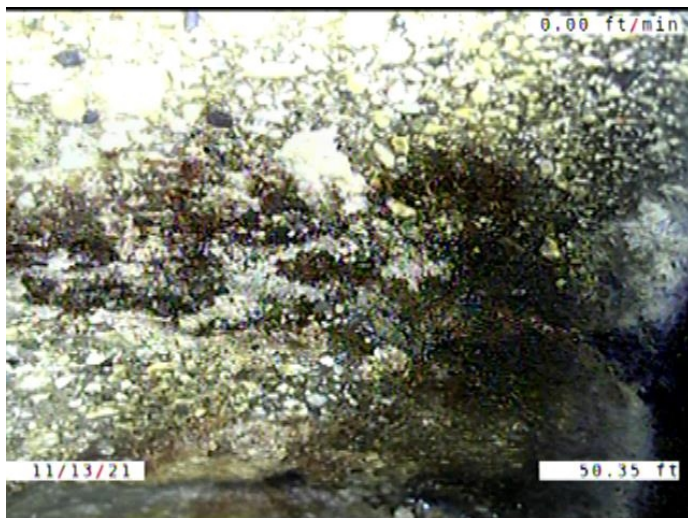
50.4	FM	Fracture Multiple	1009	S 4
55.5	TF	Tap Factory	1065	NA
55.9	TBI	Tap Break-in Intruding	1124	M 2
57.7	ISJ(F10)	Infiltration Stain Joint	1155	M 1
59.7	CM	Crack Multiple	1197	S 3

Code: **FM**
Description: **Fracture Multiple**

Distance (ft): **50.4**
Structural Grade: **4**
O&M Grade: **0**
Clock Start/From: **12**
Clock To: **12**
1st Value:
2nd Value:
Value Percent:
Continuous Index:
Within 8" of Joint: **YES**
Remarks:

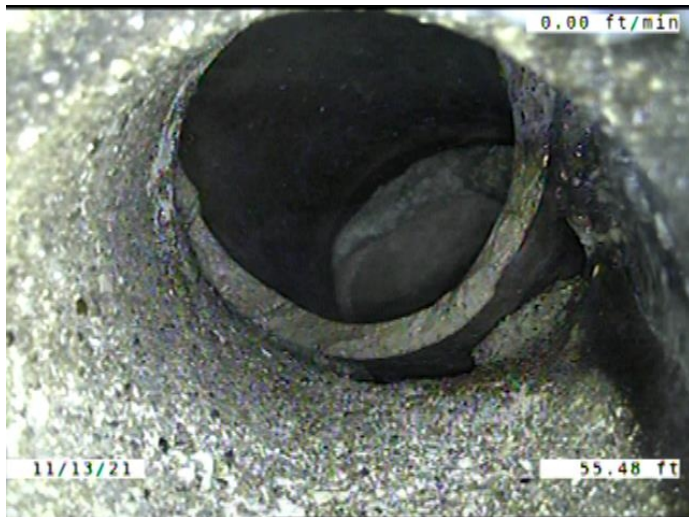
Code:	TF
Description:	Tap Factory
Distance (ft):	55.5
Structural Grade:	0
O&M Grade:	0
Clock Start/From:	2
Clock To:	
1st Value:	6.000
2nd Value:	
Value Percent:	
Continuous Index:	
Within 8" of Joint:	YES
Remarks:	CONSTANTLY RUNNING WATER.

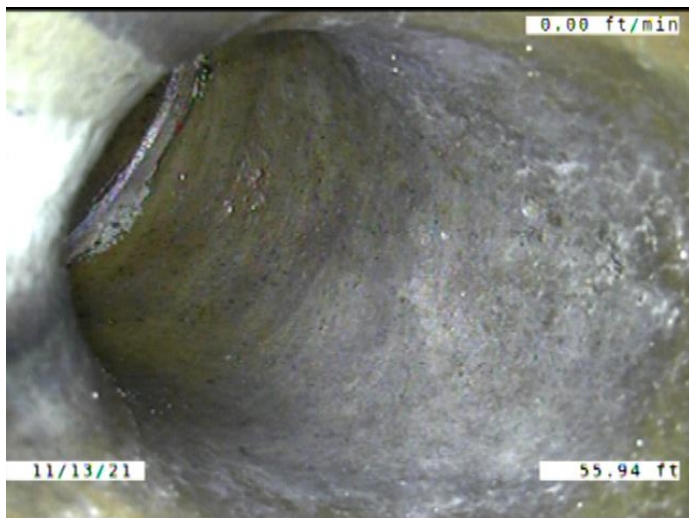
Code:	TBI
Description:	Tap Break-in Intruding
Distance (ft):	55.9
Structural Grade:	0
O&M Grade:	2
Clock Start/From:	12
Clock To:	
1st Value:	4.000
2nd Value:	1.000
Value Percent:	
Continuous Index:	
Within 8" of Joint:	YES
Remarks:

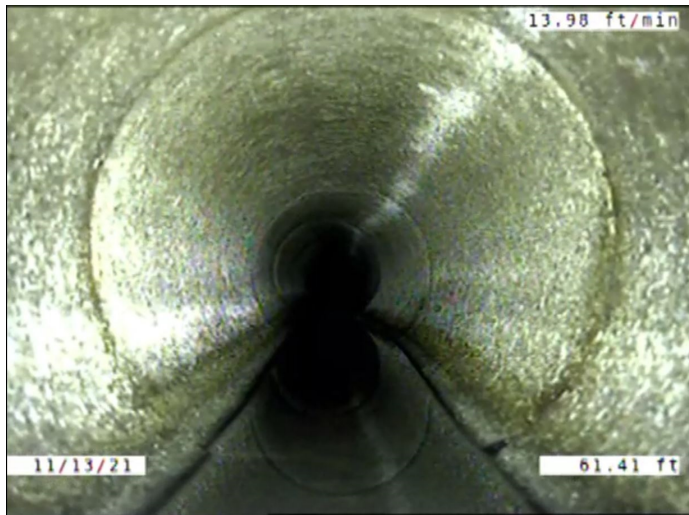
Code: **ISJ**
Description: **Infiltration Stain Joint**

Distance (ft): **61.4**
Structural Grade: **0**
O&M Grade: **1**
Clock Start/From: **3**
Clock To: **5**
1st Value:
2nd Value:
Value Percent:
Continuous Index: **F09**
Within 8" of Joint: **YES**
Remarks:

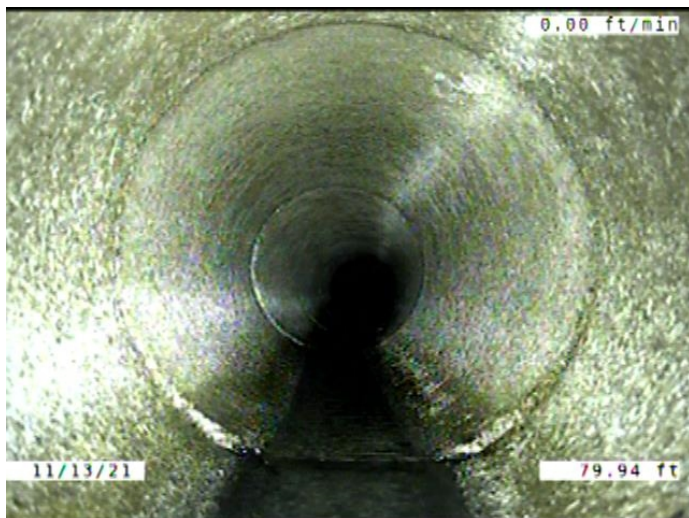
Code: **DAE**
Description: **Deposits Attached Encrustation**

Distance (ft): **79.9**
Structural Grade: **0**
O&M Grade: **2**
Clock Start/From: **7**
Clock To: **5**
1st Value:
2nd Value:
Value Percent: **5.000**
Continuous Index: **F01**
Within 8" of Joint: **YES**
Remarks:

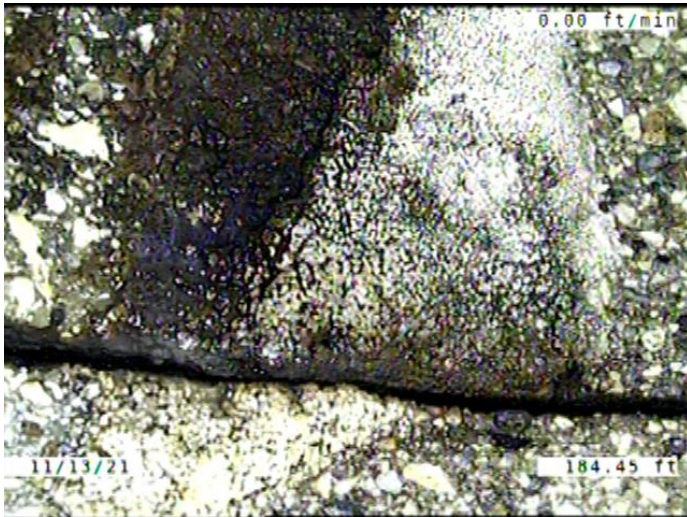
Code: **DAE**
Description: **Deposits Attached Encrustation**

Distance (ft): **184.5**
Structural Grade: **0**
O&M Grade: **2**
Clock Start/From: **2**
Clock To: **3**
1st Value:
2nd Value:
Value Percent: **5.000**
Continuous Index:
Within 8" of Joint: **YES**
Remarks:

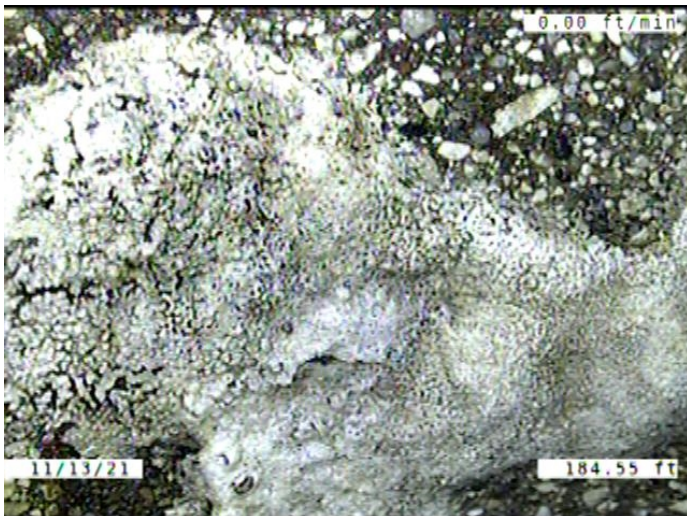
Code: **DAE**
Description: **Deposits Attached Encrustation**

Distance (ft): **184.5**
Structural Grade: **0**
O&M Grade: **2**
Clock Start/From: **9**
Clock To: **11**
1st Value:
2nd Value:
Value Percent: **5.000**
Continuous Index:
Within 8" of Joint: **YES**
Remarks:

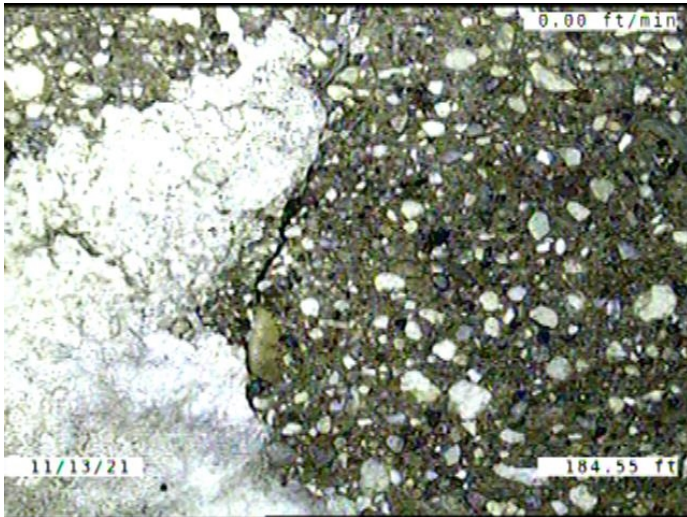
Code: **FM**
 Description: **Fracture Multiple**

Distance (ft): **184.6**
 Structural Grade: **4**
 O&M Grade: **0**
 Clock Start/From: **4**
 Clock To: **11**
 1st Value:
 2nd Value:
 Value Percent:
 Continuous Index:
 Within 8" of Joint: **YES**
 Remarks:

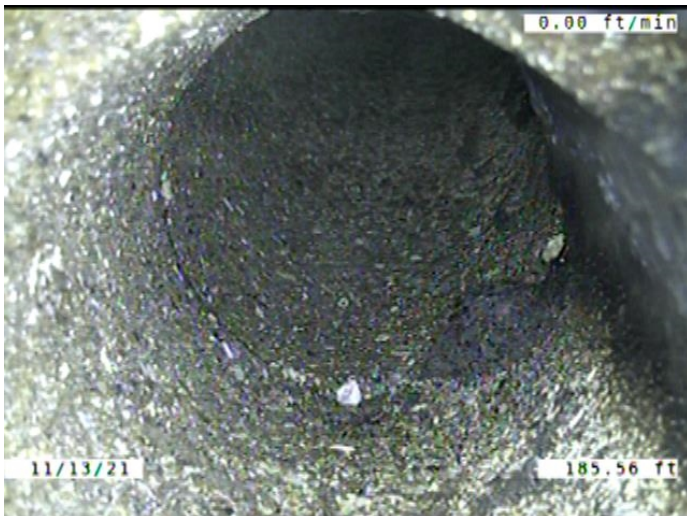
Code: **TF**
 Description: **Tap Factory**

Distance (ft): **185.6**
 Structural Grade: **0**
 O&M Grade: **0**
 Clock Start/From: **2**
 Clock To:
 1st Value: **6.000**
 2nd Value:
 Value Percent:
 Continuous Index:
 Within 8" of Joint: **YES**
 Remarks: **CONSTANTLY RUNNING WATER.**

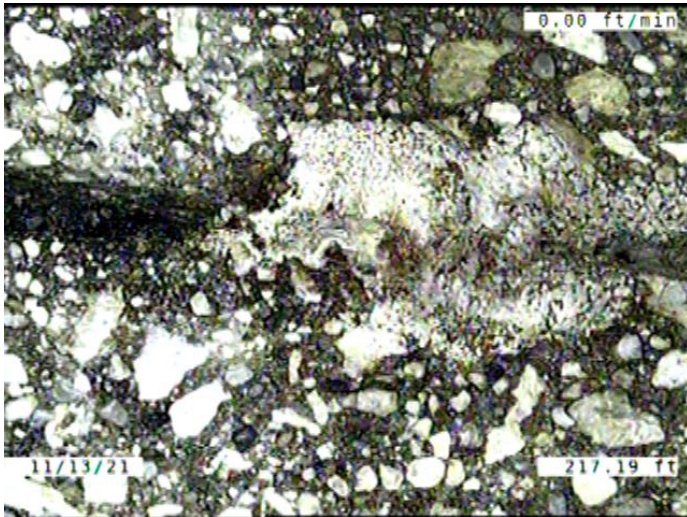
Code: **DAE**
 Description: **Deposits Attached Encrustation**

Distance (ft): **217.2**
 Structural Grade: **0**
 O&M Grade: **2**
 Clock Start/From: **3**
 Clock To: **4**
 1st Value:
 2nd Value:
 Value Percent: **5.000**
 Continuous Index:
 Within 8" of Joint: **YES**
 Remarks:

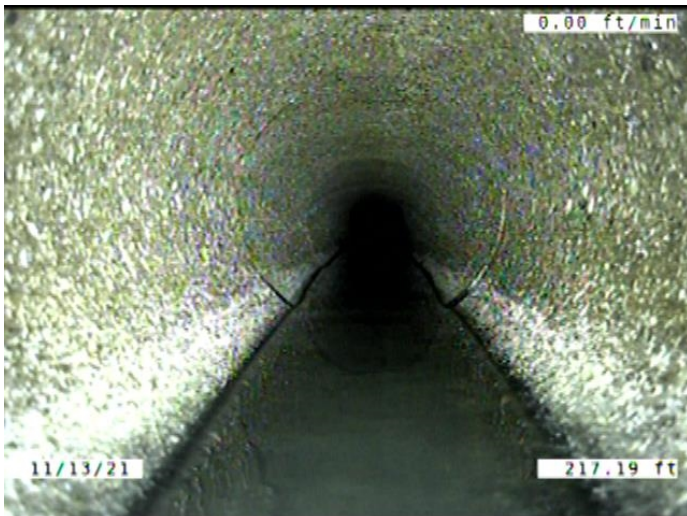
Code: **MWLS**
 Description: **Miscellaneous Water Level Sag**

Distance (ft): **217.2**
 Structural Grade: **2**
 O&M Grade: **0**
 Clock Start/From:
 Clock To:
 1st Value:
 2nd Value:
 Value Percent: **10.000**
 Continuous Index: **S07**
 Within 8" of Joint: **NO**
 Remarks:

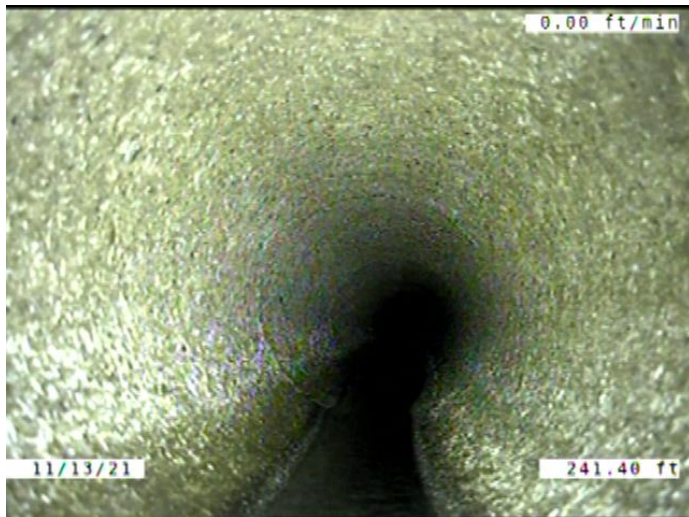
Code: **MWLS**
 Description: **Miscellaneous Water Level Sag**

Distance (ft): **241.4**
 Structural Grade: **2**
 O&M Grade: **0**
 Clock Start/From:
 Clock To:
 1st Value:
 2nd Value:
 Value Percent: **10.000**
 Continuous Index: **F07**
 Within 8" of Joint: **NO**
 Remarks:

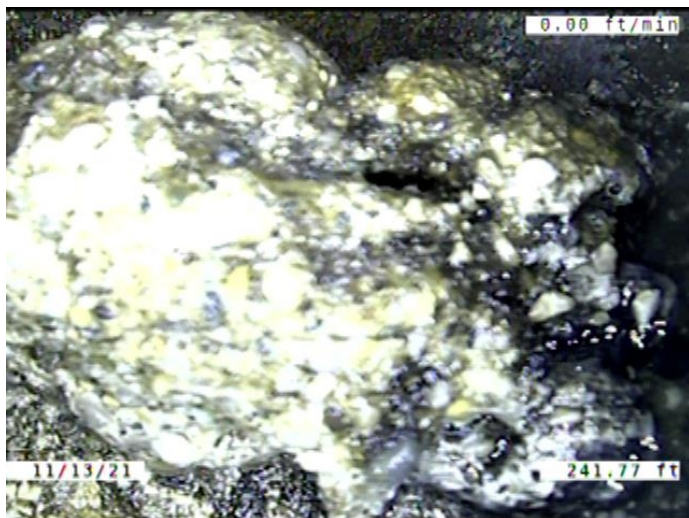
Code: **DAE**
 Description: **Deposits Attached Encrustation**

Distance (ft): **241.8**
 Structural Grade: **0**
 O&M Grade: **2**
 Clock Start/From: **7**
 Clock To: **9**
 1st Value:
 2nd Value:
 Value Percent: **5.000**
 Continuous Index:
 Within 8" of Joint: **YES**
 Remarks:
